April 2016 Newsletter

Photo Essay

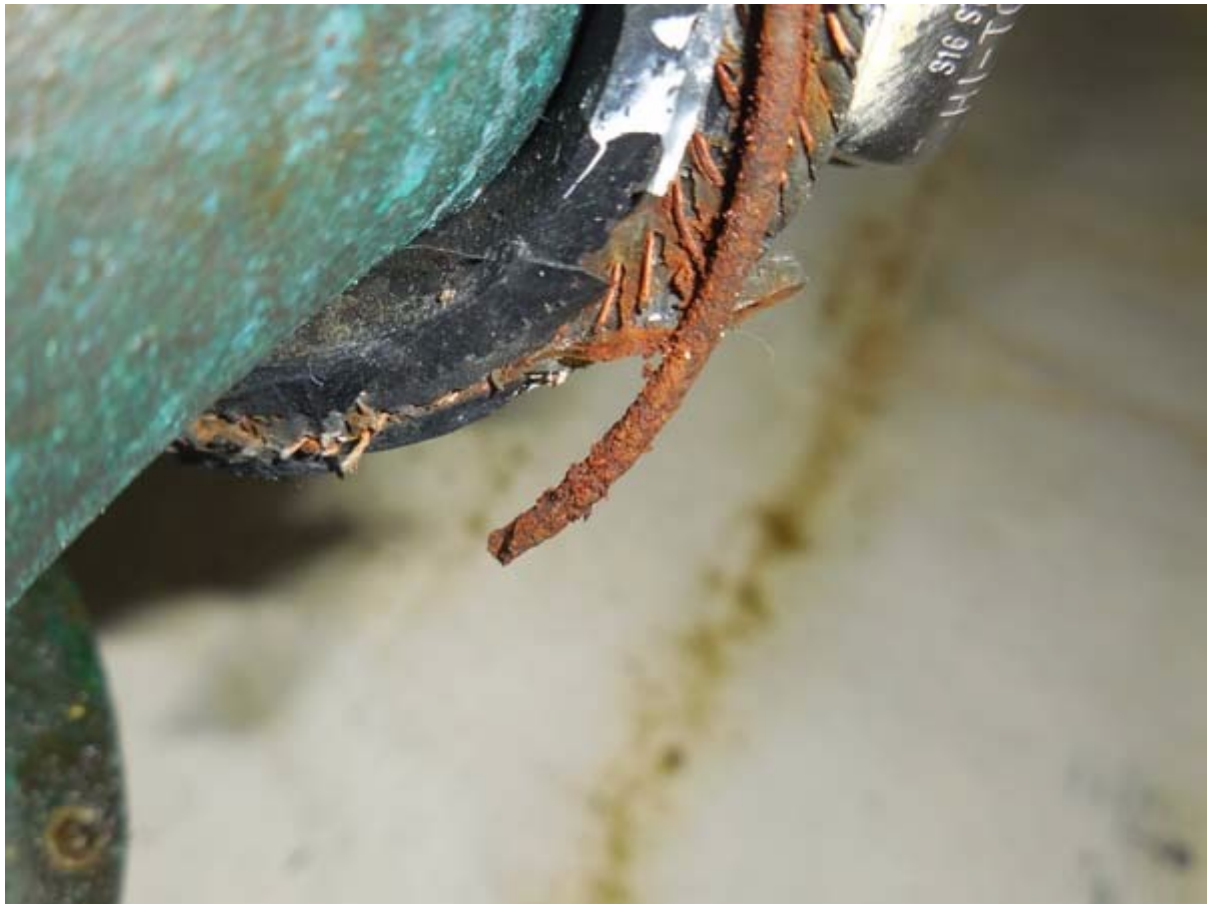
While it may be cliché, the first words that come to mind when I see this image are, “An accident waiting to happen”. As someone who spends a considerable amount of time crawling around engine rooms, through bilges and in engineering spaces, I’m acutely sensitive to laceration and injury hazards. I’ve given more than my fair share of blood thanks to errant hose clamps, cut-off wire ties and exposed fasteners. Generally speaking hose clamps are the worst offender, perhaps because there are so many of them aboard every boat. You can improve their safety record by making sure the correct length is used, avoiding the ubiquitous, scythe-like “tail” that protrudes from so many of them. Even when the length is correct, they

In the case shown here, the exposed, rusty hose reinforcing wire should be cleanly cut off as close to the hose as possible. In cases where it's impossible to cut this off flush, applying a dab of silicone or polyurethane sealant over the remaining exposed wire will cover the sharp edge.

remain a hazard which can be further mitigated with two approaches. First, using a needle nose pliers bend the bitter end down so it's pressing against the tensioned portion of the clamp. Second, install hose finishers, I prefer the silicone rather than PVC variety, they are stickier and less likely to fall off. This treatment of hose clamps is especially important in high hand traffic areas, on and around engines, near all seacocks and valves and under sinks.

Wire ties can be rendered safe by using a proprietary "flush cut" wire tie cutting tool. See this Facebook post for details.
