April 2016 Newsletter

Photo Essay

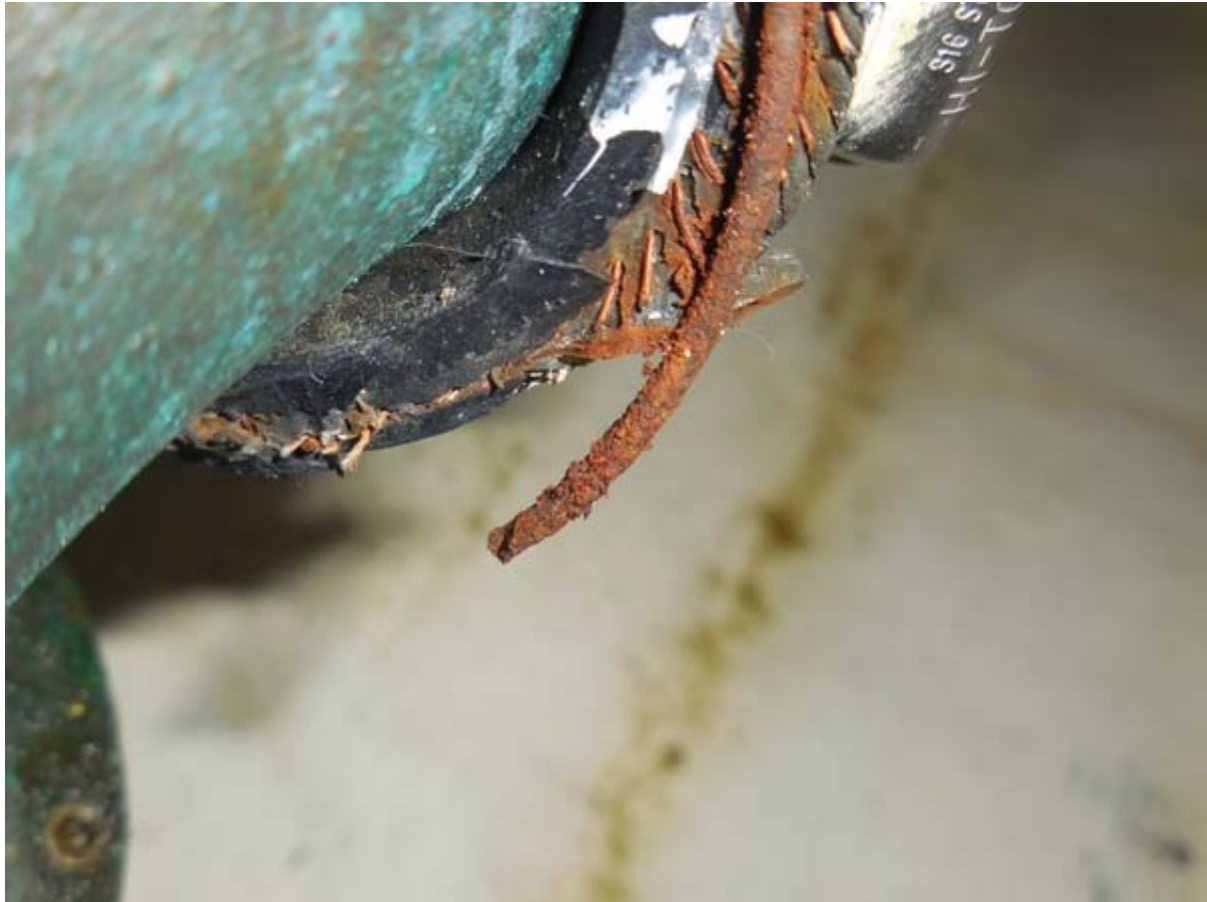
While it may be cliché, the first words that come to mind when I see this image are, “An accident waiting to happen”. As someone who spends a considerable amount of time crawling around engine rooms, through bilges and in engineering spaces, I’m acutely sensitive to laceration and injury hazards. I’ve given more than my fair share of blood thanks to errant hose clamps, cut-off wire ties and exposed fasteners. Generally speaking hose clamps are the worst offender, perhaps because there are so many of them aboard every boat. You can improve their safety record by making sure the correct length is used, avoiding the ubiquitous, scythe-like “tail” that protrudes from so many of them. Even when the length is correct, they

remain a hazard which can be further mitigated with two approaches. First, using a needle nose pliers bend the bitter end down so it's pressing against the tensioned portion of the clamp. Second, install hose finishers, I prefer the silicone rather than PVC variety, they are stickier and less likely to fall off. This treatment of hose clamps is especially important in high hand traffic areas, on and around engines, near all seacocks and valves and under sinks.

In the case shown here, the exposed, rusty hose reinforcing wire should be cleanly cut off as close to the hose as possible. In cases where it's impossible to cut this off flush, applying a dab of silicone or polyurethane sealant over the remaining exposed wire will cover the sharp edge.
