July 2025 Newsletter – Risers and Siphon-Breaks

Photo Essay: The Perils of an Unvented Loop

Raw water pump cam screw failures

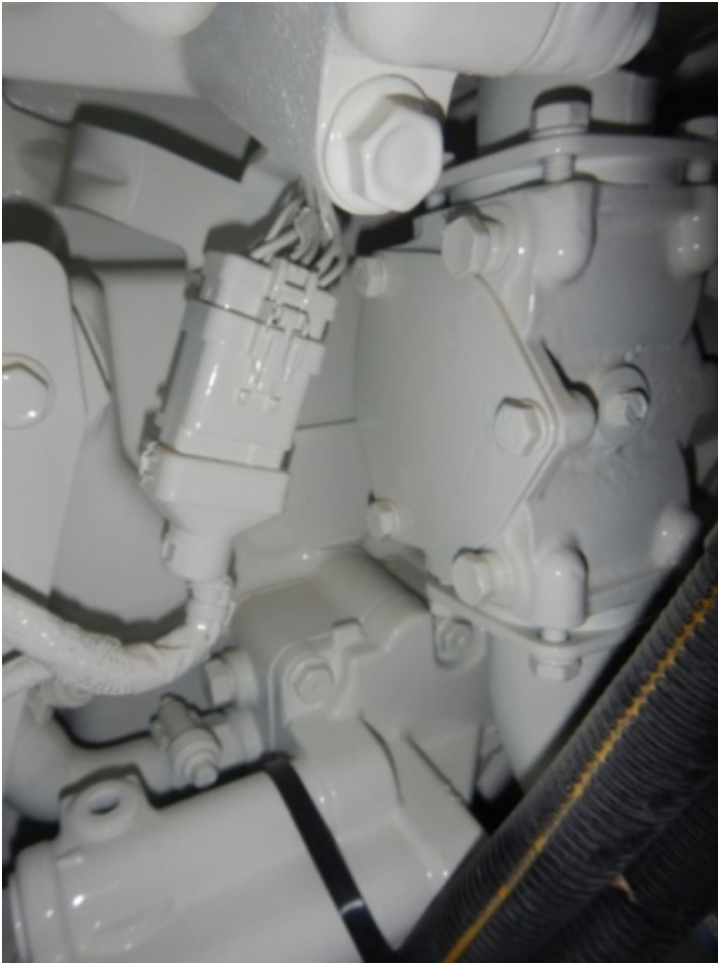
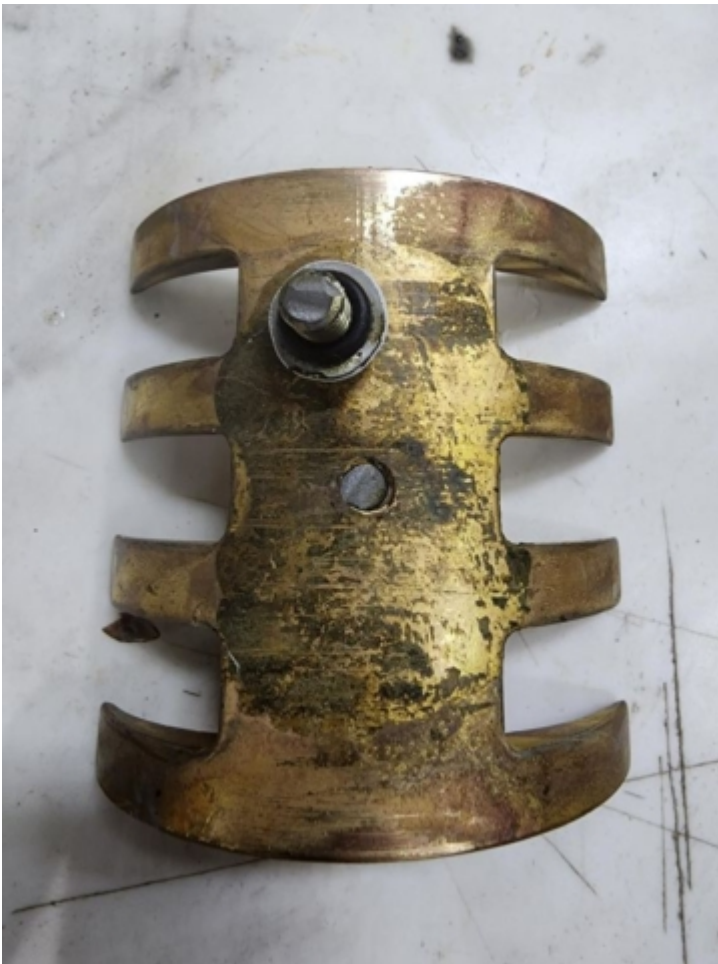
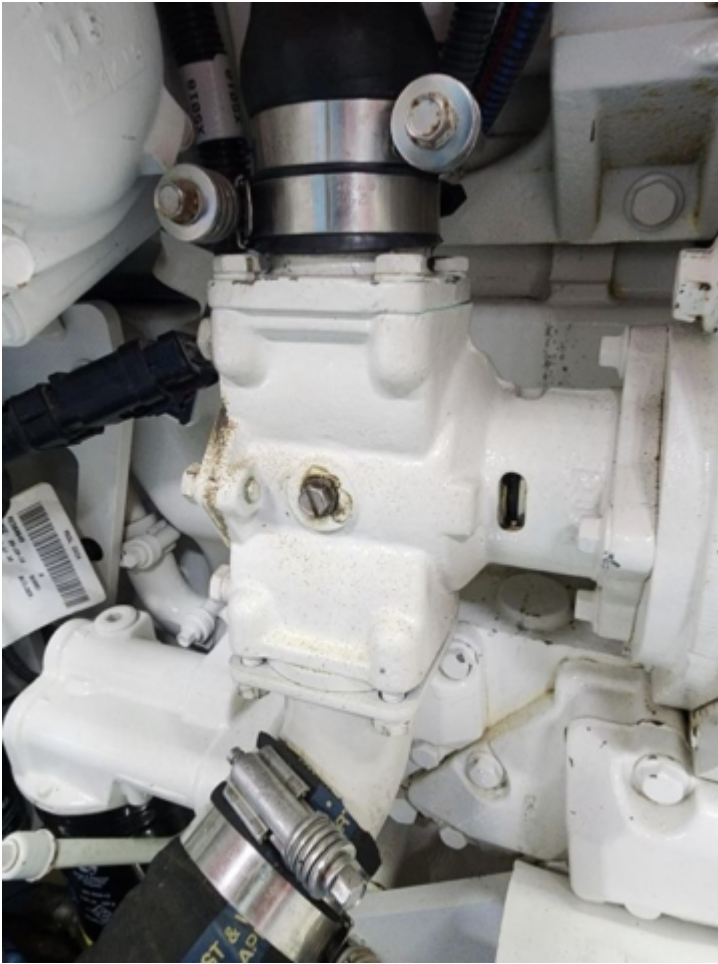
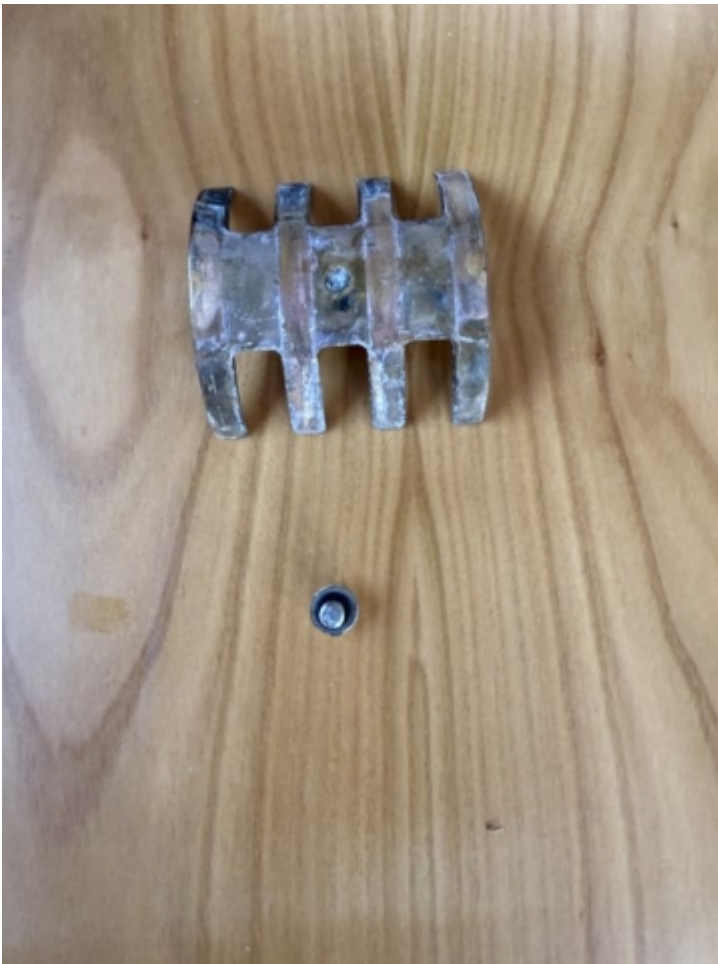
I've now encountered three such failures of the screw that secures the pump's cam in about the last 12 months, and I have heard about others, all on low hour engines. When this occurs, the pump stops pumping and a stream of water squirts from the hole left by the broken screw. One of those shown here occurred on a vessel that is less than a year old, in the other case the engine had less than 300 hrs. (a wing engine on a trawler).

Thus far I have only seen this on Sherwood pumps.

In my opinion, under normal conditions this screw should never break, it is not under much of a load. I have taken this up with Sherwood/Pentair in an attempt to determine the cause.

My recommendation is to inspect your screw regularly, although I'm not sure if you would be able to see signs of an impending failure; have a replacement cam and screw on hand, and potentially change yours preemptively (cams should be replaced about every third impeller change, or if wear/corrosion is evident). If you opt to change, closely inspect the cam to make sure it is properly seated inside the pump, and be sure to follow the installation instructions, a sample of which are included here (yours may be different, so check based on model number).
