# October 2023 Newsletter: Prop Shaft Taper

## Photo Essay: Prop Shaft Taper

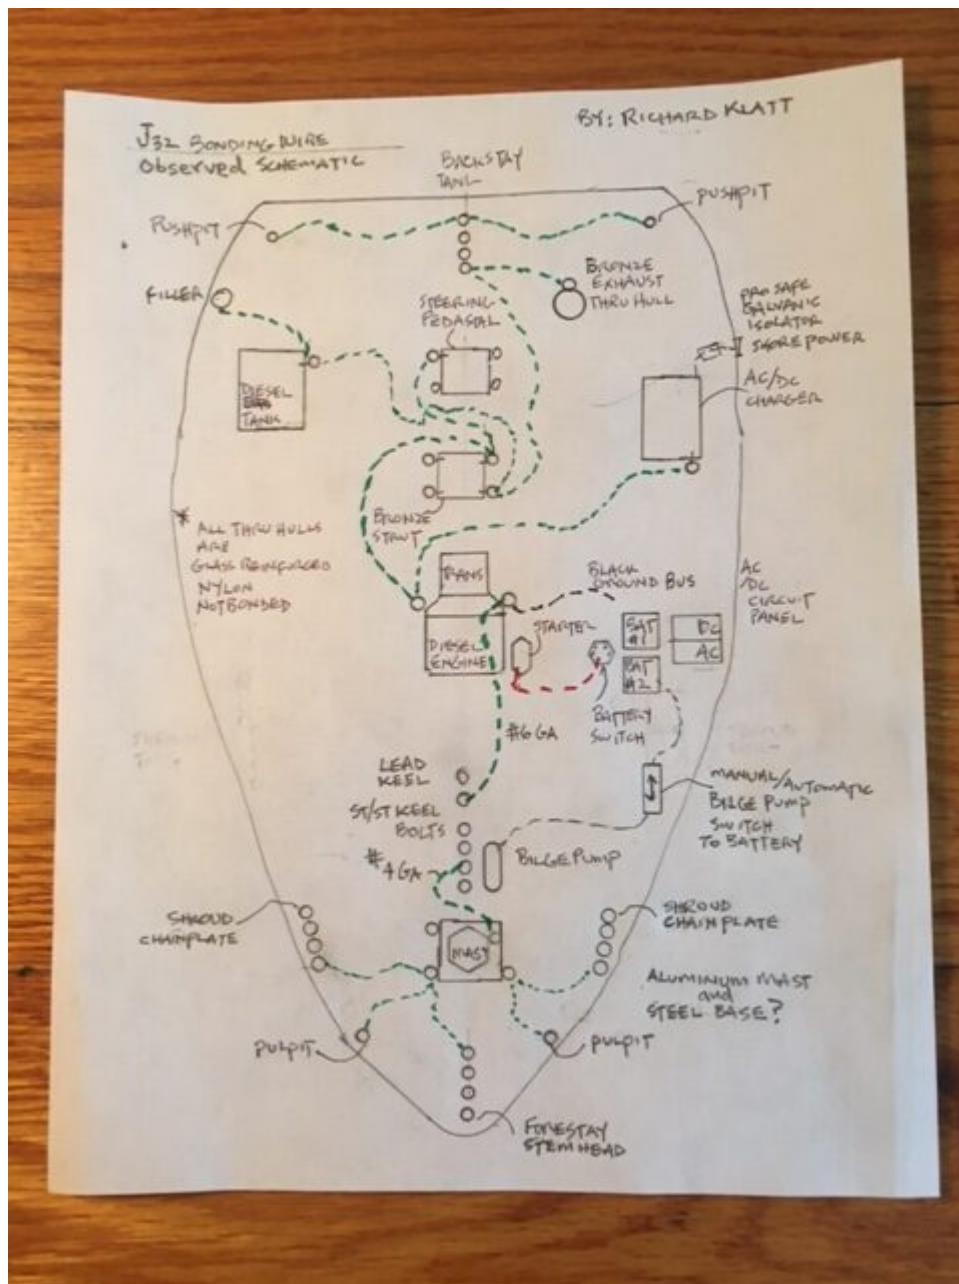
The bonding system schematic is revealing in that in several

cases, including the strut, backstay, engine, mast step and pedestal, the bonded components are used as conductors, i.e., bonding wires' ring terminals are connected to different, rather than the same, fasteners thereby making each of these components part of the circuit; this is referred to as "daisy chaining" and it is discouraged. In addition to potentially being non-compliant, this approach can lead to higher than ideal resistance in the bonding system, and under-protection for submerged components that are at or downstream electrically from the daisy chained item(s). The goal for resistance between bonded components and sacrificial anodes is a mere 1 ohm, a very high standard indeed. Therefore, I recommend that be corrected as soon as possible.

Without seeing detailed photos of the original corroded strut, it's impossible for me to even speculate on the cause, it could have been the result of the incorrect alloy having been used, or a stray current issue. If the strut had a pinkish hue, that would be indicative of dezincification, which would confirm the incorrect alloy was used. If it was heavily pitted, with areas of rough, bright metal, that's indicative of stray current corrosion. Based on the photo you provided of the current strut, I see no evidence of corrosion.

Once the bonding wire "daisy-chaining" is corrected, and while the vessel remains hauled, the continuity of the bonding system should be tested. The standard, as noted earlier, is no more than one ohm of resistance should exist between any bonded component and an anode. As far as I can tell, from your description and the schematic, the only anodes you have are for the shaft and prop. If so, they are not protecting all other underwater metals. The continuity path between and through a shaft, transmission and engine, to the bonding system, is usually tenuous because the latter two are oil-filled; it's not a connection that can be relied upon, so whether or not your shaft anode is indeed protecting other underwater bonded metals is unknown, but unlikely. However, two-month consumption of a shaft anode, if it was protecting the other bonded metals, would not be unusual, and it is not in any event indicative of stray current corrosion, which is much more vociferous and rapid. More on that here.

Finally, once the vessel is re-launched, a reference electrode test should be performed to determine the protection level of the underwater metals, including the shaft/prop and the remainder of the bonded components. You can read more about that process here. Without this test, any corrosion analysis is purely speculation. I suspect, based on the information provided, the underwater metals are under-protected and that a hull anode should be added, but again, the reference electrode
