October 2023 Newsletter: Prop Shaft Taper

Photo Essay: Prop Shaft Taper

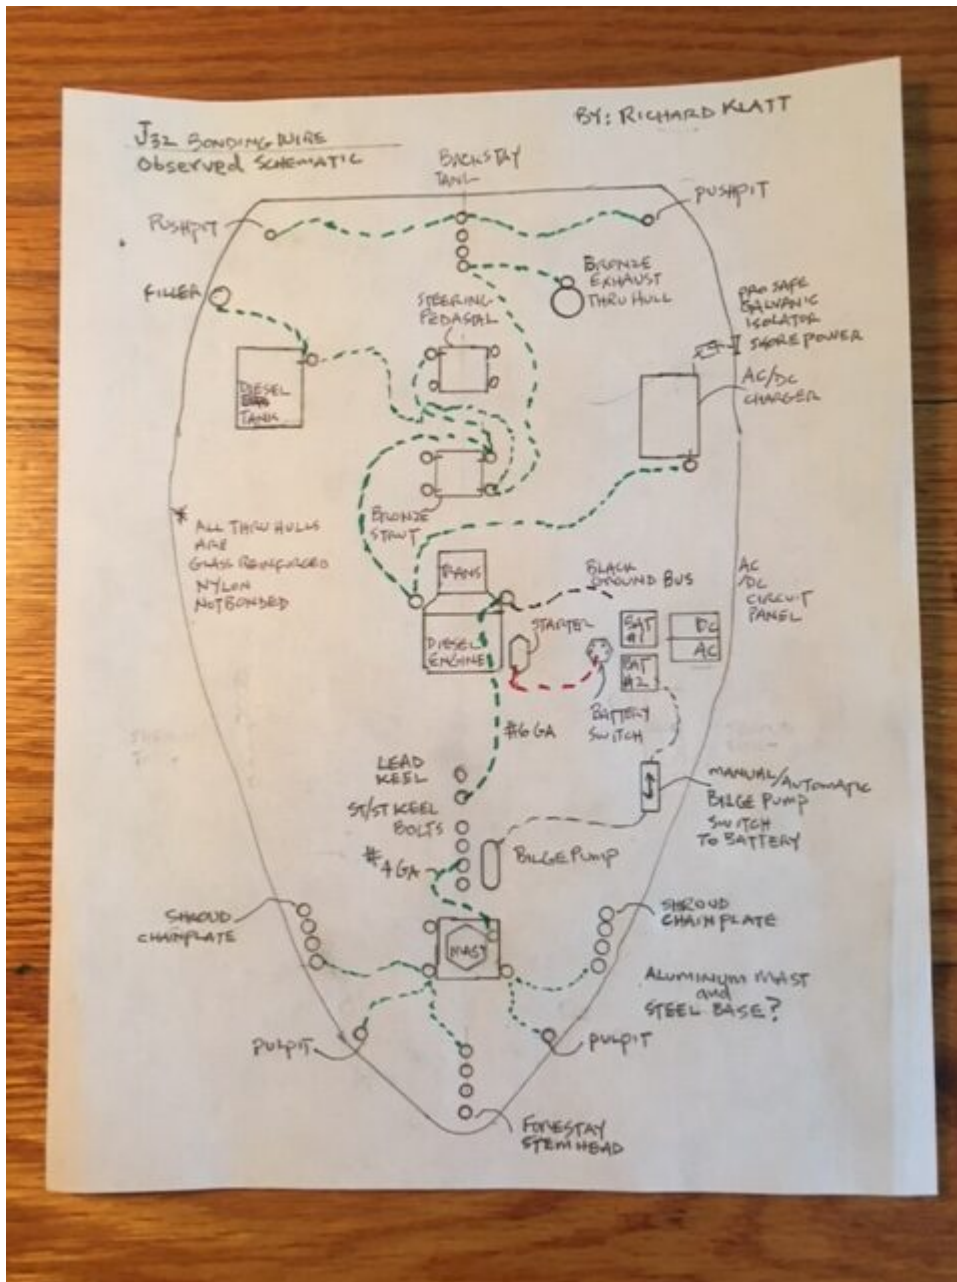
The bonding system schematic is revealing in that in several

cases, including the strut, backstay, engine, mast step and pedestal, the bonded components are used as conductors, i.e., bonding wires' ring terminals are connected to different, rather than the same, fasteners thereby making each of these components part of the circuit; this is referred to as "daisy chaining" and it is discouraged. In addition to potentially being non-compliant, this approach can lead to higher than ideal resistance in the bonding system, and under-protection for submerged components that are at or downstream electrically from the daisy chained item(s). The goal for resistance between bonded components and sacrificial anodes is a mere 1 ohm, a very high standard indeed. Therefore, I recommend that be corrected as soon as possible.

Without seeing detailed photos of the original corroded strut, it's impossible for me to even speculate on the cause, it could have been the result of the incorrect alloy having been used, or a stray current issue. If the strut had a pinkish hue, that would be indicative of dezincification, which would confirm the incorrect alloy was used. If it was heavily pitted, with areas of rough, bright metal, that's indicative of stray current corrosion. Based on the photo you provided of the current strut, I see no evidence of corrosion.

Once the bonding wire "daisy-chaining" is corrected, and while the vessel remains hauled, the continuity of the bonding system should be tested. The standard, as noted earlier, is no more than one ohm of resistance should exist between any bonded component and an anode. As far as I can tell, from your description and the schematic, the only anodes you have are for the shaft and prop. If so, they are not protecting all other underwater metals. The continuity path between and through a shaft, transmission and engine, to the bonding system, is usually tenuous because the latter two are oil-filled; it's not a connection that can be relied upon, so whether or not your shaft anode is indeed protecting other underwater bonded metals is unknown, but unlikely. However, two-month consumption of a shaft anode, if it was protecting the other bonded metals, would not be unusual, and it is not in any event indicative of stray current corrosion, which is much more vociferous and rapid. More on that here.

Finally, once the vessel is re-launched, a reference electrode test should be performed to determine the protection level of the underwater metals, including the shaft/prop and the remainder of the bonded components. You can read more about that process here. Without this test, any corrosion analysis is purely speculation. I suspect, based on the information provided, the underwater metals are under-protected and that a hull anode should be added, but again, the reference electrode
