# The Ins and Outs of Cored Composite Construction

By Steve D'Antonio  
Copyright July 2013

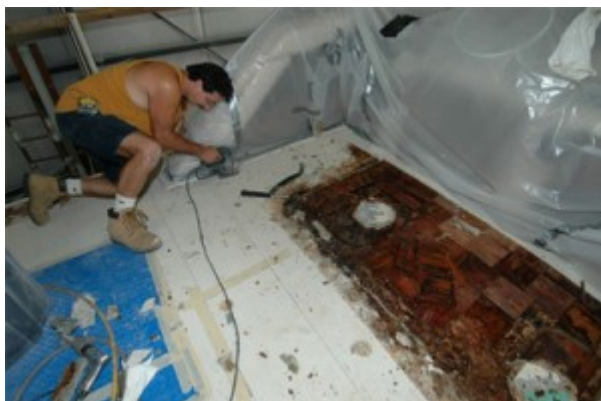
*Fiberglass cored composite construction is a reliable, proven boat building technique that when executed properly yields a stiff, light structure. When it goes awry, however, as is the case here, repairs are nearly always costly and invasive.*

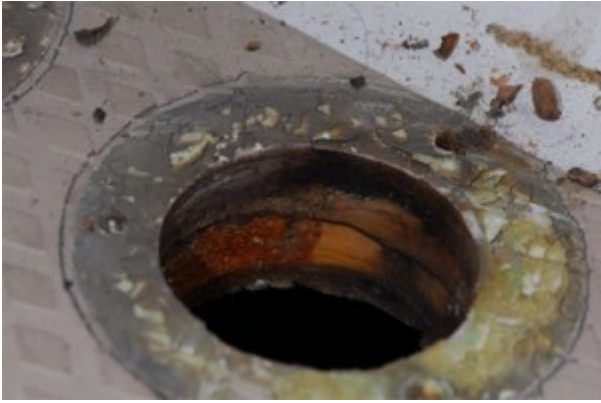
*When core material, wood in this case, is visible at a deck “penetration”, such as this fuel fill, the only thing standing between it and water saturation is sealant. Sealant, even by most manufacturers’ own admission, has a finite life of no more, and often less, than ten years. And, don’t be fooled by the thin coating of resin on this core material, it is far too delicate to prevent water entry and does nothing to prevent water from entering through fastener holes, visible around the perimeter.*

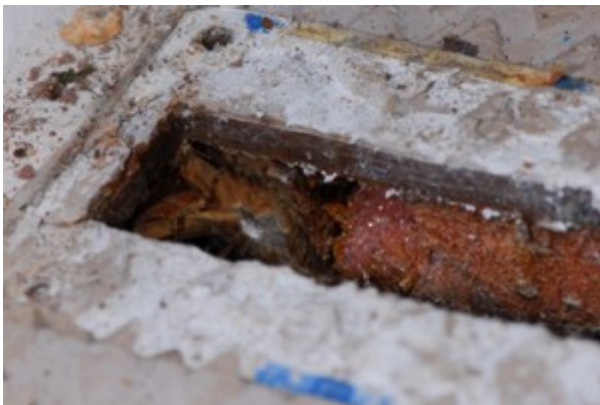
*Chain plate penetrations are notorious for acting as avenues of water ingress and core saturation. While any deck hardware can serve as an entry point for water, highly loaded structures push sealant to its limit, often resulting in early failure and saturation.*

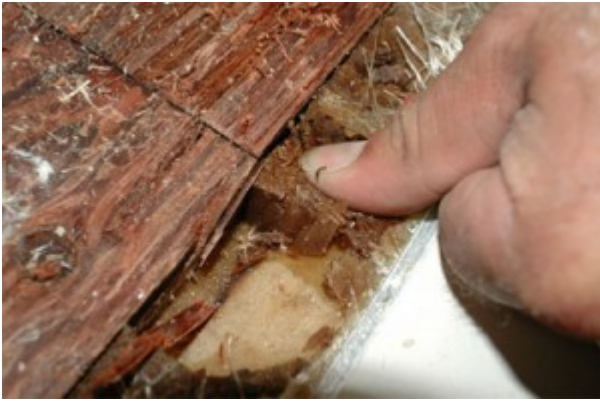
*This flybridge deck has been cored with a mixture of small plywood blocks and end grain balsa, which is both saturated and decaying. While other core materials exist, ones that are less prone to water absorption, the failure is a result of execution rather than material selection; the core was not properly closed out.*

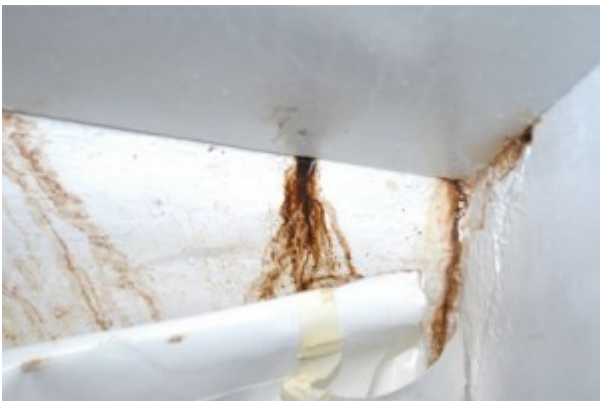
*The telltale brown "coffee stain", it's not a pretty sight and it nearly always bodes poorly for the vessel and its owner. Proper core repairs are nearly always expensive, nearly always more expensive than the preventive measures.*

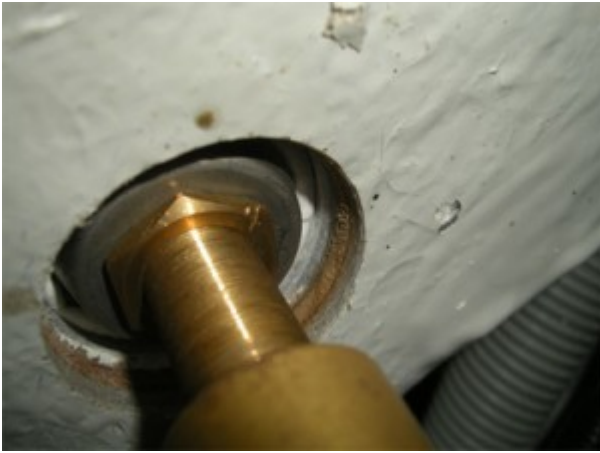
*Plywood core material is visible at the penetration for a windlass foot switch. Bedding is also visible, when it eventually dries out; water will leak past the switch flange and be absorbed by the core. Because plywood and other conventional timber has a long grain structure, water can migrate far within the composite, often many feet from the entry point.*

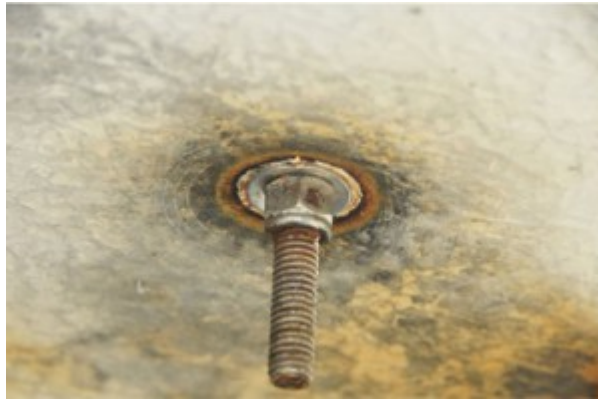
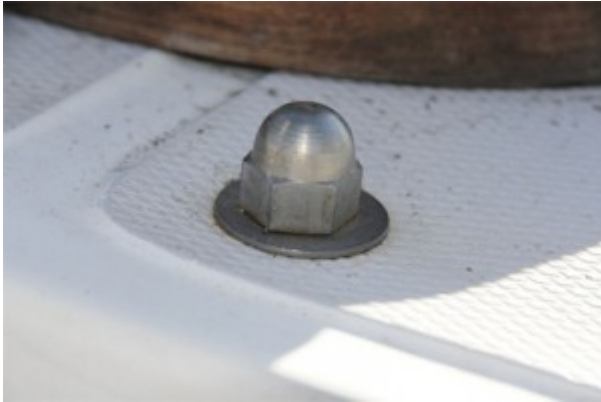
***This through bolt is compressing and crushing the core within this cored composite structure. If the laminate was solid in this area, if high density core material had been used, or if it had been reefed and back-filled, this failure would not have occurred. Make no mistake about it, this structure is now compromised, it is weaker and more prone to water penetration.***

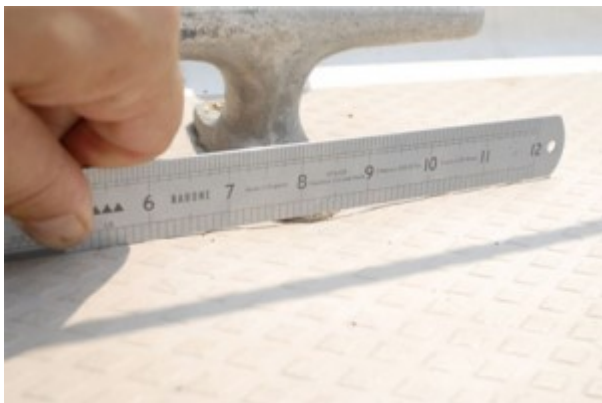
***This cleat is installed in a cored composite deck without the benefit of high density core or reefing and back filling. As a result, the core has been crushed, creating a depression, in which water will accumulate, where it will ultimately find its way into the core.***

All penetrations in cored substrates, regardless of the hardware type or load, from hatches and windshields to pad eyes and liferaft cradles, should benefit from either the pre-installed solid FRP or high density purpose made core

factory insert, or an after the fact reef and backfill procedure.

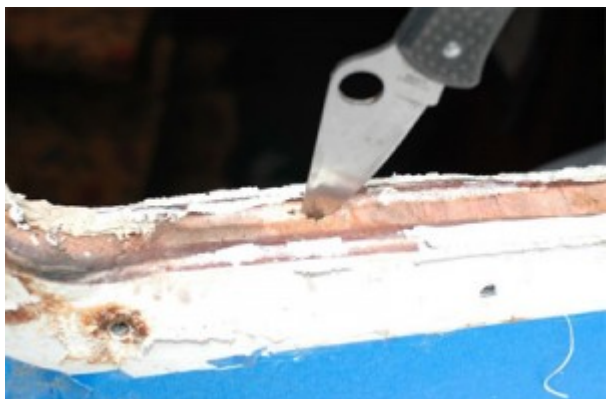
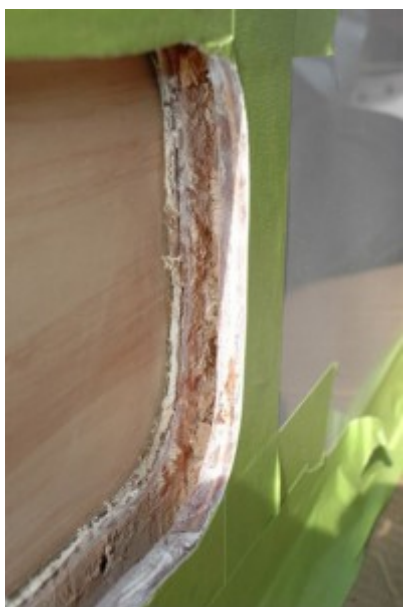
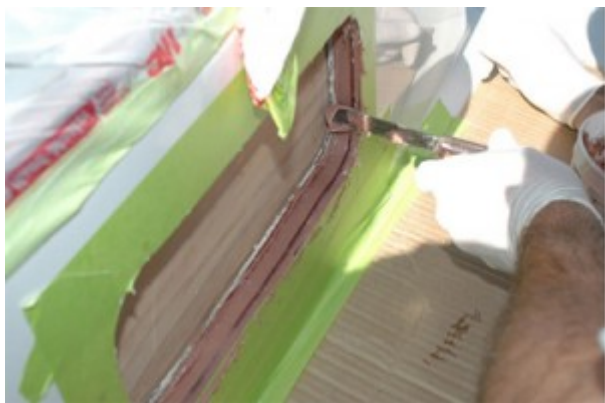
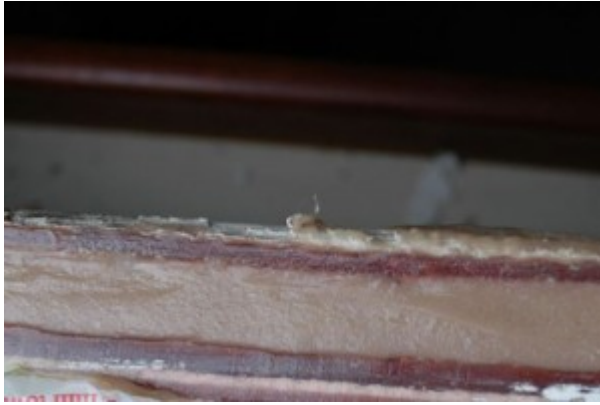
*Whenever a cored composite structure is penetrated, water penetration, and localized crushing, can be avoided by following the closeout procedure. If water does enter in improperly closed out structure, the repair process, depicted in the images above, is as follows...wet and decayed core; reefed out core; epoxy back-filling and cured epoxy filler.*
