February 2025 Newsletter – Plumbing Bonding Technique

Photo Essay: Plumbing Bonding Technique

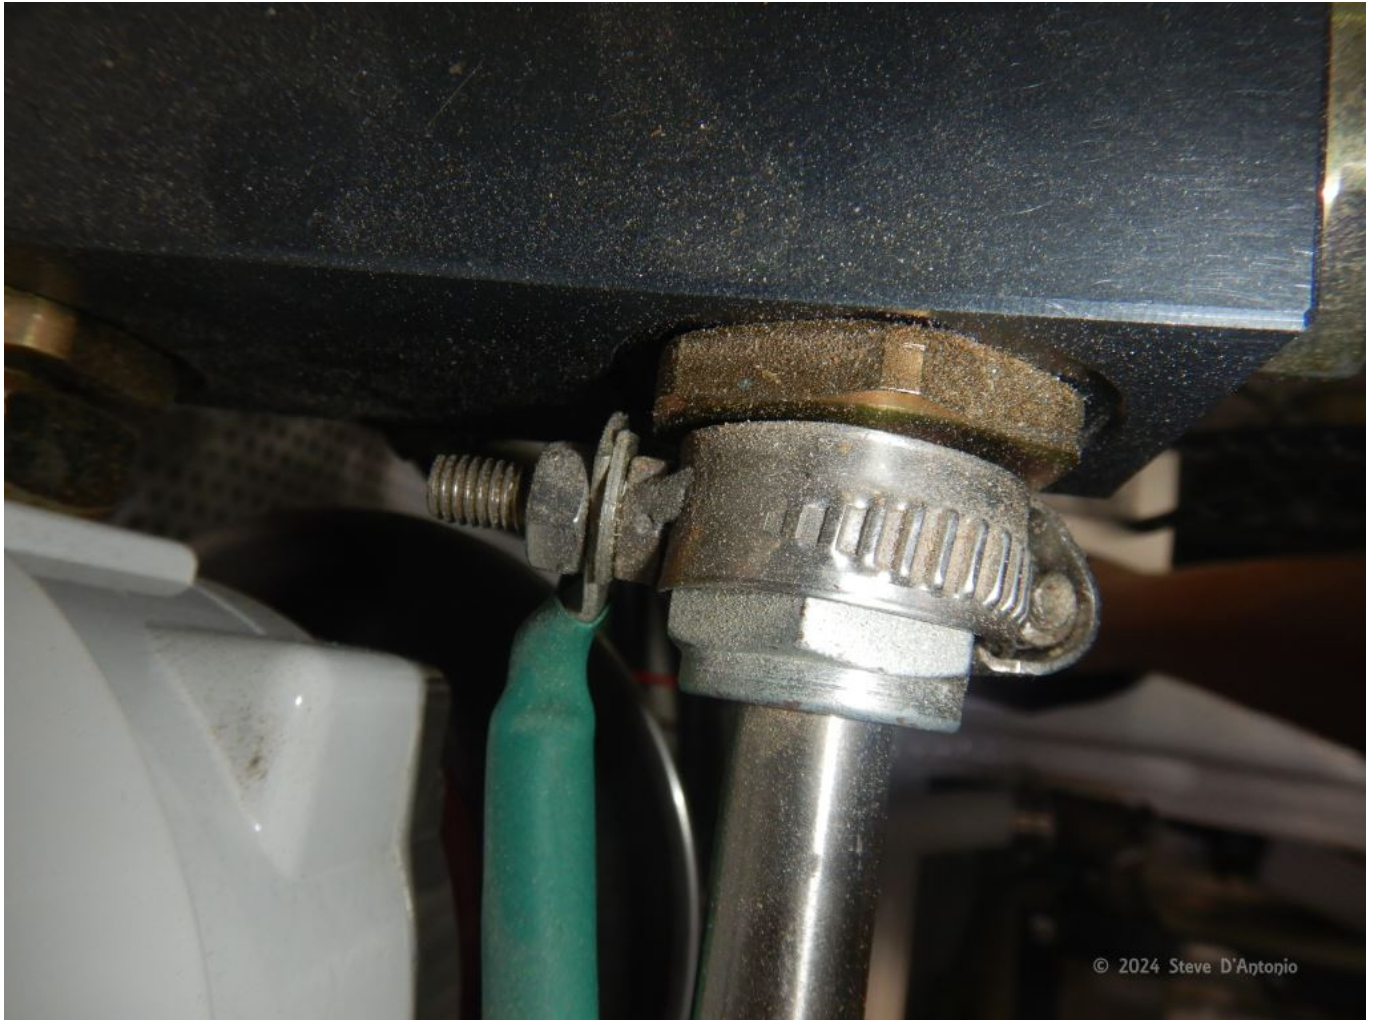
The accompanying image depicts what I believe is the best approach I've encountered yet; a stud that is passed through a hole that has been drilled in a hose clamp. The clamp presses the head of the screw tightly against the plumbing fitting, making good, reliable, and low resistance contact, and a ring terminal is then placed over what is now a stud. In this case the installer has also gone the extra step of welding the fastener to the hose clamp. While that represents a belt and suspenders approach, I don't believe it is necessary to achieve the required low resistance connection with the the bonding or grounding systems.

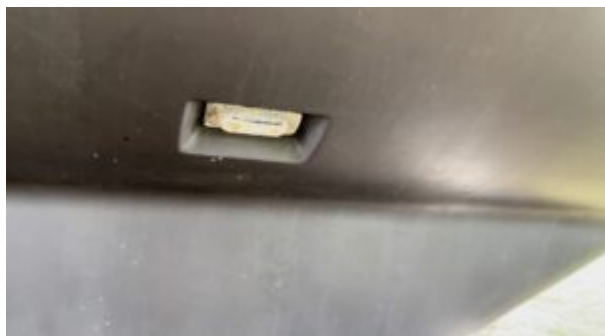
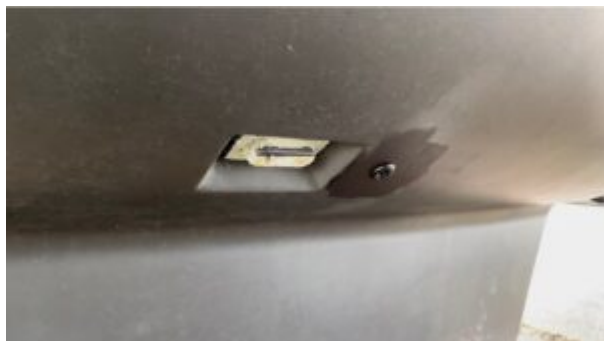
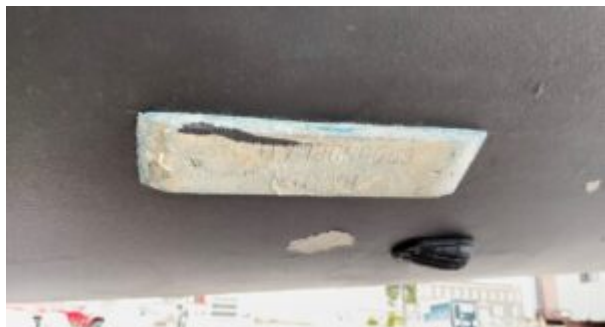
Currently the vessel has two grounds per side as manufactured, plus a larger one on the starboard side. They are only connected to the chainplates on either side of the catamaran.

The photos you shared of ground plates, at least one depicts a common product made from sintered bronze. The others appear

to be anodes. Strictly speaking, these do not meet the requirements for a solid copper plate, with sharp edges, detailed in the article.

Using the shrouds as down conductors (or connecting a 4/0 cable to the spar where the shrouds are attached), and then using 4/0 cable to connect the chain plates to ground plates, would be the most practical and common approach if you intend to (mostly) comply with this standard. Attaching a 4/0 cable to the base of the spar and then to a ground plate as well, wouldn't hurt, even if it does involve a 90-degree turn.

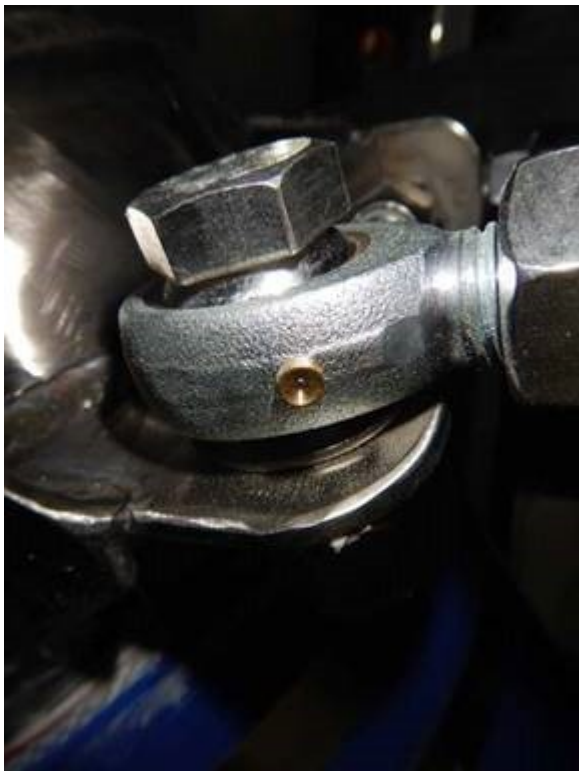
The steering ram end fitting, sometimes called a ball joint rod end, failure is note-worthy for two reasons. First, unless it was removed, I don't see the plastic insert that is often present between the inner ball and the outer cage. If it's missing, there would be considerable slop in the system. The plastic insert is slippery, providing lubrication, which means no grease is required. If none was present from the start, the ball joint would usually be equipped with bronze bushing and a zerk fitting, to allow the injection of grease, or a small hole, which also is used to inject grease with a rubber tip grease gun fitting (those are not common, so these often go ungreased, see the example photo below).

Two, the cage appears to have "sprung", which seems odd, as if it was under tension, or it elongated after the crack occurred. Either way, this is a disconcerting failure. The rust is indicative of crevice corrosion, all that's needed for that to begin is a micro-fracture and seawater. Was it

getting wet? Also, in this design, the fasteners that secures the ball joint to the tiller arm should never wear out; if it is properly tensioned, it becomes one with the center ball, within the cage, so all the movement, and wear, occurs between the inner ball and the cage (or the insert or bushing). If the fastener is allowed to move, it will wear, and this will also cause wear inside the hole through which it passes in the tiller arm. This detail is often lost even on boat builders, who believe the fastener must be left loose to prevent binding.

When replacing the ball joint end, make certain the locking nut is good and tight to prevent the ram rod from spinning and unscrewing from the ball joint, which would cause a loss of steering; I recommend the use of a thread locking compound here and TorqueSeal. If it is the greaseable variety, make certain it is greased with a good, heavy chassis grease, and if water is leaking into this area, get that resolved. More on hydraulic steering system design, installation and maintenance here.
