# January 2021 Newsletter “Wire Design”

## Photo Essay: Wire Design

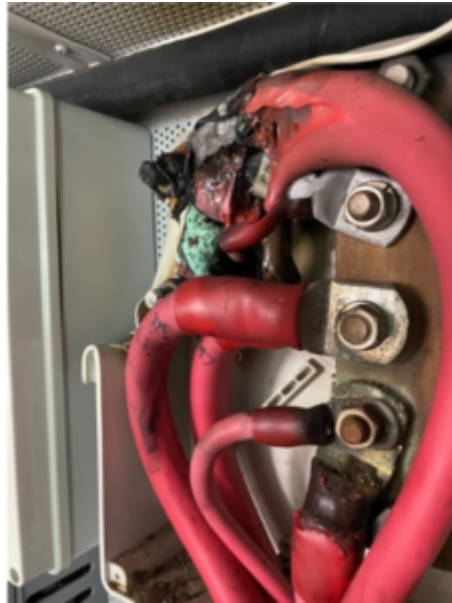
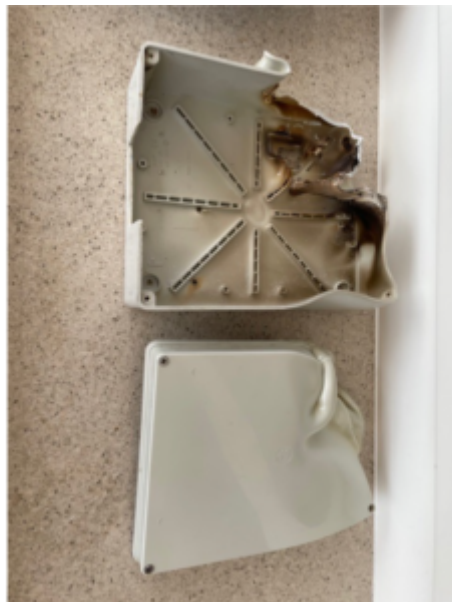
In your Pre-Purchase Inspection Report on my boat two years ago you made the following observation: "Junction box above batteries, a loose connection is arcing and has caused heat damage. A. ABYC T:1. 677-681." The dealer from whom I purchased the vessel has electricians, carpenters, etc. for commissioning and maintaining customers' boats, so I gave them an initial list including this item to be done before I used the boat. They checked this item off as complete. Shame on me I never opened the junction box to check.

So last week the main engine big alternator quit charging the house batteries when underway. I did some basic troubleshooting at the alternator and regulator and could not find an issue. When the electrician at the Hinckley yard here

checked it out, he came up and said “Your alternator is working fine but your problem could be the melted junction box on the aft bulkhead of the engine room.”

So, all is fixed now, but I have learned the hard way to inspect work I thought was done. I suppose I’m lucky there wasn’t a fire.
