Understanding the causes of corrosion will help you keep your boat's hardware shipshape. BY STEVE D'ANTONIO

CORROSION

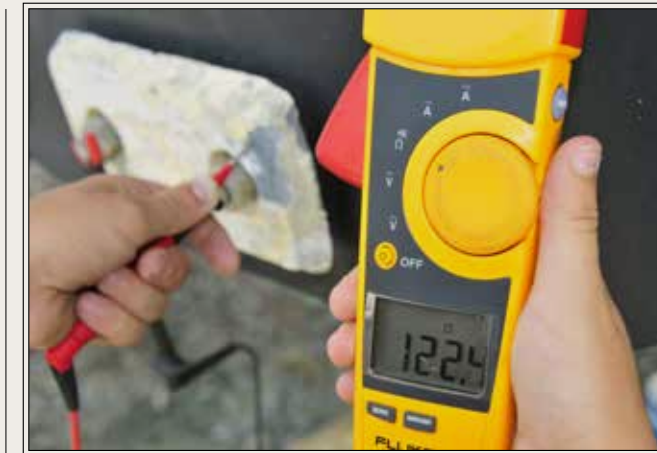
With the boat on the hard, an ohm meter can be used to confirm a low-resistance connection between zincs and bonding (top). Zinc anodes are designed to be consumed as they protect other bonded underwater metals (center). Without anode protection, aluminum saildrives are susceptible to corrosion; particularly the stray-current type.

Like any other system aboard your sailboat, the bonding system should be periodically inspected and maintained. Corroded or otherwise poor connections should be cleaned or replaced. If doubt exists about the integrity of the system, resistance between components should be checked by using an ohm meter while the vessel is hauled out to measure the resistance between the anode and the metals to which it is connected.

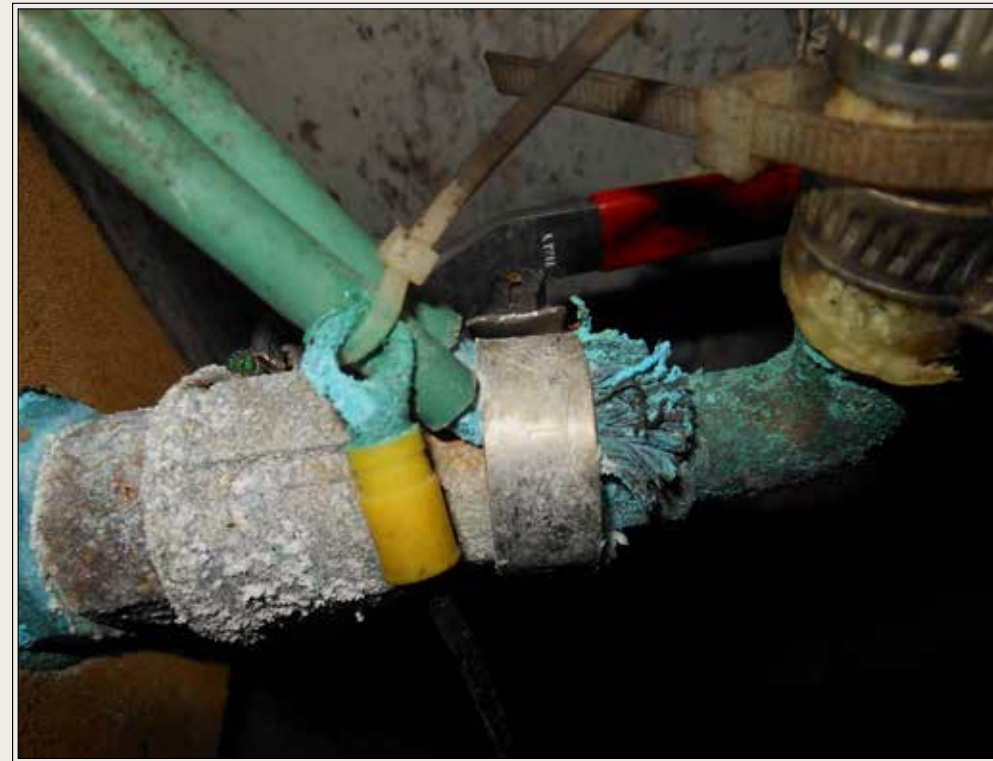
A sailboat's bonding system performs a number of functions, including protecting dissimilar types of metals from galvanic corrosion. To work properly, it's imperative to keep connections clean. Using a hose clamp to attach wires is not recommended.

In brief, a bonding system electrically interconnects underwater metals and many metallic machinery components, including through-hull fittings and seacocks, rudder and propeller shafts, struts and strainers. It does this by maintaining all underwater metals at the same voltage. If all metals are of equal voltage, no current can flow between them, and there will be no stray-current damage.

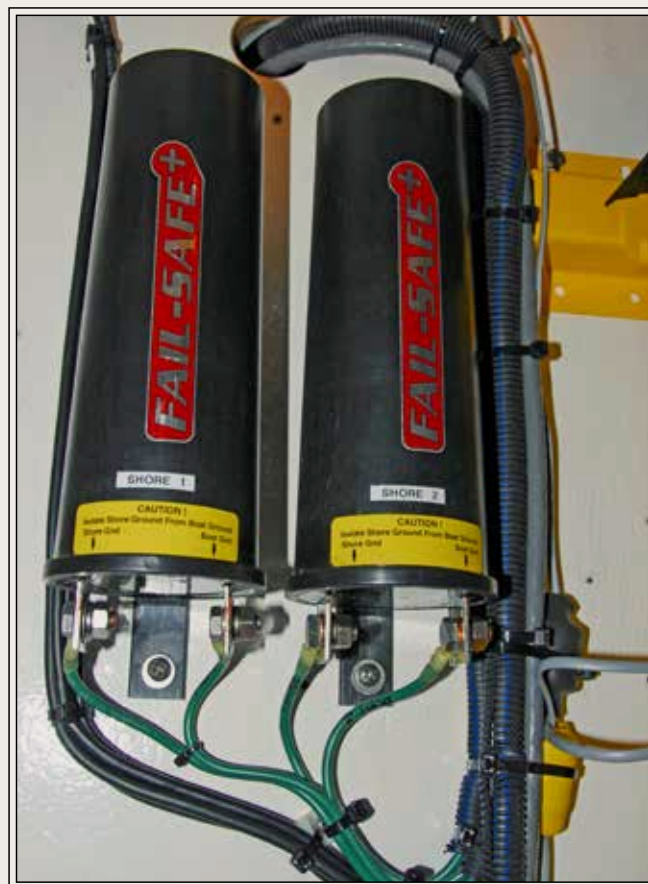
Galvanic isolators are used to protect boats that are berthed in proximity of each other from damage when they're plugged into shore power (above, left). An aluminum bracket is being eaten away as water drips on it from a bronze pump (top, right). A metal shaft log corroded because the alloy it was made of contained too much zinc.

Galvanic isolators work by blocking up to 1.4 volts DC (which is above the typical galvanic corrosion-voltage threshold) on the AC shore-power safety ground wire. The isolator still allows AC fault current to flow freely, which is critical from a safety perspective. Because galvanic corrosion involves DC current, the electrical interconnection of adjacent vessels is prevented by the galvanic isolator.

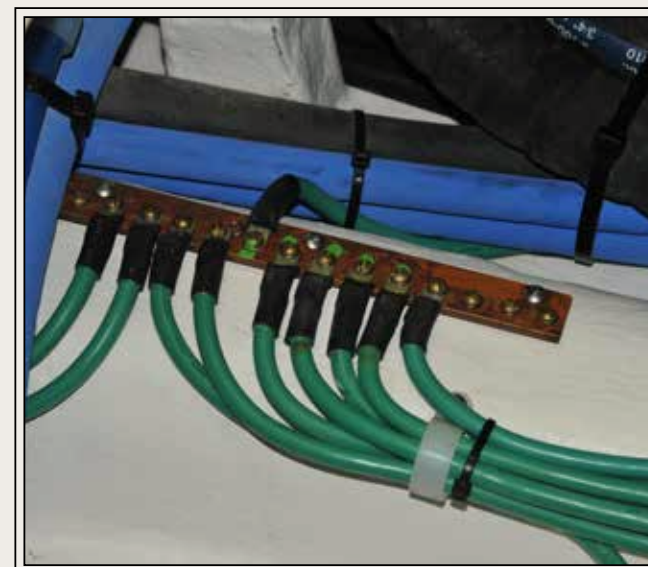
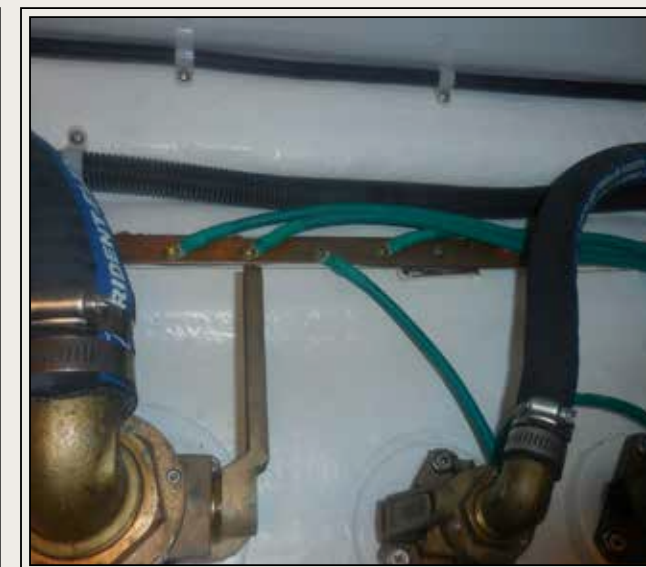
The bonding system, typically wired using green (sometimes with a yellow stripe) insulation, relies on good, clean, low-resistance connections. Ideally, heat-shrink terminals, or supplemental heat-shrink tubing should be used, and connections should be coated with a corrosion inhibitor. Each piece of underwater metal requires a bonding wire (right).

Connecting underwater metals to each other, and then to an anode follows the "bond-and-protect" protocol, a proven approach that works, provided a handful of guidelines are followed. Chief among these is ensuring low-resistance connections are made between bonded components and hull anodes, the standard for which, established by ABYC, is stringent indeed: a maximum of just 1 ohm.

Aboard the vast majority of vessels I inspect, bonding systems, and specifically, their connections, are in abominable condition: They are green, crusty, loose or
