Antisiphon Valves – Editorial: “Workplace Distraction Revisited”

Antisiphon Valves

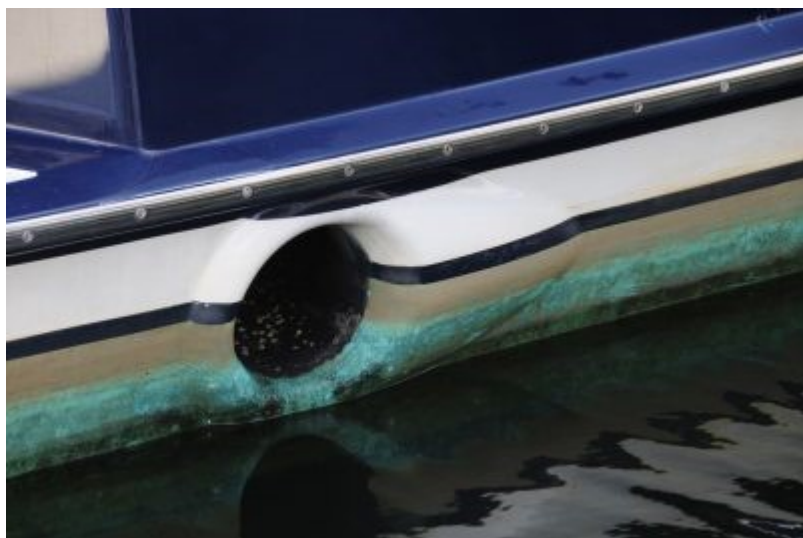
It's important to understand the difference between siphoning and water that is forced back aboard. A deflector can often prevent the latter while an antisiphon valve is required to resolve the former.
