# Antisiphon                      Valves                      – Editorial:                      “Workplace Distraction Revisited”

## **Antisiphon Valves**

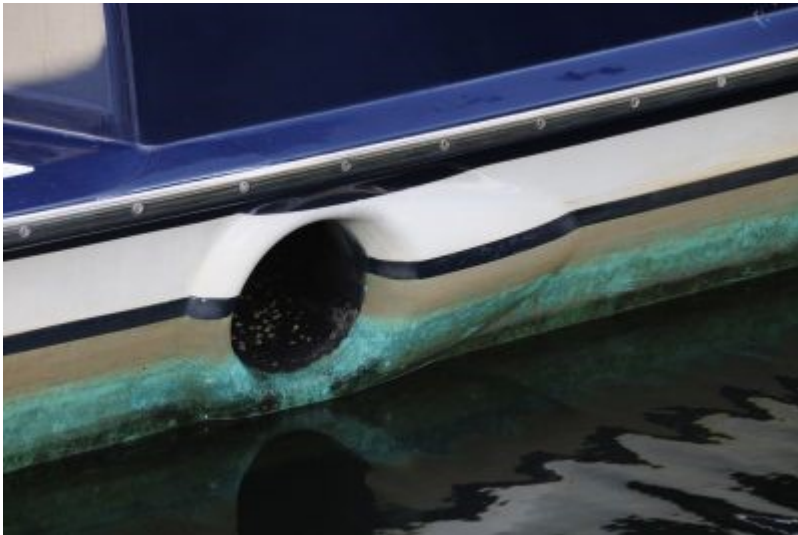
**It's important to understand the difference between siphoning and water that is forced back aboard. A deflector can often prevent the latter while an antisiphon valve is required to resolve the former.**

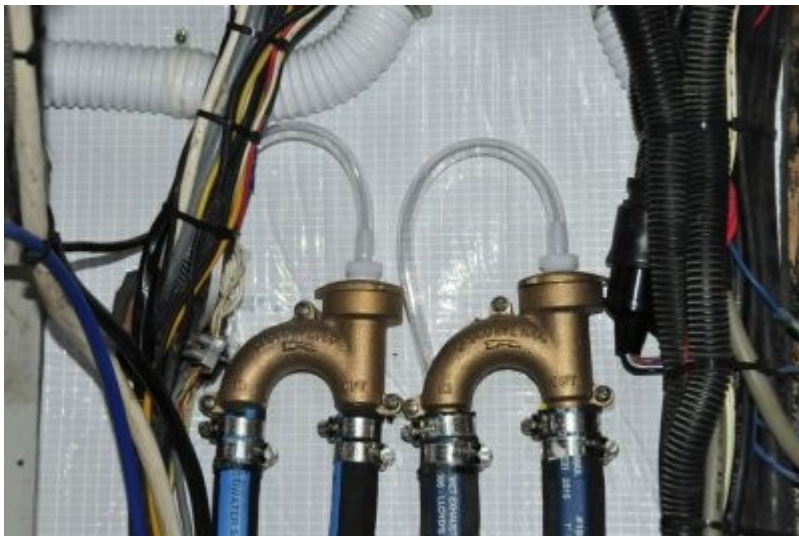
**A leaking antisiphon valve needs to be serviced or replaced. Though it's common practice to add remote vents to antisiphon valves, small diameter hose like this is prone to clogging and kinking, or its outlet may become submerged if it's near the bilge. The author has encountered two cases in which a generator and propulsion engine flooded because of this arrangement.**

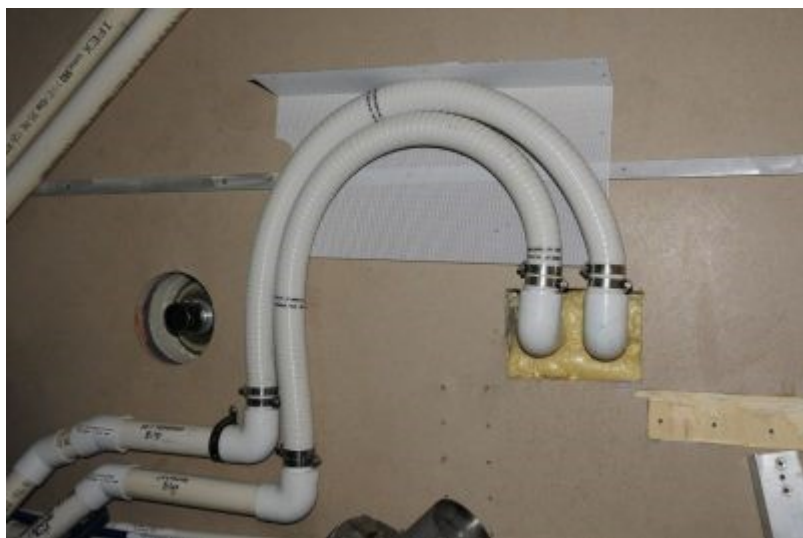
**Bilge pump risers will prevent downflooding; however, they will do nothing to prevent a siphon and thus should be equipped with antisiphon valves.**

For bilge pumps, the problem is exceedingly simple. Siphons begin when the overboard discharge is submerged, in spite of the fact that the hose rises at some point above the heeled waterline. (If it doesn't rise above the waterline, then it's simple down-flooding rather than siphoning, and an antisiphon valve would not prevent it.) The water running back into the bilge initiates the self-sustaining siphon. As an aside, ABYC Standards define the "waterline" as all portions of the hull that are submerged when heeling to the toe rail for sailing vessels, and all portions of the hull that are submerged when heeling 7 degrees for power vessels. If a bilge pump discharge can be submerged, its plumbing must be equipped with a riser and an anti-siphon valve. Also, consideration should be given to the possibility of extreme heeling in the event of a grounding.

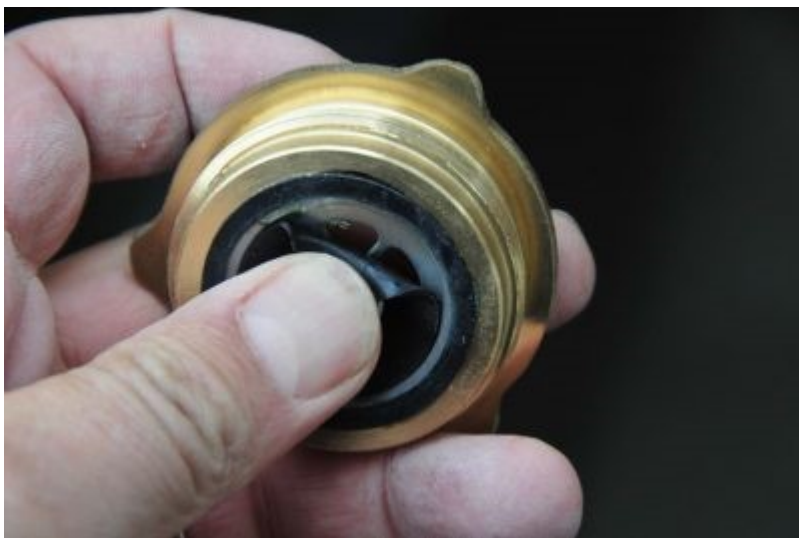
**Antisiphon valves come in a variety of types. All rely on an in-situ check valve of sorts, which should be inspected and cleaned at least annually.**

In simple terms, antisiphon valves allow air to enter while preventing water under pressure from exiting the plumbing run, thereby "breaking" the siphon. Every engine, generator, head, and bilge pump needs a properly installed antisiphon valve (also called a siphon break) if they are ever below the

Antisiphon valves are typically installed: between the heat exchanger and the injection point on the exhaust elbow; between the raw-water flush pump and the toilet bowl (they are commonly and incorrectly installed on the pump inlet, where they will suck air); and anywhere along the discharge line for the bilge pump.

Most important is that the antisiphon valve be installed well above the waterline under all operating conditions. Some antisiphon valve manufacturers require the valve to be installed a minimum of 2' (61cm) above the waterline to ensure proper operation, so make certain you read the installation instructions regardless of how many times you've installed these valves. Antisiphon valves should be inspected regularly, and serviced, disassembled, and cleaned annually to prevent clogging. If you are uncertain that an antisiphon valve is necessary, then install one. There's little harm in having one
