# Antisiphon Valves – Editorial: “Workplace Distraction Revisited”

## **Antisiphon Valves**

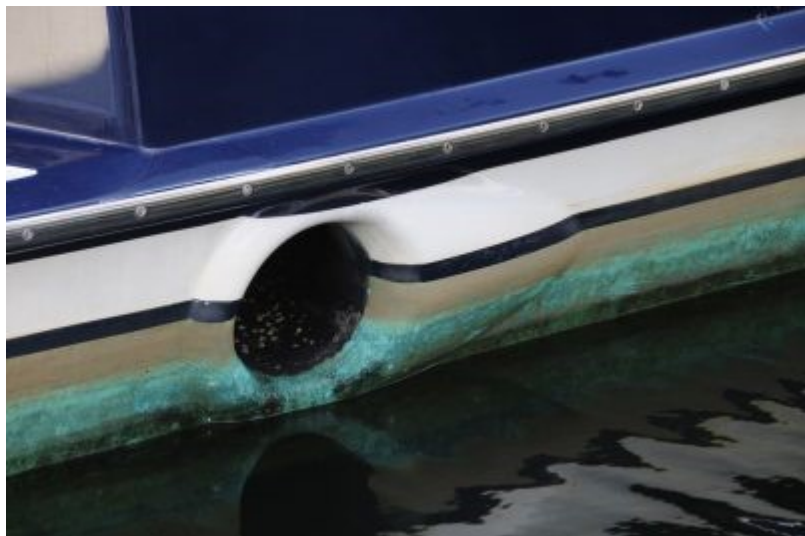
**It's important to understand the difference between siphoning and water that is forced back aboard. A deflector can often prevent the latter while an antisiphon valve is required to resolve the former.**
