April 2024 Newsletter – Steering Components

Photo Essay: Steering Components

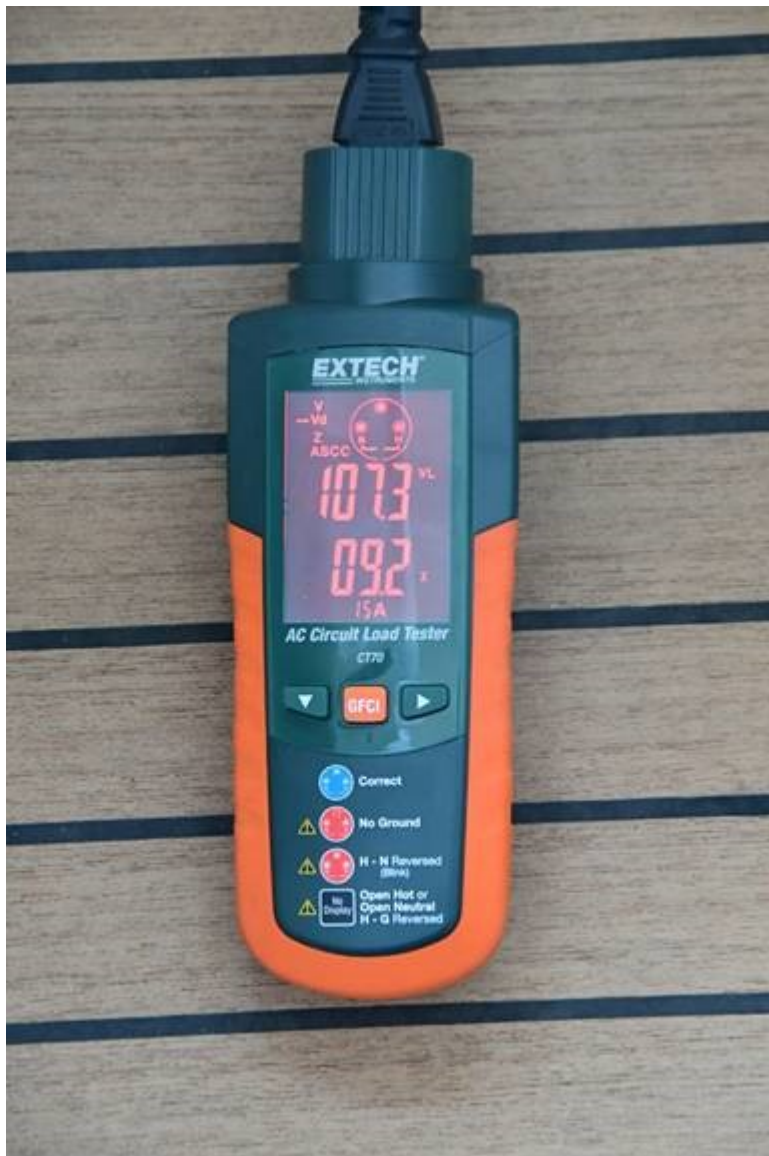
Testing for these phenomena is relatively easy provided you have the requisite skill and experience. Initially, the polarity can be tested with a test tool like the one shown [here](#). This, or one like it, should be in the tool bag of any technician who is troubleshooting electrical issues.
