# Shaft Bearing Etiquette

Story and photos by Steve D'Antonio

**Shaft bearings play a vital role, however, the nuances of their selection, operation and maintenance are often overlooked.**

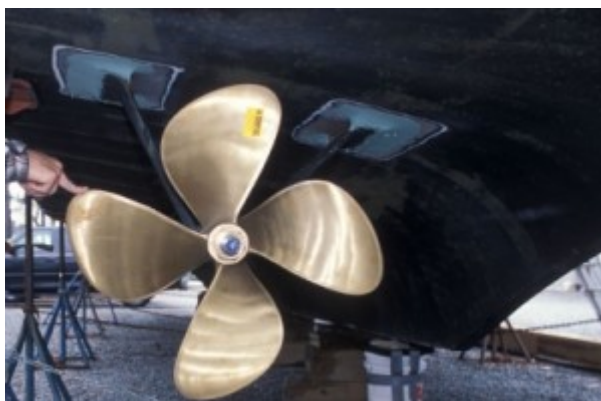
**While not necessarily definitive, the ease with which a propeller can be turned while a vessel is hauled can be an indicator of shaft to bearing fit and alignment.**

While carrying out a vessel inspection a few years ago, I grabbed the blades of the propellers on a twin screw 50-foot vessel, to turn them so I could read the props' specifications. Try as I might, my feet lifted off the ground; I was unable to get either prop to turn. In some cases, particularly on new boats, this may not necessarily mean there's a problem. New, unused shaft bearings tend to be a little sticky. They can be lubricated with diluted dishwashing detergent, which usually enables them to turn easily.

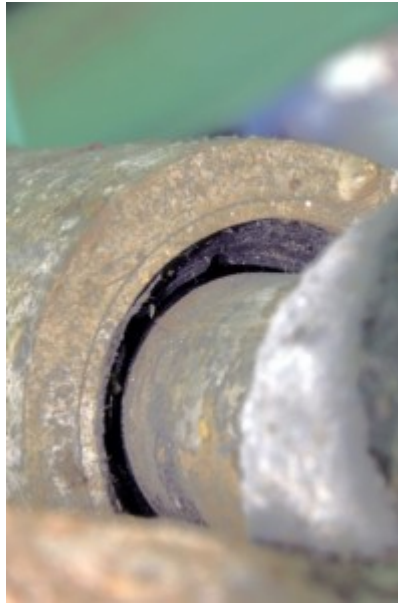
**The significant gap between this bearing and the shaft can be an indication of severe wear or misalignment.**

As I looked more closely at the shaft bearing I could see that the aft end at the three o'clock position was pinched, the

rubber in the bearing was being squeezed, and the opposite side at the forward end of the bearing was similarly pinched, while the nine o'clock positions showed a noticeable gap.

This is a classic sign of shaft to bearing misalignment (not to be confused to with engine to shaft alignment) and one that demands immediate attention.

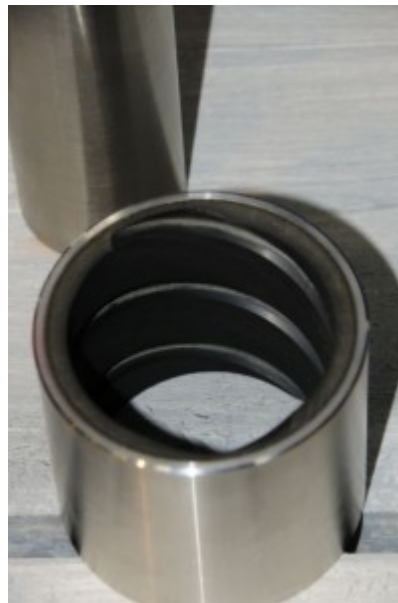
**Not all shaft bearings rely on longitudinal groove, this one uses an involute design.**

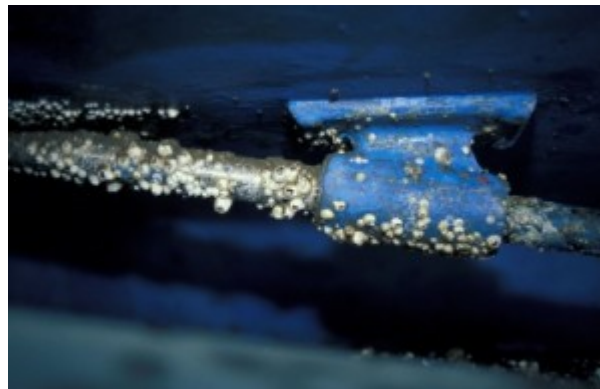
**Shaft bearings rely on a steady, uninterrupted flow of water for lubrication. Hard growth on the shaft forward of the bearing can upset this flow and lead to accelerated wear.**

worth making an effort to ensure that shaft bearings last as long as possible. Common causes of premature failure include improper installation of shaft anodes, if they are installed too close to the forward end of the bearing they can impede water flow, twelve inches is a minimum clearance between an anode and the leading end of the strut. Additionally, allowing an accumulation of hard barnacle growth on the shaft forward of the bearing can upset water flow, which leads to increased wear.

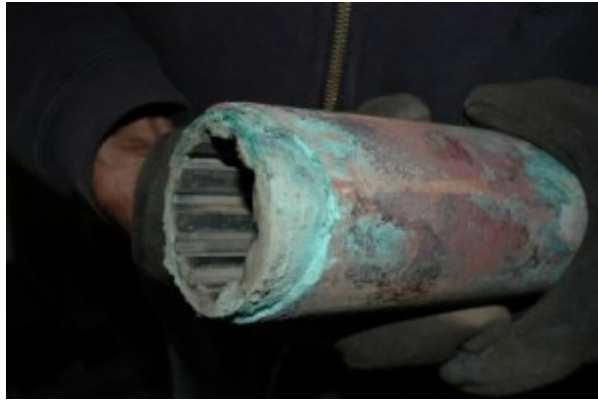
The metallic shell used for shaft bearings is often made of a brass alloy. Because brass alloys contain zinc they are prone to galvanic corrosion. This can be prevented with proper anodic protection, i.e. use of zinc or aluminum anodes. However, it's important to keep in mind that the shell is somewhat sacrificial, it's designed to corrode before the more valuable strut, and is more easily replaced.

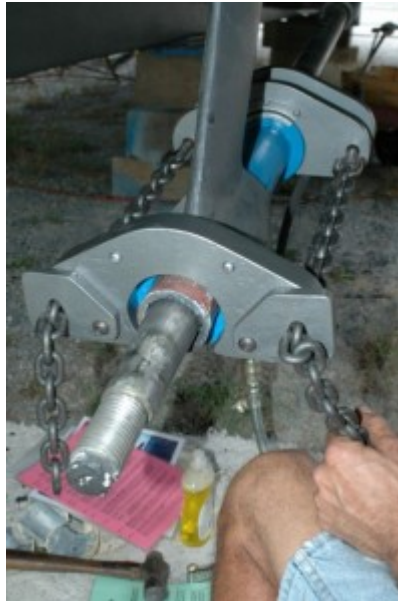
There are several ways to remove shaft bearings. Here, a hydraulic split drift removal tool is being used. While costly, on the order of \$2500 at the time this was written, they make bearing removal easier in that the shaft does not require removal.

Alternatively, strut-mounted bearings can be removed using a mechanical or hydraulic 'split drift' bearing removal tool, *without removal of the shaft*. Many boat yards and marine contractors utilize such a kit. For professionals who undertake this task routinely it's well worth the expense, the hydraulic version can cost over \$2000, however, do-it-yourselfers will likely be relegated to the manual method.

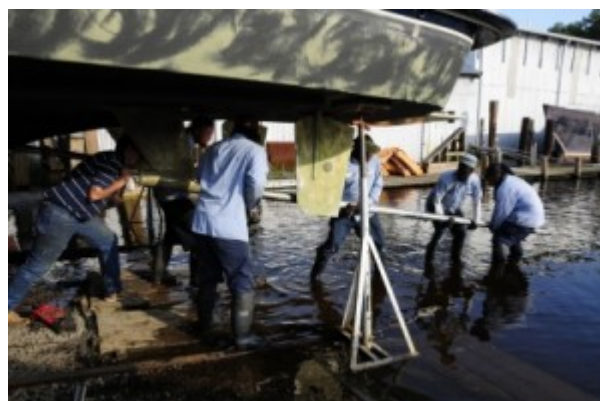
**The bearings used with this shaft suffered from swelling, making shaft**

removal extremely difficult (a come-along winch was required to pull the shaft out of the bearings). While not common, swollen bearings lead to accelerated shaft wear and increased fuel consumption. If your shaft is virtually impossible to turn by hand it may be suffering from this phenomenon.

Yet another issue that afflicts some bearings is a swelling phenomenon. At first these scenarios may be mistaken for misalignment between shafts and bearings. However, I've encountered several vessels whose bearings inexplicably swelled, causing uniform shaft binding. This scenario can be avoided by using only high quality, name brand bearings.

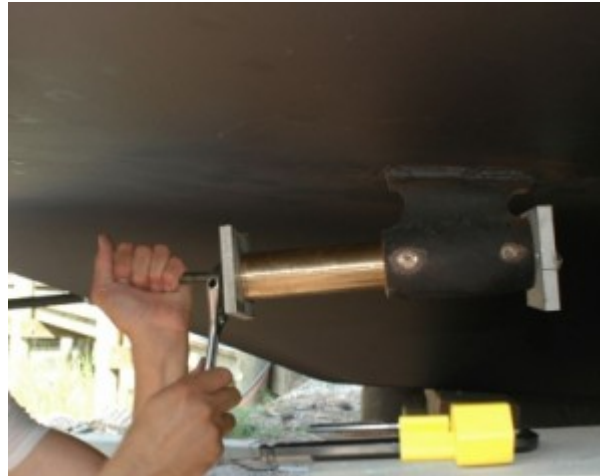
**A mechanical bearing installation tool made using a length of threaded rod and two sections of aluminum plate. This technique is easy on the strut and often works well. The alternative, and one that is frowned upon, involves using a mallet to drive the bearing into the strut.**

If you have a strut mounted bearing use a length of threaded rod that's more than twice the length of the bearing and two squares of aluminum that are larger than the diameter of the bearing as caps at either end, a little liquid soap on the

outside of the bearing will ease the process. The bearing's fit should offer slight resistance, what's known as a 'light interference fit', it's unnecessary for it to be extremely tight. If it's too tight, the bearing could be distorted during installation. If necessary, the bearing's outer shell could be turned down on a lathe to improve the fit if it's too tight.

Using the rod draw the new bearing into the strut by tightening the nuts. For an en-bloc log, drive the bearing into place using a block of soft wood and a mallet, and never strike the bearing directly.

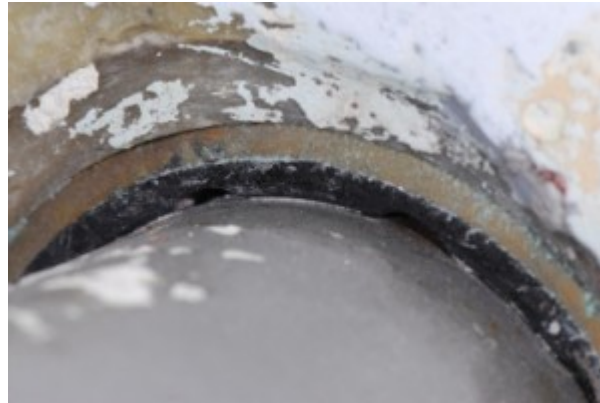
**This bearing has swollen, there is no gap between it and the shaft, making the shaft both difficult to turn and prone to accelerated wear.**
