# Shaft Bearing Etiquette

**Shaft bearings play a vital role, however, the nuances of their selection, operation and maintenance are often overlooked.**

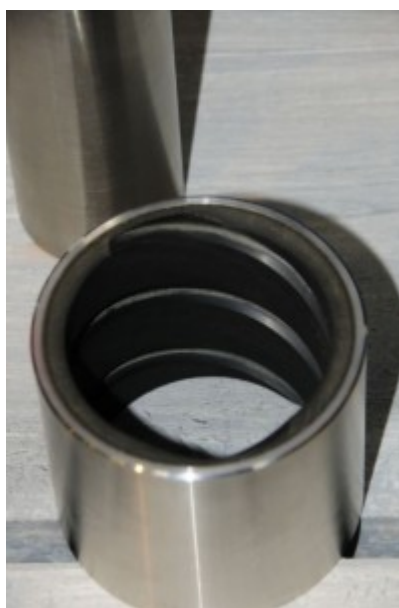
**Not all shaft bearings rely on longitudinal groove, this one uses an involute design.**

shaft bearing. The bearing's support material is typically a hard rubber-like substance known as nitrile; it's mildly resistant to oil and fuel as well as other contaminants found in seawater along with silt and salt itself. Longitudinal flutes or valleys in the rubber tube through which the shaft passes are designed to improve water flow, remember water is the sole source of lubrication, as well as channel away sand, grit and other hard particles.

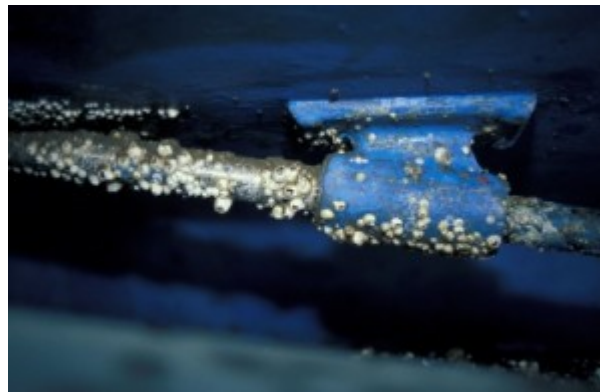
**Shaft bearings rely on a steady, uninterrupted flow of water for lubrication. Hard growth on the shaft forward of the bearing can upset this flow and lead to accelerated wear.**

worth making an effort to ensure that shaft bearings last as long as possible. Common causes of premature failure include improper installation of shaft anodes, if they are installed too close to the forward end of the bearing they can impede water flow, twelve inches is a minimum clearance between an anode and the leading end of the strut. Additionally, allowing an accumulation of hard barnacle growth on the shaft forward of the bearing can upset water flow, which leads to increased wear.

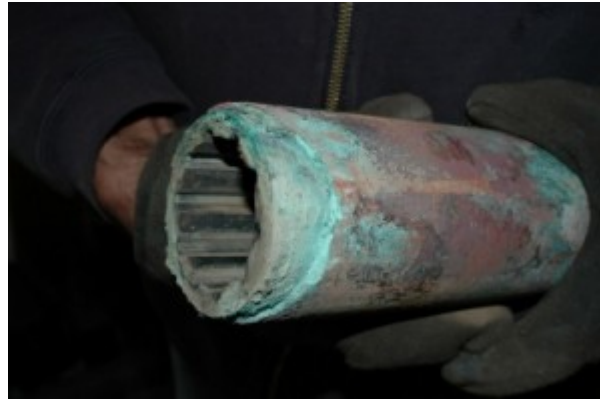
The metallic shell used for shaft bearings is often made of a brass alloy. Because brass alloys contain zinc they are prone to galvanic corrosion. This can be prevented with proper anodic protection, i.e. use of zinc or aluminum anodes. However, it's important to keep in mind that the shell is somewhat sacrificial, it's designed to corrode before the more valuable strut, and is more easily replaced.

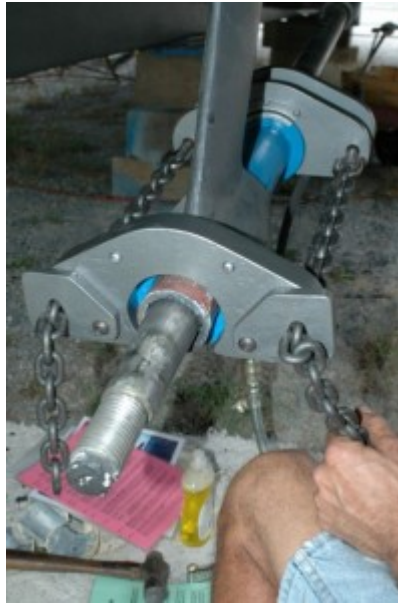
There are several ways to remove shaft bearings. Here, a hydraulic split drift removal tool is being used. While costly, on the order of \$2500 at the time this was written, they make bearing removal easier in that the shaft does not require removal.

Alternatively, strut-mounted bearings can be removed using a mechanical or hydraulic 'split drift' bearing removal tool, *without removal of the shaft*. Many boat yards and marine contractors utilize such a kit. For professionals who undertake this task routinely it's well worth the expense, the hydraulic version can cost over \$2000, however, do-it-yourselfers will likely be relegated to the manual method.

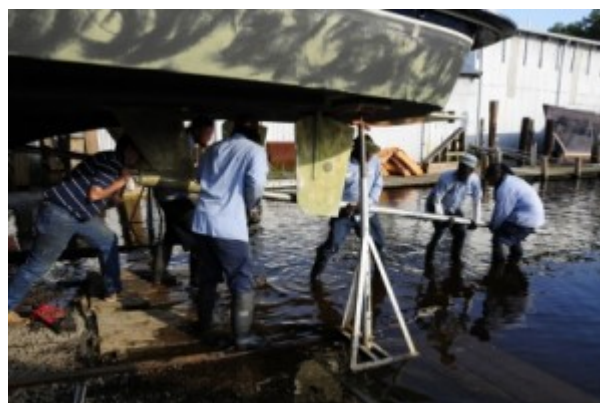
**The bearings used with this shaft suffered from swelling, making shaft**

removal extremely difficult (a come-along winch was required to pull the shaft out of the bearings). While not common, swollen bearings lead to accelerated shaft wear and increased fuel consumption. If your shaft is virtually impossible to turn by hand it may be suffering from this phenomenon.

Yet another issue that afflicts some bearings is a swelling phenomenon. At first these scenarios may be mistaken for misalignment between shafts and bearings. However, I've encountered several vessels whose bearings inexplicably swelled, causing uniform shaft binding. This scenario can be avoided by using only high quality, name brand bearings.

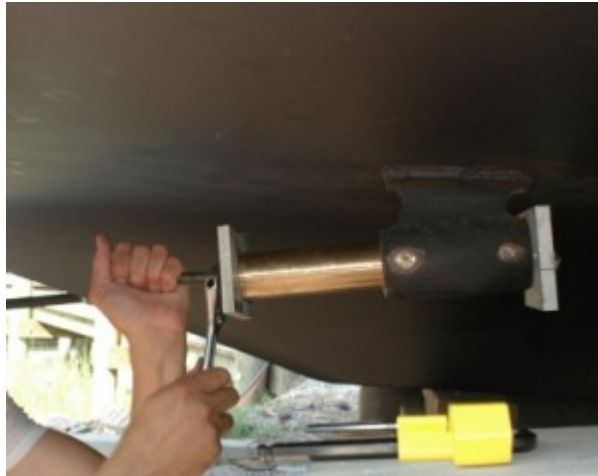
**A mechanical bearing installation tool made using a length of threaded rod and two sections of aluminum plate. This technique is easy on the strut and often works well. The alternative, and one that is frowned upon, involves using a mallet to drive the bearing into the strut.**

If you have a strut mounted bearing use a length of threaded rod that's more than twice the length of the bearing and two squares of aluminum that are larger than the diameter of the bearing as caps at either end, a little liquid soap on the

outside of the bearing will ease the process. The bearing's fit should offer slight resistance, what's known as a 'light interference fit', it's unnecessary for it to be extremely tight. If it's too tight, the bearing could be distorted during installation. If necessary, the bearing's outer shell could be turned down on a lathe to improve the fit if it's too tight.

Using the rod draw the new bearing into the strut by tightening the nuts. For an en bloc log, drive the bearing into place using a block of soft wood and a mallet, and never strike the bearing directly. Finally, reinstall the bearing set screws (set screws should be located at the 4 and 8 o'clock position, or alternatively at the 3 and 9 o'clock, but not in the hemisphere above this) using blue LocTite thread locking compound. Set screws should bear against the shaft bearing's outer shell; the bearing shell should be partially spot drilled to create an indentation into which a cupped set screw will recess and engage, with the angle of the drilled indentation, and that of the set screw tip, being the same angle; and thus pointed, and not cupped, set screws should be used. However, the bearing shell must *not* be drilled through

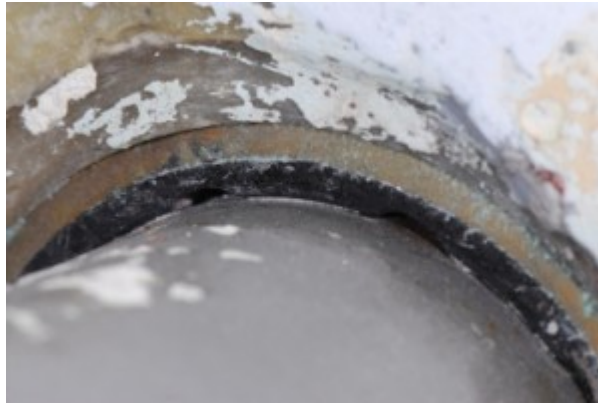
**This bearing has swollen, there is no gap between it and the shaft, making the shaft both difficult to turn and prone to accelerated wear.**
