December 2025 Newsletter – Lithium-Ion Batter Terminals

Photo Essay: Lithium-Ion Battery Terminals

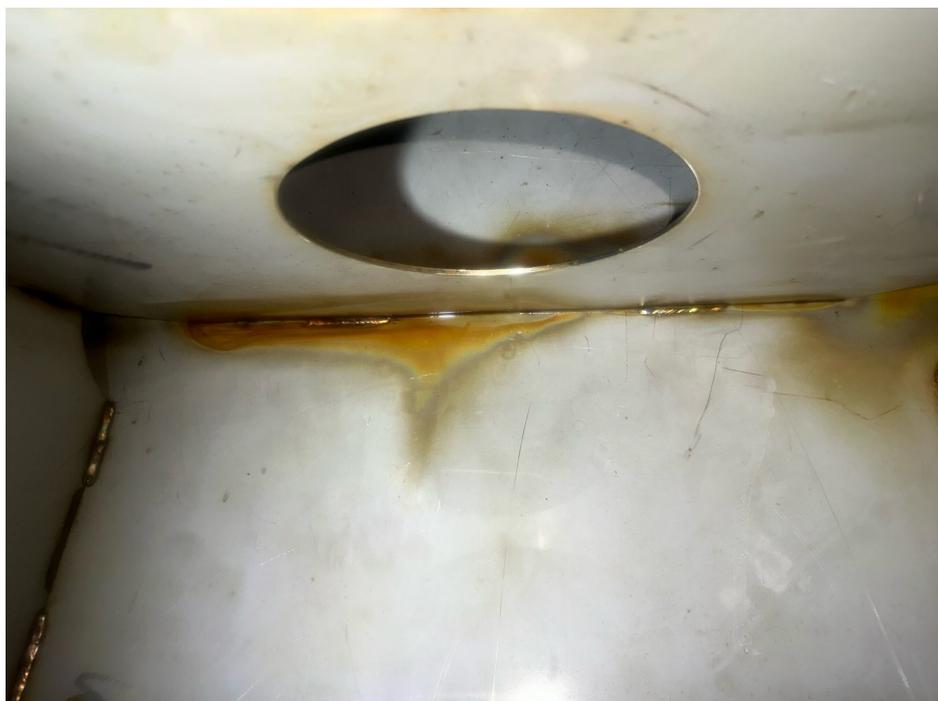
My wife and I have a trawler... lately, in rough conditions, our domestic water supply is a brownish color with fine sediment. We opened the stainless-steel water tanks and saw light rust and golden colors on the baffle welds and side welds, and brownish sediment on the bottom. We thoroughly cleaned the tanks.

Stainless steel, even the most corrosion resistant alloys, can be susceptible to a phenomenon known as crevice corrosion. This type of corrosion occurs when stainless steel is exposed to stagnant, and thus oxygen depleted, water. Without a fresh supply of oxygen, stainless steel cannot maintain its otherwise tough, corrosion resistant oxide coating. Potable water tanks are, unfortunately, are an ideal environment for this to occur, you can read more about this type of corrosion [here](#).

Regarding tank coatings, I have yet to encounter one that works. The challenges are, cleaning the inside of the tank adequately to ensure adhesion, and fully encapsulating all the many faceted baffle surfaces is nearly impossible, particularly in a tank with limited access. If water migrates behind the coating, it will accelerate the crevice corrosion process.

I'm sorry I don't have a more optimistic response. While stainless steel was once the most desirable material for potable water tank fabrication, today better options, such as fiberglass and plastic, exist. While I hope it isn't necessary, if the tank needs to be replaced, it can be cut up in place and replaced with two smaller polyethylene tanks.
