# Editorial: Jet Lost because of Maintenance Error – Feature: Offshore Passage Prep

## **Offshore Passage Prep**

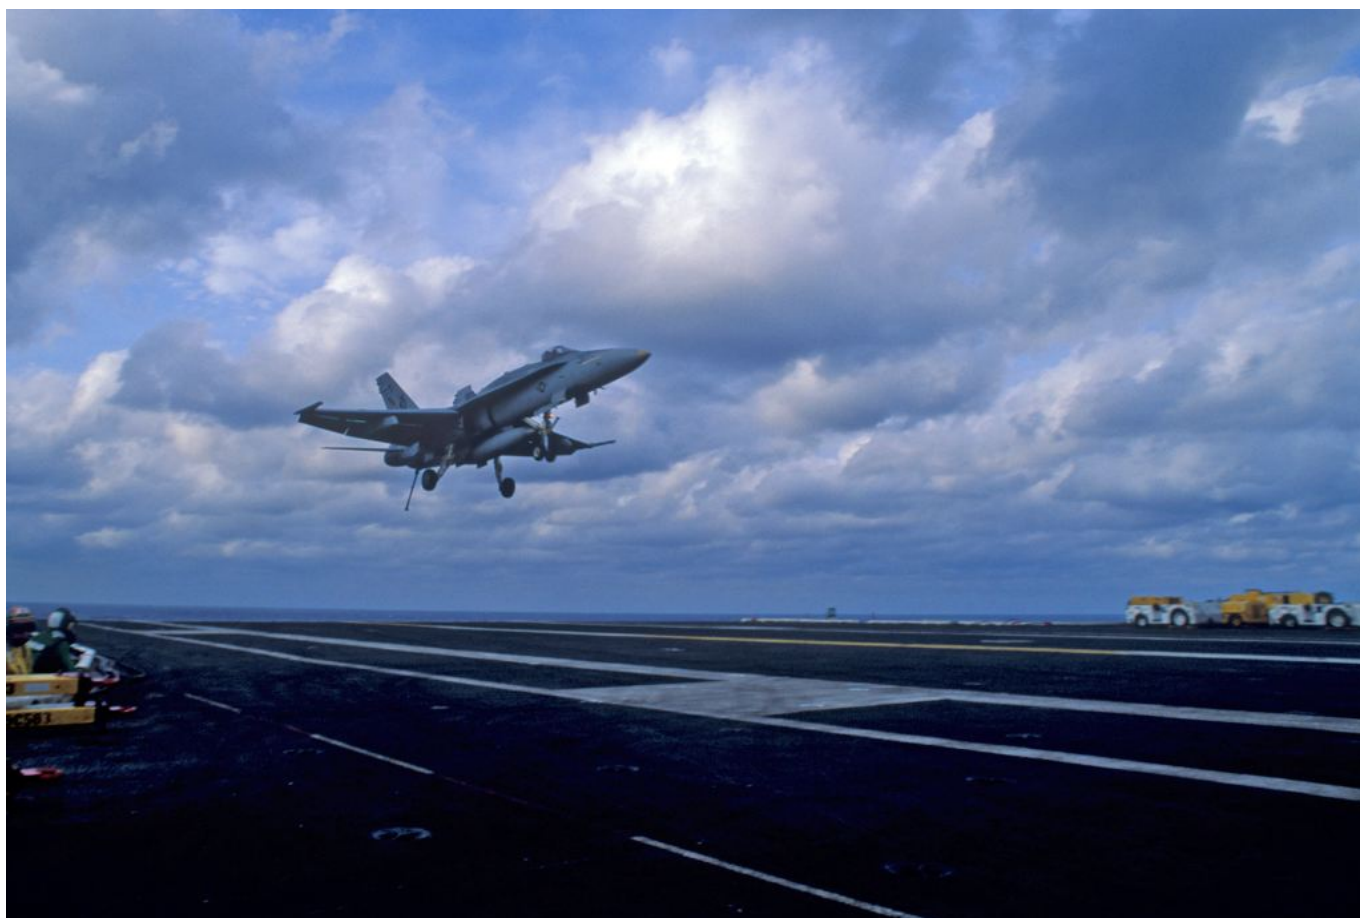
**An F/A-18 Hornet, like the one that was lost, on approach to**

## **the USS Enterprise.**

More recently, on May 6, 2025, a US Navy F/A-18 fighter jet was lost overboard in the Red Sea, during a failure of the carrier's arresting gear. Three or four (depending on the carrier's class) arresting wires are positioned on the flight deck, any one of which are designed to be caught by the aircraft's arresting hook; the cables are designed to pay out slowly, bringing the aircraft to a comparatively gradual stop. While it is "controlled", I've had the pleasure of making an arrested landing, and catapult launch, and I can attest to the suddenness of both. The arresting gear, including the cables, are under tremendous load, and thus their maintenance must be impeccable. In this case, the aircraft had partially arrested when the failure occurred; it was traveling too slowly to regain flight, forcing the crew to ejected as the aircraft headed over the side, and down toward the sea surface. Both were recovered safely.

The investigation determined that a failure of the arresting gear machinery, which in turn caused an arresting cable to fail, was the source of the accident, stating, “The root cause, the investigation report said, was “the material failure of the clevis pin.” *The pin lacked a washer* [author’s emphasis], a small part that helps keep the system in place”.

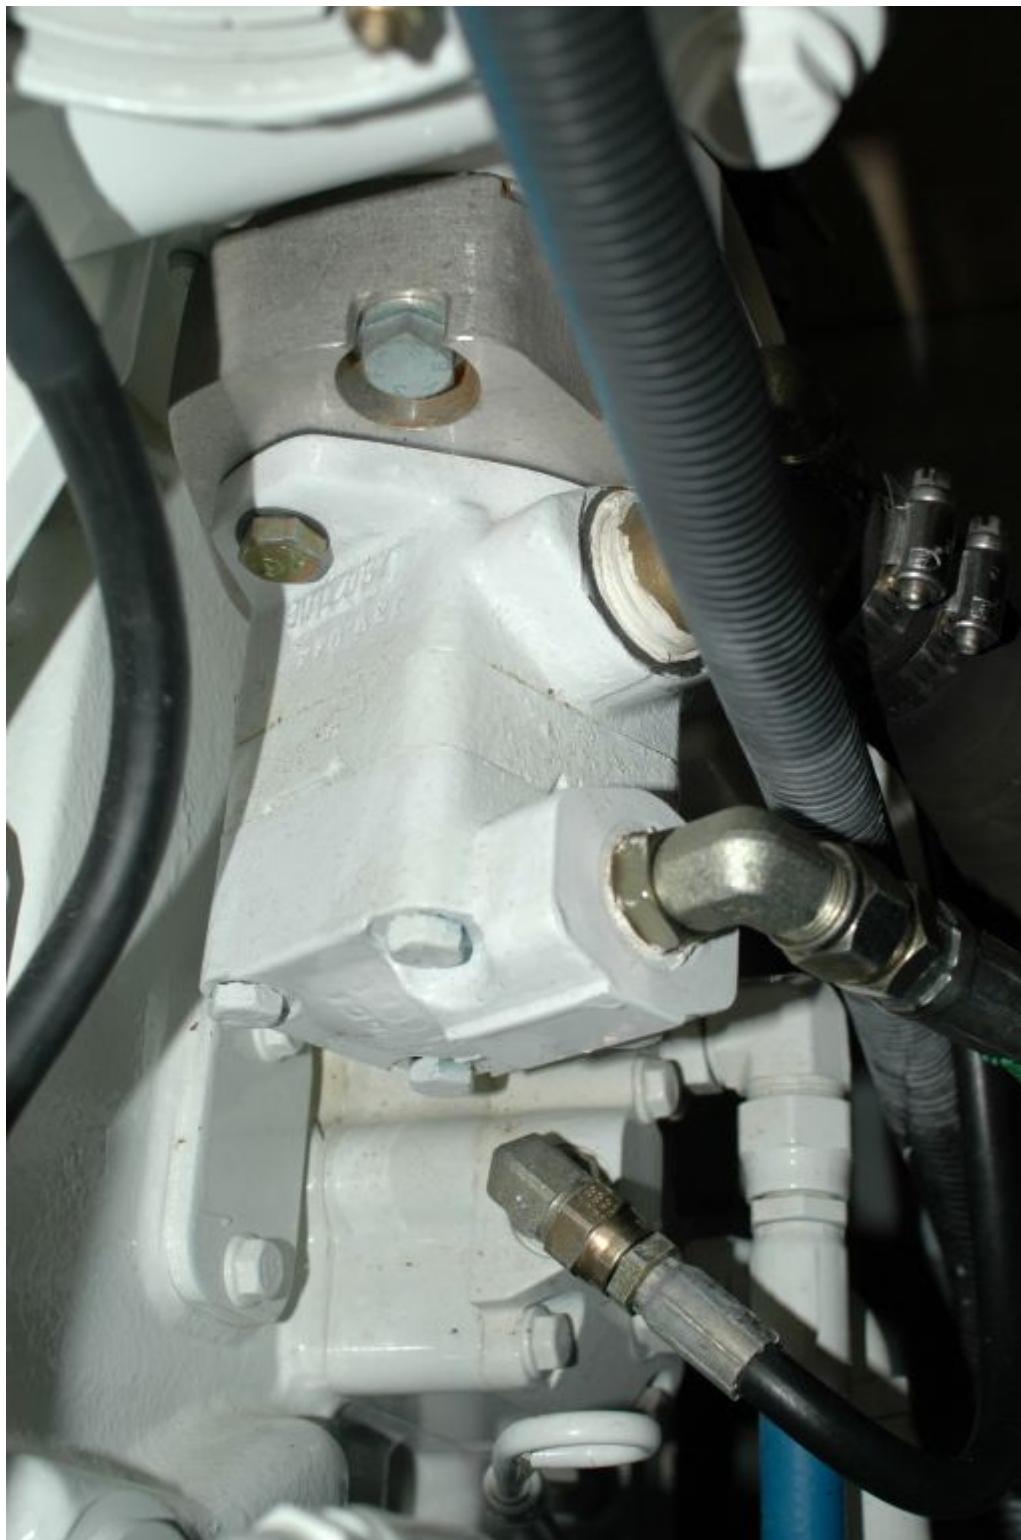
**Depending on their mission, hydraulic pumps range in size, from diminutive to beasts.**

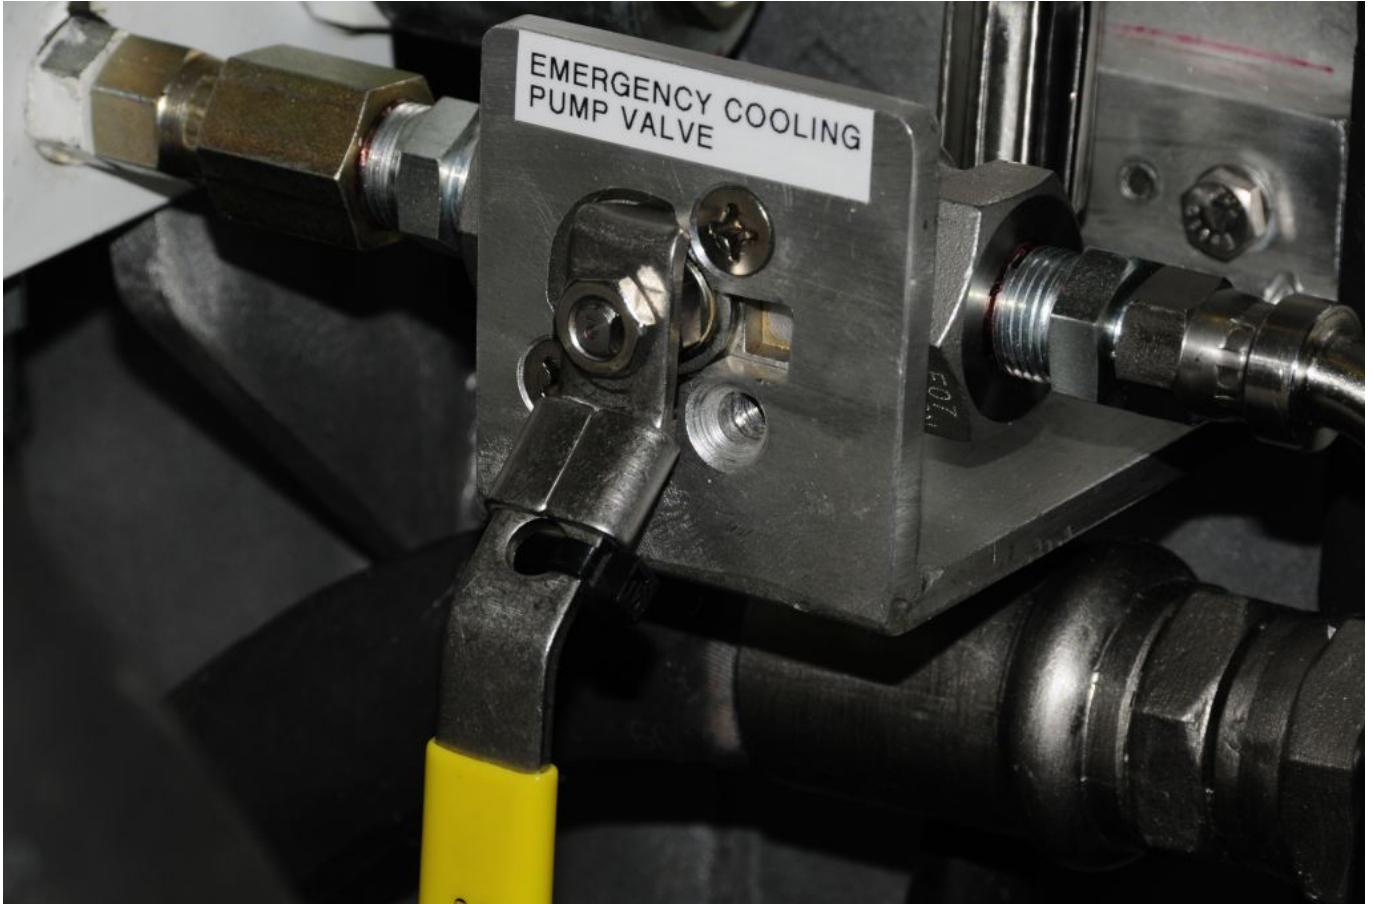
**Back up hydraulic cooling systems are typically installed with valves, so water flow can be directed to the active pump.**

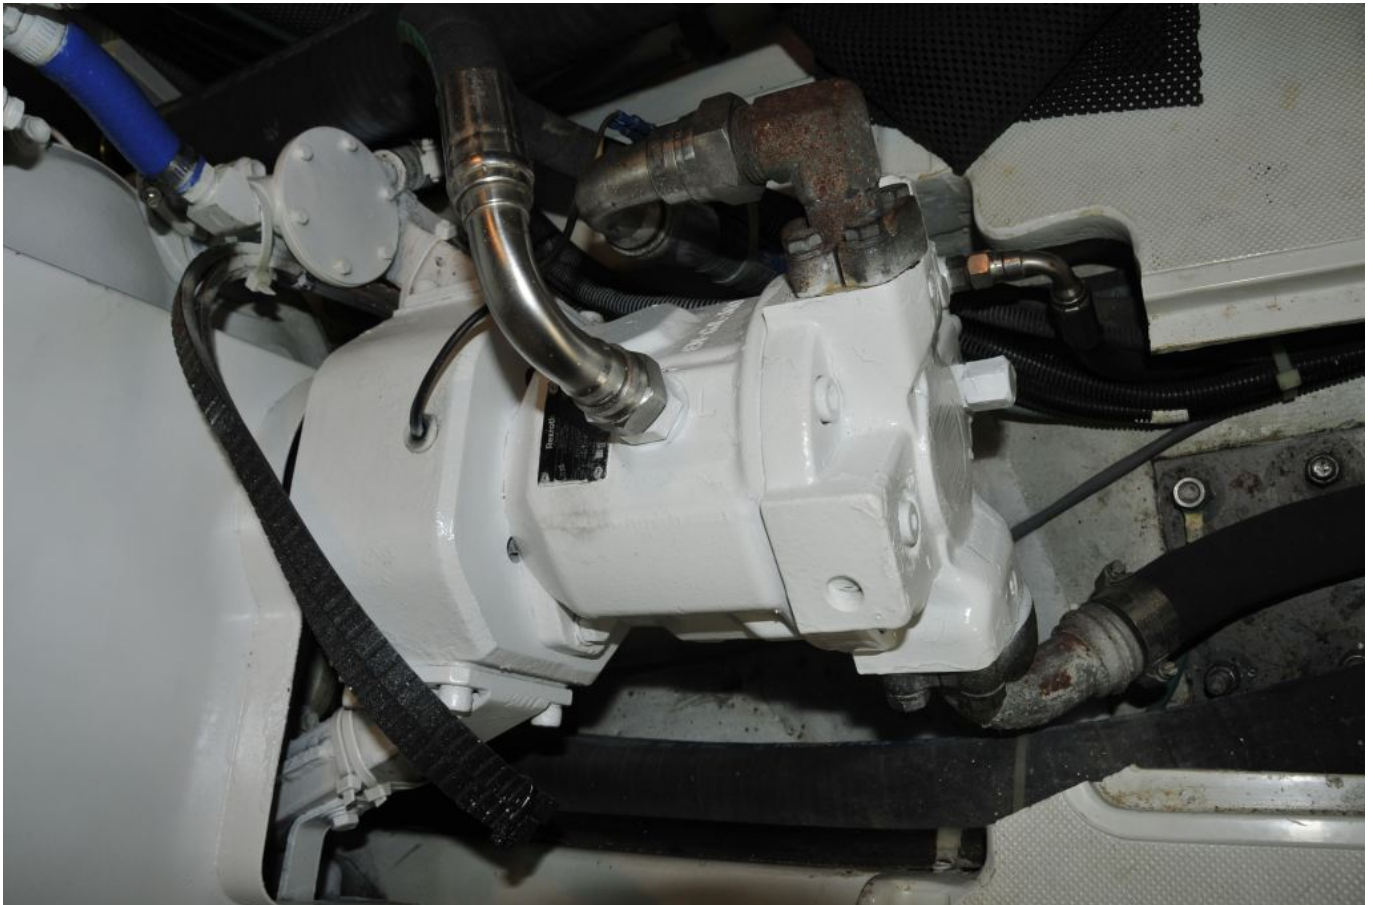
**This hydraulic pump is connected to a wing engine via an electric clutch.**

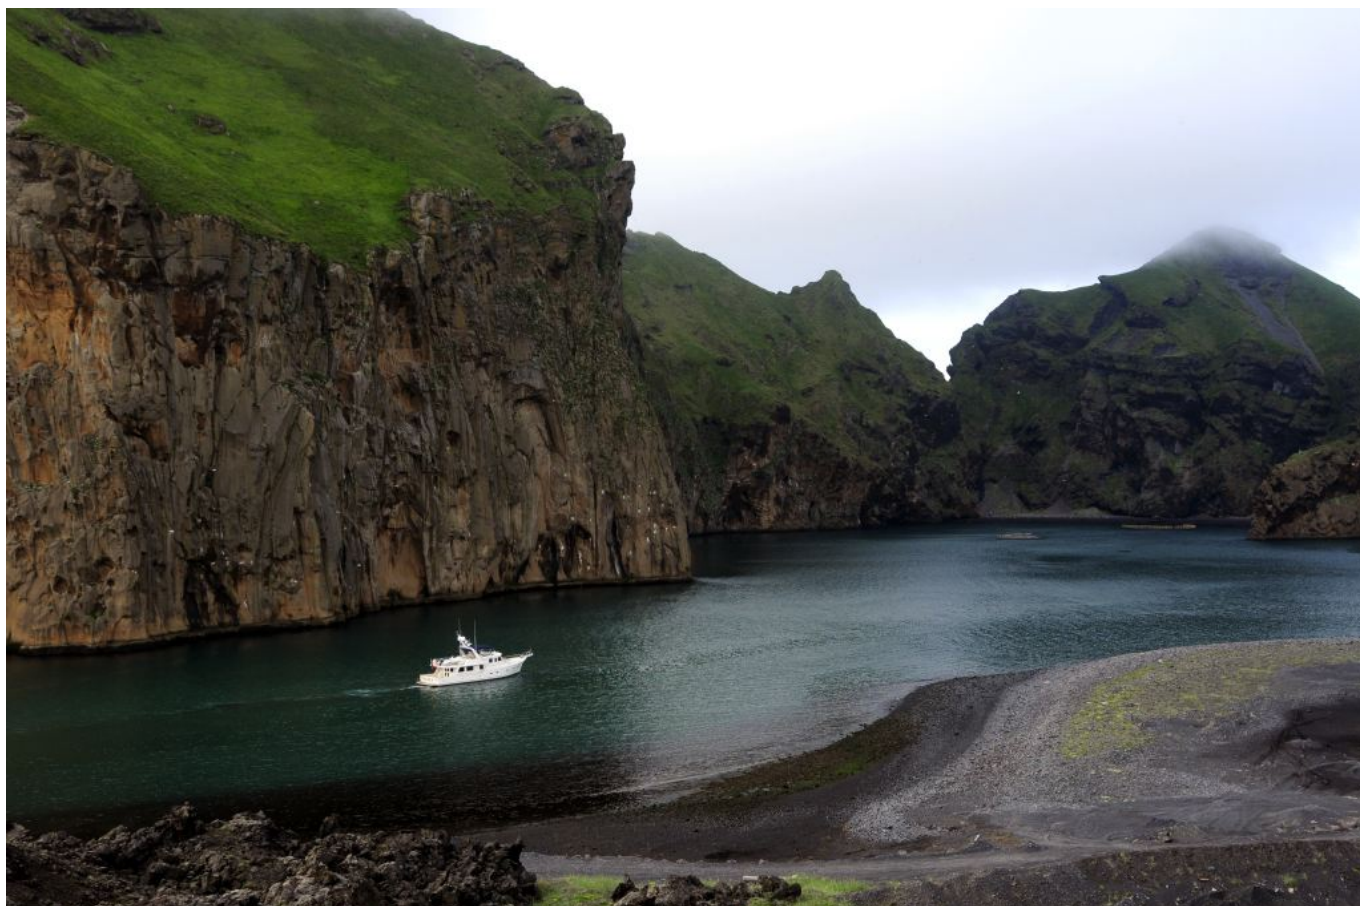
**With full hydraulic functionality, the vessel leaves the harbor at Heimaey Island, in southern Iceland.**

A few hours after departing from Stornoway, Scotland, however, an alarm sounded indicating that the temperature of the hydraulic oil used for the vessel's stabilizers was rising, and while it was not yet at a critical level, all eyes were upon the gauge thereafter. It continued its inexorable climb and eventually the decision was made to seek shelter in the lee of the Butt of Lewis (the northern most tip of the Isle of Lewis, on which Stornoway is also located) to effect repairs. After setting the anchor it was discovered that the raw water-cooling pump impeller, used to cool the hydraulic fluid, had failed. Not only did the impeller fail, it failed in such a way that the remnants, instead of breaking into the familiar small pieces flexible impellers are wont to do, melted into a congealed and solidified mass within the pump. Clearing the pump of all of these pieces would have involved time consuming disassembly and the weather was good, at the moment, a

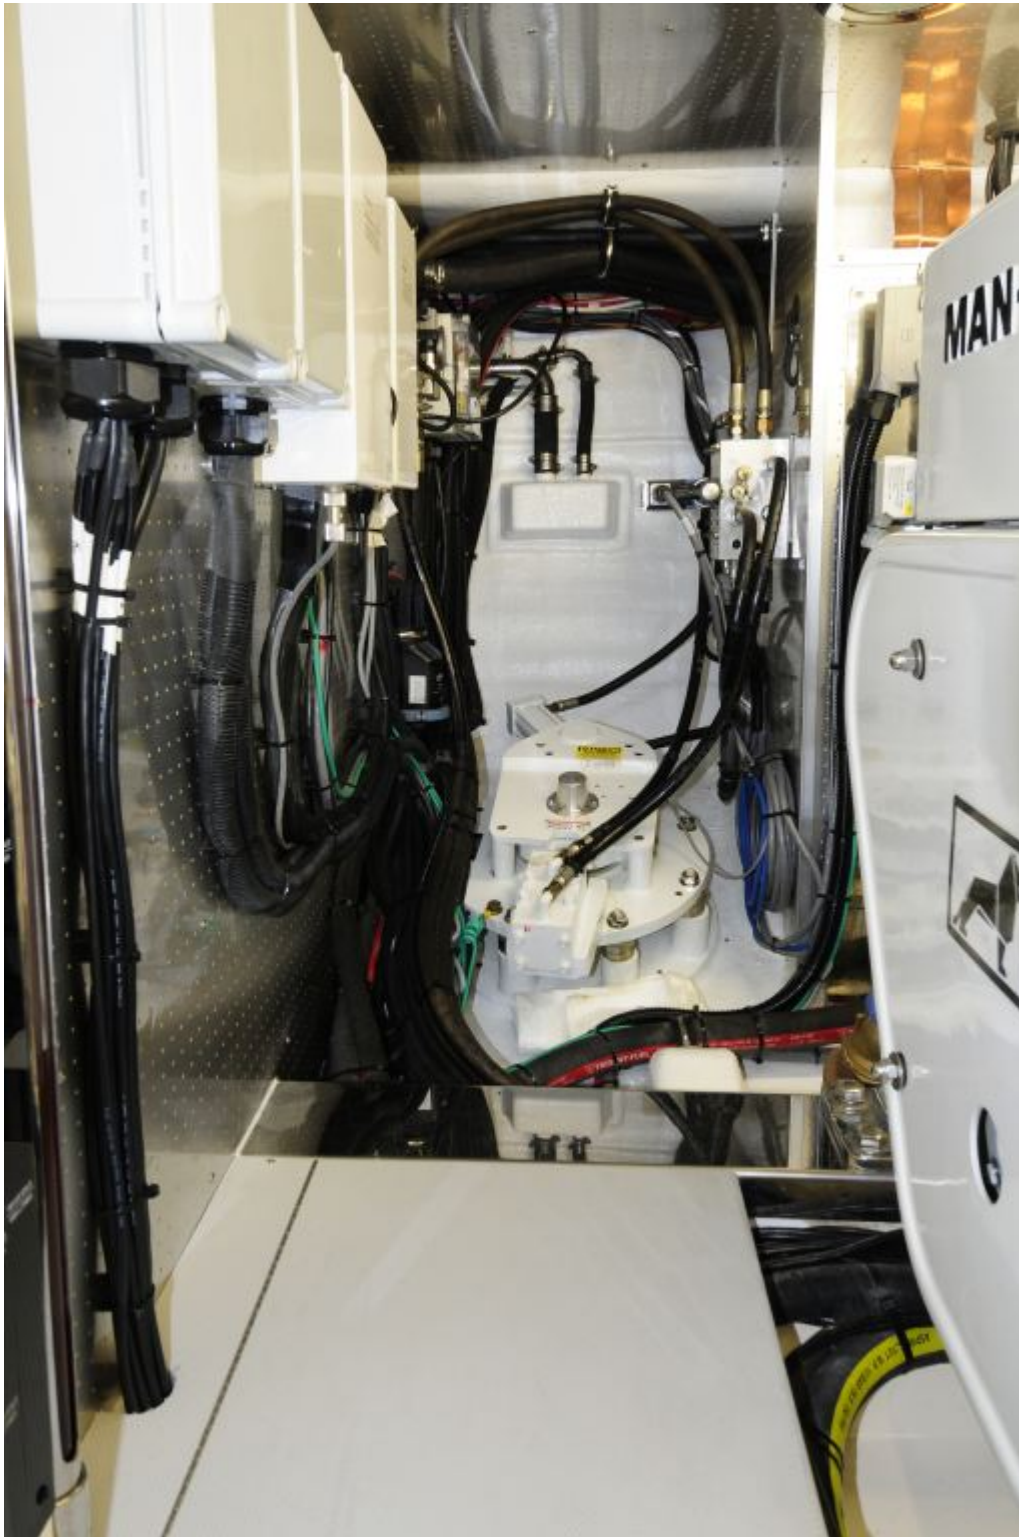
**Hydraulic components are renowned for their durability and ability to operate under the most severe conditions.**

Once the sole domain of large yachts, and commercial or military vessels, hydraulic systems are increasingly found on smaller and smaller cruising vessels, they are used to actuate and control not only stabilizers, but thrusters, windlasses, cranes, winches and steering systems, among other gear. While initially more costly than similar electric gear, hydraulic equipment is known for its reliability, particularly in the marine environment, as well as its brute strength. Hydraulic thrusters, for instance, as anyone who has used them knows, typically offer a 100% duty cycle, something that cannot be said of their electrically powered brethren. I have inspected both hydraulic stabilizer actuators and bow thrusters, and found them to be completely submerged within their compartments, and still fully functional.

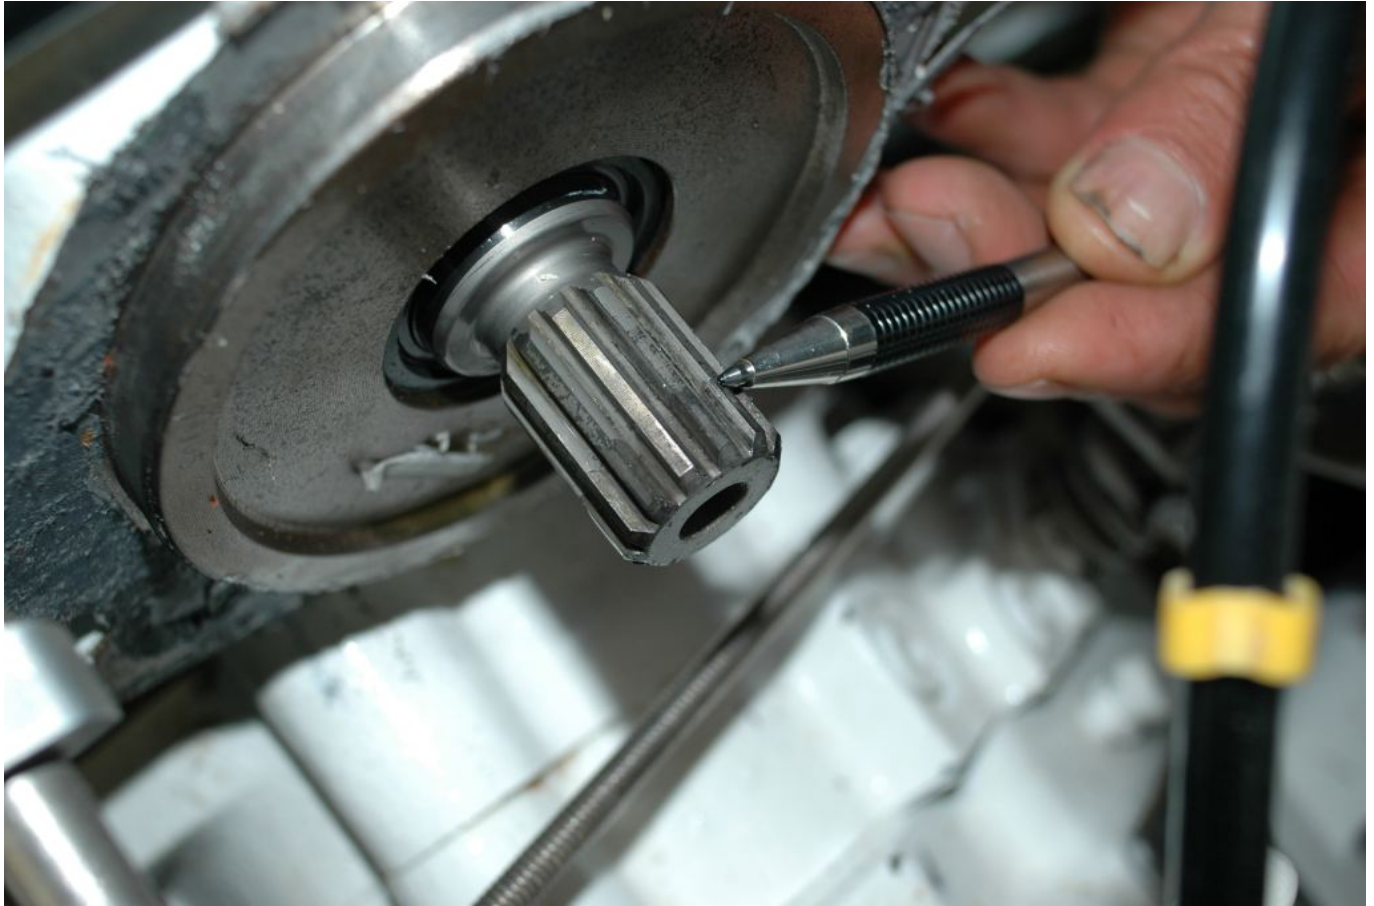
**Hydraulic pump splines, these typically engage mating female splines in an engine or gear mounted power take off device.**

**These splines should always be thoroughly greased before assembly.**

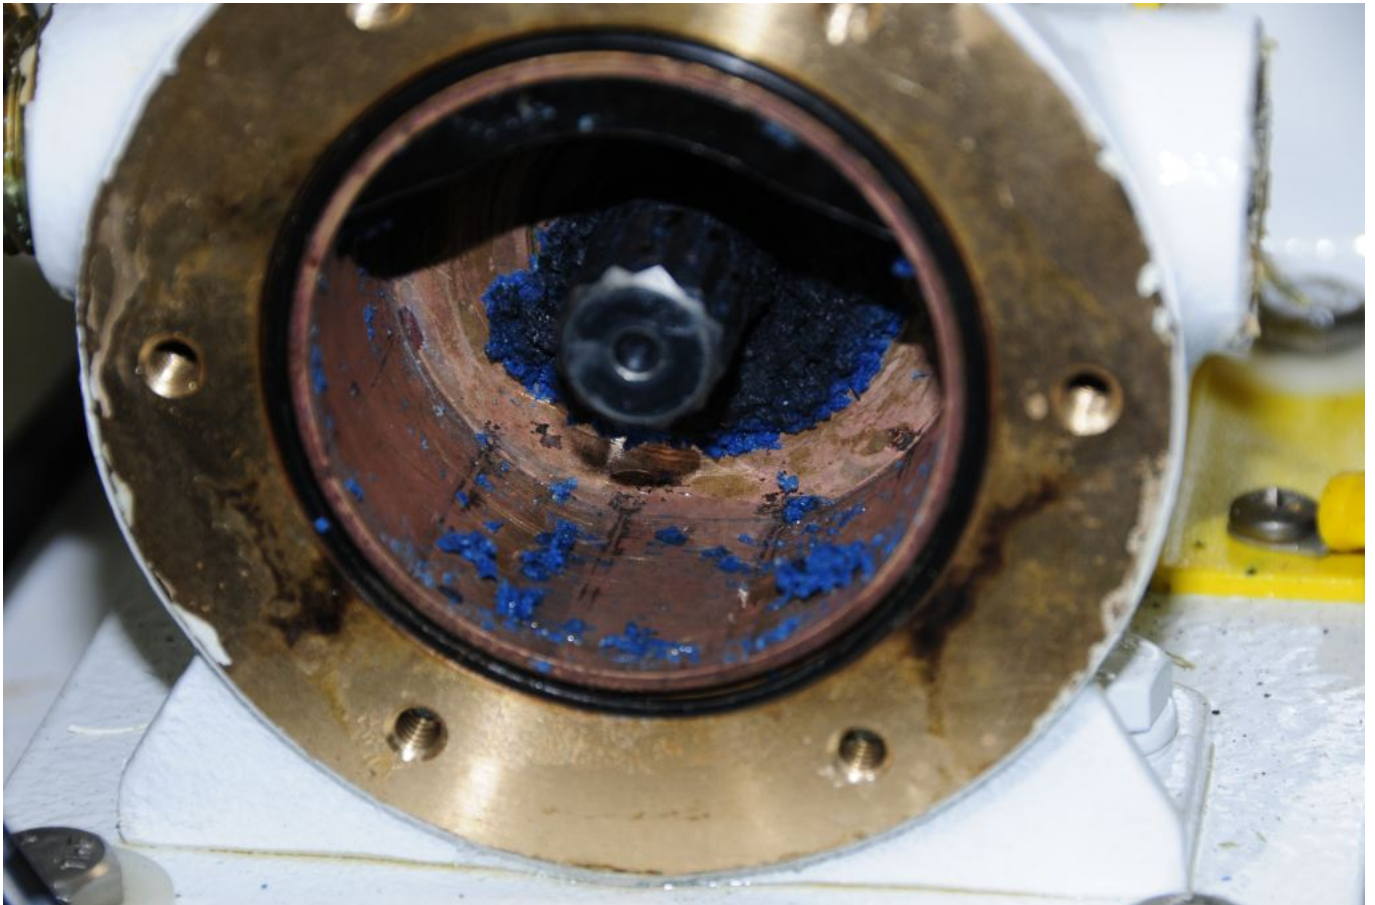
**Without fluid, a hydraulic system will grind to a halt,  
literally.**

Perhaps of greater or more immediate concern is the chain of events that may occur with such a system in the event hydraulic fluid is lost, i.e. if a hose should fail. Almost as soon as this occurs the pump loses lubrication, which in turn leads to rapid heat generation and eventual seizure, which then leads to gear and shaft shearing, possibly bringing the engine, or propulsion system at the very least, should the transmission be damaged, to a halt.

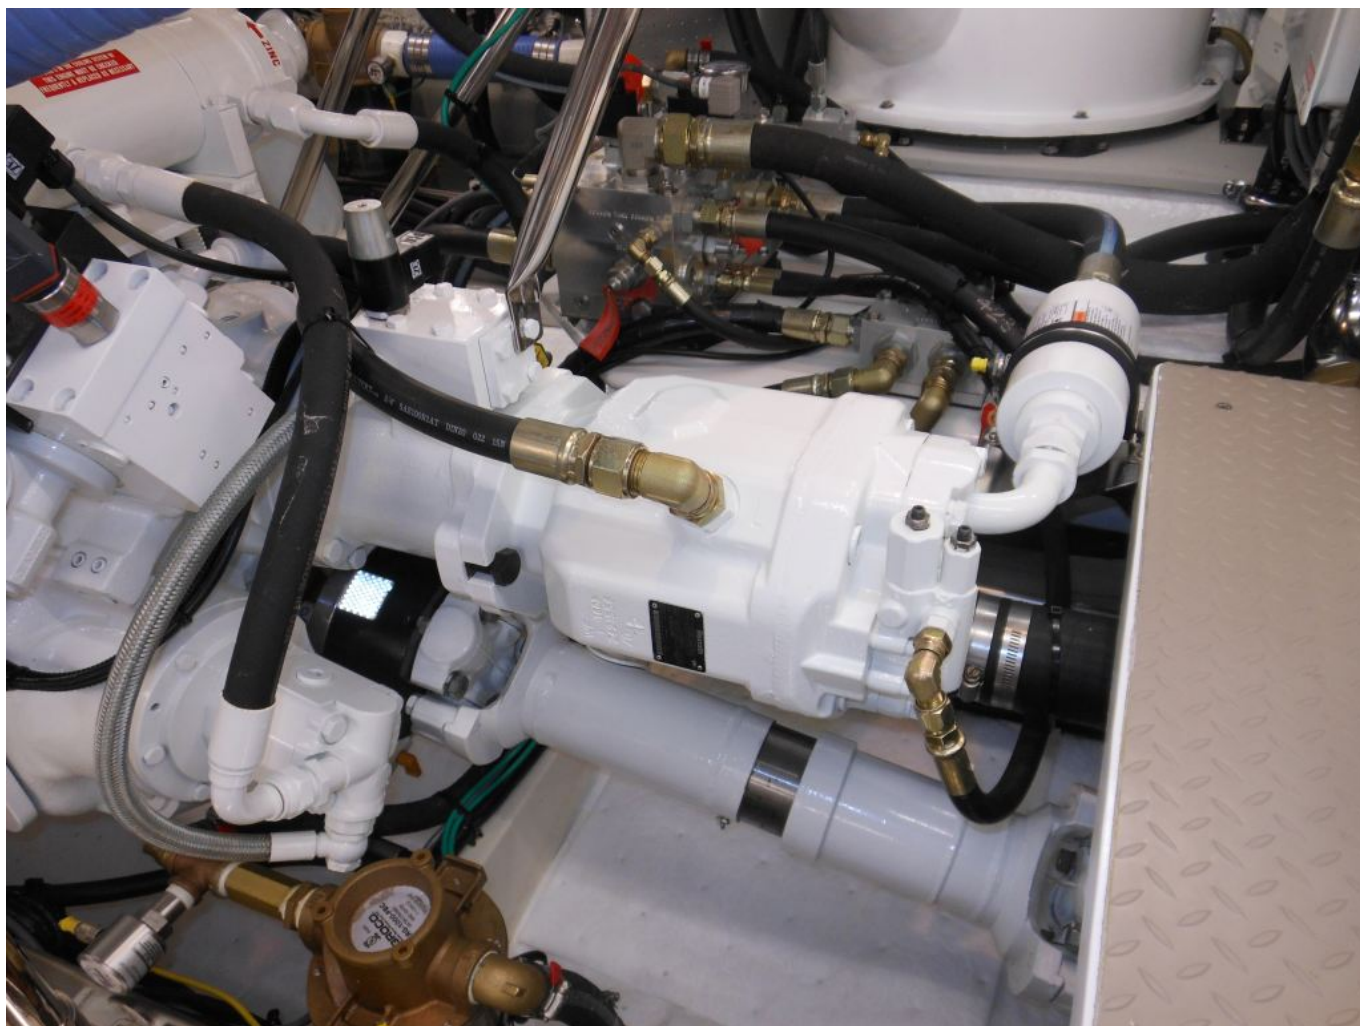
**A clutched hydraulic pump running off of a marine gear power take off (PTO).**

It's important to remember that these scenarios involve gear-driven, live hydraulic pumps, pumps that are bolted to the engine or transmission *and* lack a clutch. This accounts for pumps used on most of today's small systems and many moderately sized systems where space (or budget) prohibits the use of a clutched PTO (if space permits, a clutch can nearly always be included). It's also important to remember, if twin pumps are used, one on each engine in a paralleled system, the most common arrangement, fluid loss will similarly affect both pumps.

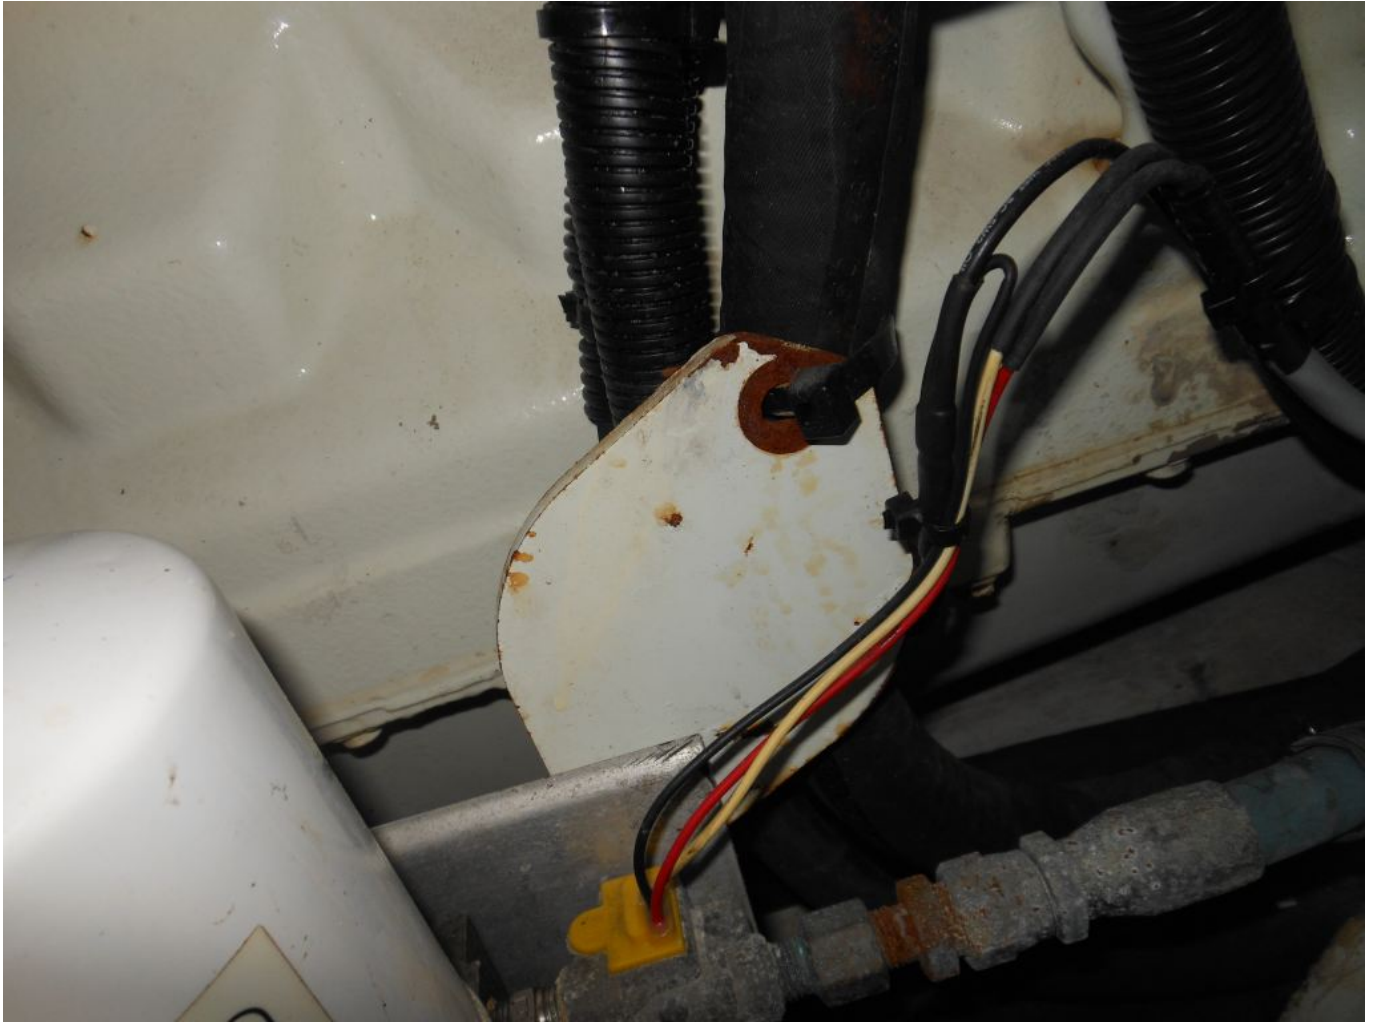
**A blanking plate, used to cover the hole left by a removed hydraulic pump, can be attached to the engine so it is easily accessed when needed.**

It's likely that the life of the hydraulic pump can be measured in minutes if not seconds once it's lost all fluid and lubrication. Therefore, if the vessel is to continue on, the only solution is to remove the hydraulic pump from the PTO on the engine or transmission. A metallic blanking plate should be made and remain aboard as part of the vessel's spare parts kit (it can be secured to the engine adjacent to the pump); it would be installed over the orifice on an engine and some transmissions where the pump once resided. The function of the blanking plate is to keep oil in and dust, dirt and debris out of the engine's lubricated components. If the pump can be separated from the PTO adapter, without exposing a gear
