# Editorial: Visiting the USS SAGINAW's Gig- Feature: Buying a Metal Boat

## **Metal Boats**

### ***Buying, Owning and Selling Metal Boats***

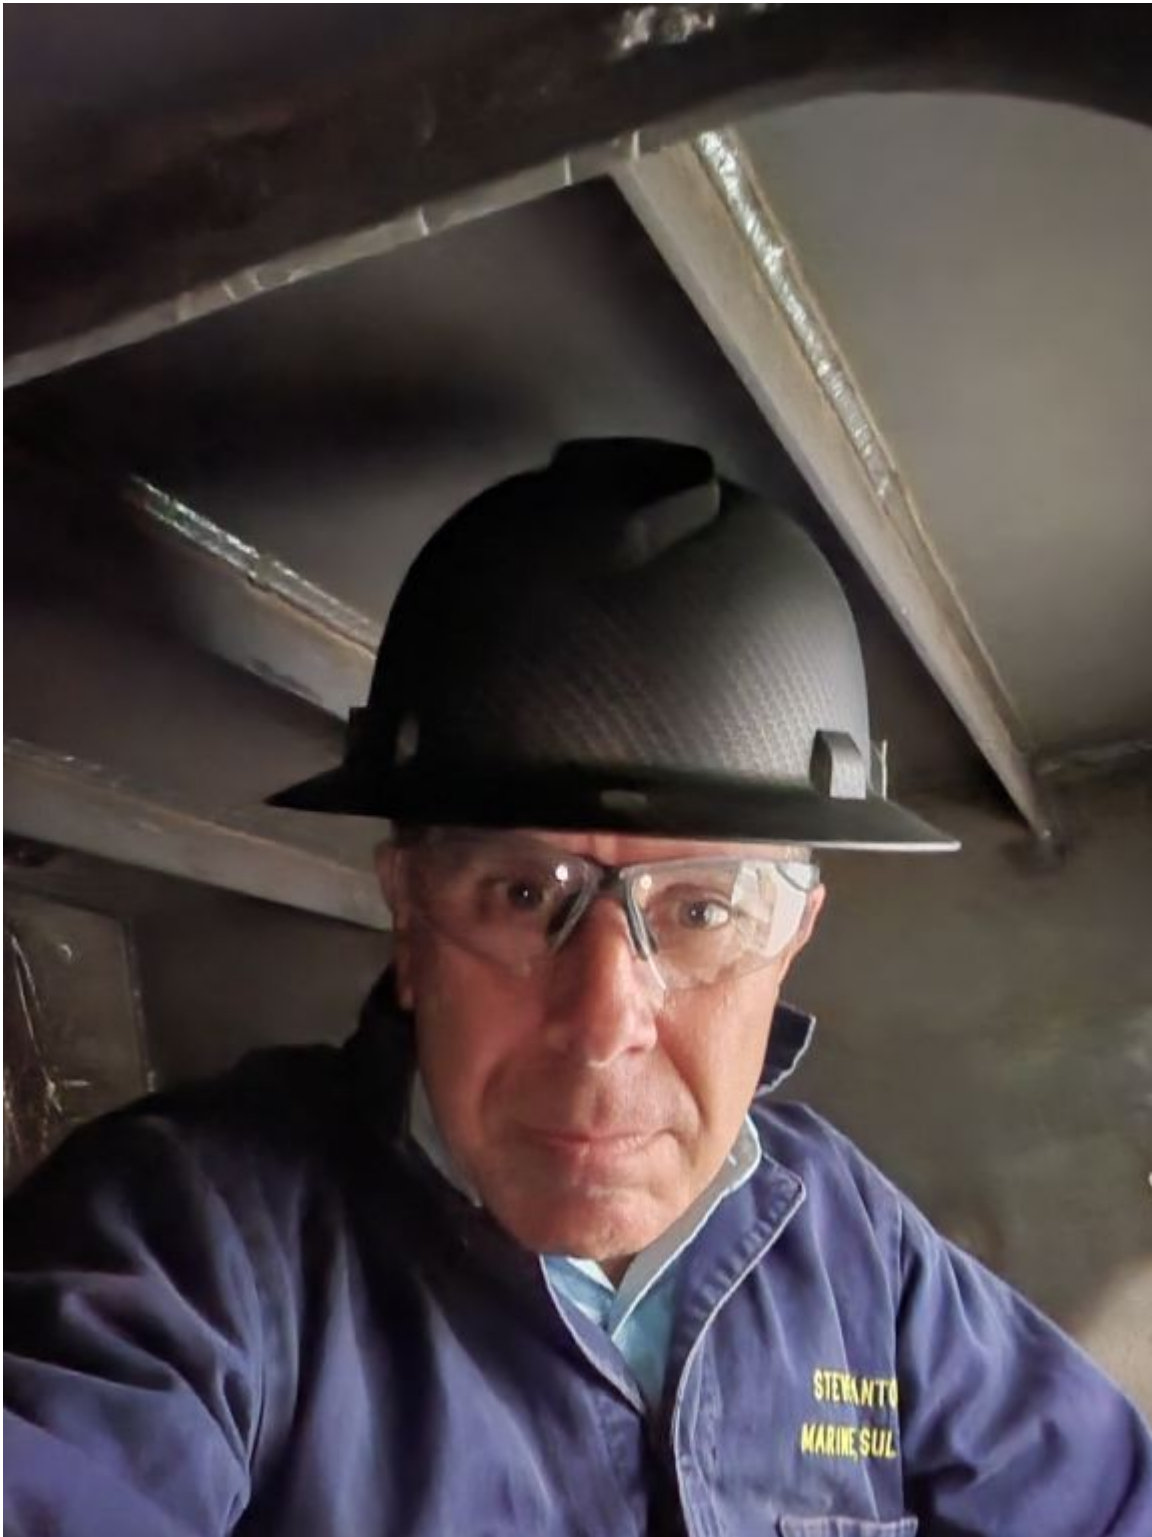
**The author inside the fuel tank of a steel vessel under construction.**

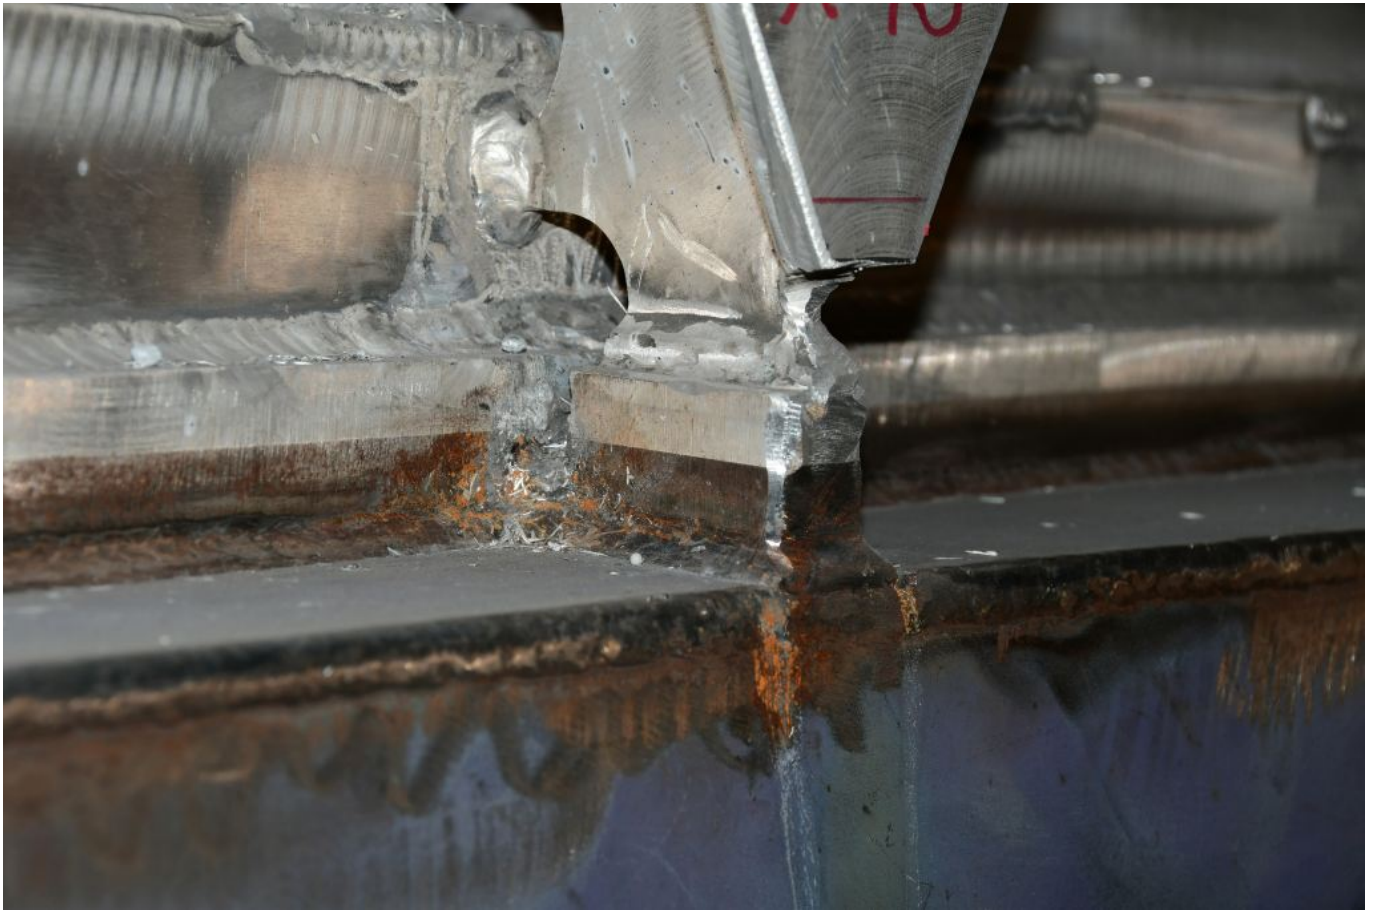
**Many steel vessels utilize aluminum for cabins and other above deck structures. Joining these two metals typically relies on specialized products that act as an interface between the two.**

Most “steel” yachts utilize aluminum superstructures (the two are usually welded together using product known as “Detacouple”, which joins both of these metals using explosive force), which means details for both of these metals are relevant in in the case of steel hulled vessels.

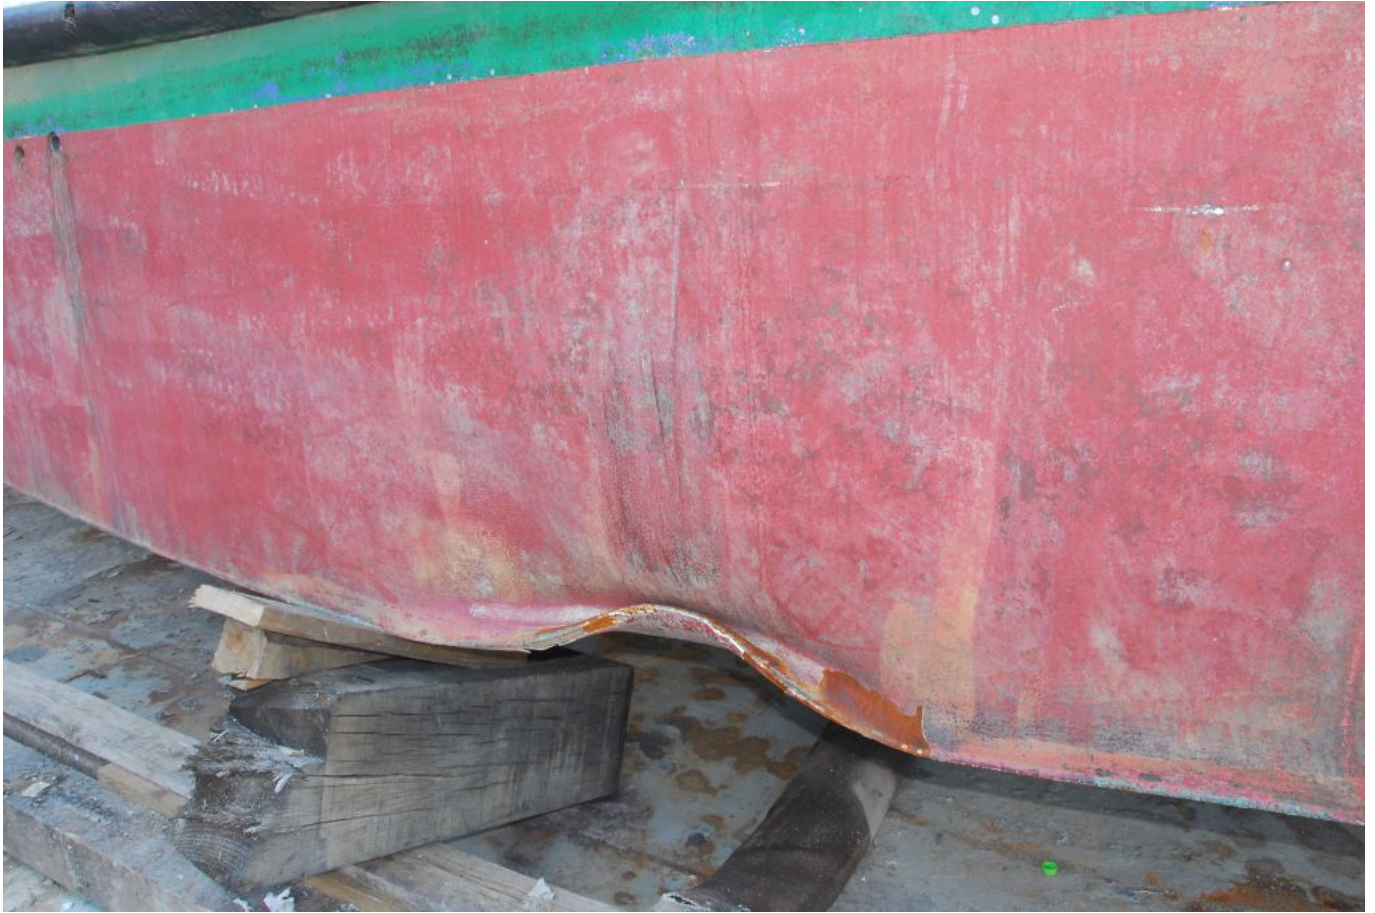
**One advantage of steel and aluminum is their ability to deform significantly before being breached.**

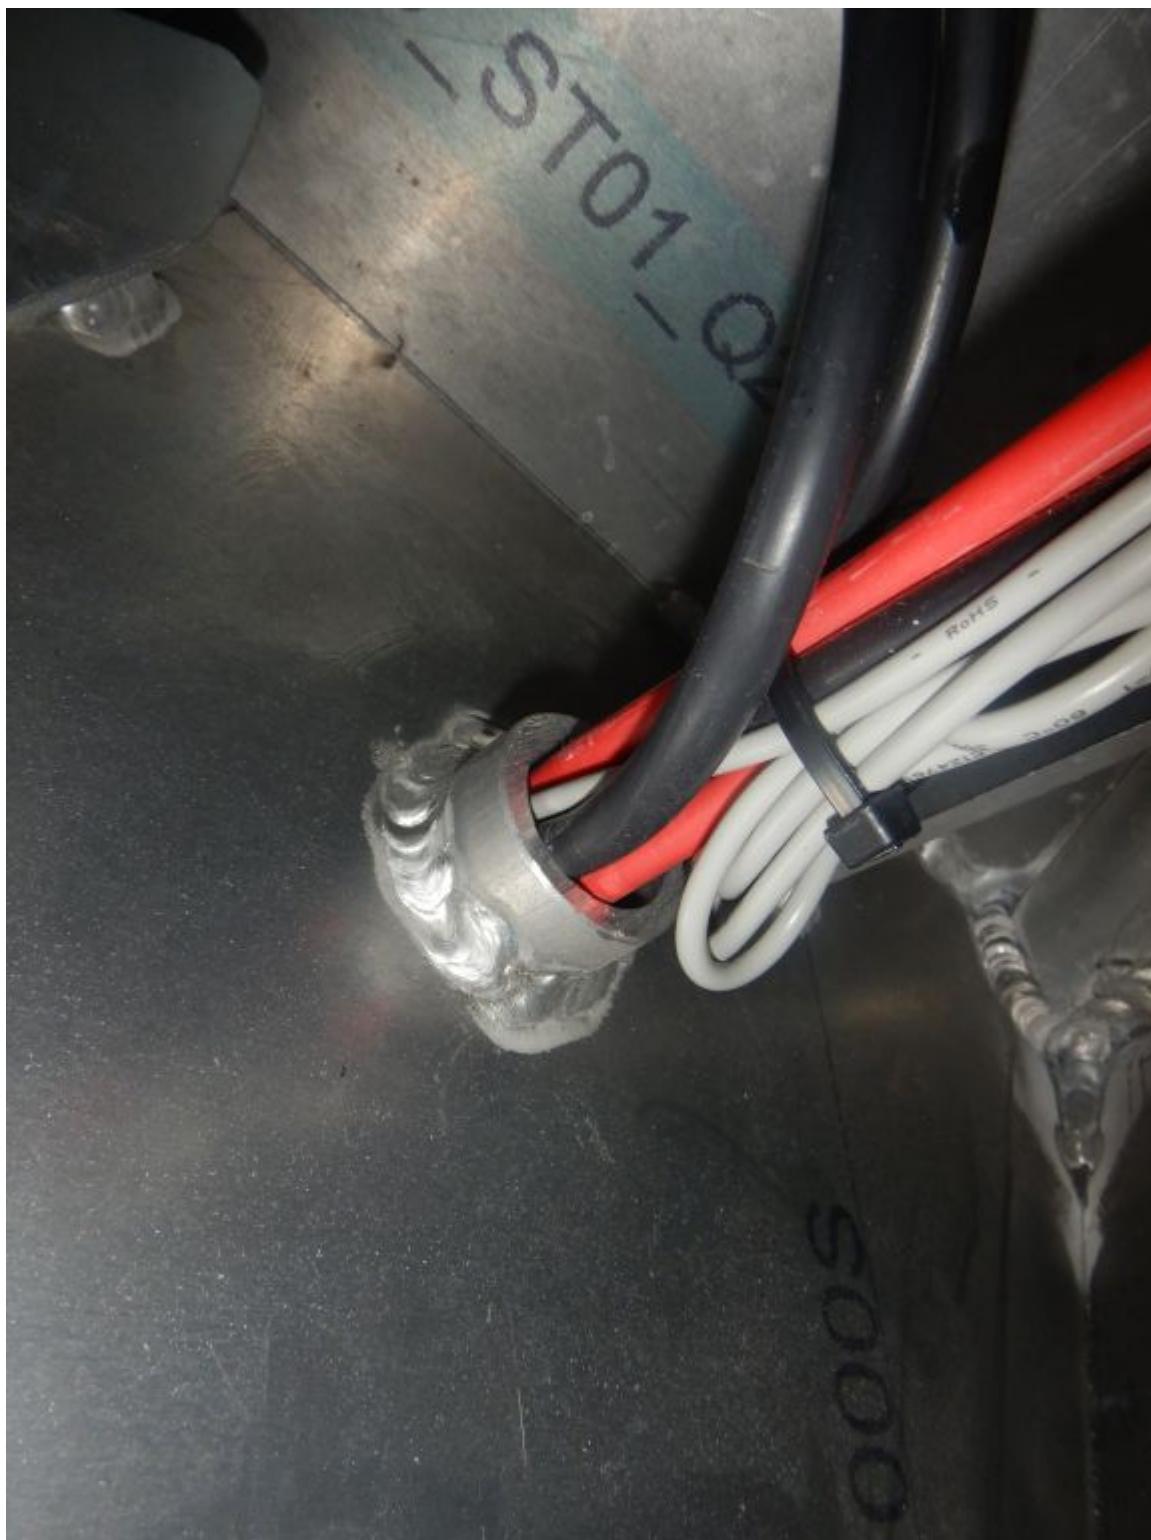
**Because of the risk of chafe and short circuits, additional caution must be used when installing wiring on metal vessels.**

As noted earlier, because aluminum and steel vessels' hulls and cabins must be grounded, the risk of wire chafe, a short circuit, fire and stray current corrosion, is high. Therefore, extreme attention to detail must be exercised in wire routing, all possibility of chafe/abrasion must be eliminated.

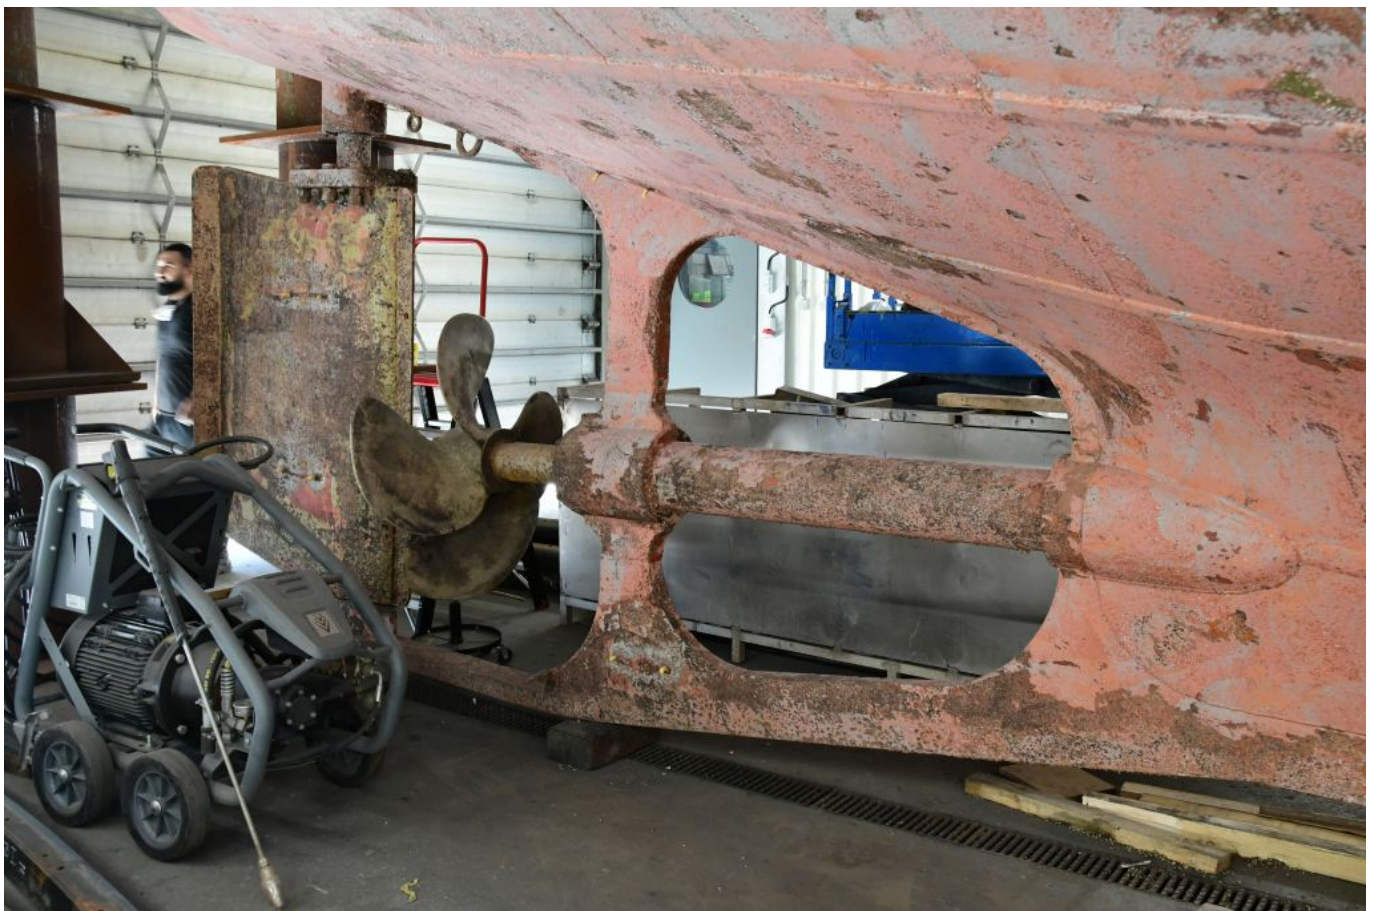
**In contrast to aluminum, steel requires thorough preparation, priming and coating, on a regular basis, in order to remain rust-free.**

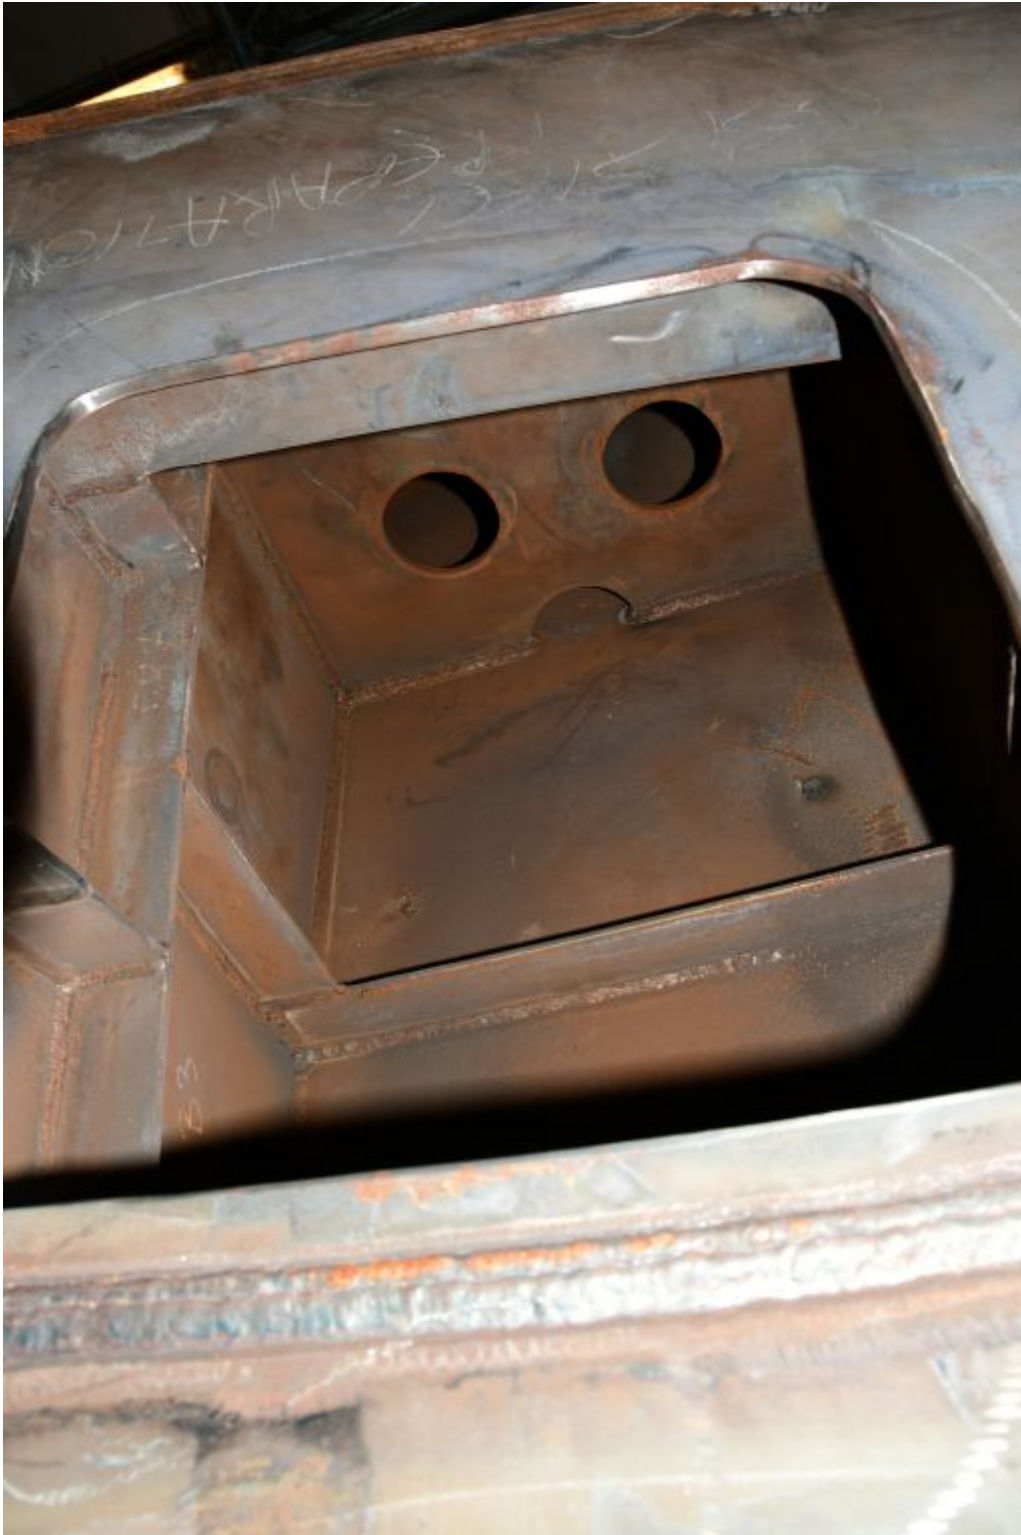
Most steel vessels utilize this alloy for integral tanks. For fuel, no treatment or coating is necessary, however, for potable water and waste, tank interiors must be thoroughly coated to prevent rusting. Additionally, while the inside of

most steel fuel tanks are not coated, every effort must be made to prevent the accumulation of water, as it can lead to rusting. Of course, this is also true for aluminum integral tanks, where stagnant water can lead to poultice corrosion.

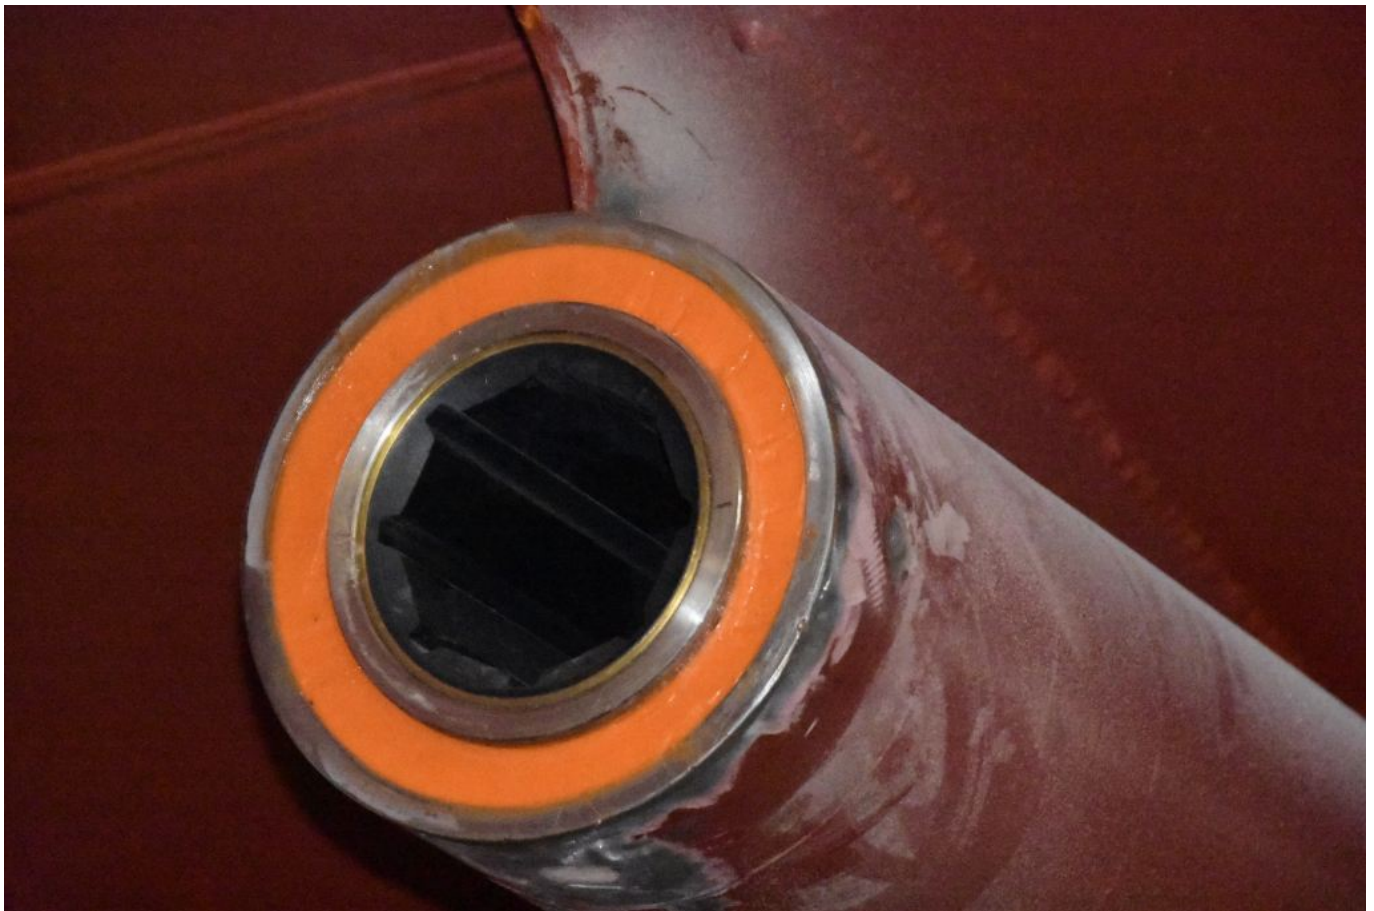
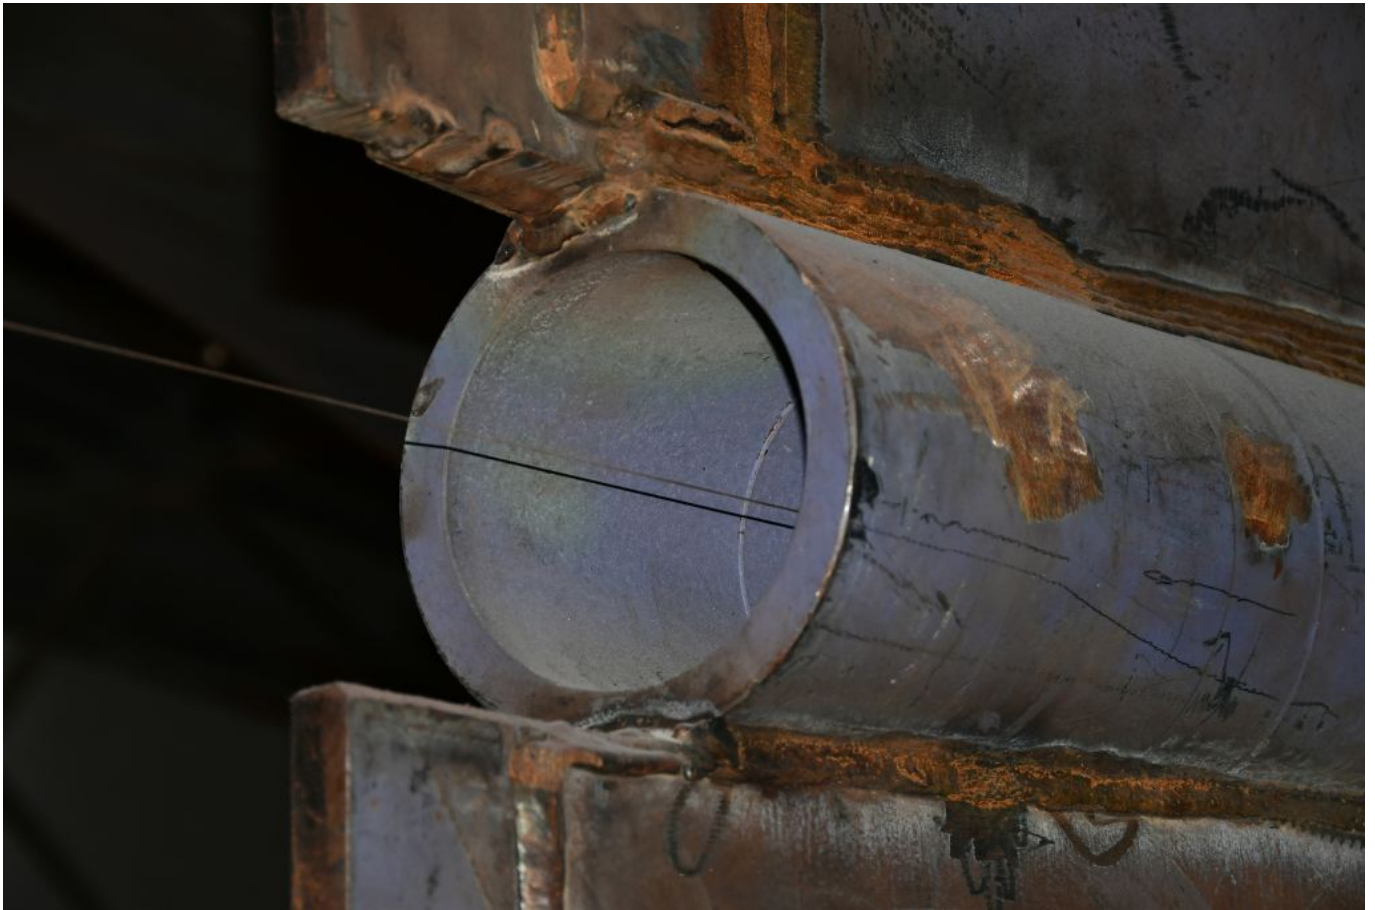
The inside of propeller and rudder shaft logs, are areas on steel vessels that often receive inadequate attention, once a vessel enters service. Rust in this location is virtually impossible to detect without shaft removal.

Another area of concern is the inside of propeller and rudder shaft logs on steel vessels. This area is *typically* thoroughly prepared, primed and painted when a vessel is new. However, once the vessel enters service, the area is rarely inspected or maintained, which in turn leads to rust and eventually a possible breach and leaks. Ideally, on an older (i.e. more than 10 years old) steel vessel, shafts and rudders should be removed, and these areas inspected.

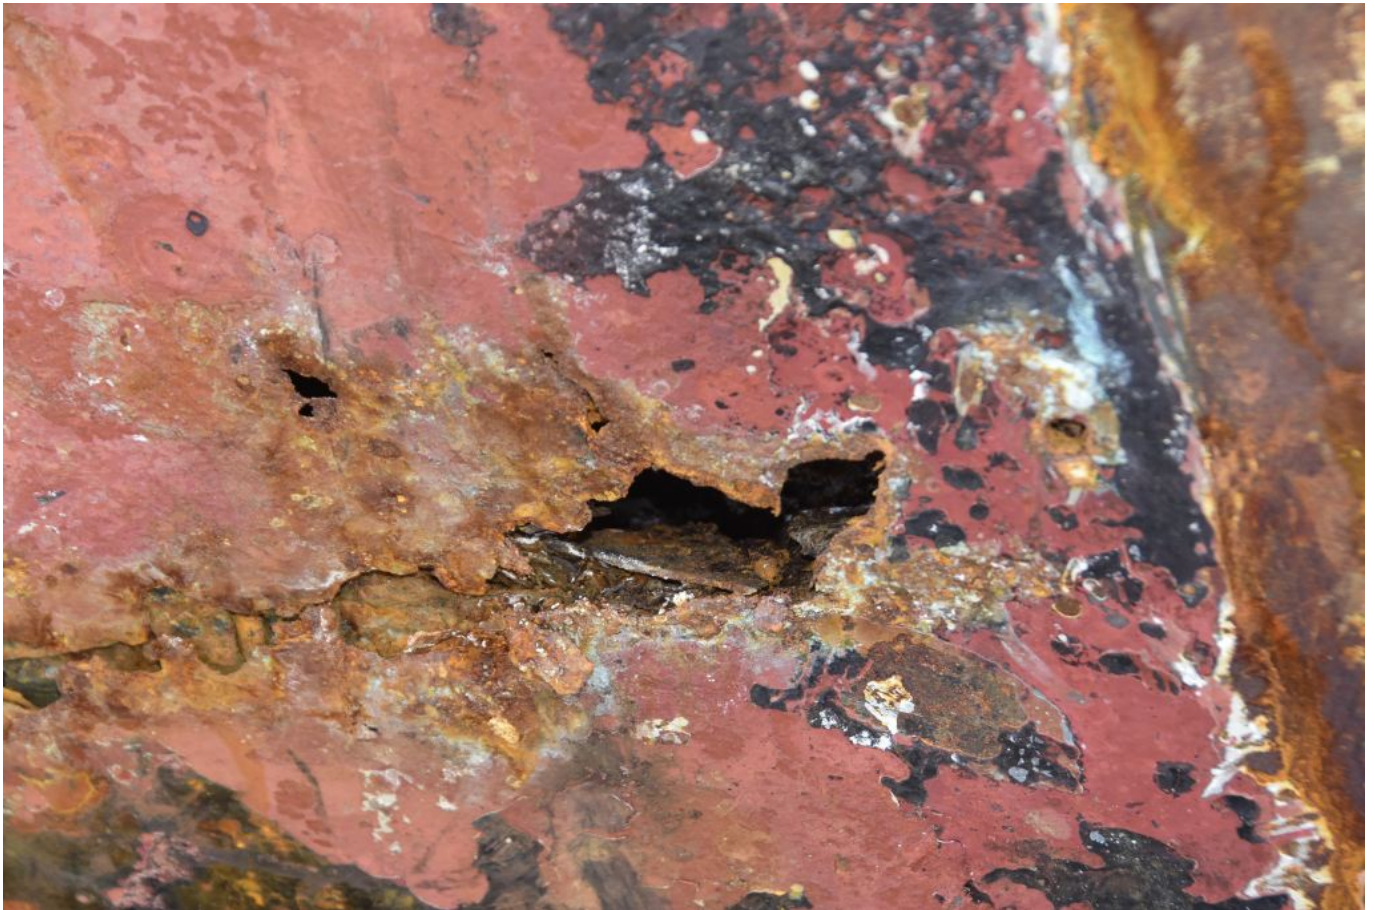
**Proper maintenance of coatings is a critical, and ongoing aspect of steel vessel ownership.**

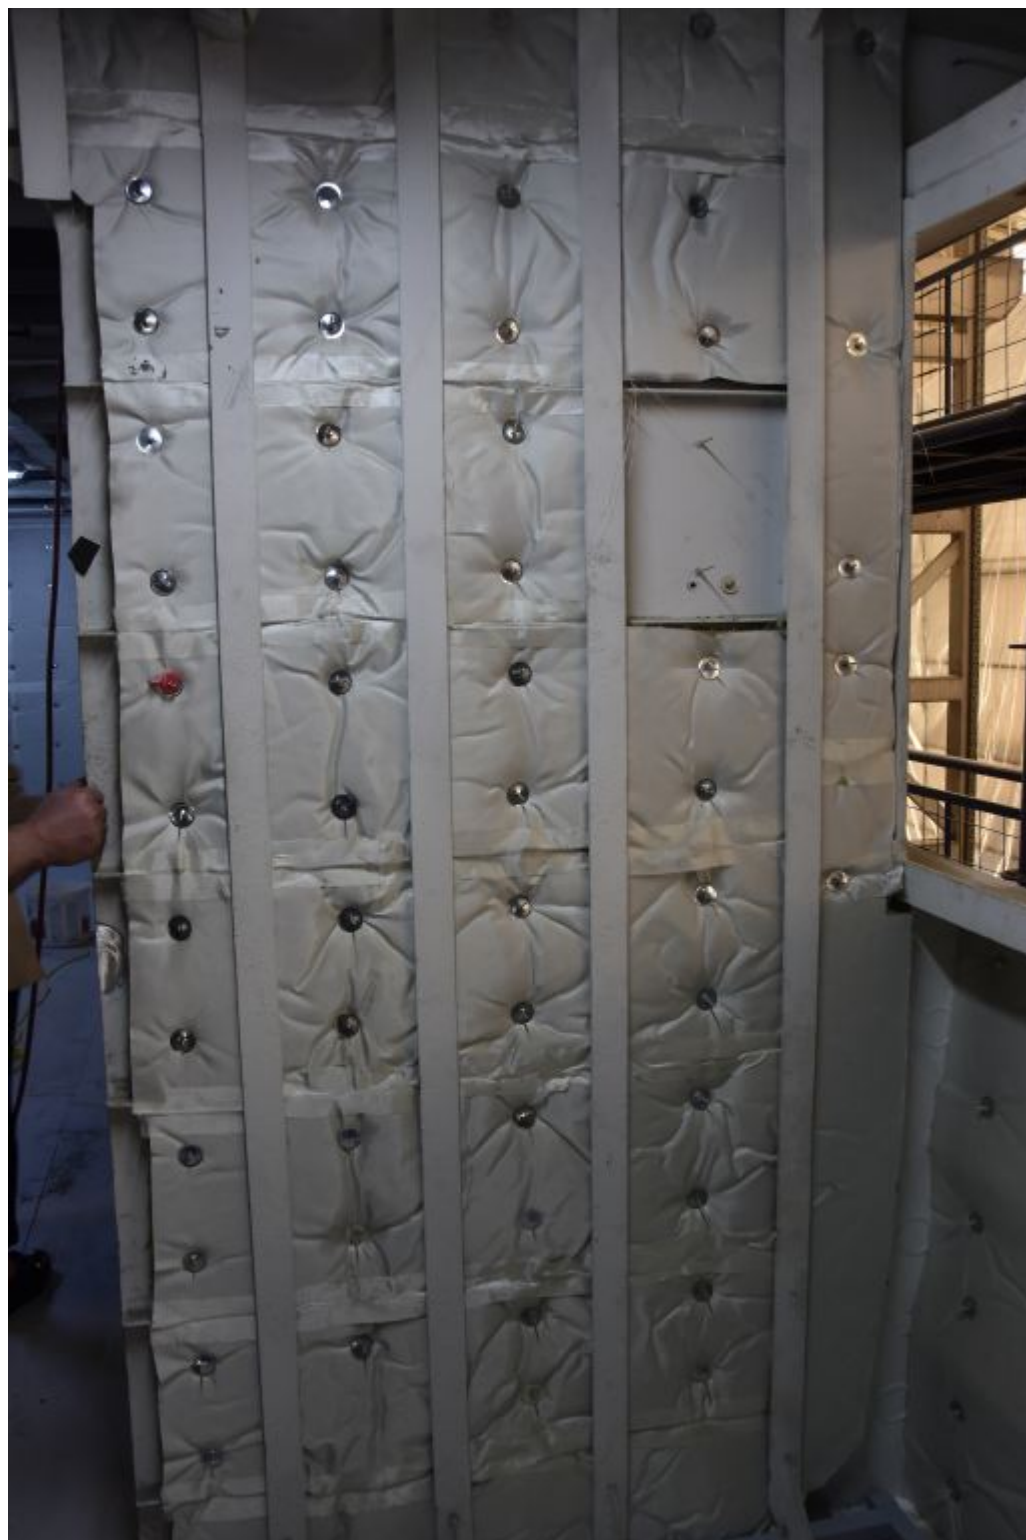
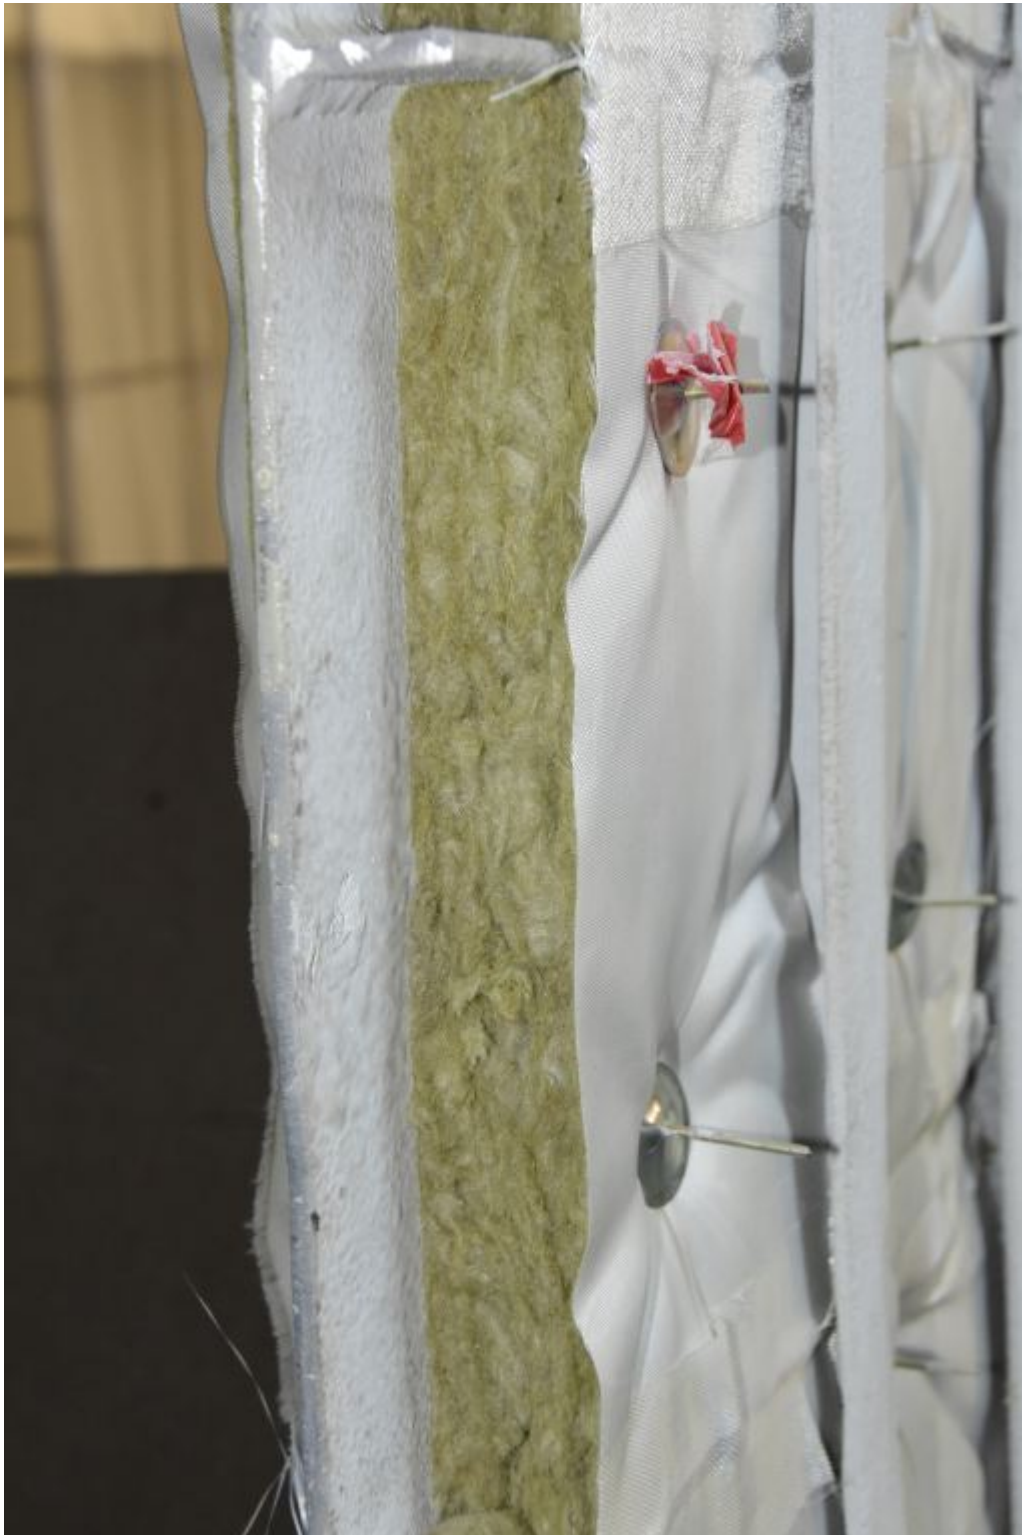
**Different types of insulation are used on metal vessels. The batting style shown here can be relatively easily removed if welding becomes necessary.**

Repairing and modifying steel is relatively easy for professional welders; these can be found in virtually every port. However, extreme caution must be taken when doing “hot work”, as the heat generated by welding can cause nearby flammable materials, especially sprayed foam insulation, and timber joinerwork, to catch fire. Metal vessels have caught fire in boat yards, both while under construction, as well as when undergoing repairs. Metal vessels that use batting, often a mineral-based product, which is fire resistant, are more easily prepared for welding work.

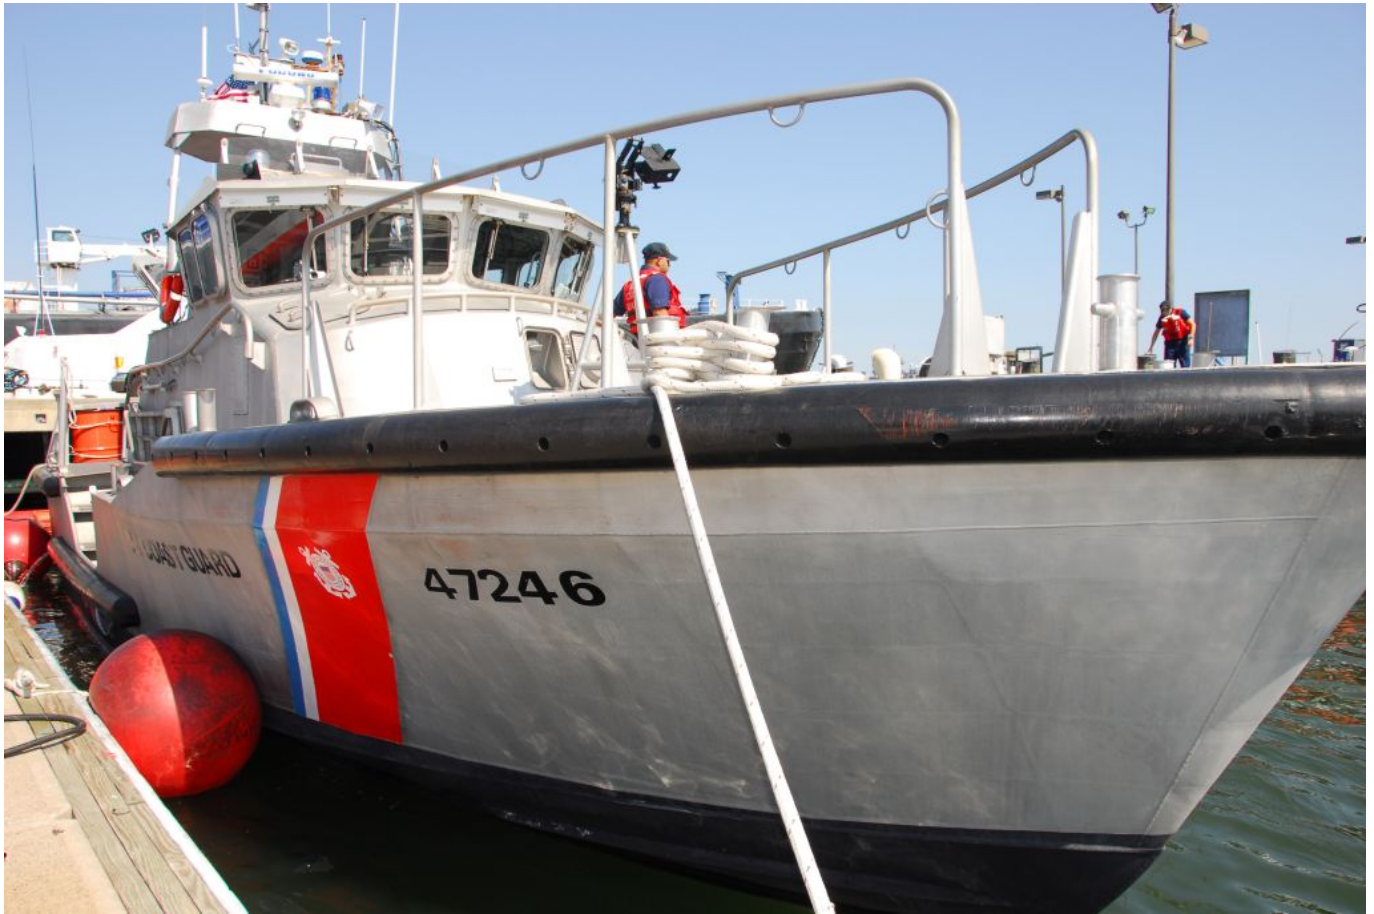
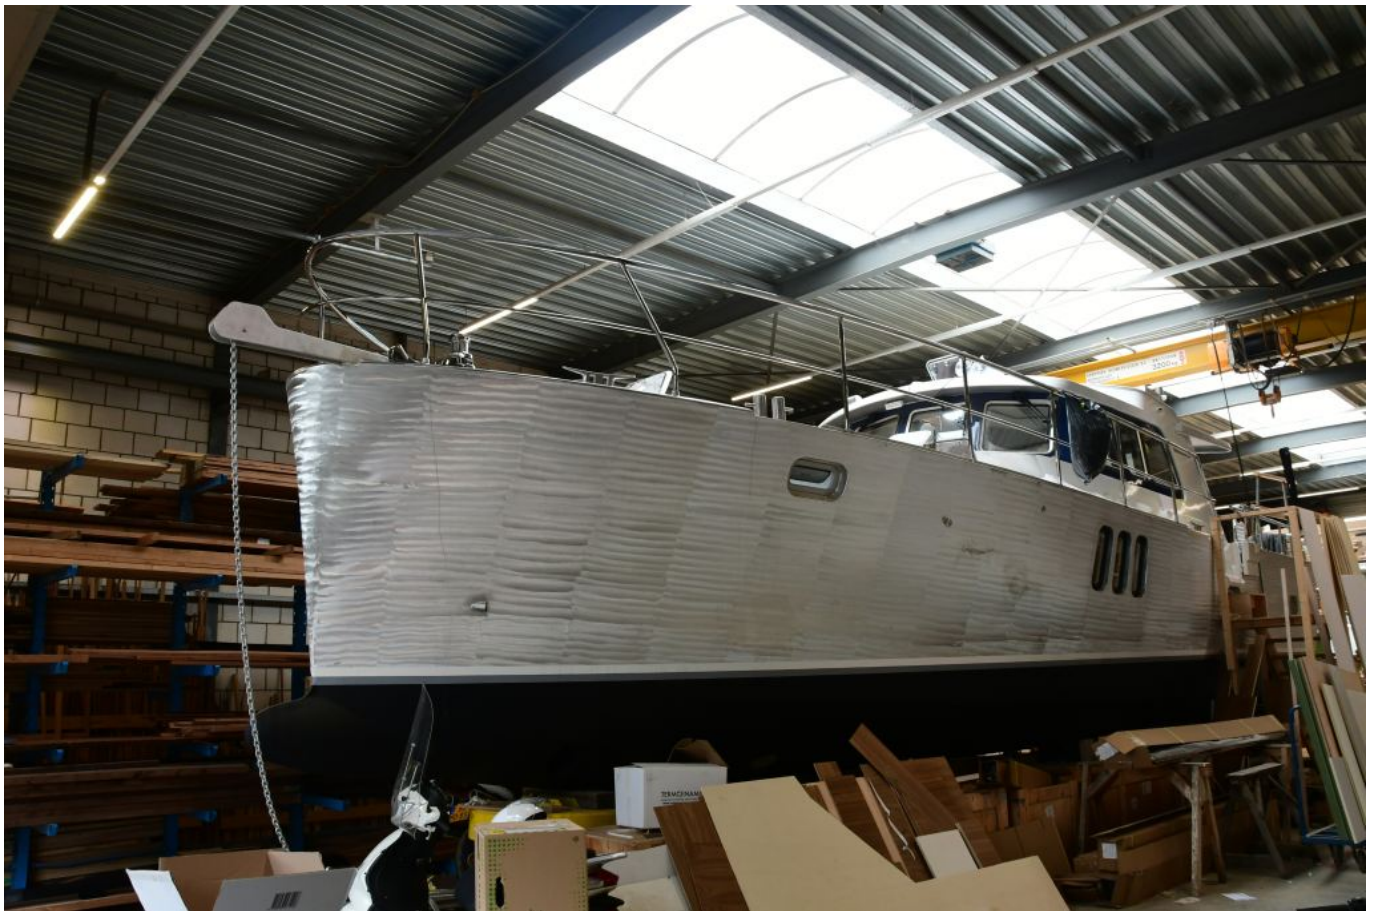
One of aluminum's attributes is its natural resistance to

**simple corrosion; and as a result it does not require coating. In fact, coatings, when breached, trap water, which in turn fosters the formation of poultice corrosion. Therefore, where possible, and aesthetics aside, aluminum is best left in its natural state.**

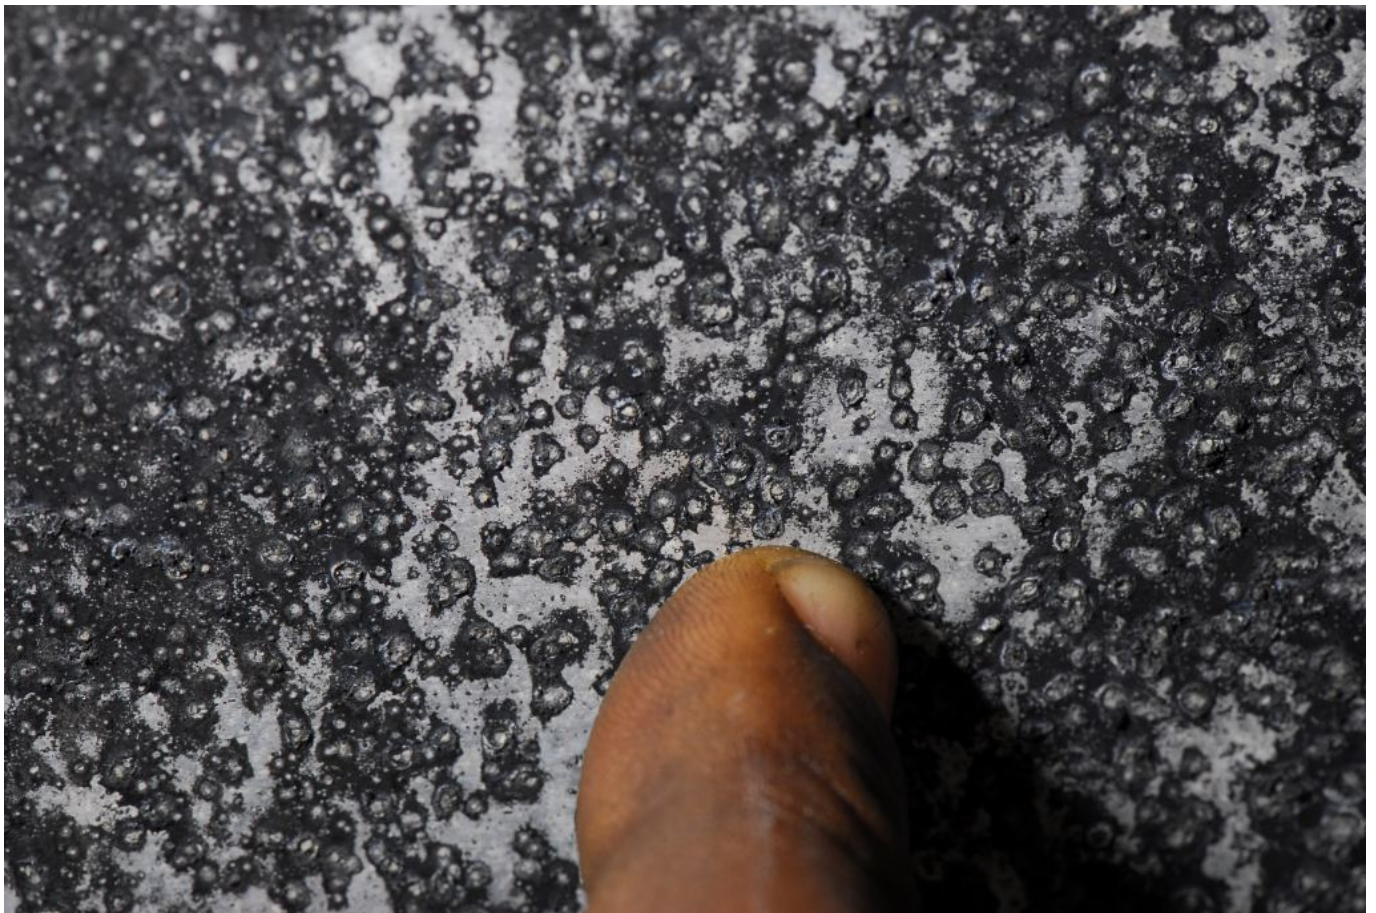
Aluminum is susceptible to poultice corrosion, which occurs when water is trapped, and becomes oxygen depleted. Without design and manufacturing care, there can be many areas on aluminum vessels where this may occur insidiously. Aluminum is susceptible to poultice corrosion, which occurs when water is trapped, and becomes oxygen depleted. Without design and manufacturing care, there can be many areas on aluminum vessels where this may occur insidiously.

Aluminum isn't subject to rust; however, it is susceptible to its own peculiar type of decay called poultice corrosion, which occurs when it is exposed to stagnant, oxygen depleted water. This can occur if wet fabric, insulation, bilge debris, or wood, or simply bilge water, remains in contact with aluminum, more on that subject here. It can, and often does, occur when aluminum is painted. If the paint is breached, even minutely, water can migrate through the void, giving poultice corrosion a toe hold, more on that subject here. While perhaps not as aesthetically attractive, this is why unpainted aluminum is far more desirable, maintenance is far lower and poultice corrosion is all but eliminated, at least on weather decks and hulls.
