# Editorial: Visiting the USS SAGINAW's Gig- Feature: Buying a Metal Boat

## **Metal Boats**

### ***Buying, Owning and Selling Metal Boats***

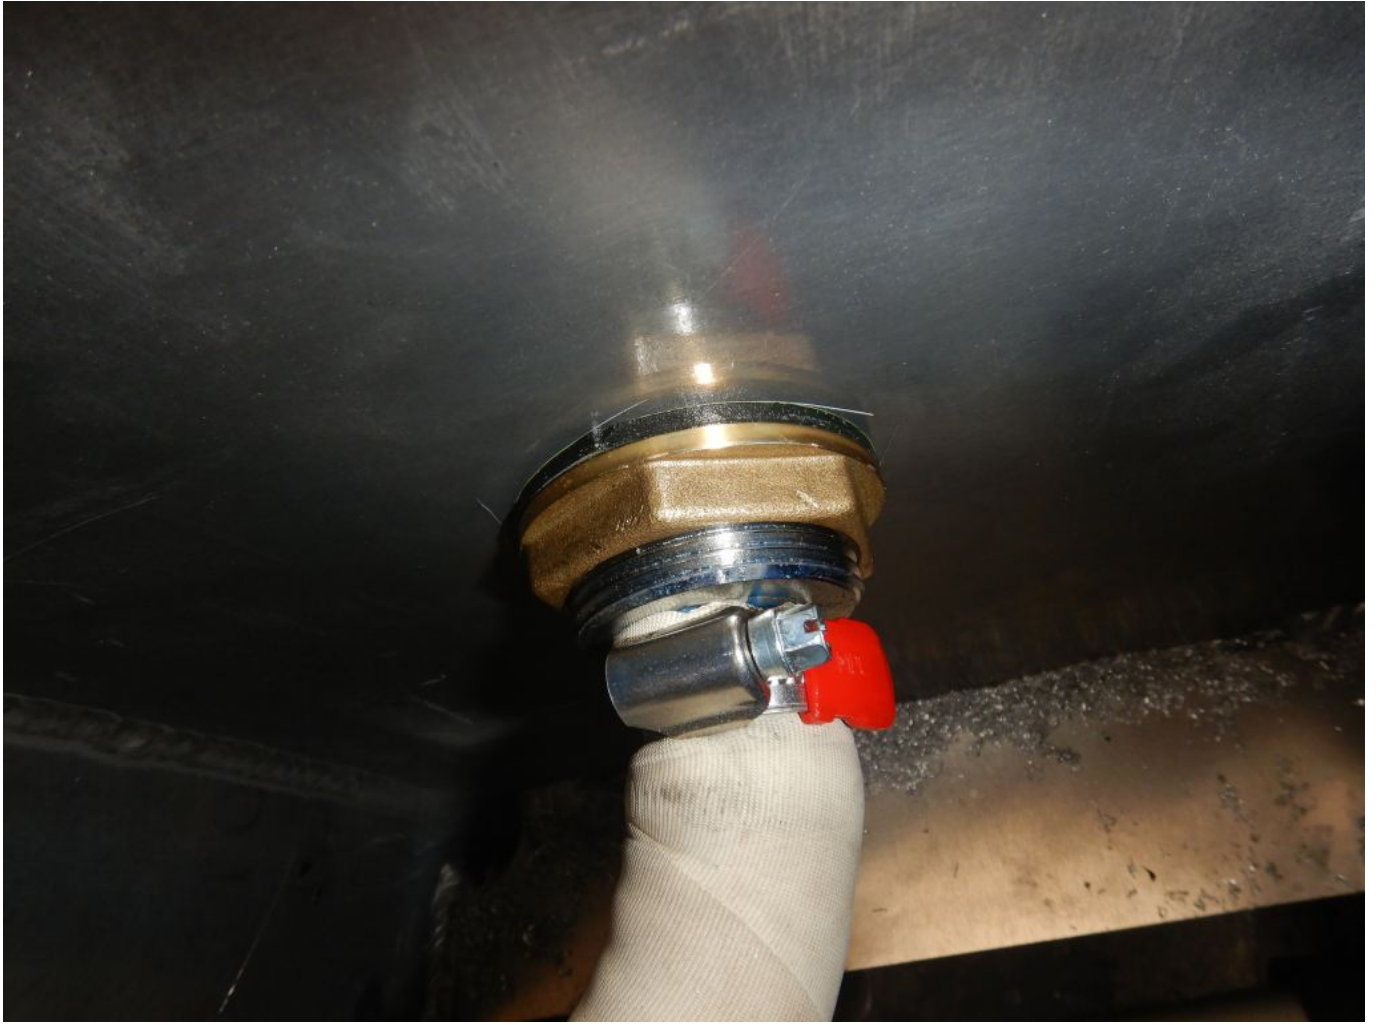
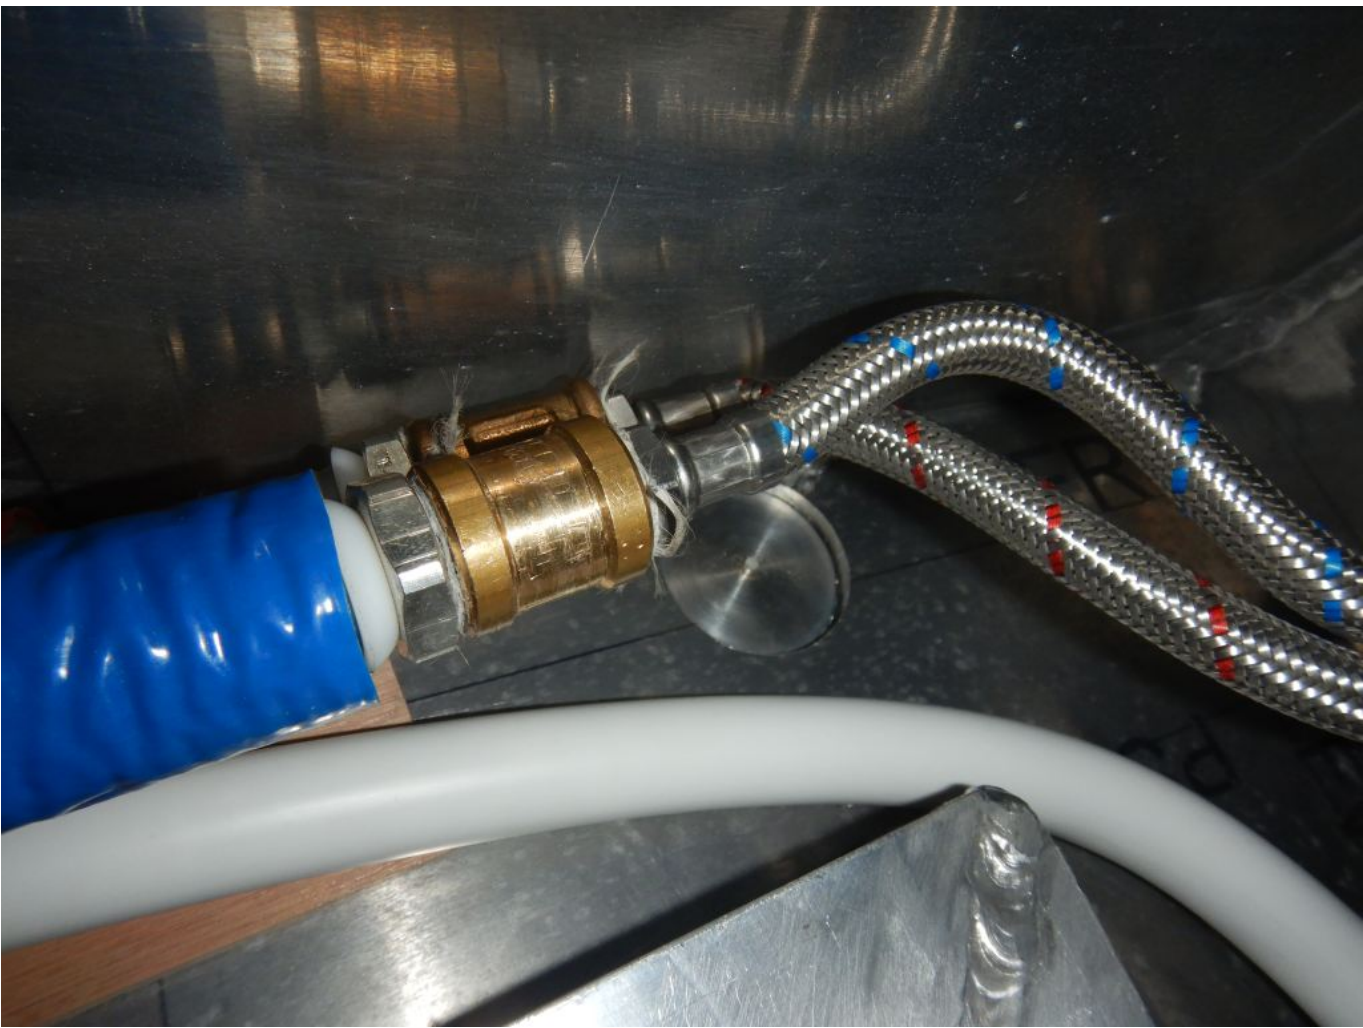
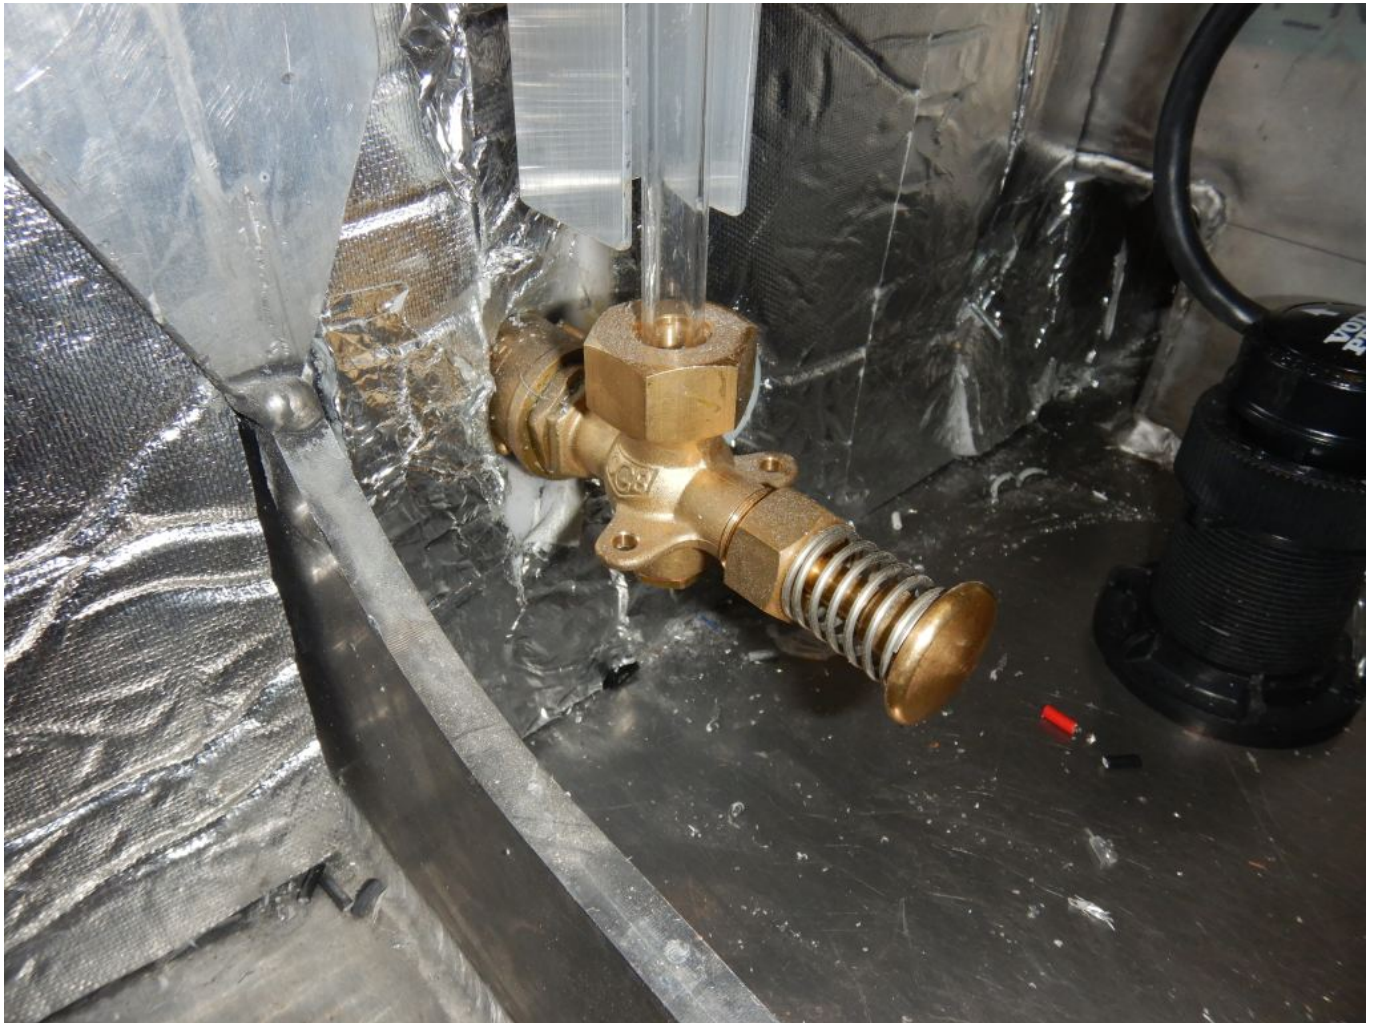
**Where aluminum vessels are concerned, in order to avoid galvanic and deposit corrosion, care must be taken to avoid the use of copper and copper alloy plumbing. Where it must be used, it should be encapsulated.**

Aluminum is subject to deposit corrosion. This can occur when water, fresh or salt, even condensation, drips from a copper alloy (copper, brass or bronze) pipe onto an aluminum surface. The water carries with it salts of copper, which over time will cause the aluminum to corrode.

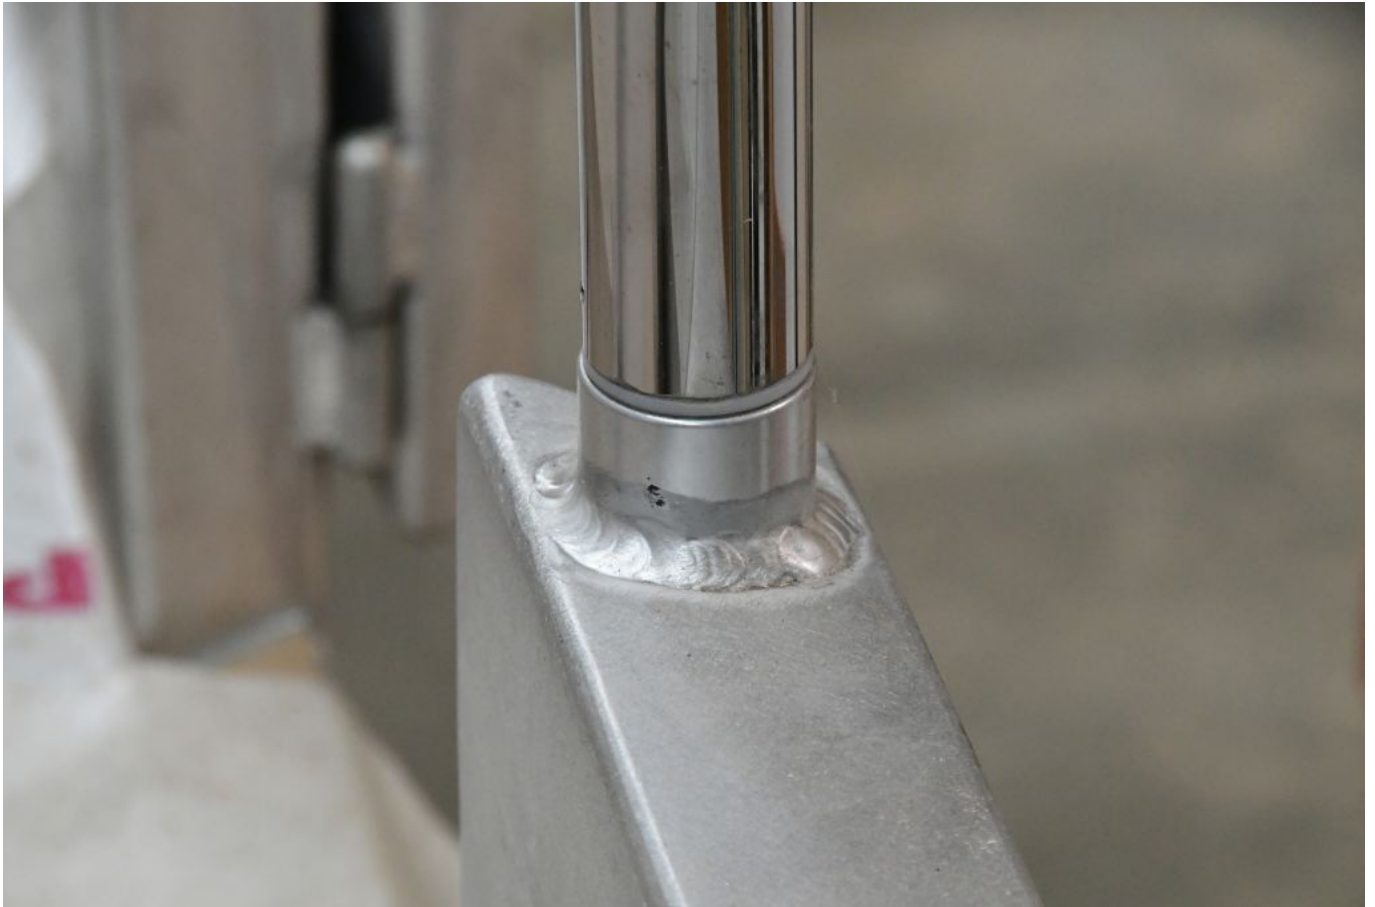
**An insulating bushing is used between this stainless stanchion and its aluminum deck fitting. While this will prevent galvanic corrosion at this interface, if water becomes entrapped between the bushing and aluminum, it can lead to poultice corrosion.**

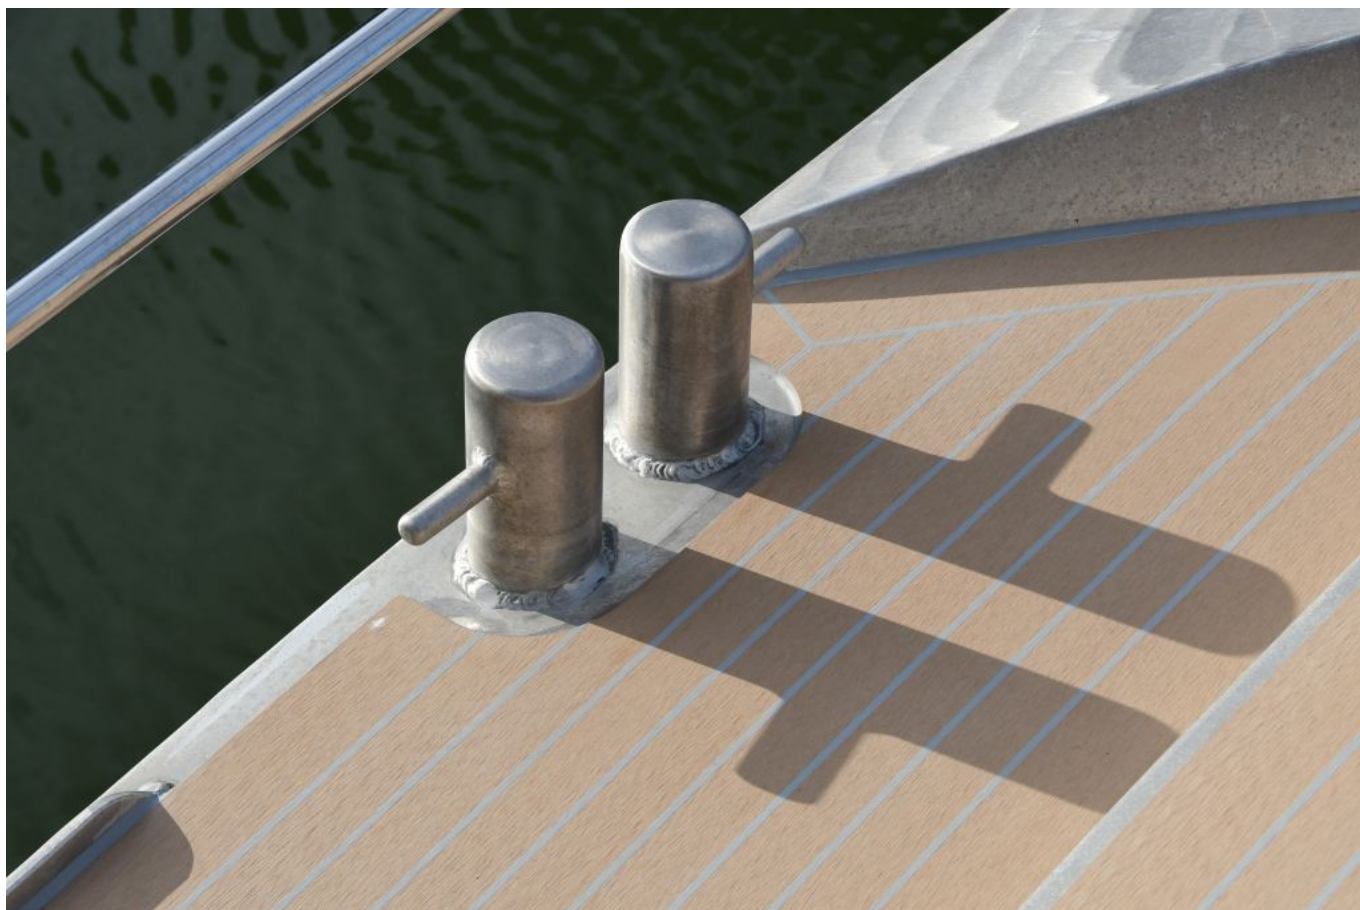
**Because much if not all of the deck components (or brackets to which components can be bolted), can be welded directly to the deck, rather than through bolted, deck leaks are generally very rare on metal vessels.**

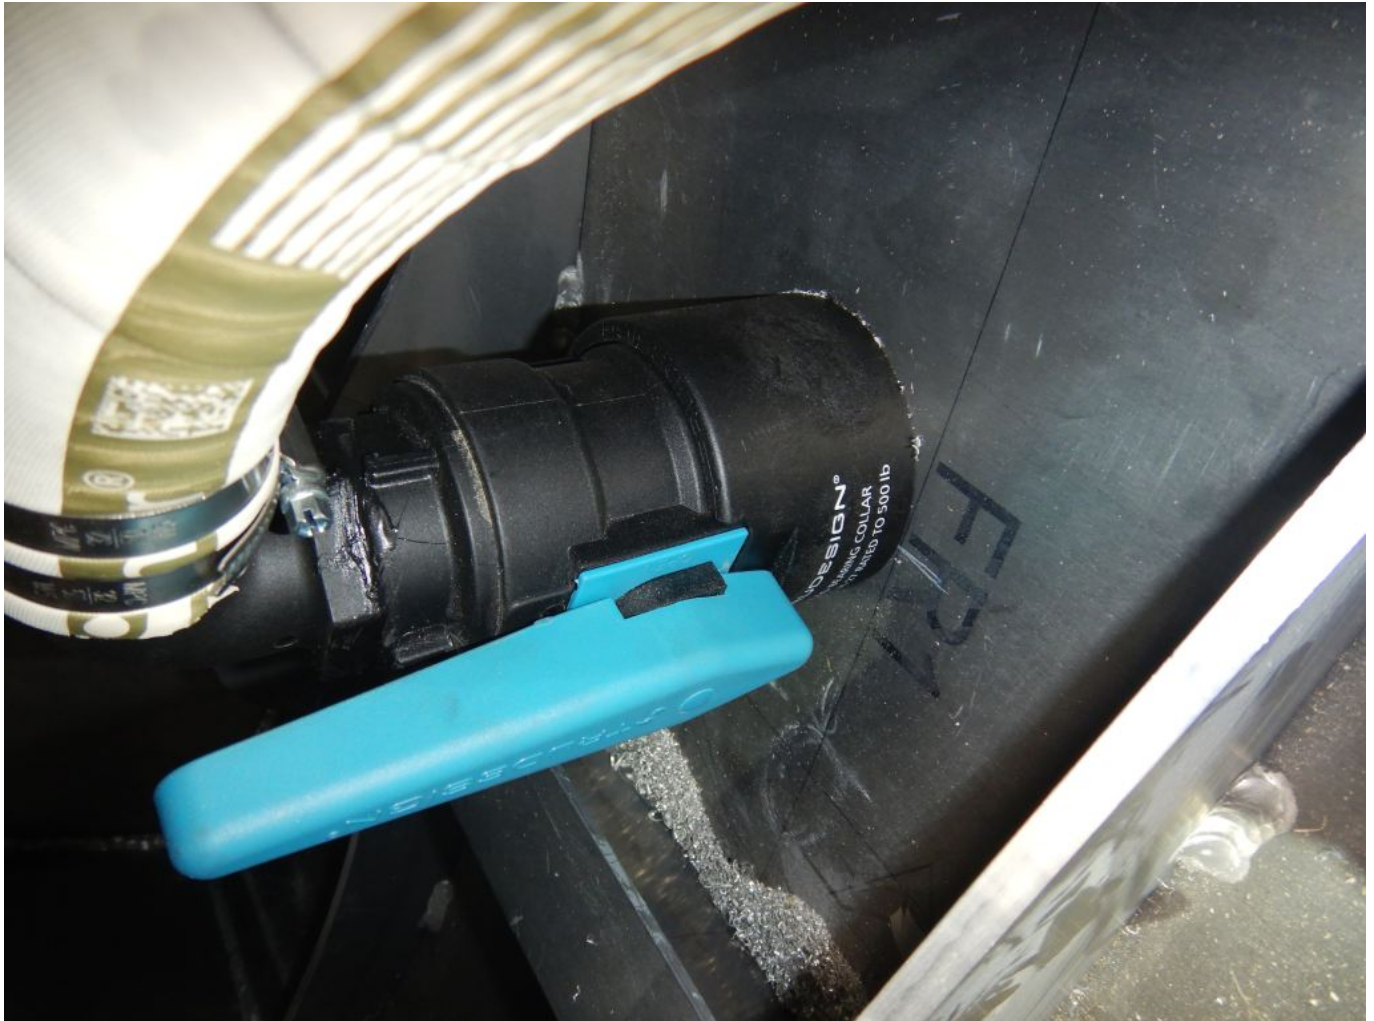
**Non-metallic seacocks are frequently used on aluminum and steel vessels, as they avoid galvanic corrosion issues.**

With some exceptions, the anti-fouling paint used on aluminum and steel hulls generally must exclude copper. Likewise, seacocks, through hulls and internal plumbing of all types must exclude copper-based alloys, or it must be fully isolated/encapsulated (through hulls and seacocks must not utilize copper alloys at all, no amount of isolation, again in my opinion, is sufficient). Non-metallic through hulls and seacocks are preferred on both steel and aluminum vessels,

although stainless steel components can be used if metal is required.

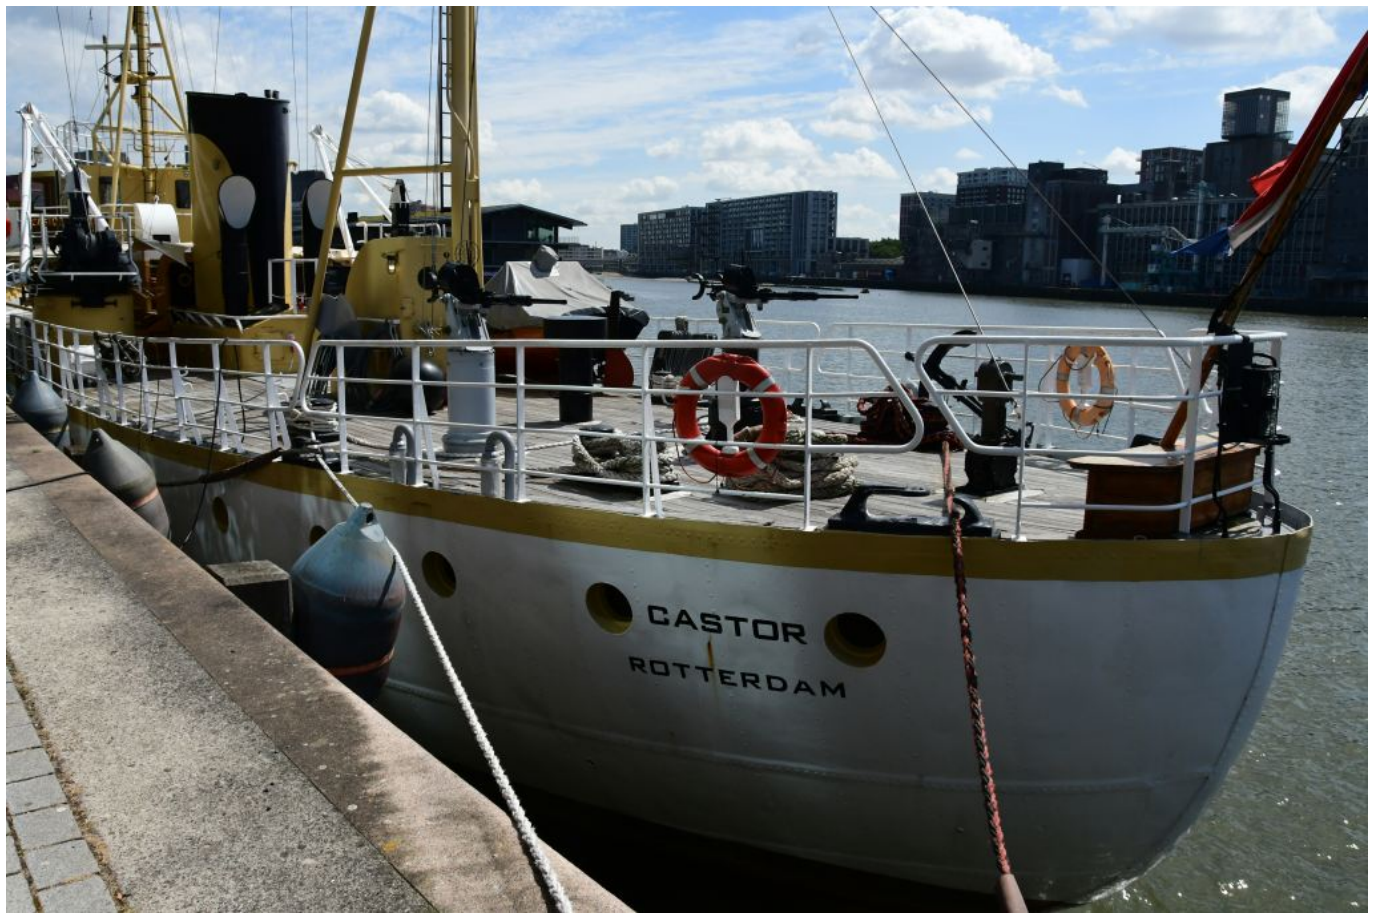
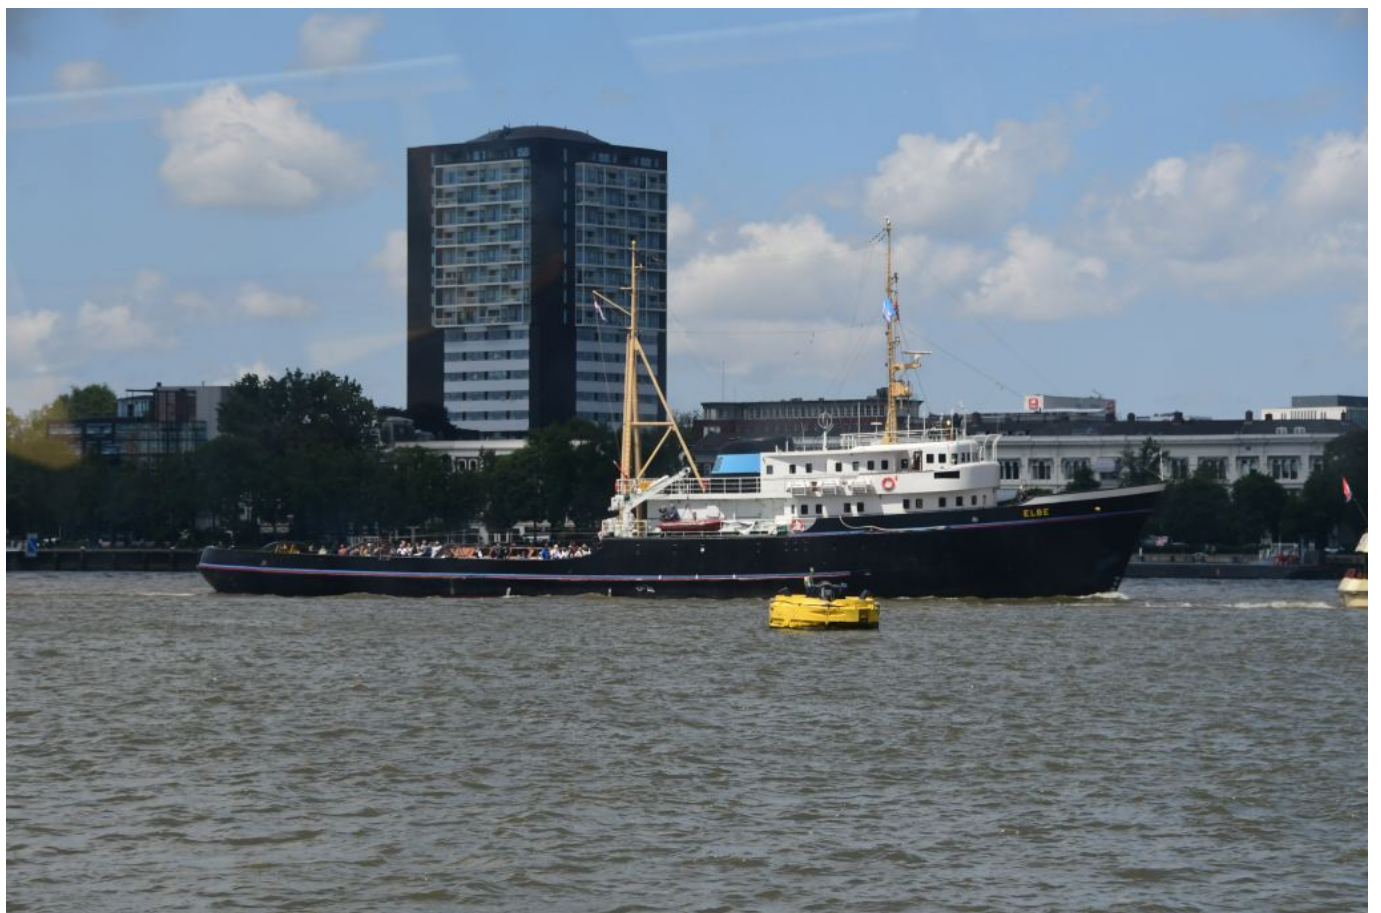
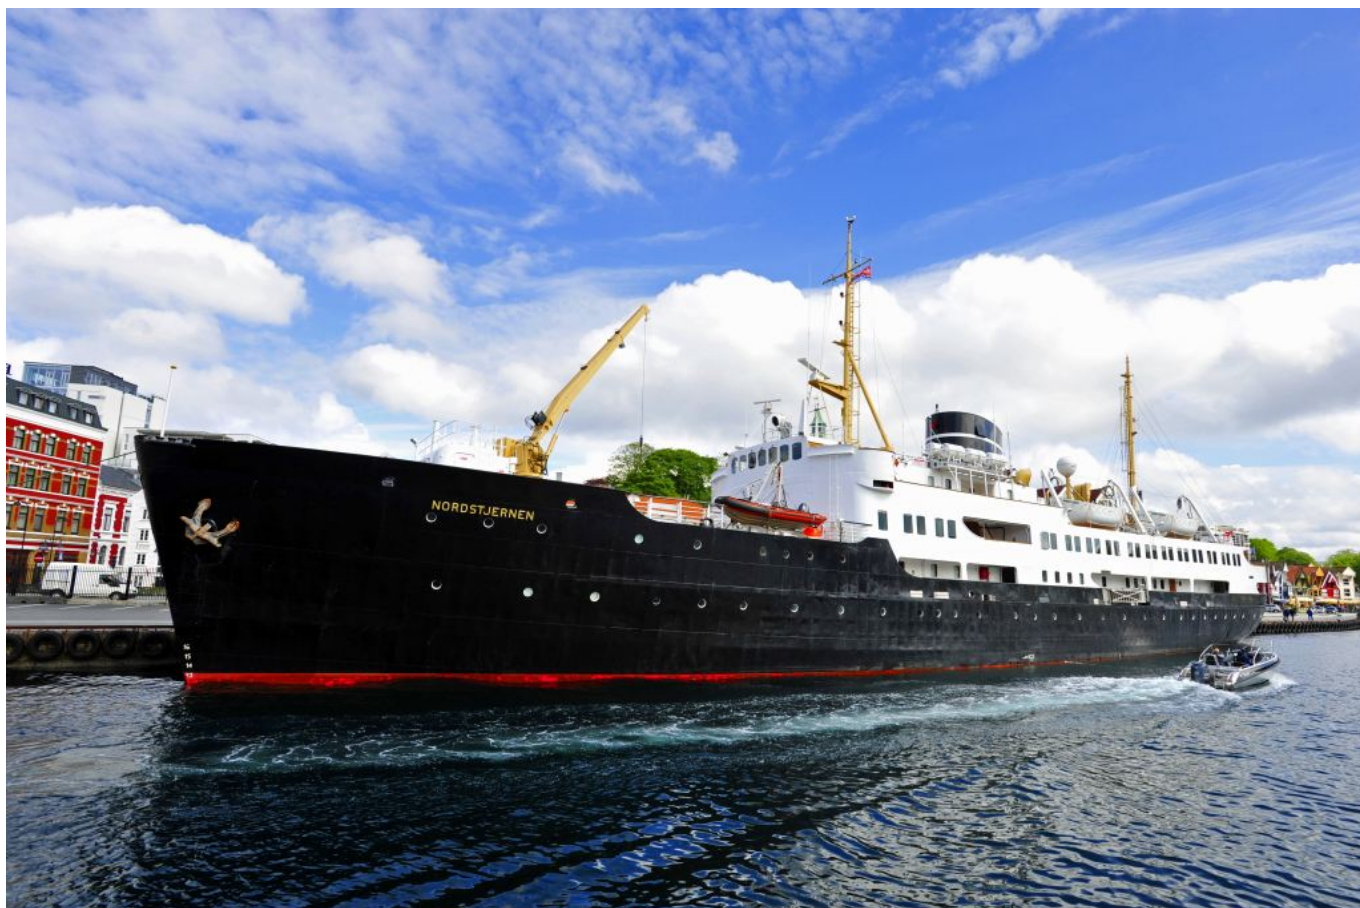
**These vessels have been cruising for decades; when properly maintained, steel can be long-lasting and durable. Castor, built in 1950; Elbe, built in 1959; Nordstjernen, built in 1956.**
