“Fiberglass Repair and Secondary Bonds” & “Steering You Straight”

Fiberglass Repair and Secondary Bonds

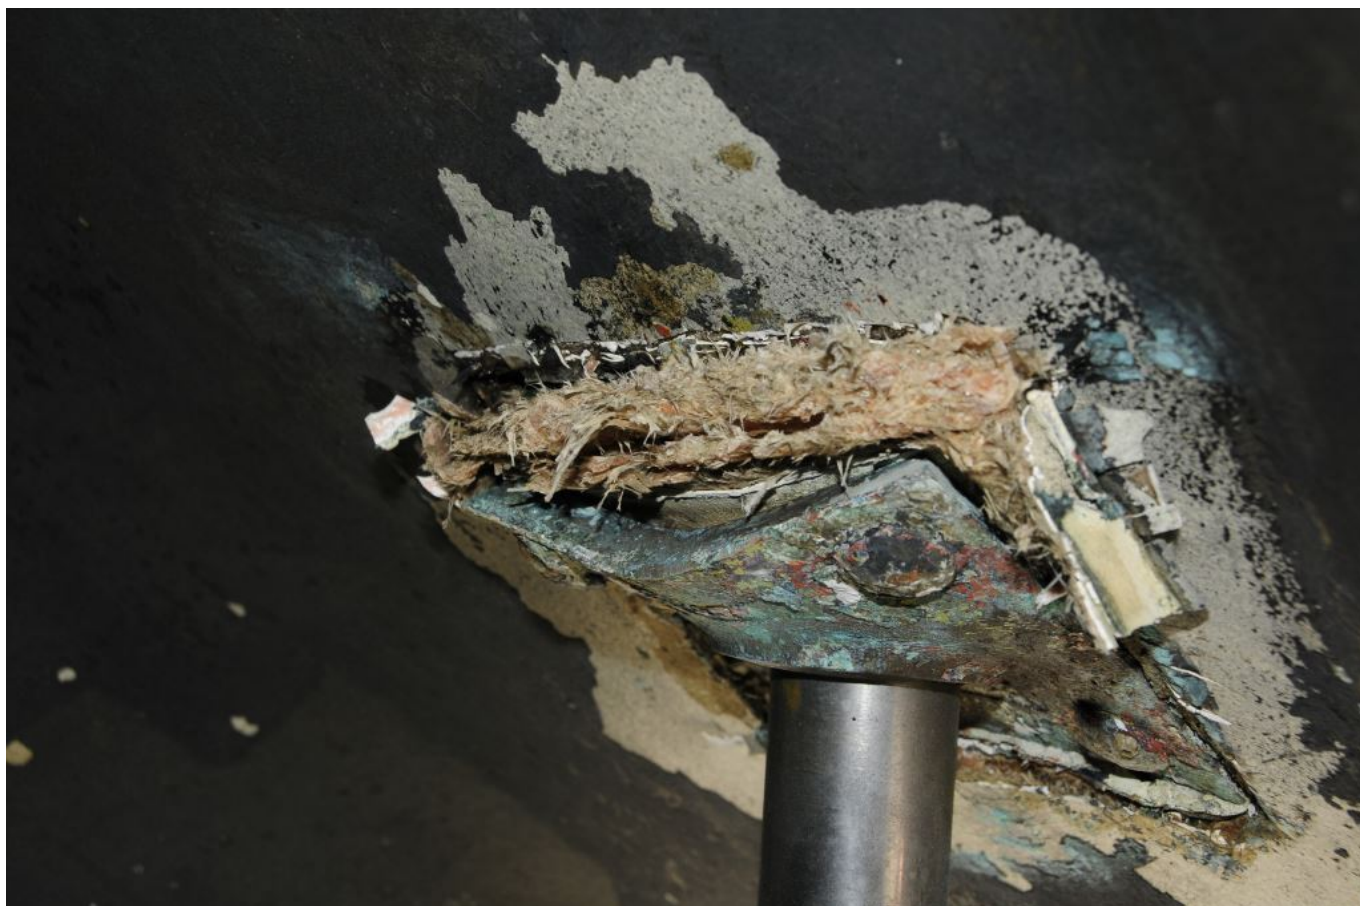
For highly loaded parts like this grounding-damaged strut, the importance of achieving a strong, reliable secondary bond cannot be over-emphasized.

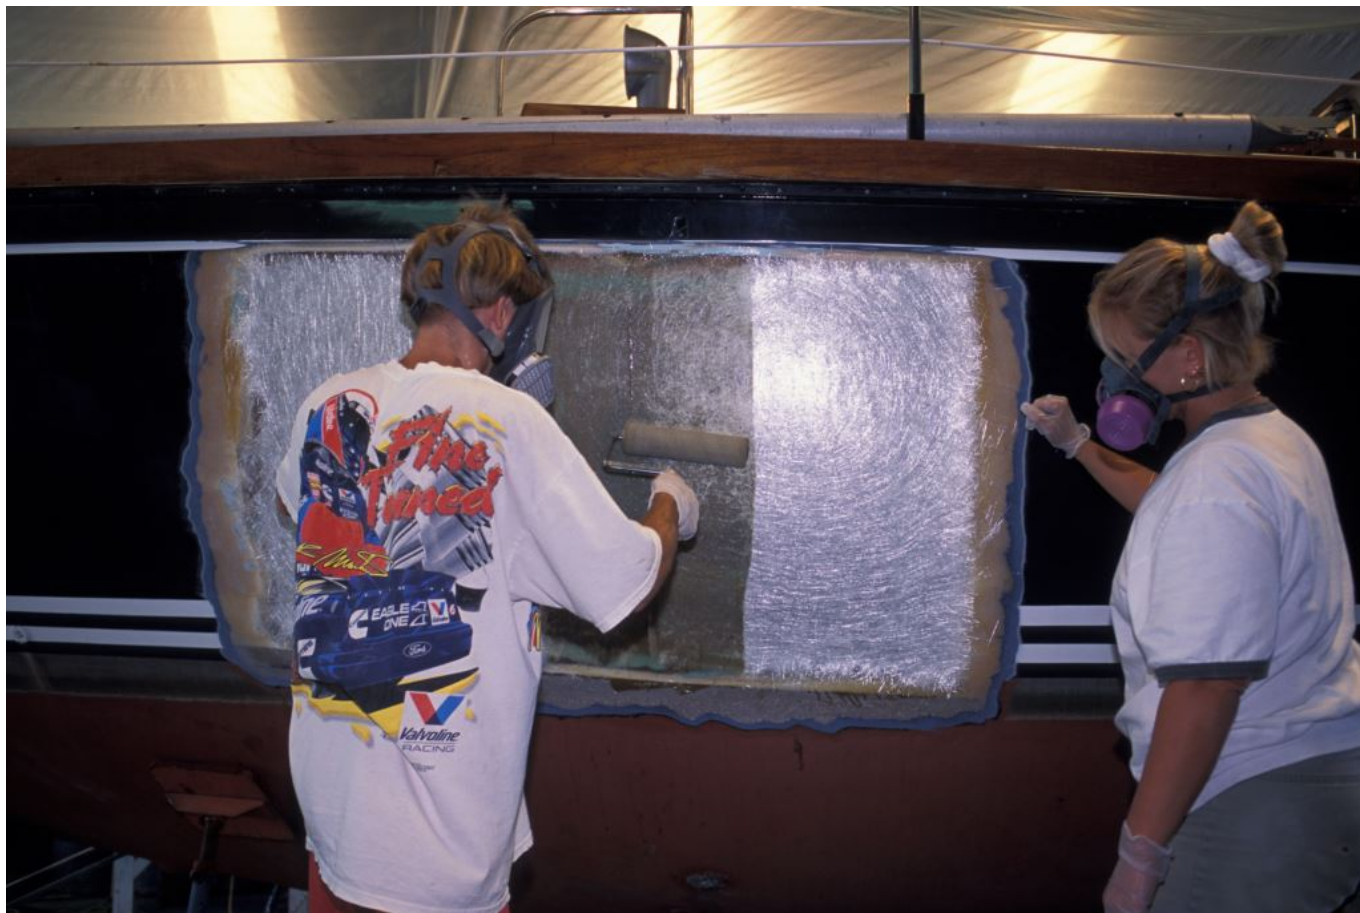
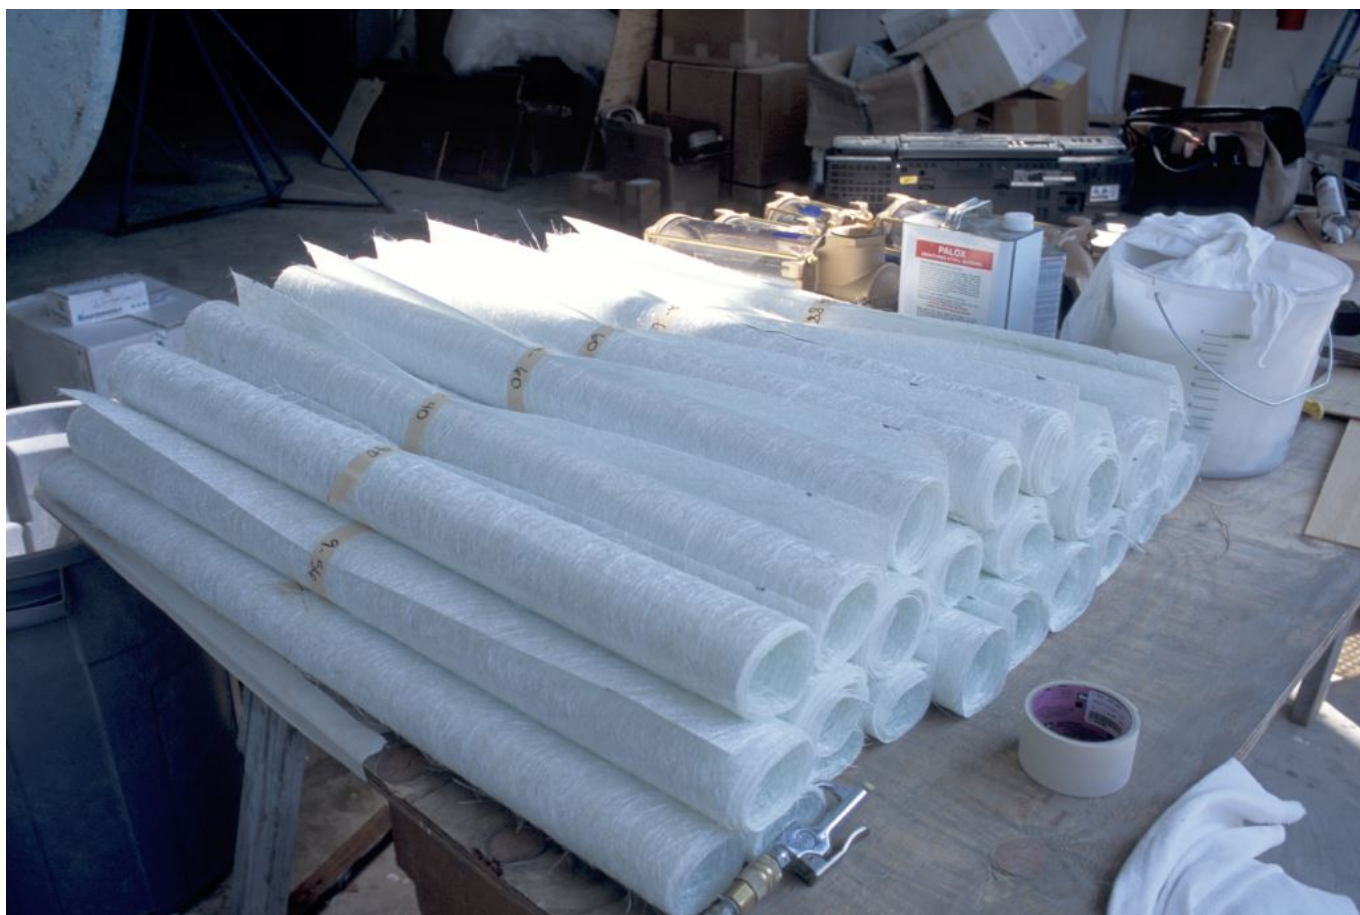
Fiberglass is a simple combination of fabric and resin, each successive layer adding strength and stiffness. Primary bonds are achieved when the resin is not fully cured, with secondary bonds coming into play after the substrate is no longer "green".

Regardless of which materials are used, the traditional construction of these parts is accomplished in such a way that the resin used for each laminate (a laminate is a single layer of resin-saturated reinforcement) is applied before the previous laminate fully cures, it's referred to as being "green", like unripe bananas, establishing a chemical, or cross linked resin polymerization, connection with the laminate beneath. This is a primary bond, and it's the most desirable as it is especially tenacious.

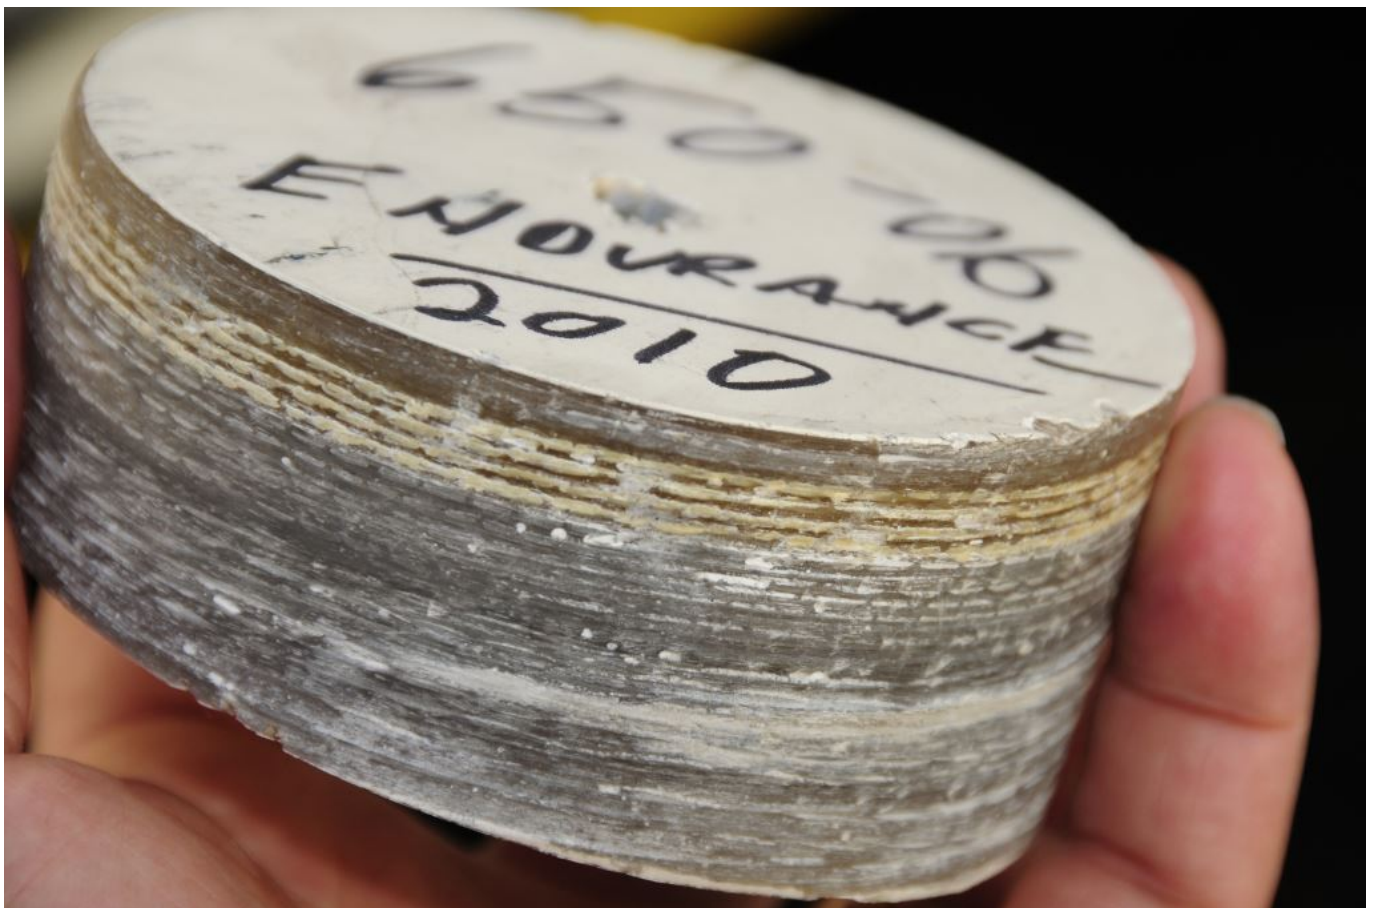
Each laminate is a separate layer of fabric and resin, which looks somewhat like tree rings when section cut. The one shown here includes four layers of Kevlar.

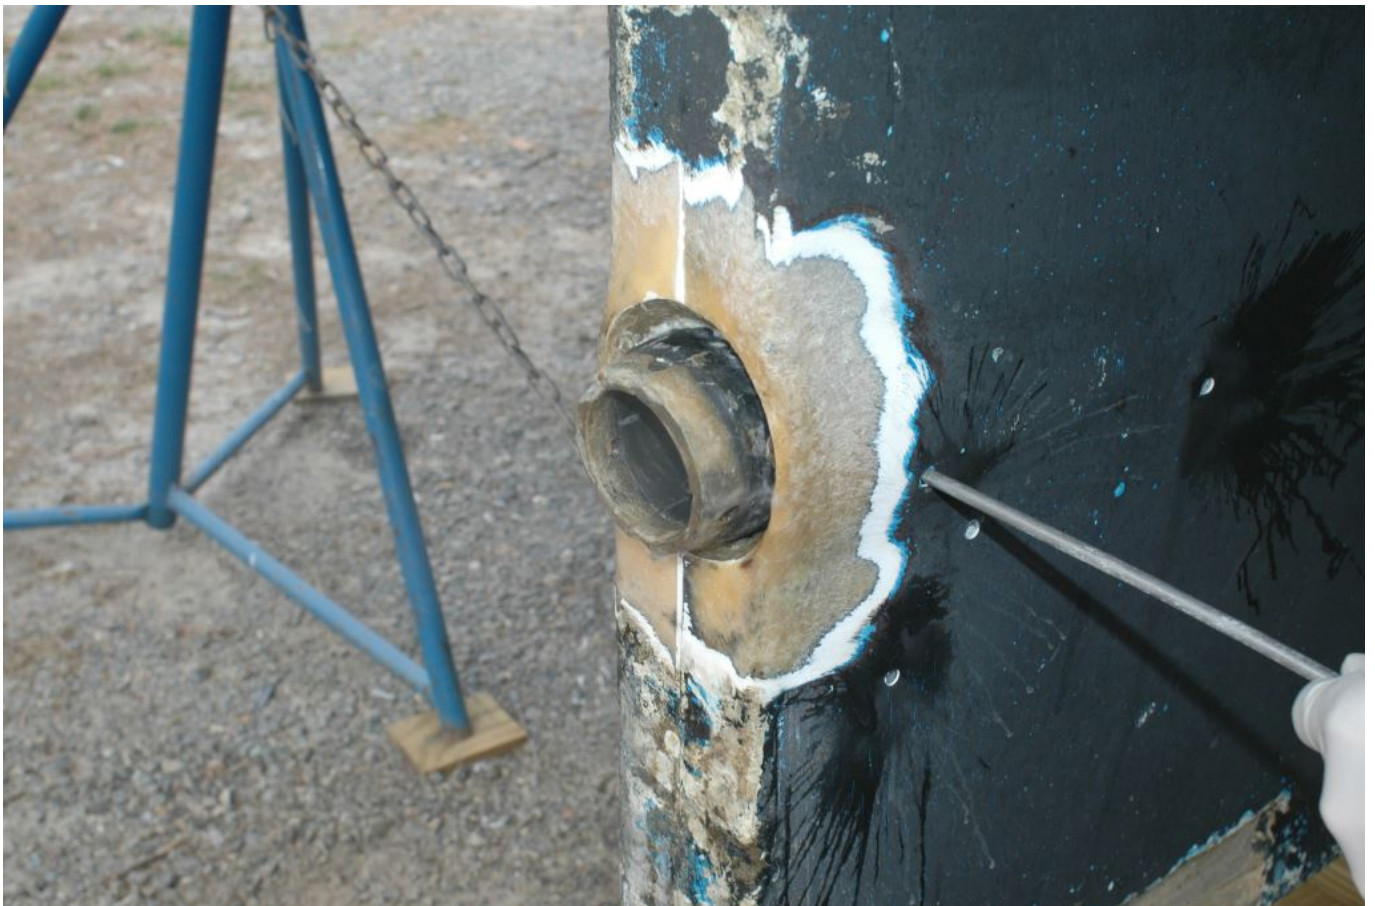
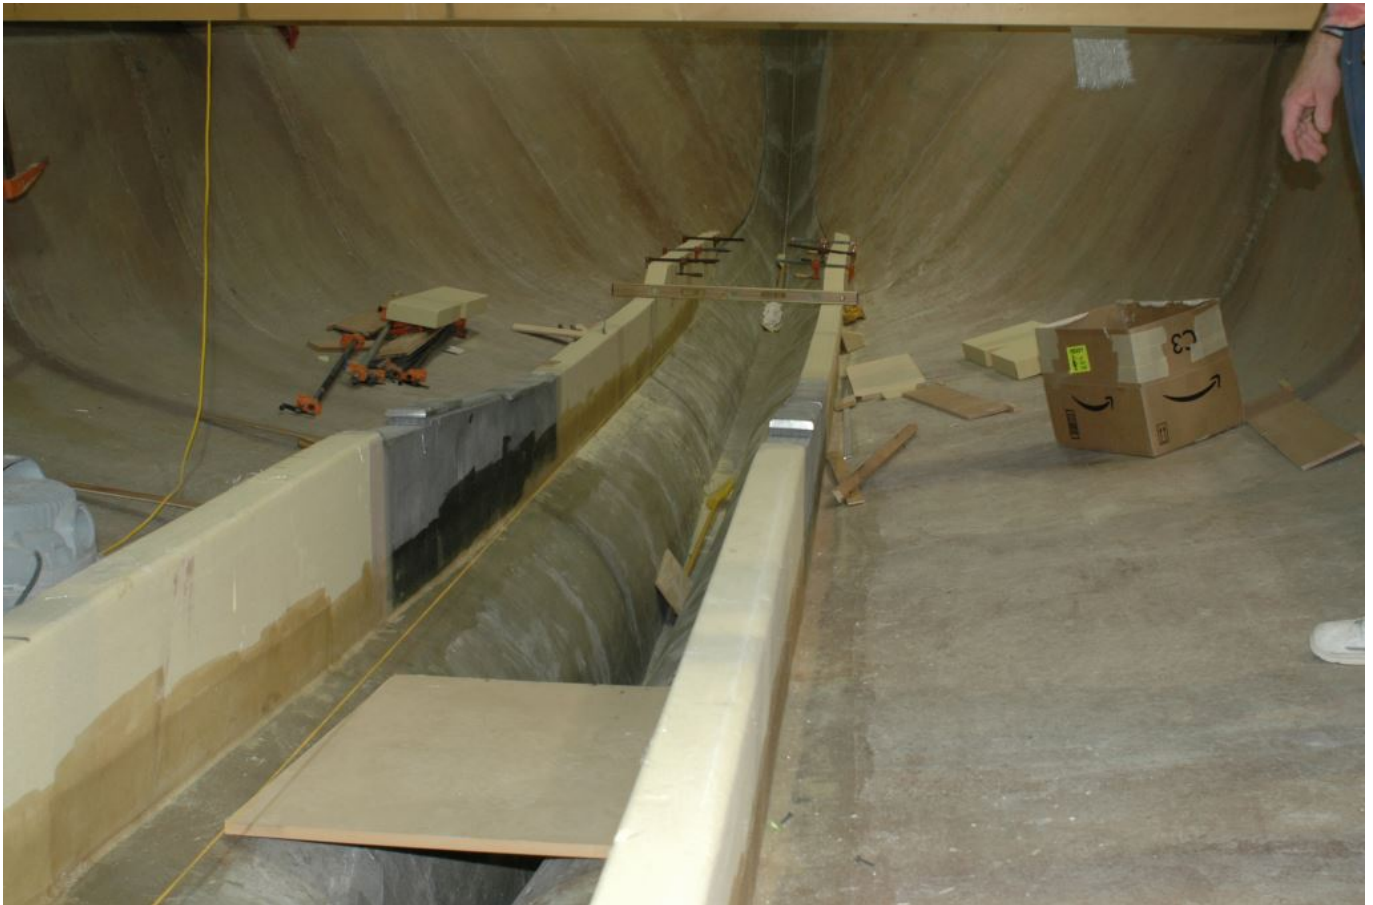
Stringers, shaft logs and other structure components, utilize secondary bonds.

Virtually every other fiberglass component or structure added to the hull or deck after the initial, primary layup, utilizes what's known as a secondary bond. Secondary bonds differ from primary bonds in that they rely on adhesion, or mechanical bonding, rather than establishing a chemical matrix. Components that are fiberglassed or "tabbed" to the hull and deck in this manner include stringers, engine beds, shaft logs, structural bulkheads, thruster tubes, structural shelving that supports machinery like generators, and hull to deck joints that are glassed from the inside after being joined. That's a short list, the average 40 to 60-foot power or sailing vessel can have anywhere from a few dozen to several score or a hundred or more secondary bonds.

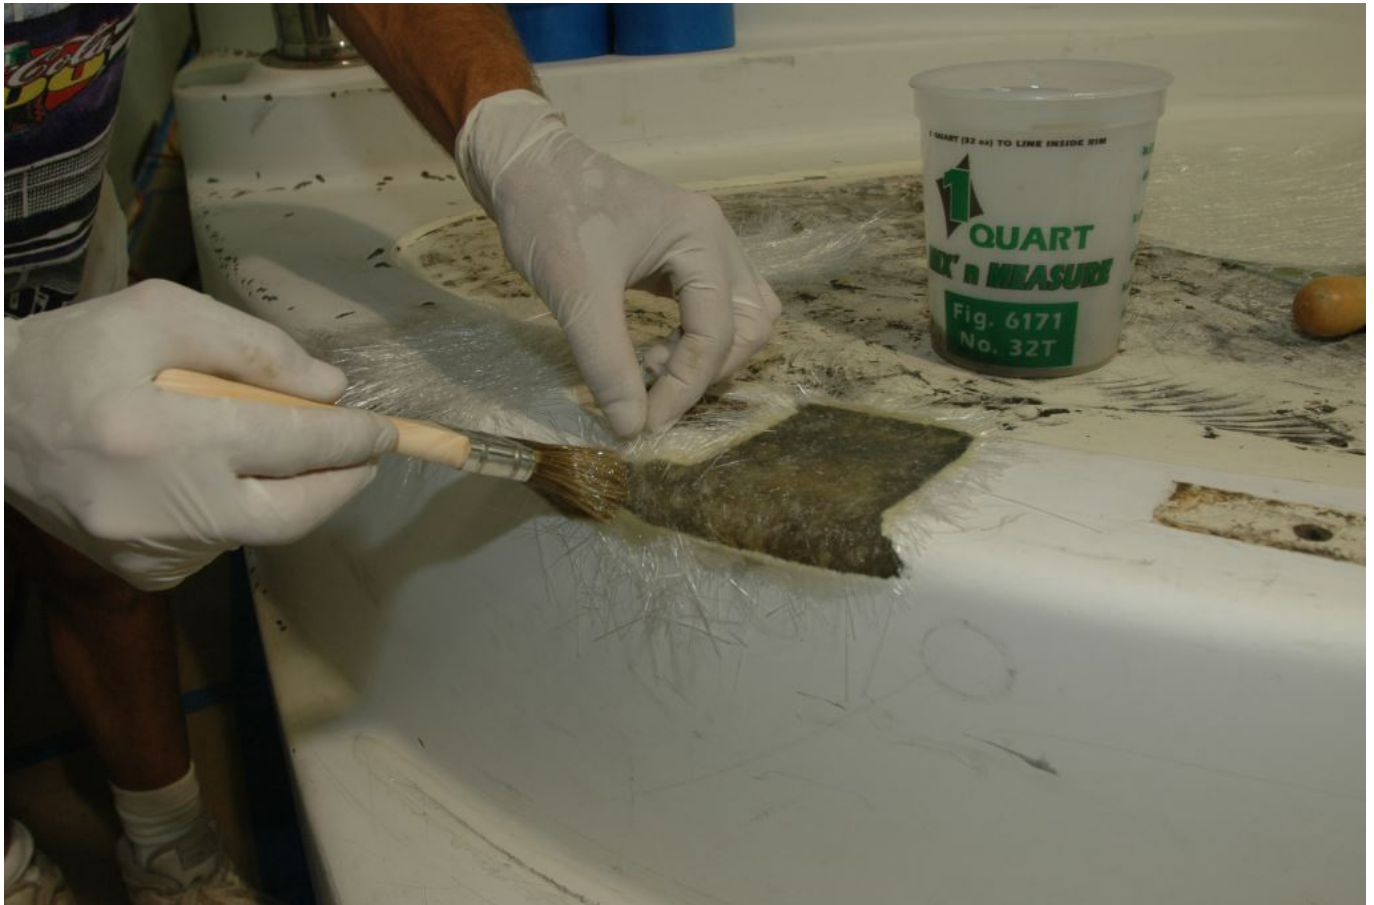
In order for a secondary bond to be reliable, the surface over which the resin and fabric are applied must be properly prepared.

Unlike primary bonds, secondary bonds rely on achieving a good “grip” onto a fully cured FRP surface. As such, that surface requires special treatment, it can’t be smooth, slick or contaminated with salt, oil, grease, silicone, paint etc. As the adage goes, preparation is everything and secondary bonds are no exception. Grinding or sanding is the primary means by which a secondary bonding surface is prepared; this usually involves the use of a very aggressive 80 grit sand paper, which will leave the surface rough, while exposing filaments of glass reinforcement, a surface feature that is ideally suited to enhancing adhesion. If using an electric or pneumatic grinder caution must be used to avoid overheating the surface, which could damage the existing resin. Pneumatic sanders can also contaminate surfaces with oil. For small jobs, hand sanding is often good enough. If the surface is gelcoated, all of the gelcoat must be fully removed in the

area to be bonded. Under no circumstances should you attempt to bond to gelcoat, as its own adhesion to the fiberglass substrate is not nearly tenacious enough for structural tension or shear loads.

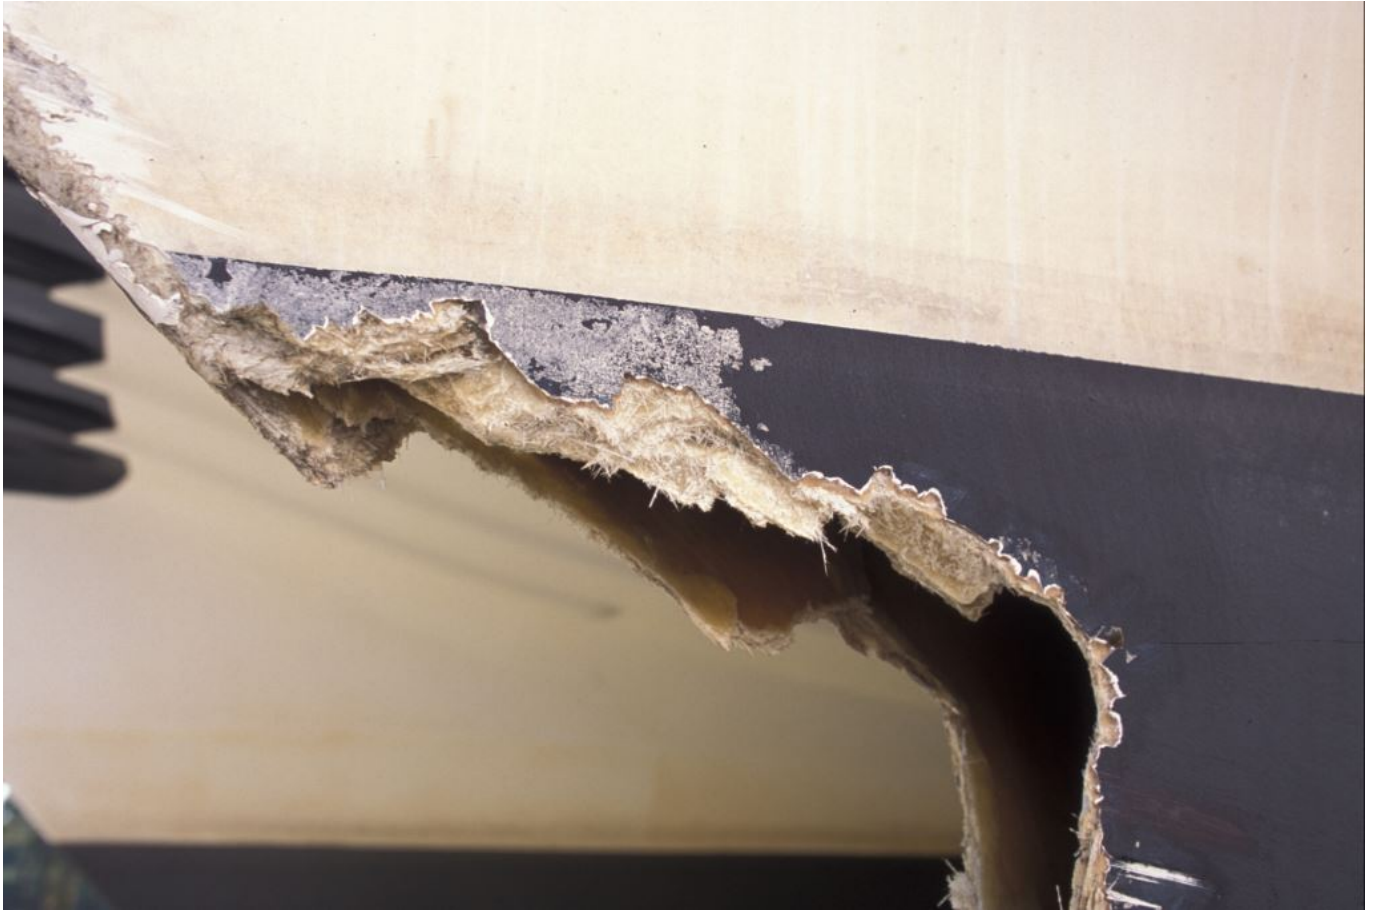
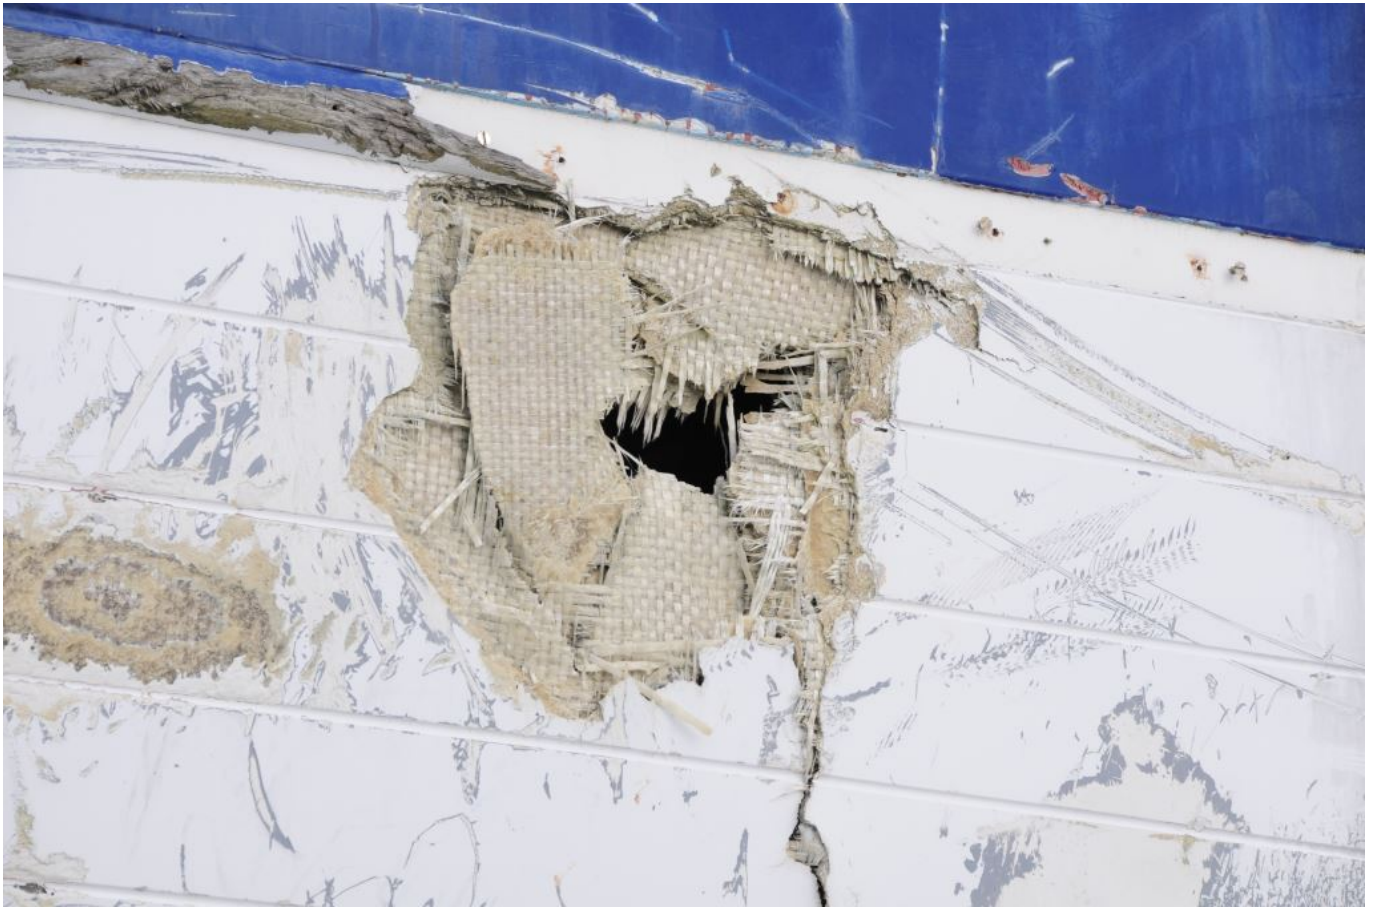
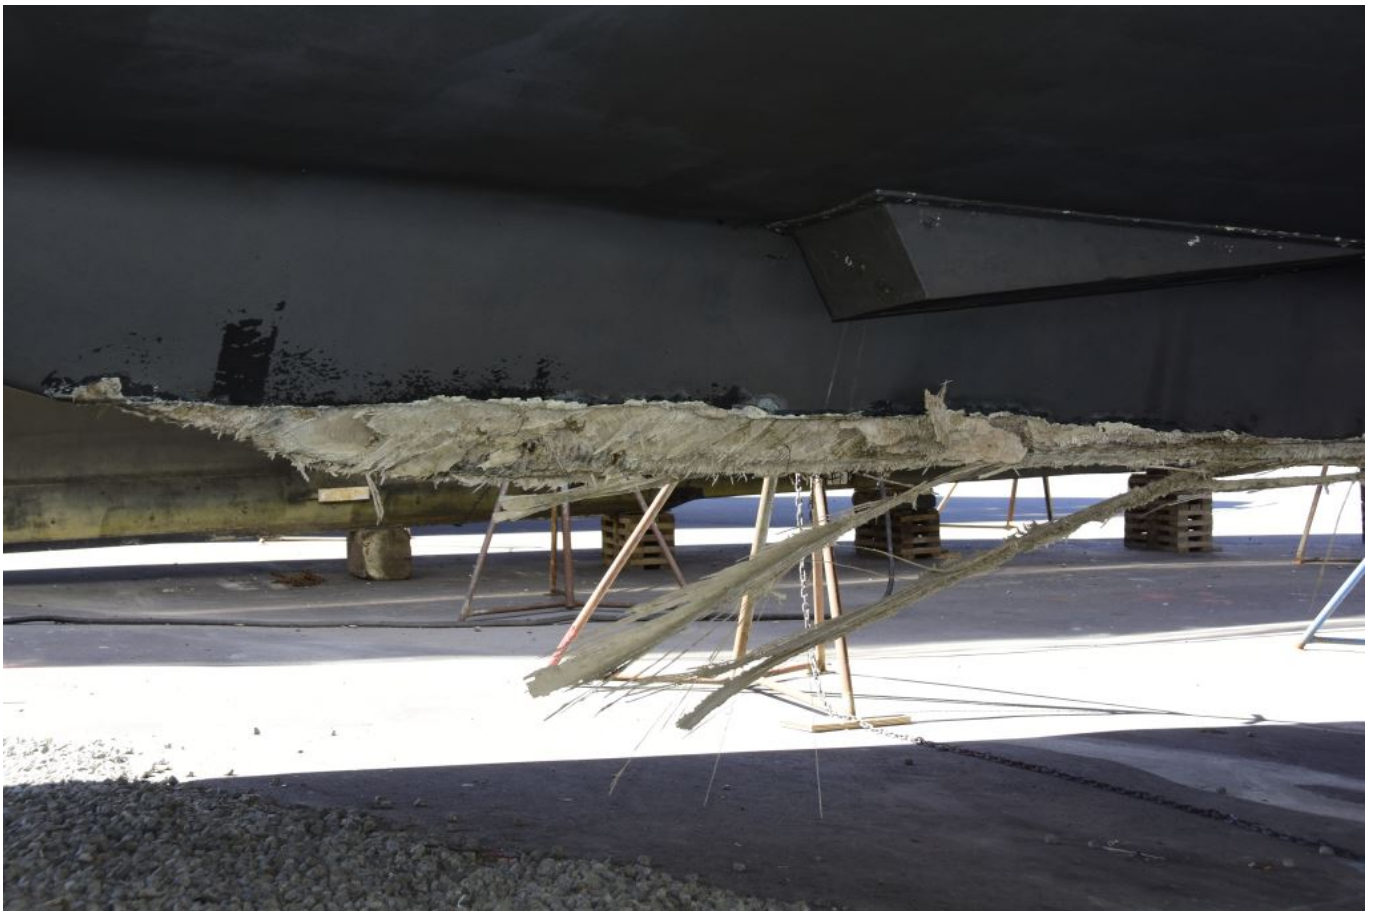
Collision and grounding damage, this will require secondary

bonds to effect repairs.

In the case of repairs, once all the damaged laminate has been removed and the region has been carefully shaped and tapered, all sanding residue must be removed, and the area wiped down with acetone or denatured alcohol. Then, the laminate is tapered in much the same way a scarf is made in a plank, using a gradual slope. In some cases, this is done from the inside and the outside of the hole creating what's essentially a large diameter, FRP rivet.

Additionally, the tenets of fiberglass repair dictate the following, the repair should as closely as possible mimic the original laminate schedule, duplicating the fabric reinforcement type, thickness and orientation. Where repairs are concerned, more laminate is not better, as it can have an effect on load distribution, and the creation of stress risers. Additionally, the resin used should be of equal and preferably greater adhesive strength than what was used originally; that usually means vinyl ester or epoxy. When it comes to FRP repairs, it's usually the quality of the work at the interface between old and new laminate that determines success.

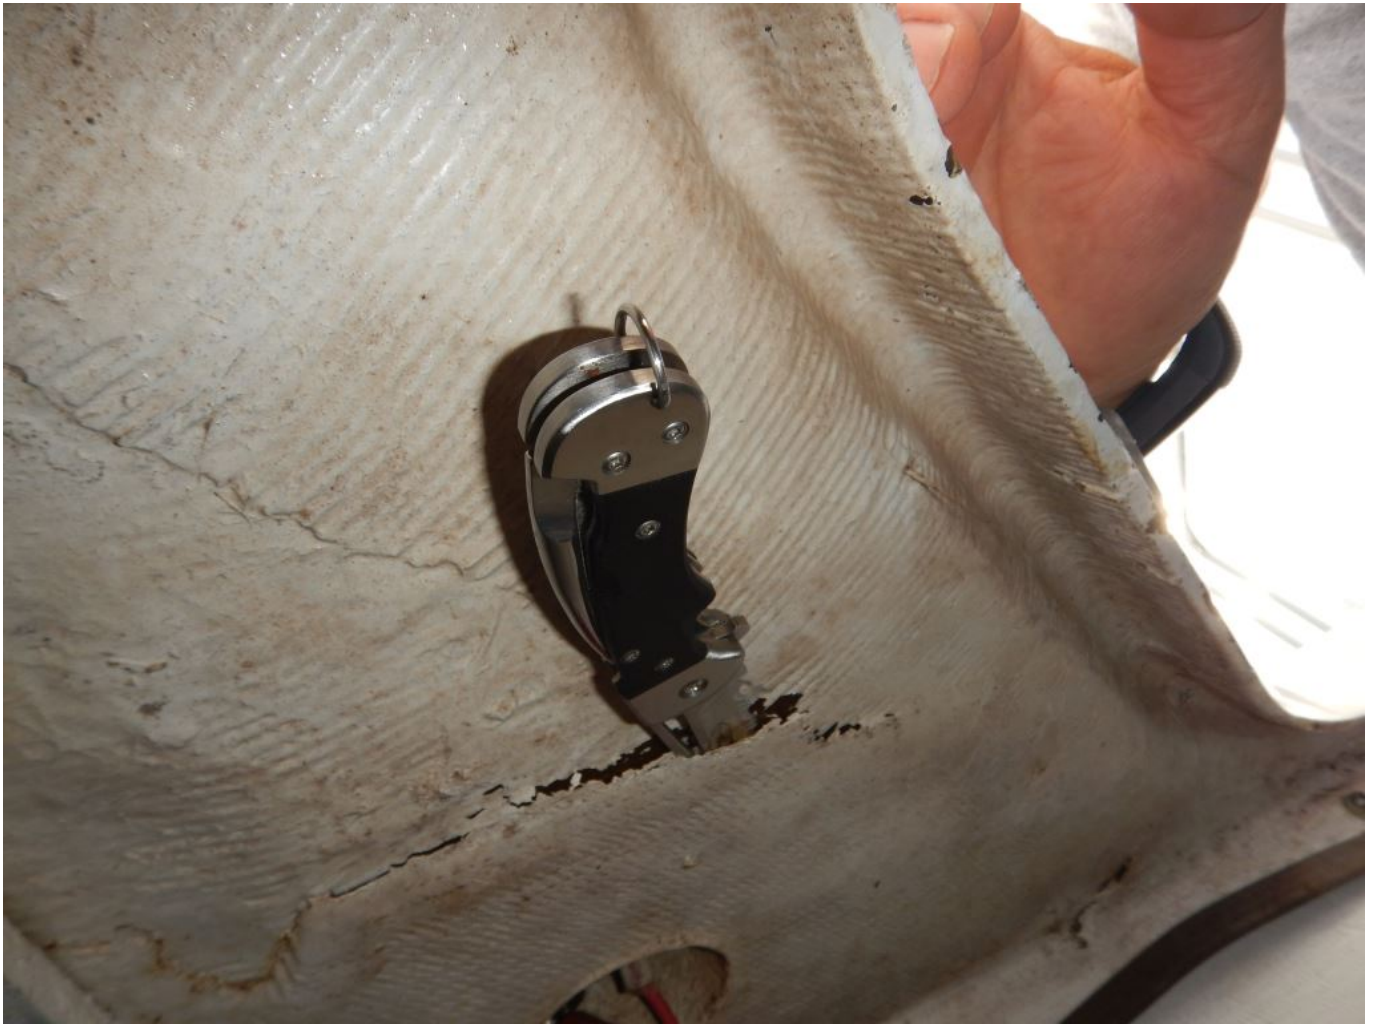
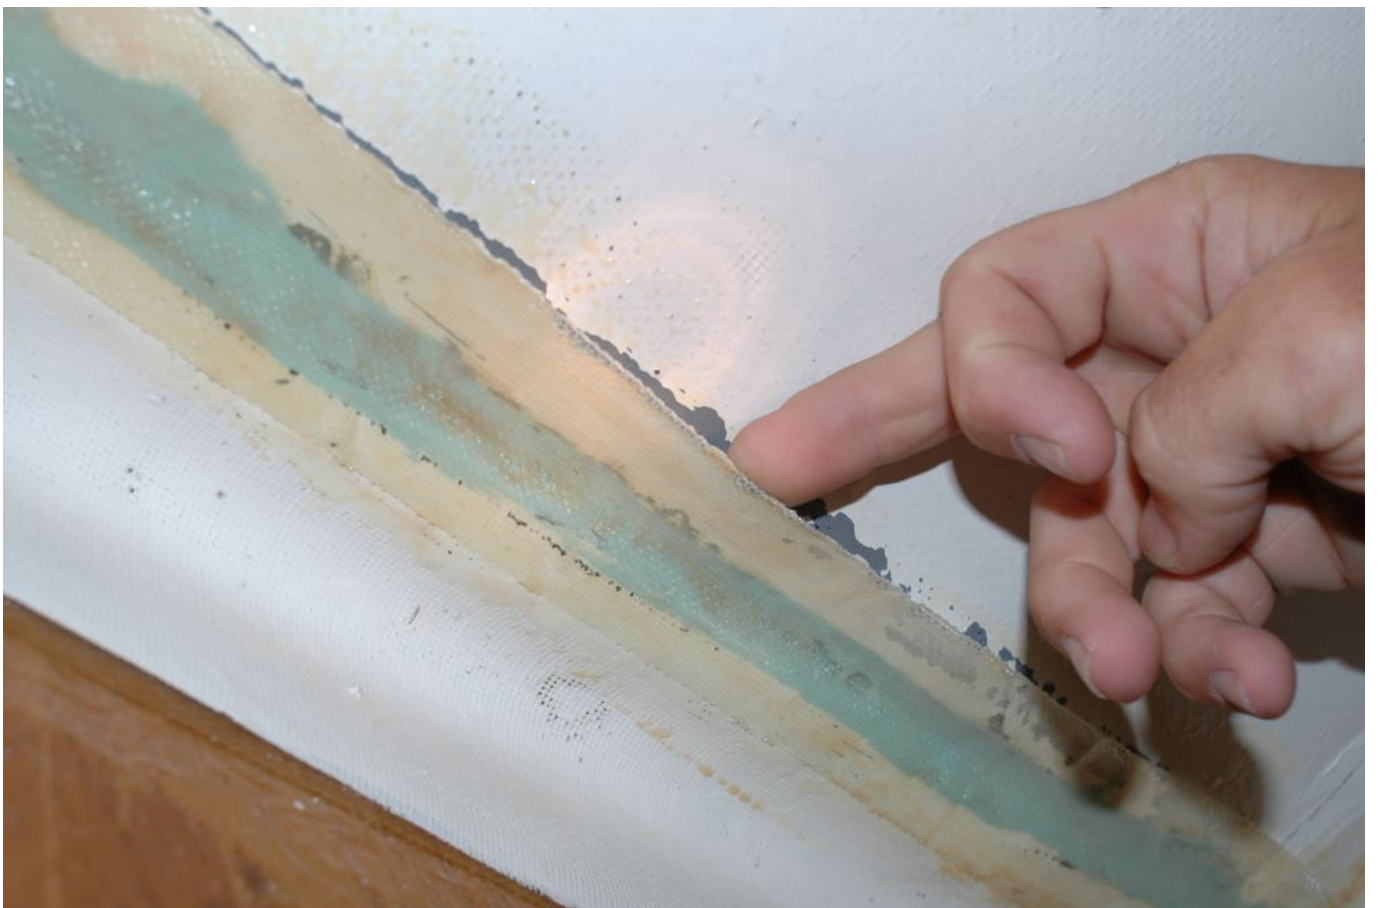
Failed secondary bonds are not uncommon, they are almost always the result of poor or improper preparation.

I moved my knife to the edge of the tabbing that supported the shelf, and then easily drove the point under the edge of the tabbing, separating it from the inside of the hull. It was clear to see that the surface, which was gelcoated, had only been lightly sanded, leaving no effective "tooth" for the tabbing's resin to lock onto. It would have to be torn out and completely redone. 'Better, however, to make that determination now', I said, 'than while you are pounding into a head sea, with 800 pounds of batteries knocking around under the bilge, and...before you own the boat".
