Fuel Tank Installation

There's More to it than Meets the Eye

Text and Photos by Steve D'Antonio

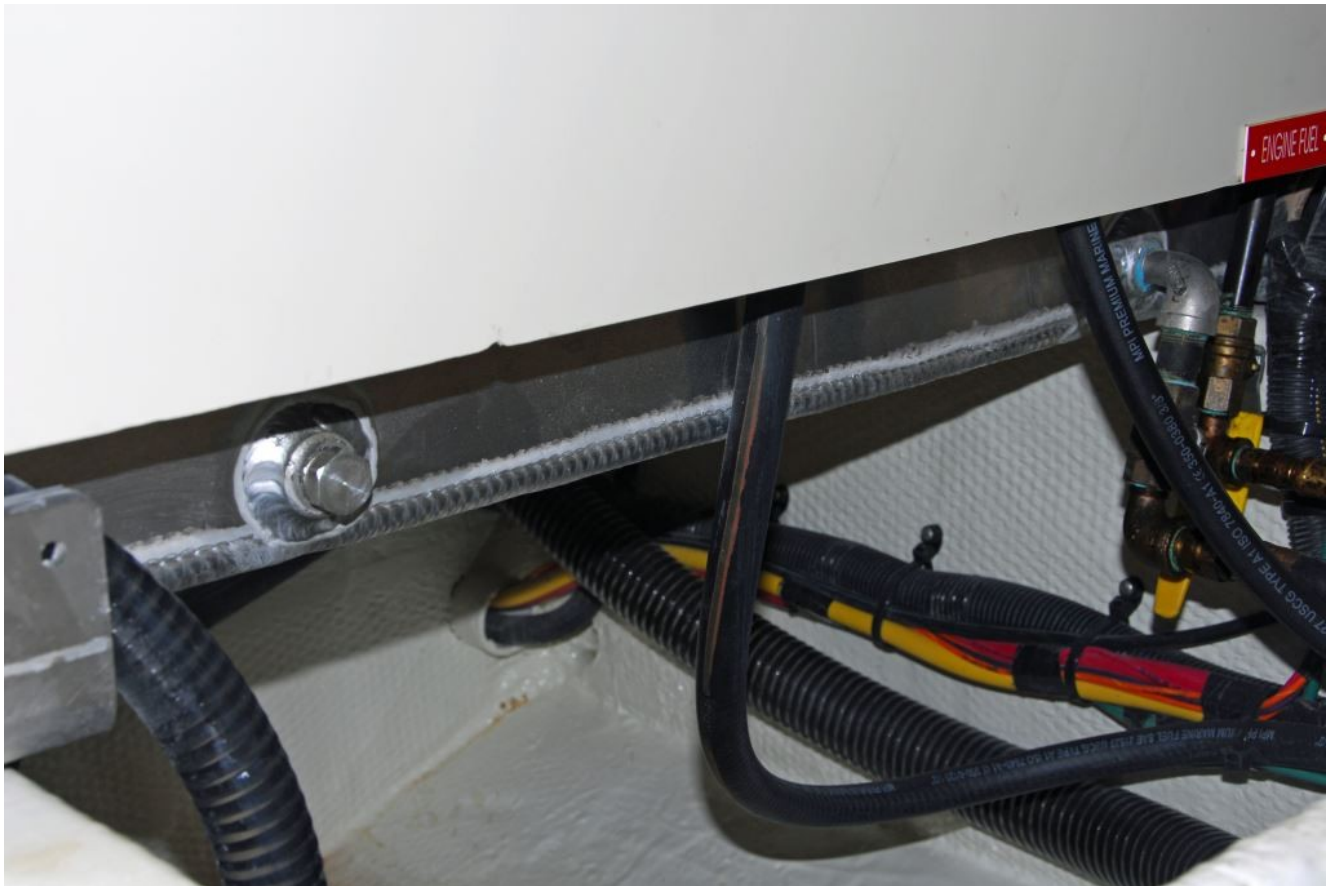
Large tanks that span great distances, between stringers like this one for instance, are challenged. Unless the tank is specifically designed and built to support its own weight, as well as the fuel within, and pounding g-force loads, then it should be supported by a shelf.

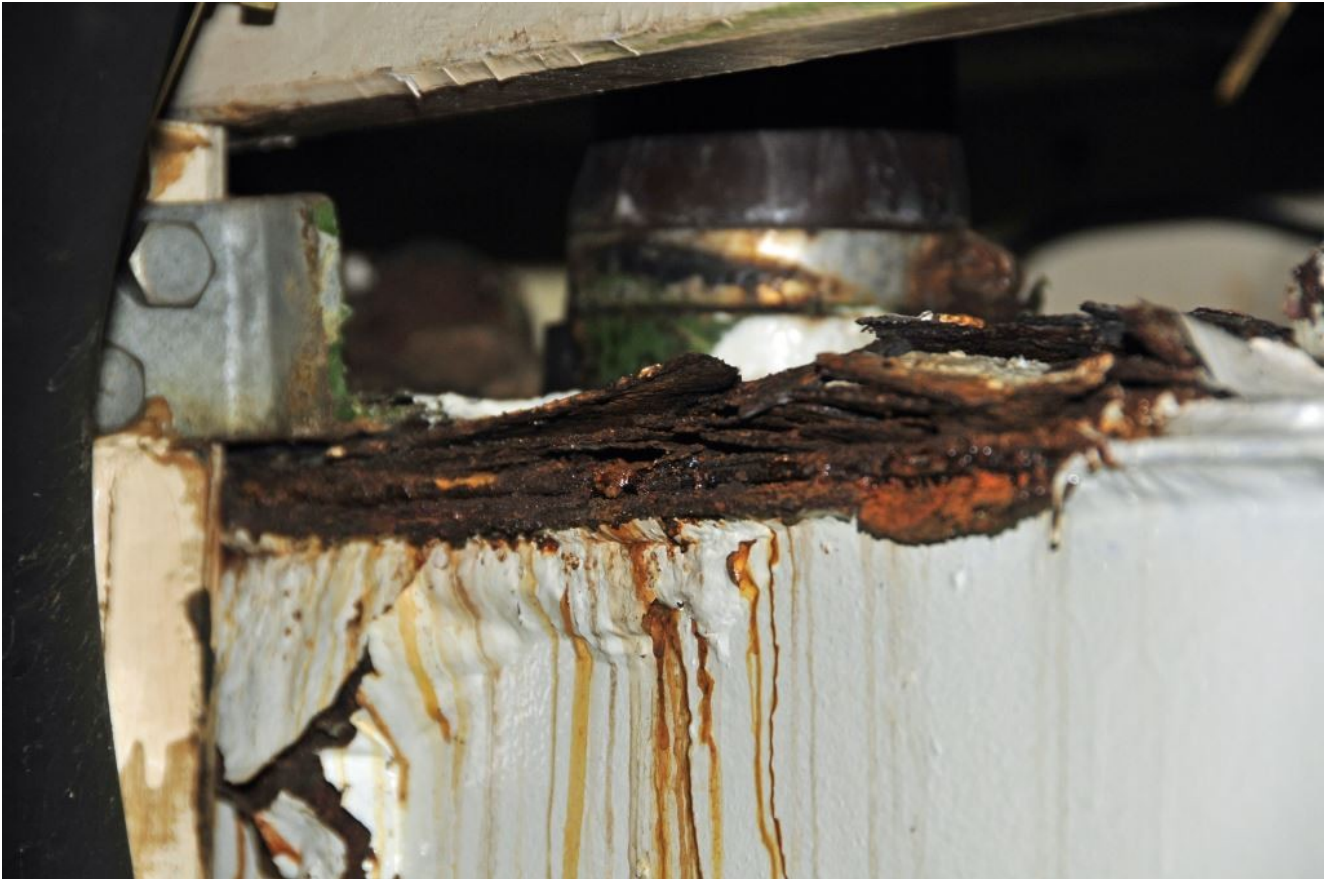
These steel tanks suffer from the classic, deck leak-induced rust and failure scenario. If the tank tops were angled they may have shed water, giving users a clue as to the impending failure. Tanks should be installed in such a way as to enable easy, casual inspection, i.e. they should remain exposed.

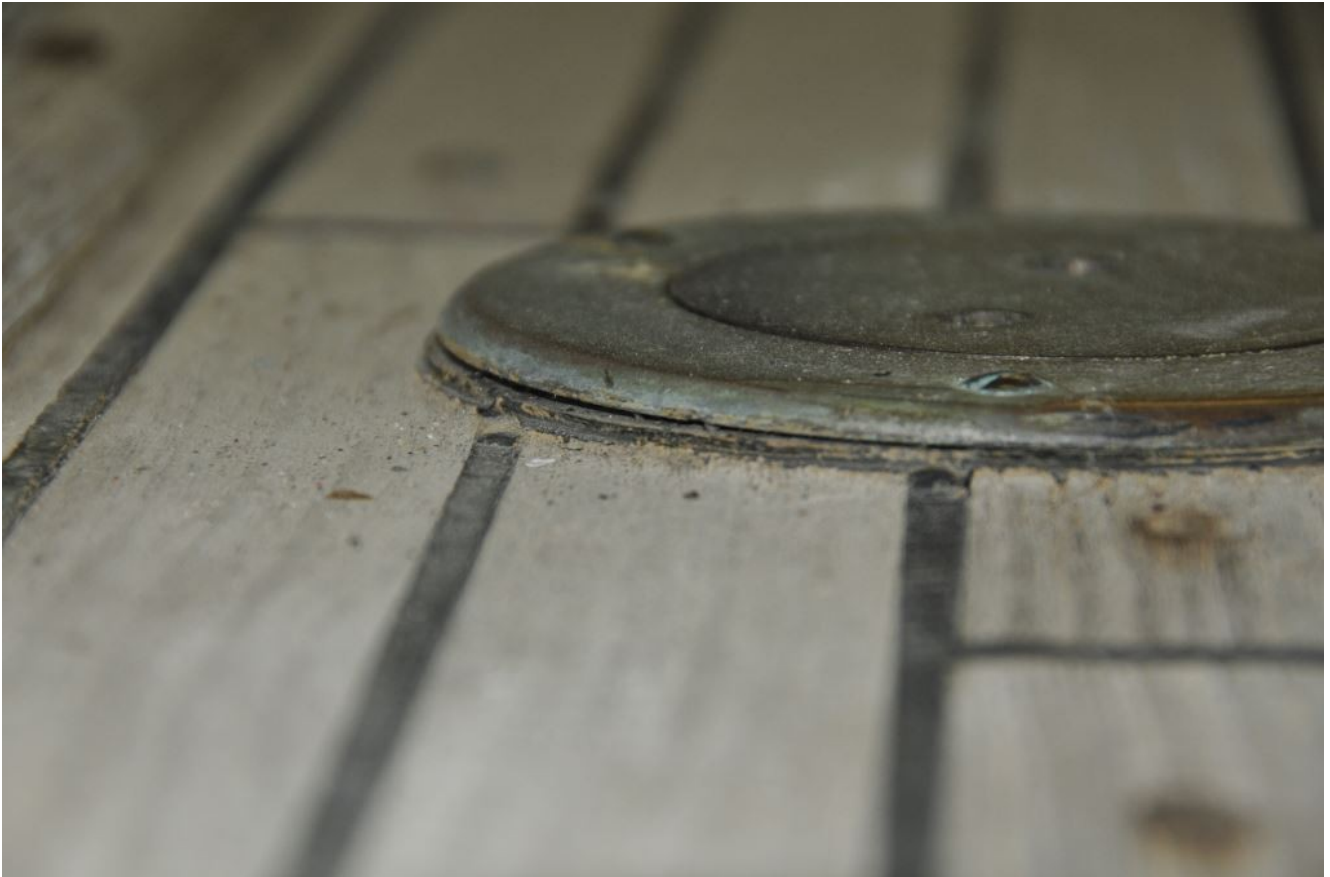
Deck fills, in teak decks are notorious for leaking water onto tank tops. The gap between this deck fill and its bedding is clear to see. Inspect your deck fills and tank tops regularly.

visible (such angling is required for compliance with ABYC standards). The number of tanks I've encountered that have failed from the top down, as it were, is simply astounding. Deck fuel fills are notorious for leaking water onto the tops of tanks (why deck hardware leaks, and how to avoid it, is the subject of an upcoming Marine Systems Excellence article), where it often stands, ultimately causing rust or corrosion on steel and aluminum respectively.

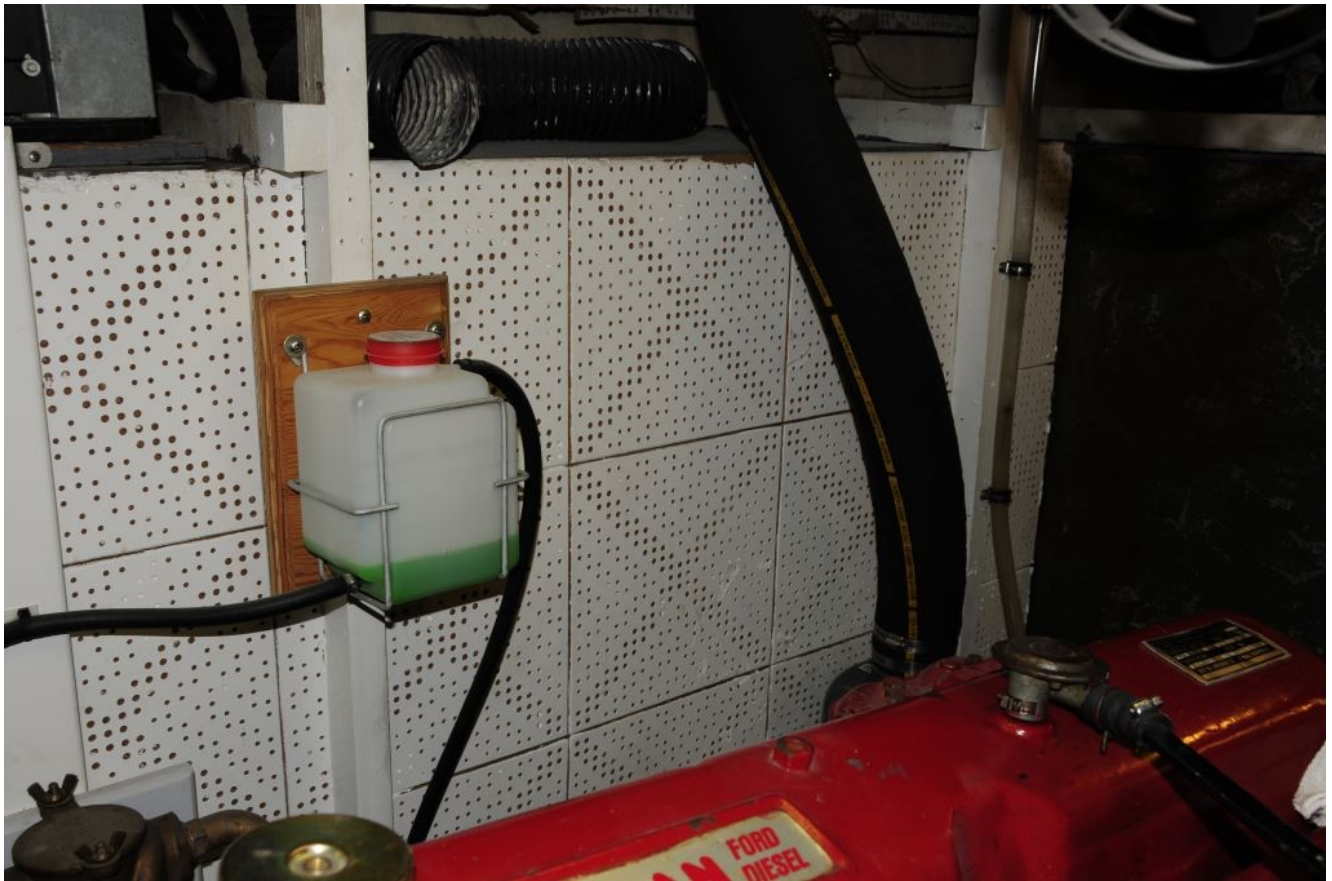
Many boat builders cover tanks with a fascia or acoustic insulation. While that may provide a small modicum noise reduction, and it may be visually appealing (I don't believe it is, and if it is it's not worth the price paid), it prevents identification of leaks and corrosion. Tanks should remain exposed, particularly metallic tanks.

A final note on tank installations relates to serviceability and accessibility. Once the tank is installed all “serviceable” components, fill, vent and supply fittings and senders as well as inspection ports should be accessible and ideally they should be visible as well. Covering or sheathing a tank for cosmetic or acoustic purposes is a double edged sword, it may look more attractive, to some, or it may offer (minimal of any) noise reduction in accommodation spaces, however, it also means that leaks, corrosion, deteriorating hose and other issues may go unnoticed. Given the choice, I’d rather see the tank in all its glory.

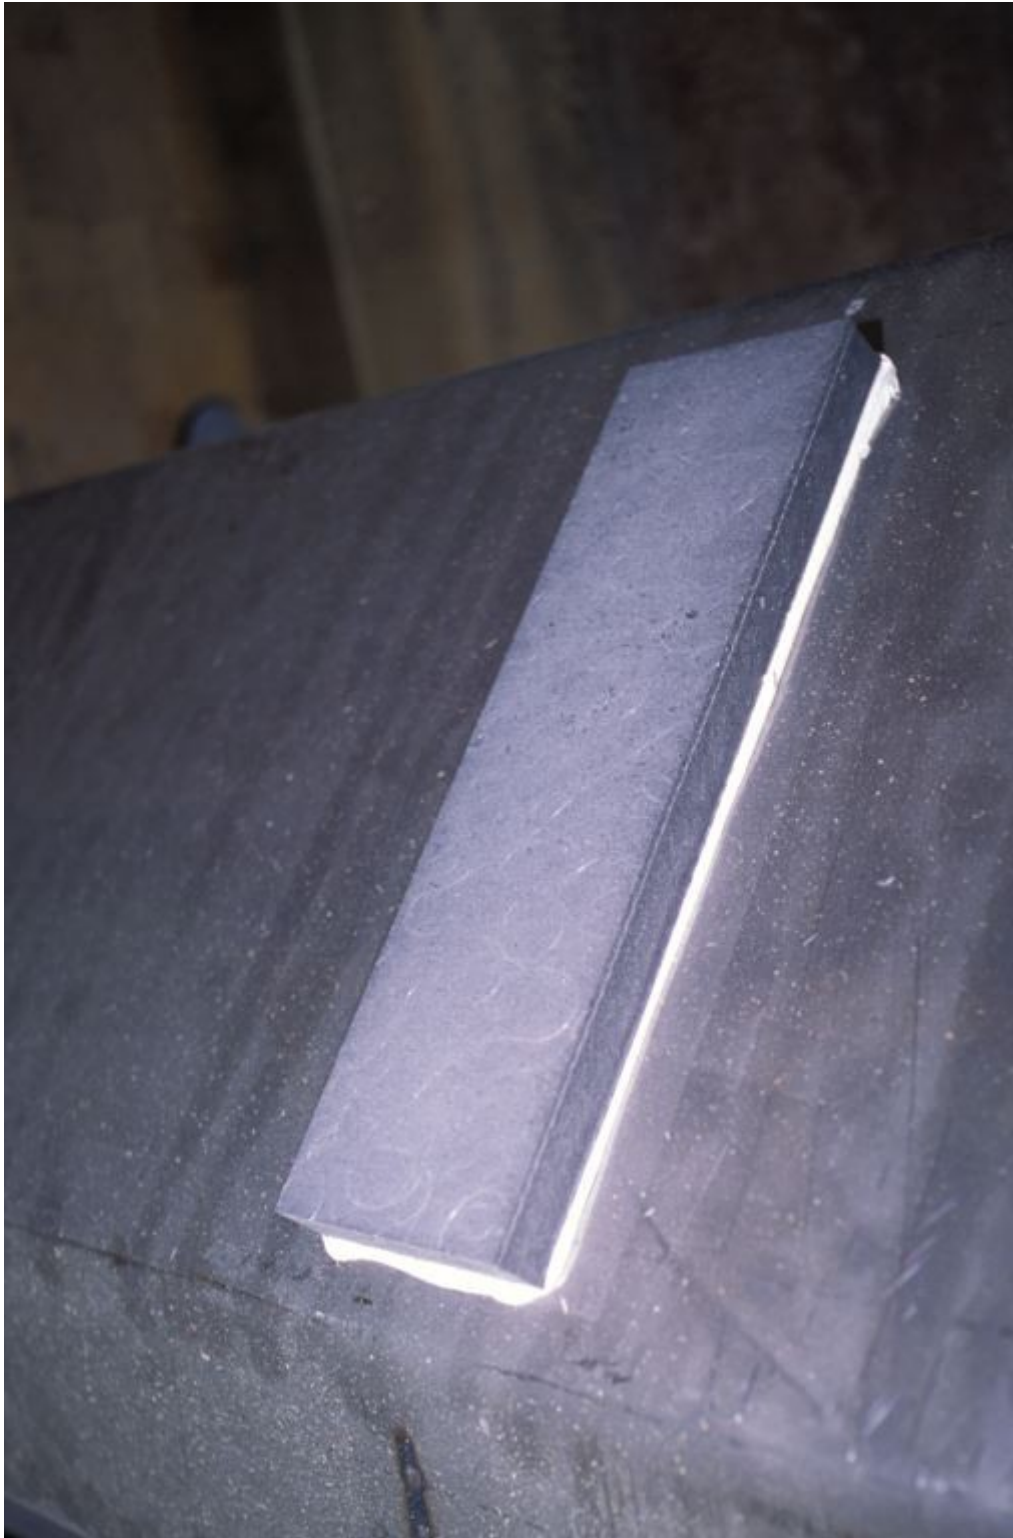
Spacer material should be bedded to tank bottoms, like that shown here. Doing so prevents water migrating between the tank and the spacer.

(prefabricated fiberglass or GP03 works well) should be *bedded* athwartships to the tank bottom on four to six inch centers, using a polyurethane bedding compound. With this approach, the tank can't rest in standing water and water can't migrate between the tank and the spacers, either of which will lead to corrosion.
