# **Fuel Tank Installation**

## **There's More to it than Meets the Eye**

Text and Photos by Steve D'Antonio

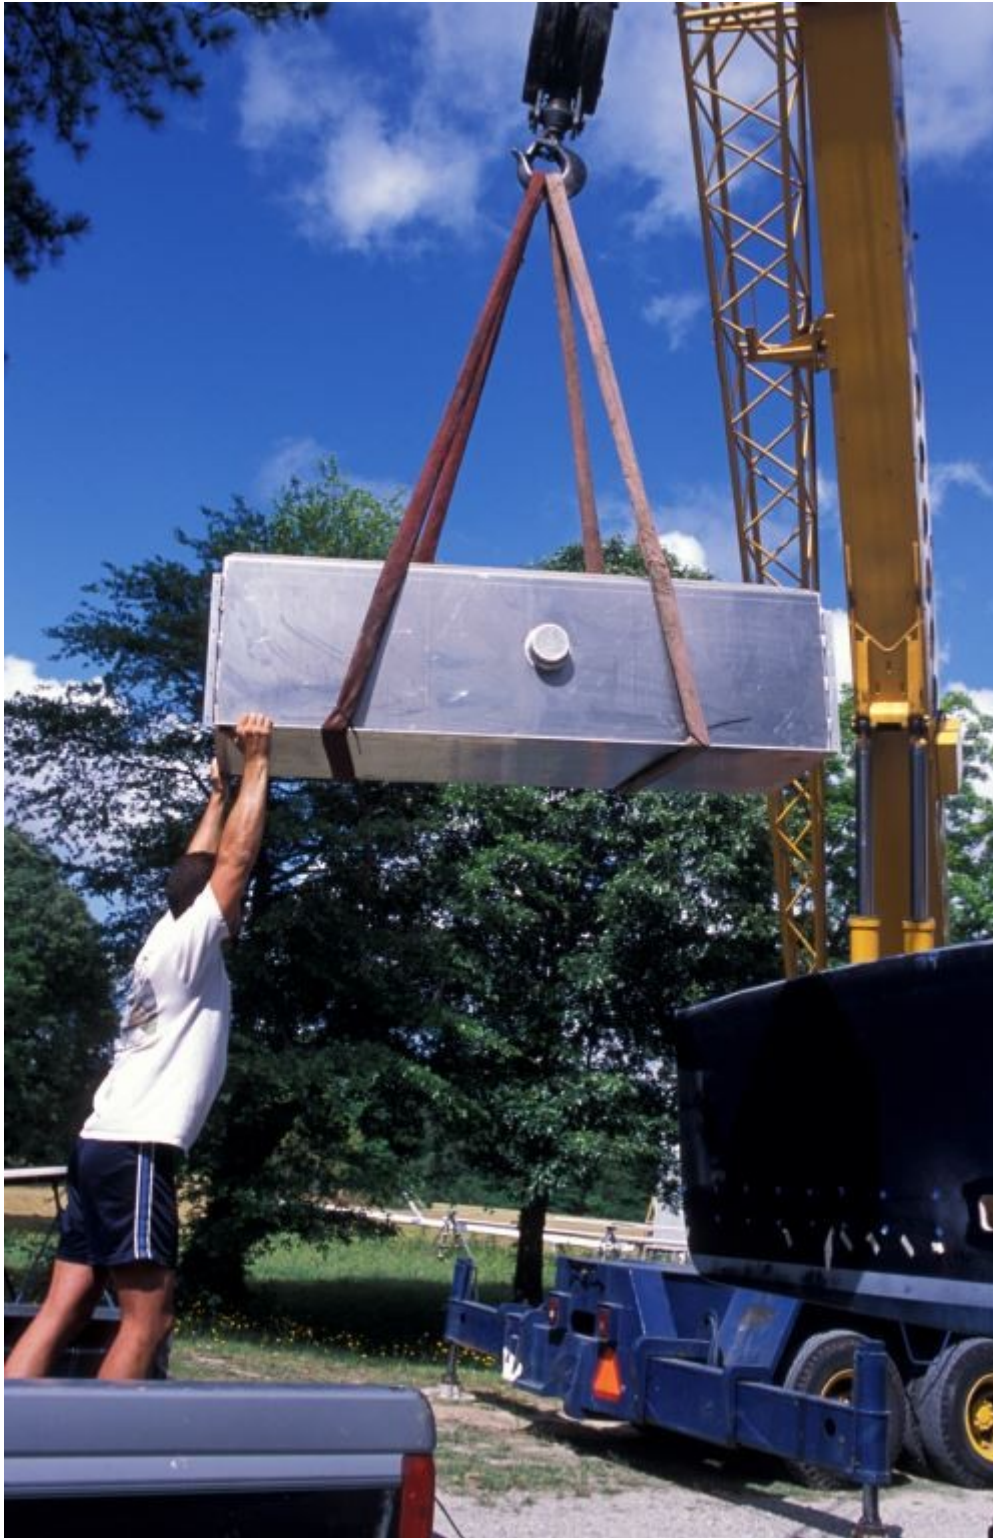
**Fuel tank installations should last the life of the boat, if not for decades.**

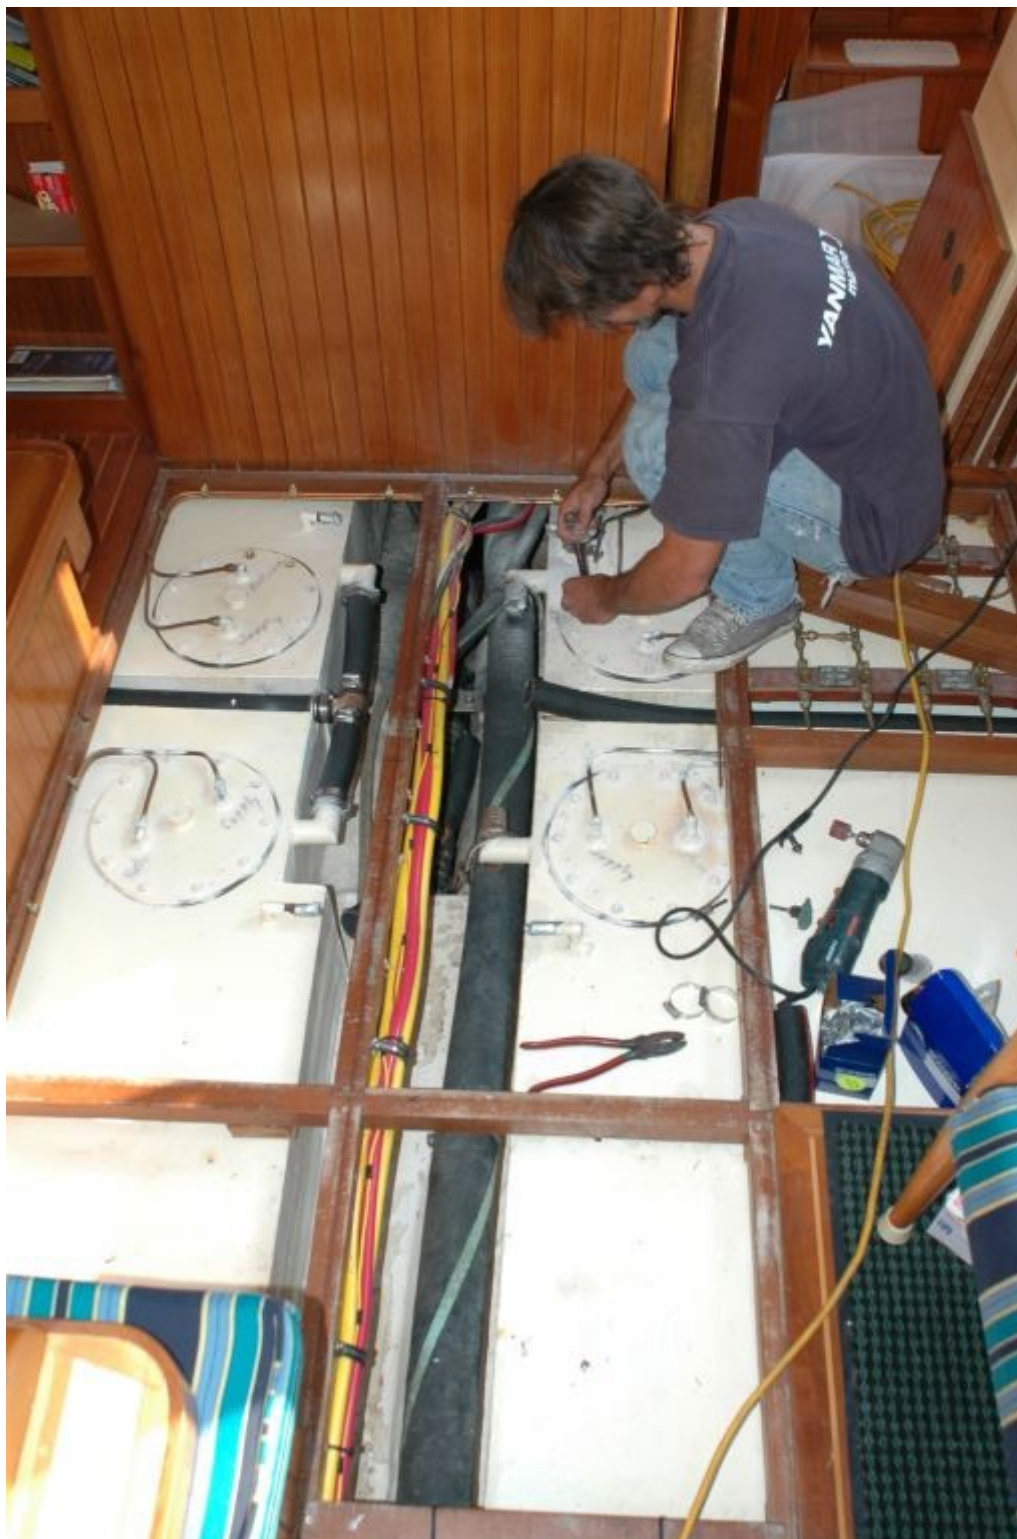
**Replacing tanks on an existing vessel is nothing short of a daunting process. It's nearly always costly and physically invasive. In many cases, two tanks must replace one, with**

**their consequent interconnecting plumbing, in order for them to fit through existing ports or hatches.**

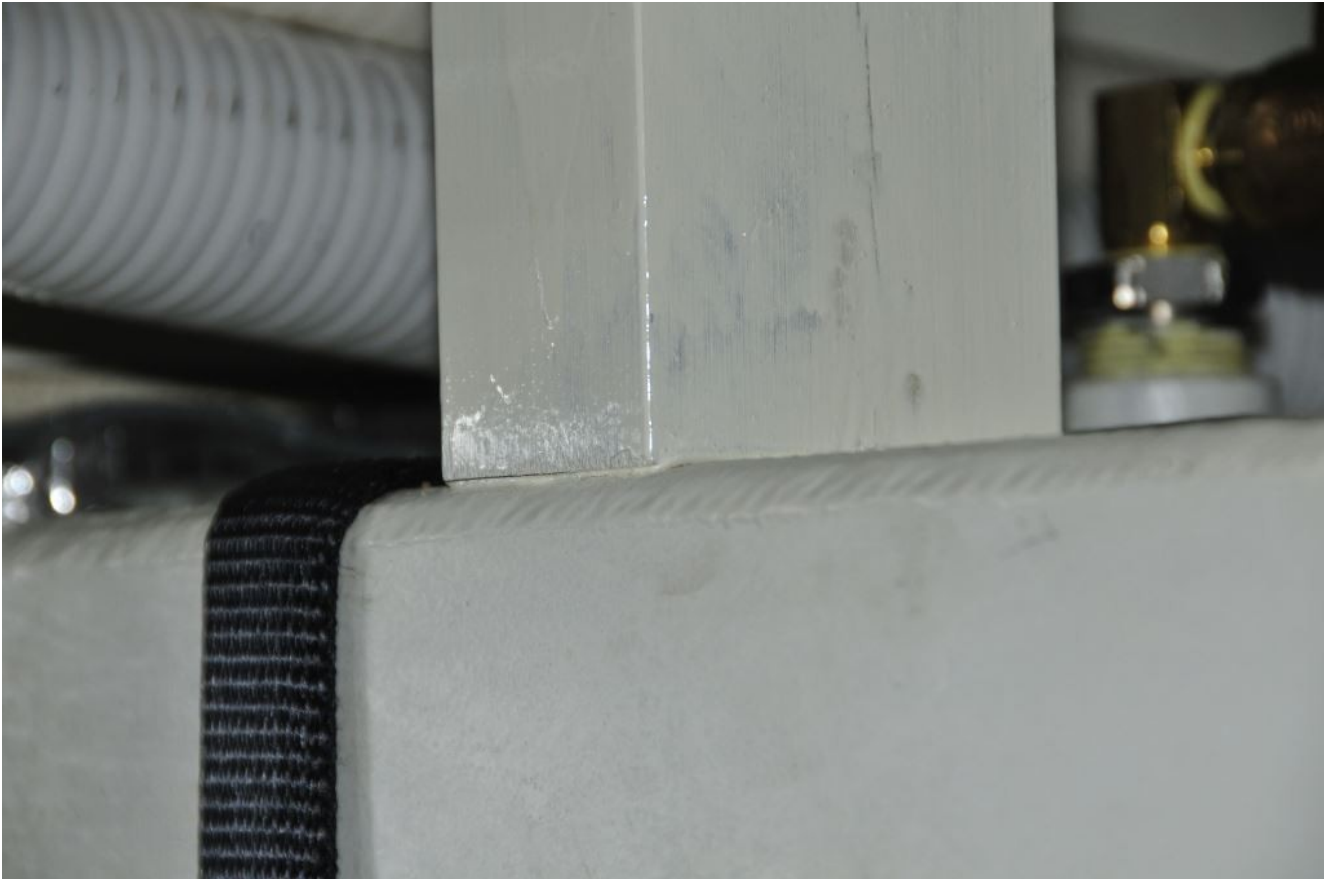
**Fuel tanks must never be used as a supporting structure, to support a sole for instance as is the case in this image, unless they are specifically designed for this purpose. Most tanks are not designed to support anything other than themselves and the fuel they contain.**

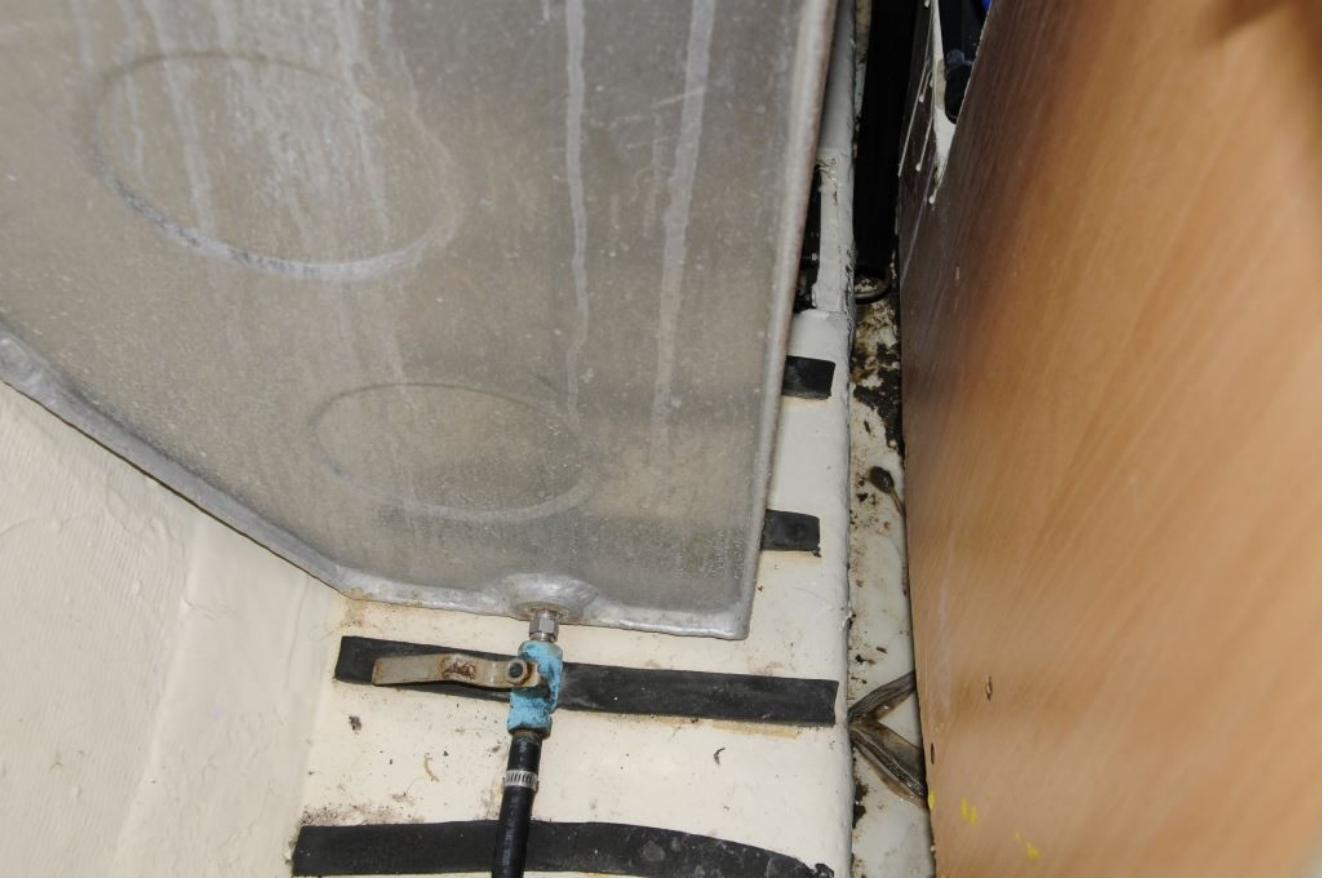
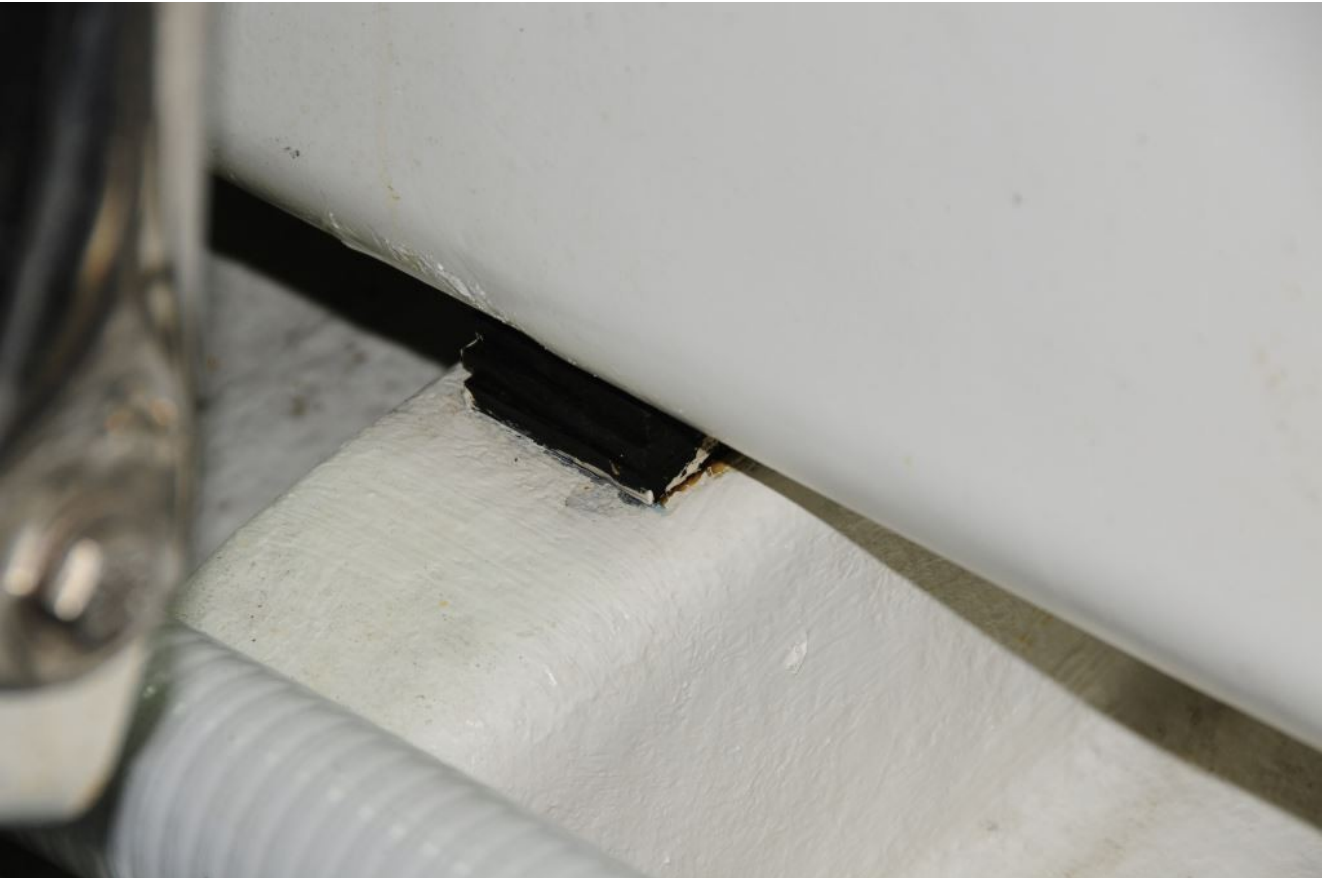
**Tanks, especially metallic tanks, should be elevated above a self or deck to allow for water drainage. Often this is accomplished with thin strips of rubber material, which often compress, and in turn fail to fulfill their intended purpose. Whatever material is used as this spacer, it must be resistant to compression, decay and water absorption.**

Ideally, unless designed and built to be self supporting (this would include internal reinforcement), tanks should rest on continuous shelf-like structures rather than stringers or beams of any sort. When supported in this manner, flexing is minimized if not eliminated. In order to promote drainage and prevent corrosion to a metallic tank's bottom, one to two inch wide,  $\frac{1}{4}$  inch thick spacers made of non-hygroscopic material

(prefabricated fiberglass or GP03 works well) should be *bedded* athwartships to the tank bottom on four to six inch centers, using a polyurethane bedding compound. With this approach, the tank can't rest in standing water and water can't migrate between the tank and the spacers, either of which will lead to corrosion.

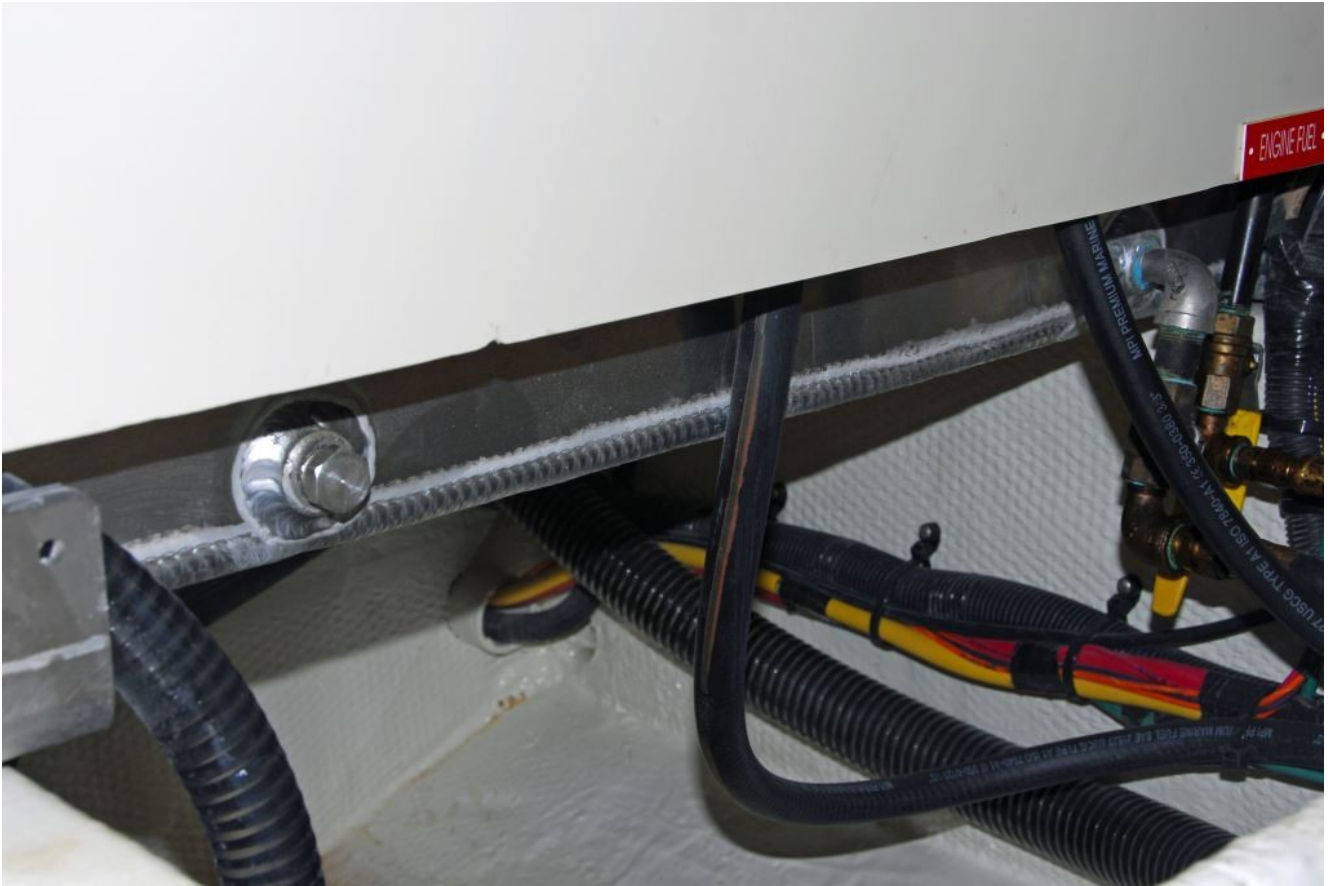
**Large tanks that span great distances, between stringers like this one for instance, are challenged. Unless the tank is specifically designed and built to support its own weight, as well as the fuel within, and pounding g-force loads, then it should be supported by a shelf.**

In another similar flex-induced failure, a large tank, nearly 1000 gallons, spanned the entire beam of a vessel. It was located beneath the cockpit where it rested on a closely spaced set of central stringers as well as on supports located outboard at the tank's extreme beam ends. Once again, when the tank wasn't full it was capable of supporting itself as well as the weight of the fuel. However, once filled the weight of the fuel, over 3.5 tons, caused the beam ends to sag because there was a small gap between the bottom of the tank and these outboard supports, an installation defect if ever there was one. Further exacerbating this problem was the fact that this was a high speed, off shore fishing vessel that was designed to endure slamming loads, as it made its way through tumultuous seas. As the tank absorbed these loads it flexed, initially anyway, which eventually led to its failure at the fulcrum point on the tank's centerline. Interestingly, the crack that developed did so precisely in the middle of a weld bead, indicating that the weld itself, as well as the plate, was sound. The structure simply could not absorb the movement caused by inadequate support.

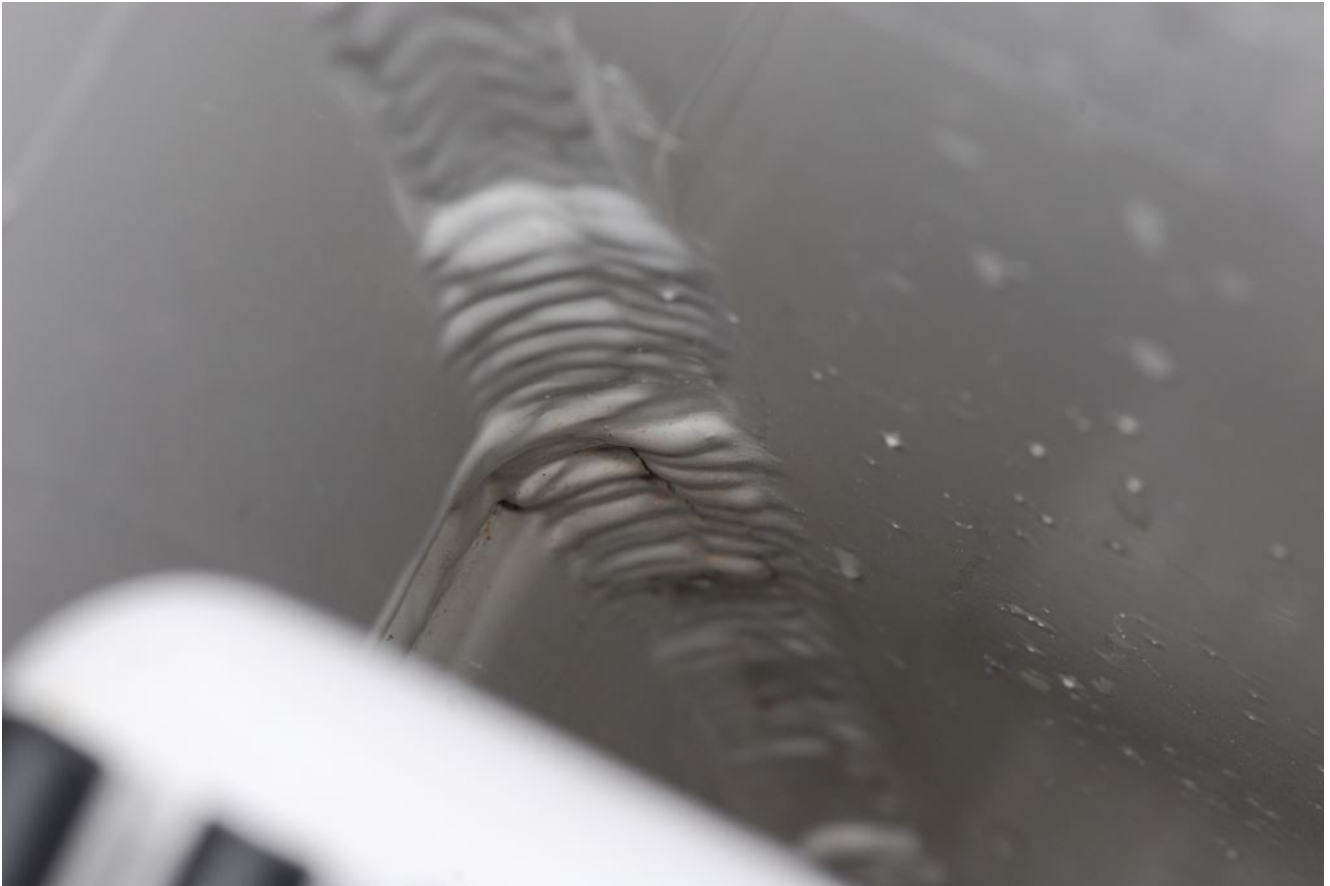
**Tanks should not be allowed to flex or move once installed, they should be fully supported and secured. This large tank, installed in a new vessel, cracked at a weld shortly after the vessel went into service. The tank was not properly supported and as a result, when full, the outboard ends sagged, stressing the center section.**

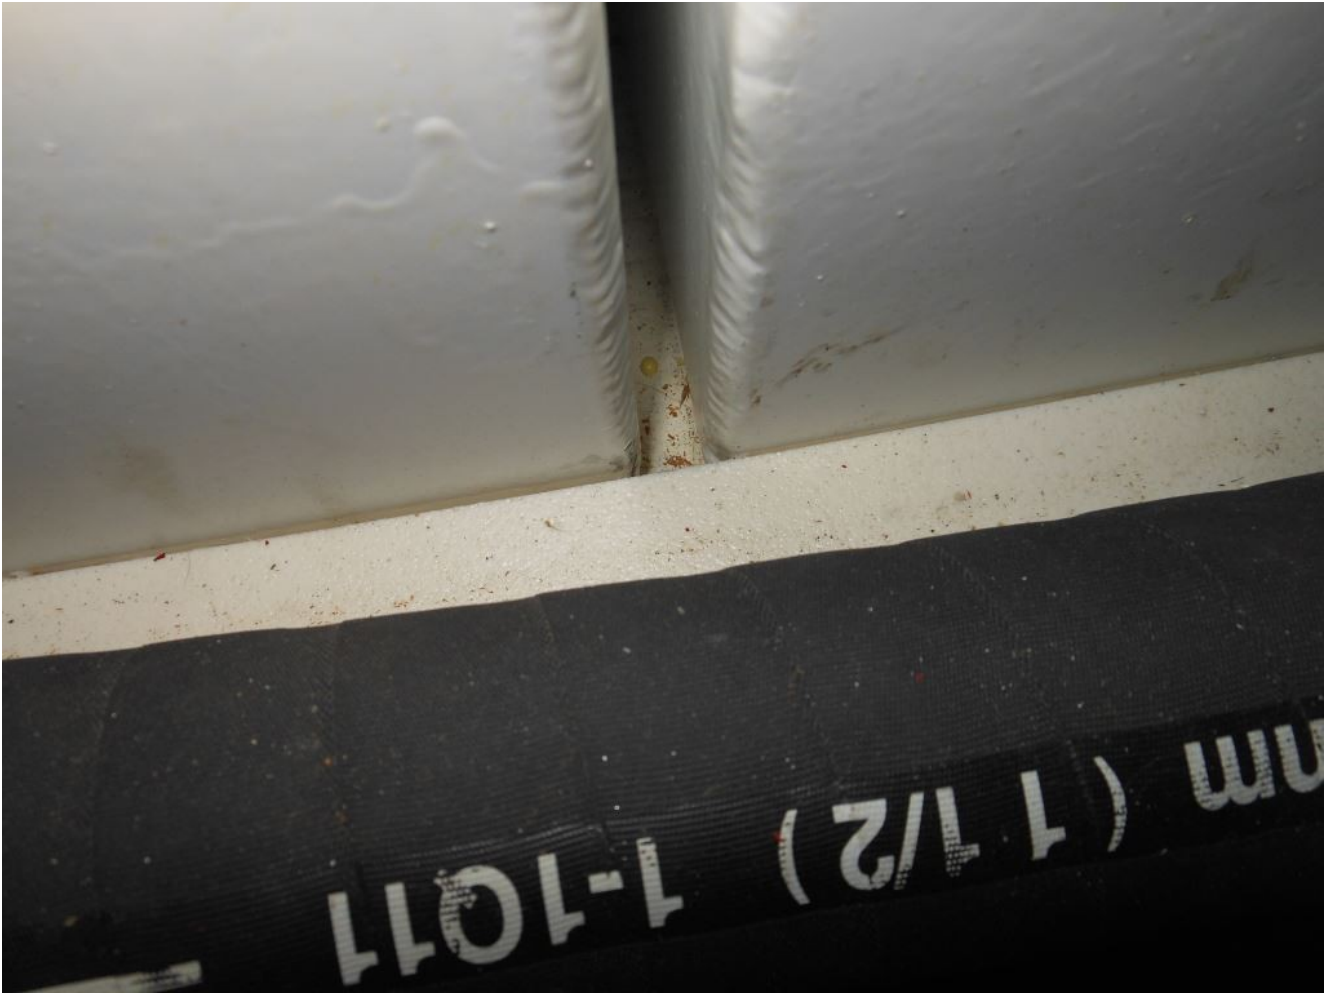
Water entrapment sounds the death knell for many metallic tanks. Gaps and voids that can retain water allow corrosion and rust to gain a toe hold, which could ultimately lead to tank failure. Tanks should never be installed directly against a surface such as a shelf or cleat like that shown here, as the small gap between the two will retain water. Tank installations should be self-draining, avoiding traps like the one shown here.

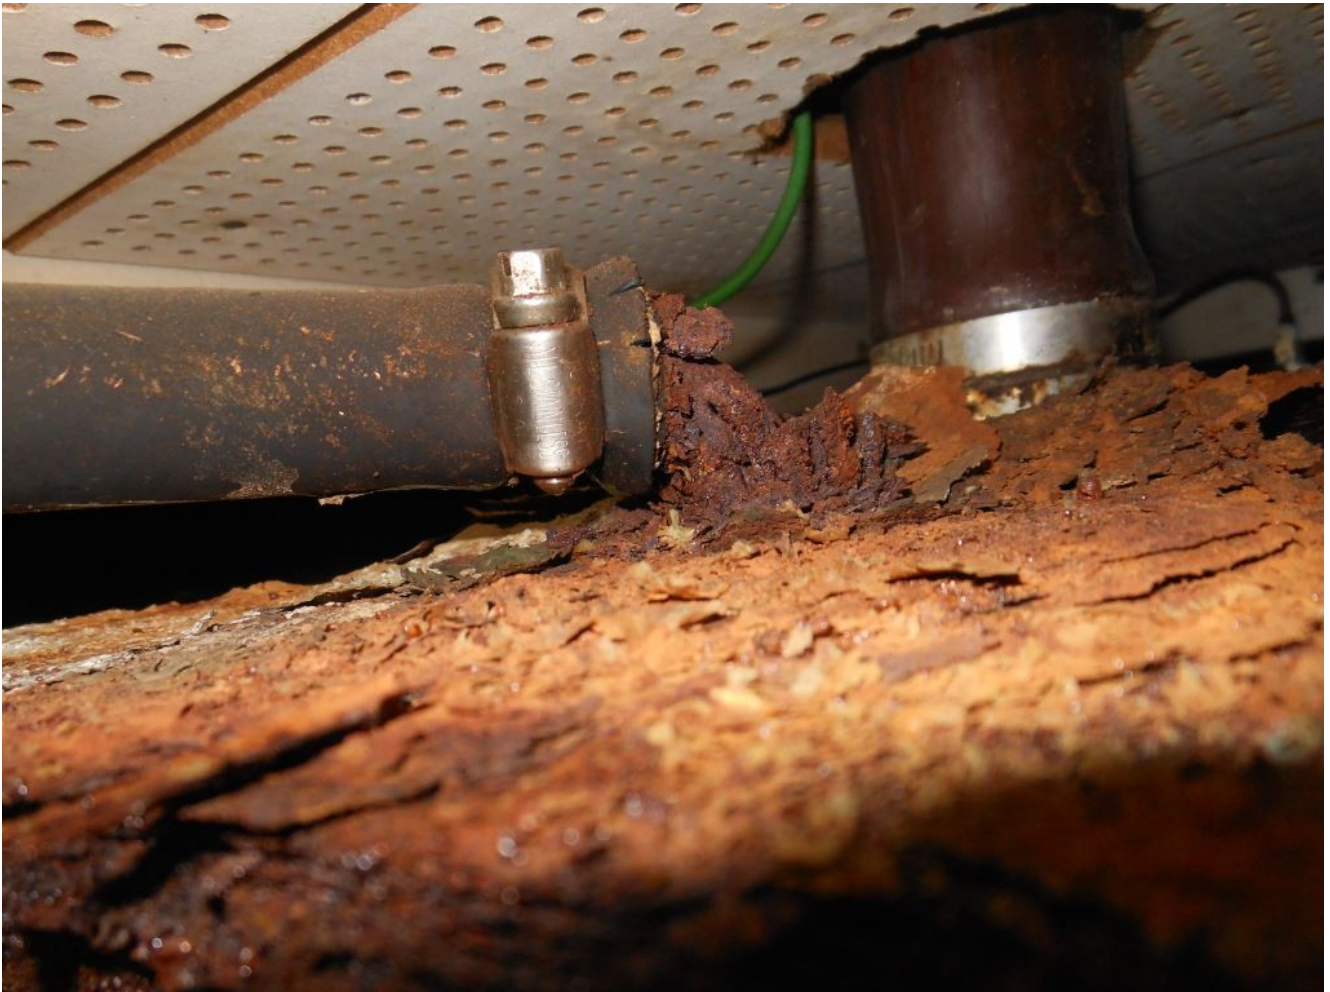
**These steel tanks suffer from the classic, deck leak-induced rust and failure scenario. If the tank tops were angled they may have shed water, giving users a clue as to the impending failure. Tanks should be installed in such a way as to enable easy, casual inspection, i.e. they should remain exposed.**

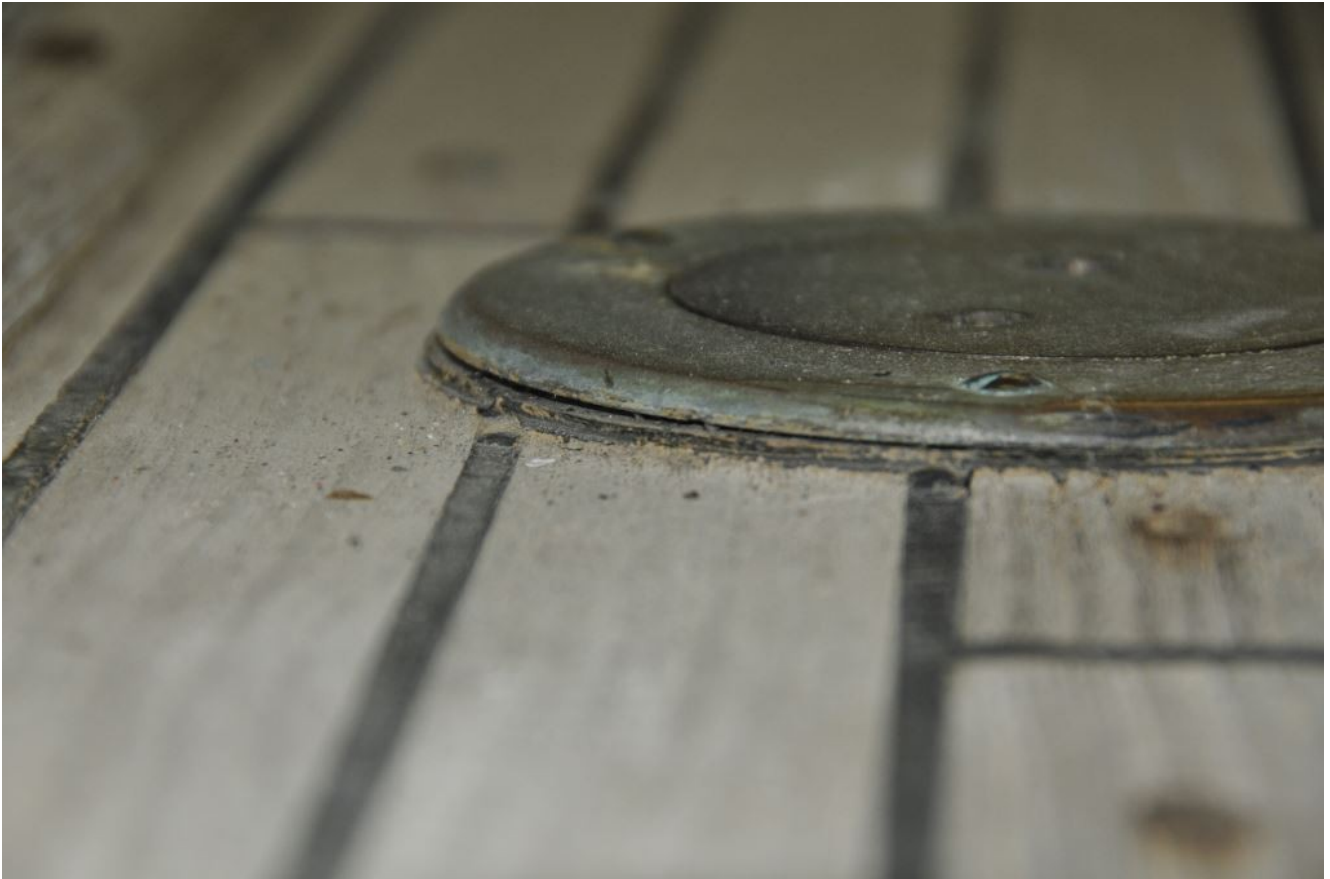
**Deck fills, in teak decks are notorious for leaking water onto tank tops. The gap between this deck fill and its bedding is clear to see. Inspect your deck fills and tank tops regularly.**

visible (such angling is required for compliance with ABYC standards). The number of tanks I've encountered that have failed from the top down, as it were, is simply astounding. Deck fuel fills are notorious for leaking water onto the tops of tanks (why deck hardware leaks, and how to avoid it, is the subject of an upcoming Marine Systems Excellence article), where it often stands, ultimately causing rust or corrosion on steel and aluminum respectively.

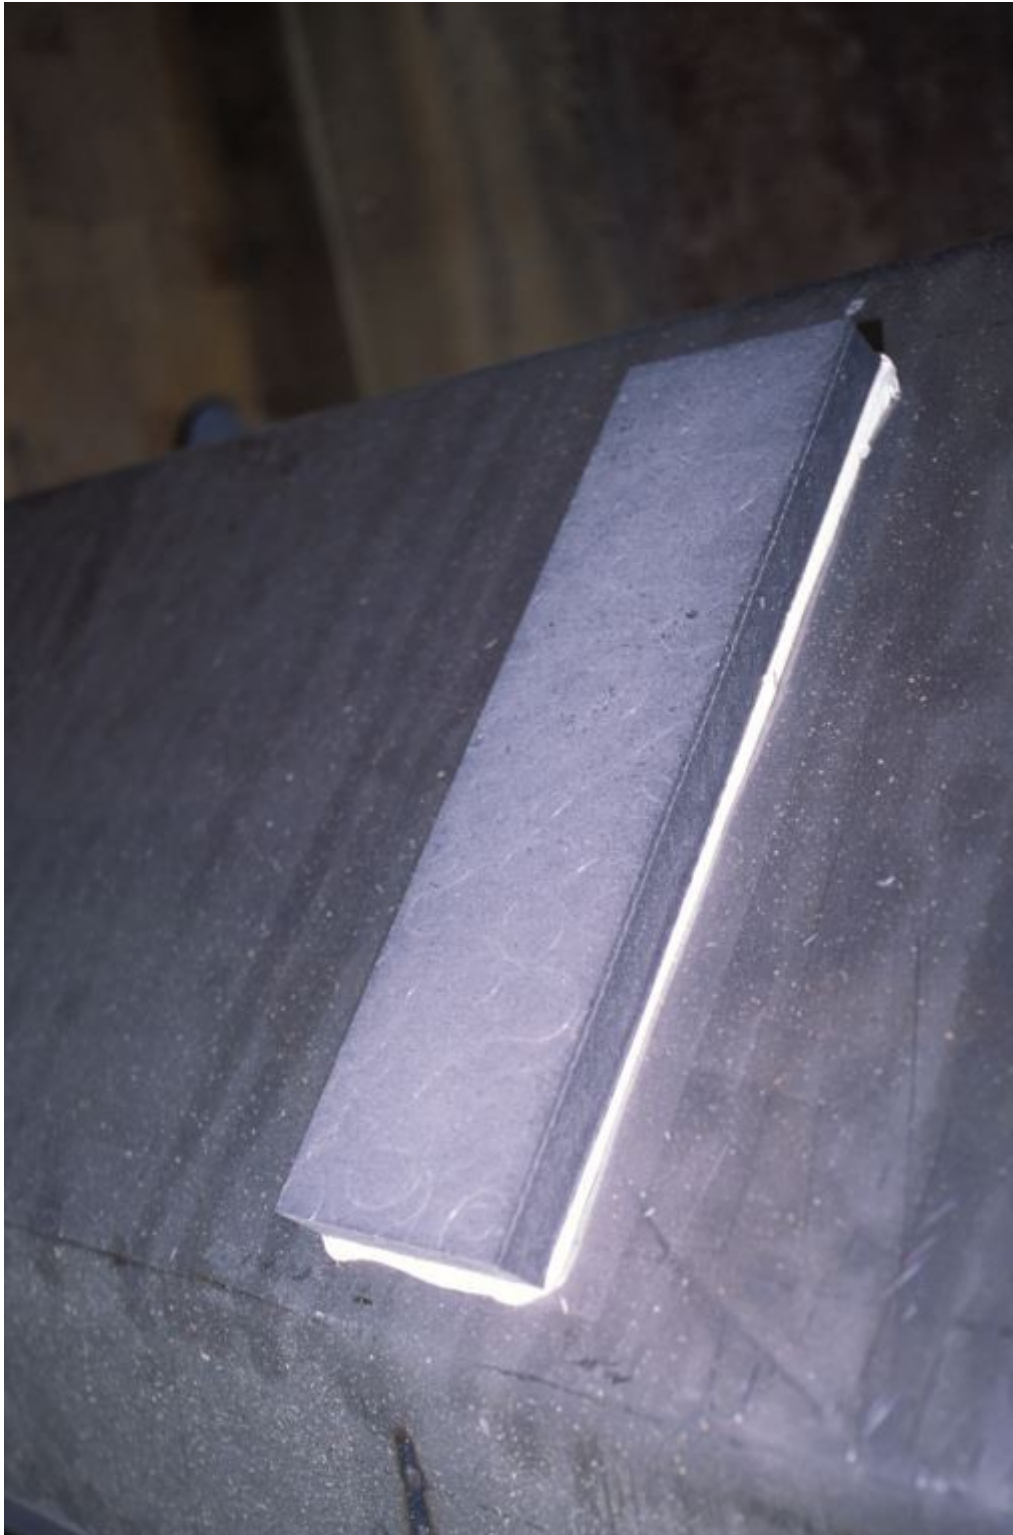
**Spacer material should be bedded to tank bottoms, like that shown here. Doing so prevents water migrating between the tank and the spacer.**

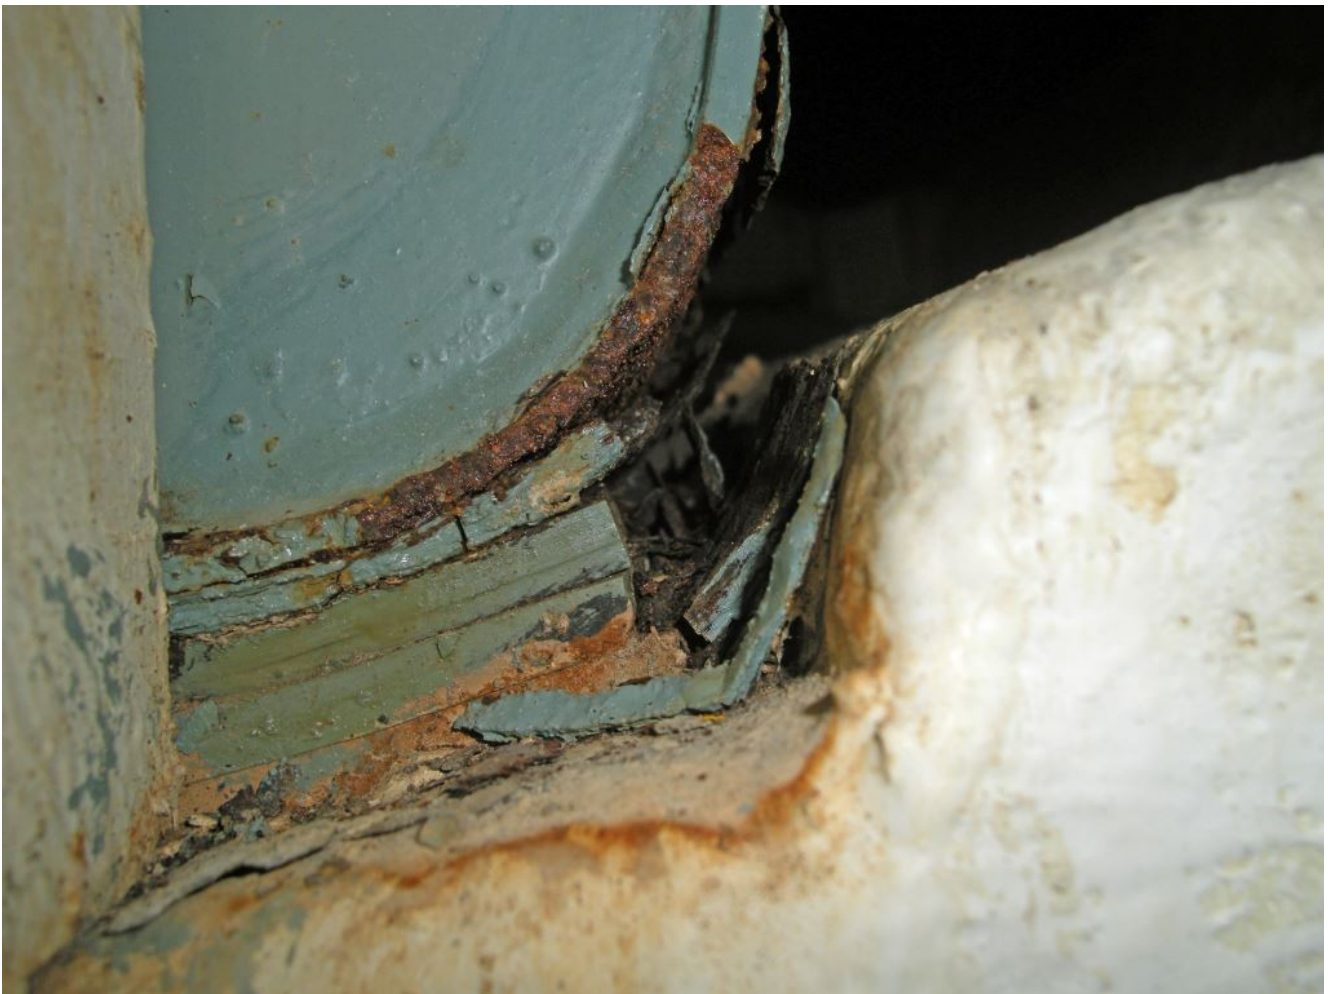
**In spite of the cushion, a strip of hard rubber, this tank rests on, it's suffering from near-terminal corrosion as a result of a deck leak. It is imperative that cushion material, regardless of what form it may take, must be bedded to the tank.**
