Fuel Tank Installation

There's More to it than Meets the Eye

Text and Photos by Steve D'Antonio

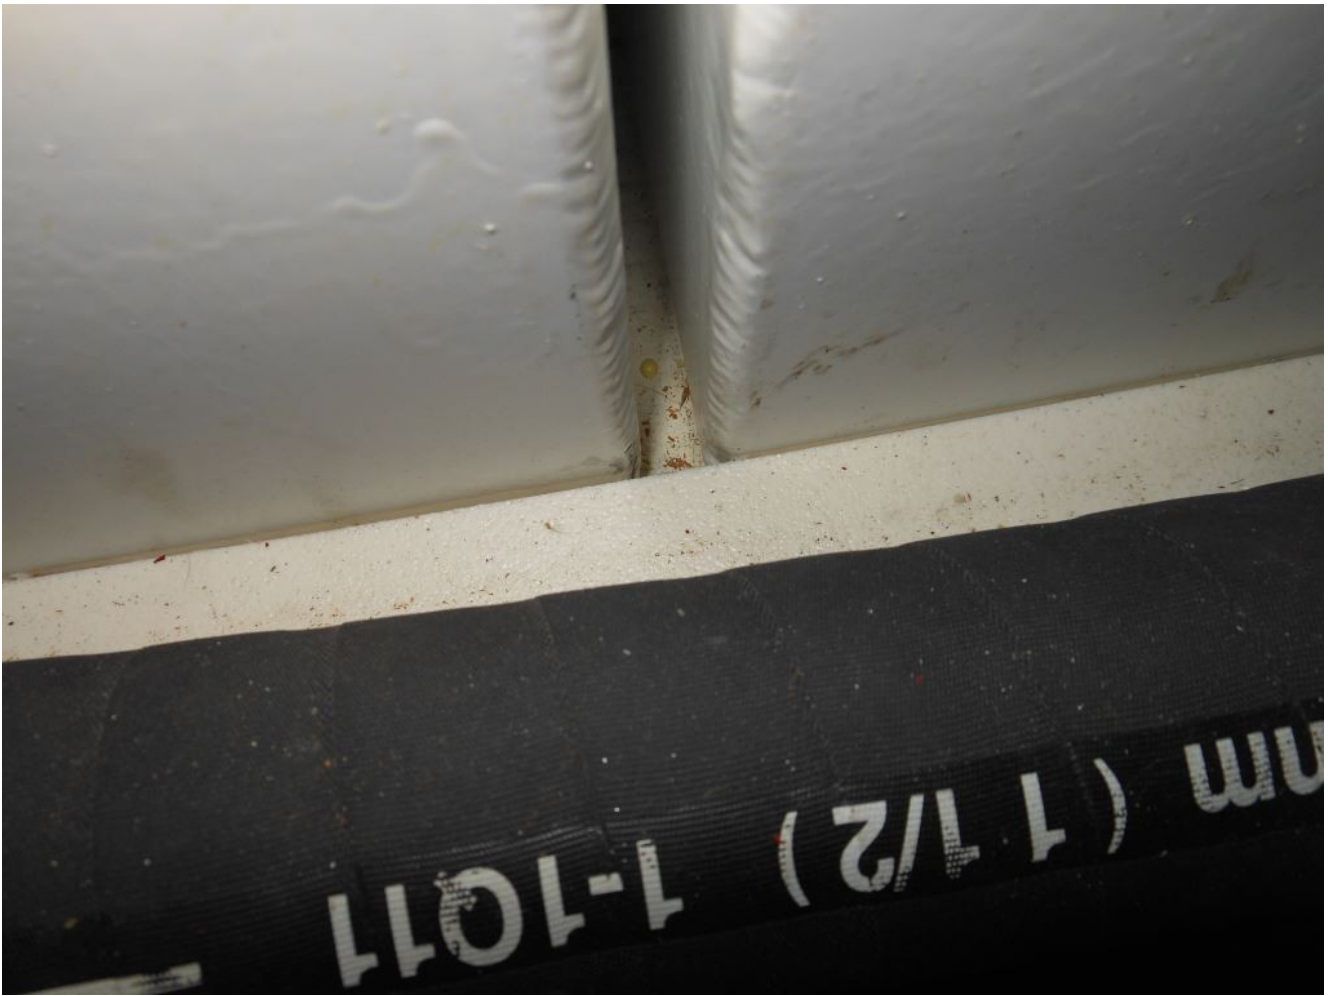
Water entrapment sounds the death knell for many metallic tanks. Gaps and voids that can retain water allow corrosion and rust to gain a toe hold, which could ultimately lead to tank failure. Tanks should never be installed directly against a surface such as a shelf or cleat like that shown here, as the small gap between the two will retain water. Tank installations should be self-draining, avoiding traps like the one shown here.
