# **Fuel Tank Installation**

## **There's More to it than Meets the Eye**

Text and Photos by Steve D'Antonio

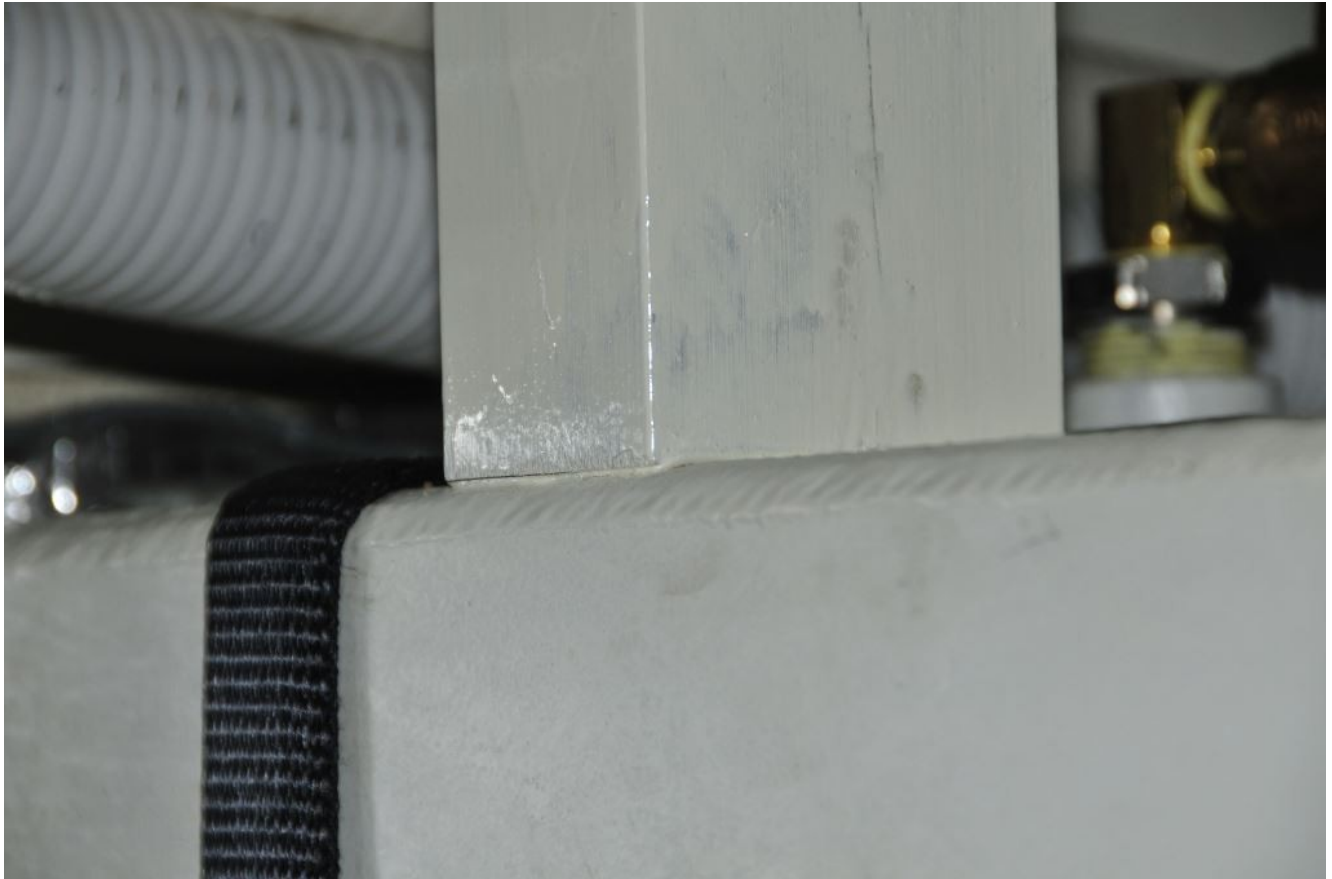
**Fuel tanks must never be used as a supporting structure, to support a sole for instance as is the case in this image, unless they are specifically designed for this purpose. Most tanks are not designed to support anything other than themselves and the fuel they contain.**

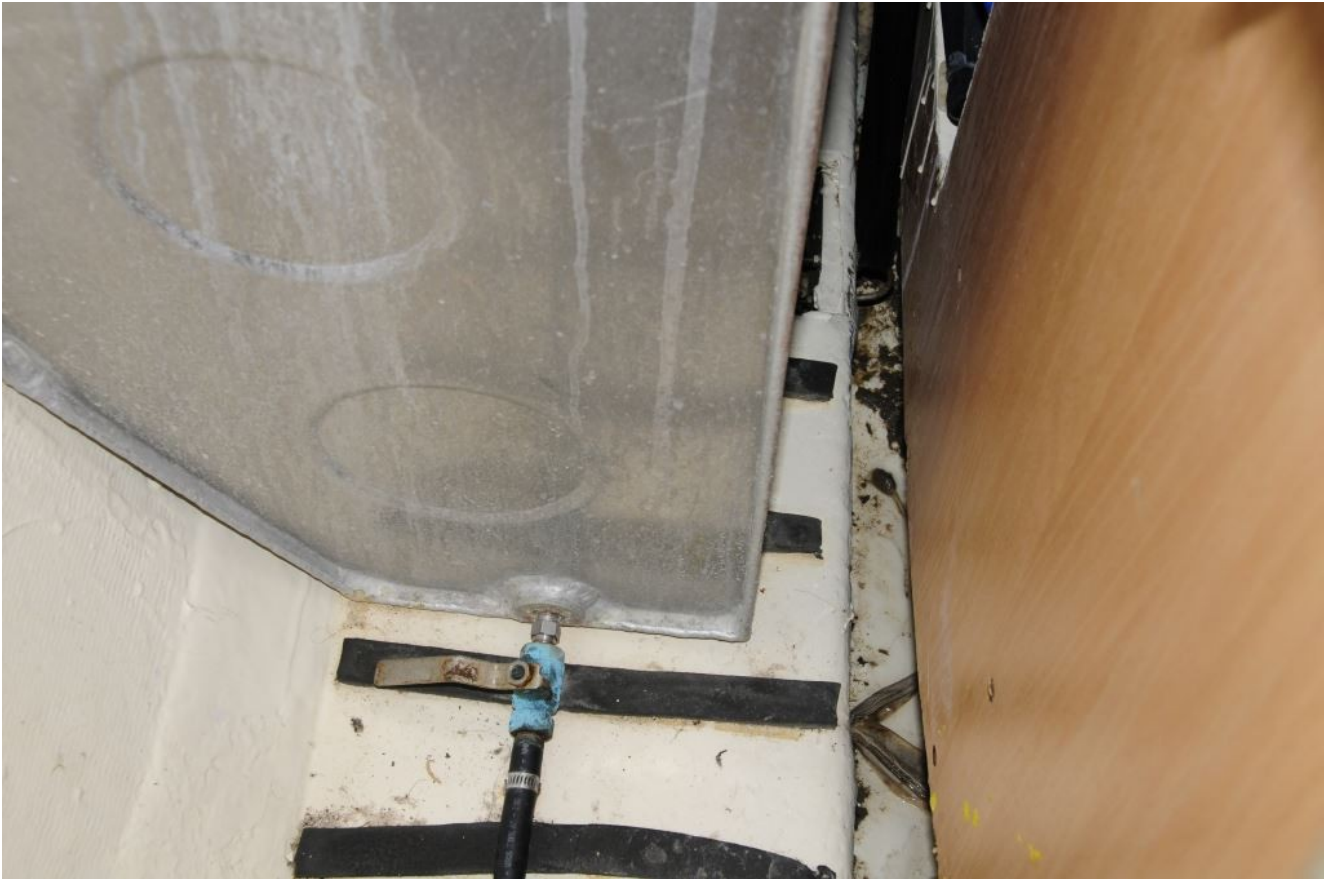
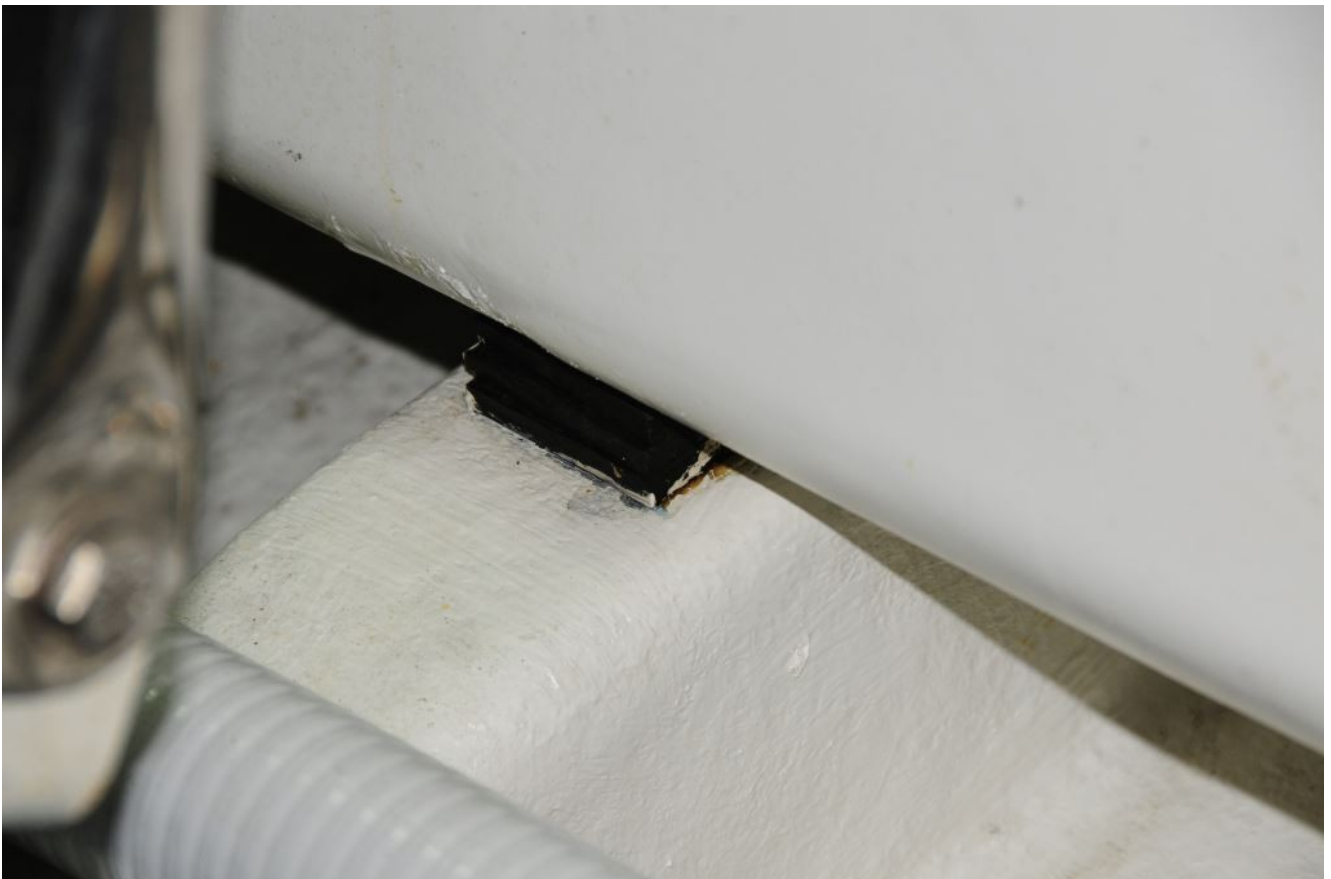
**Tanks, especially metallic tanks, should be elevated above a self or deck to allow for water drainage. Often this is accomplished with thin strips of rubber material, which often compress, and in turn fail to fulfill their intended purpose. Whatever material is used as this spacer, it must be resistant to compression, decay and water absorption.**

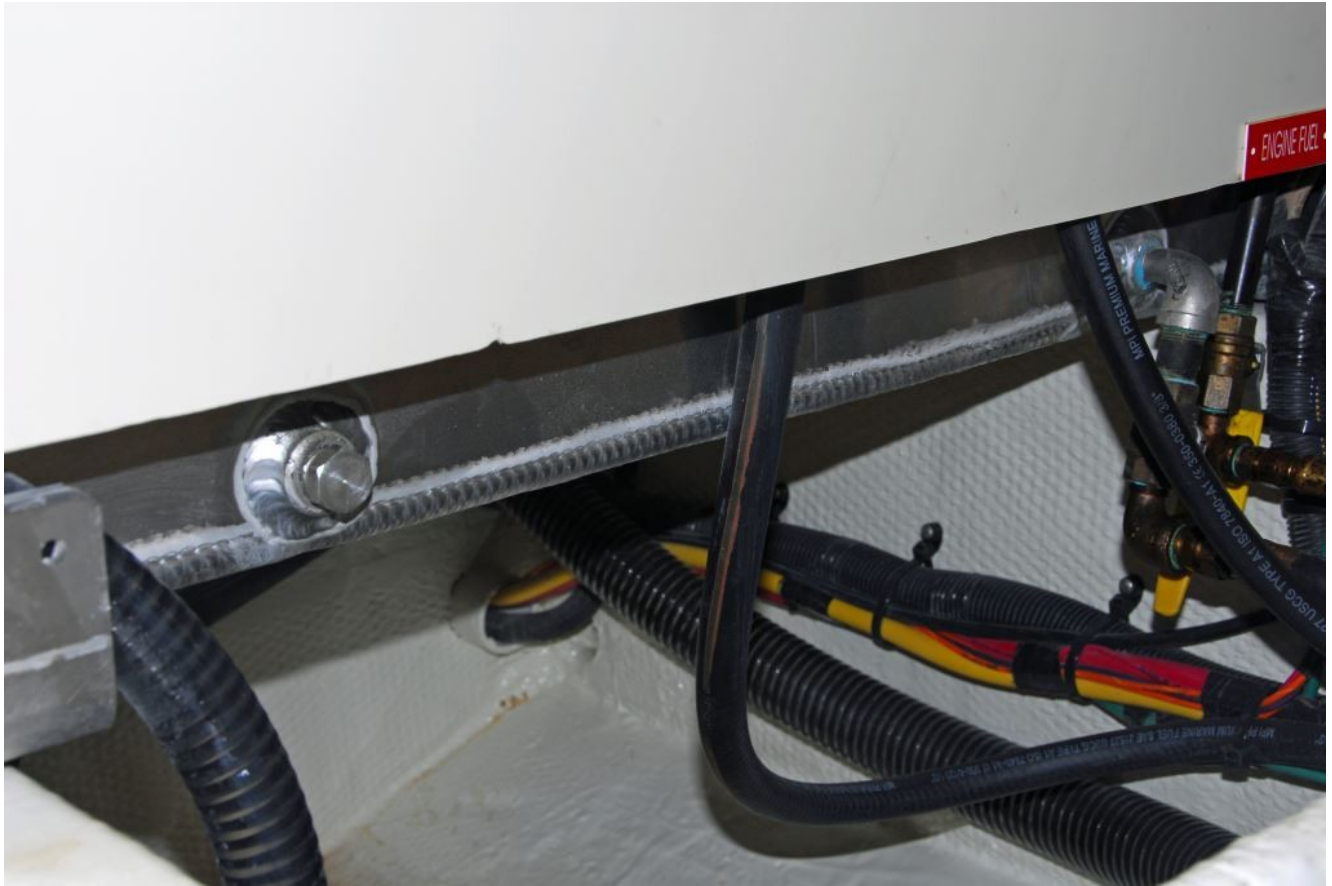
**Large tanks that span great distances, between stringers like this one for instance, are challenged. Unless the tank is specifically designed and built to support its own weight, as well as the fuel within, and pounding g-force loads, then it should be supported by a shelf.**

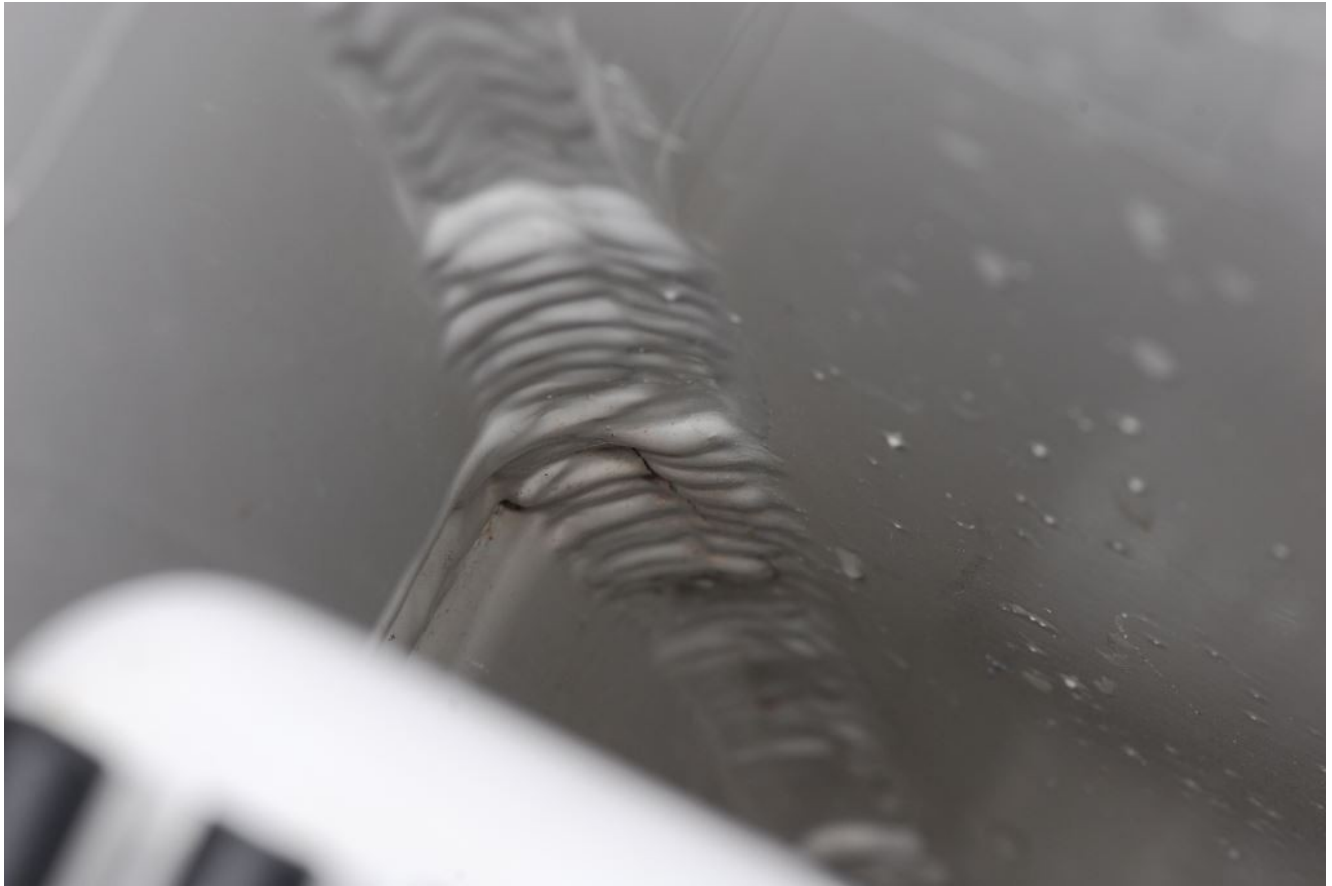
**Tanks should not be allowed to flex or move once installed, they should be fully supported and secured. This large tank, installed in a new vessel, cracked at a weld shortly after the vessel went into service. The tank was not properly supported and as a result, when full, the outboard ends sagged, stressing the center section.**

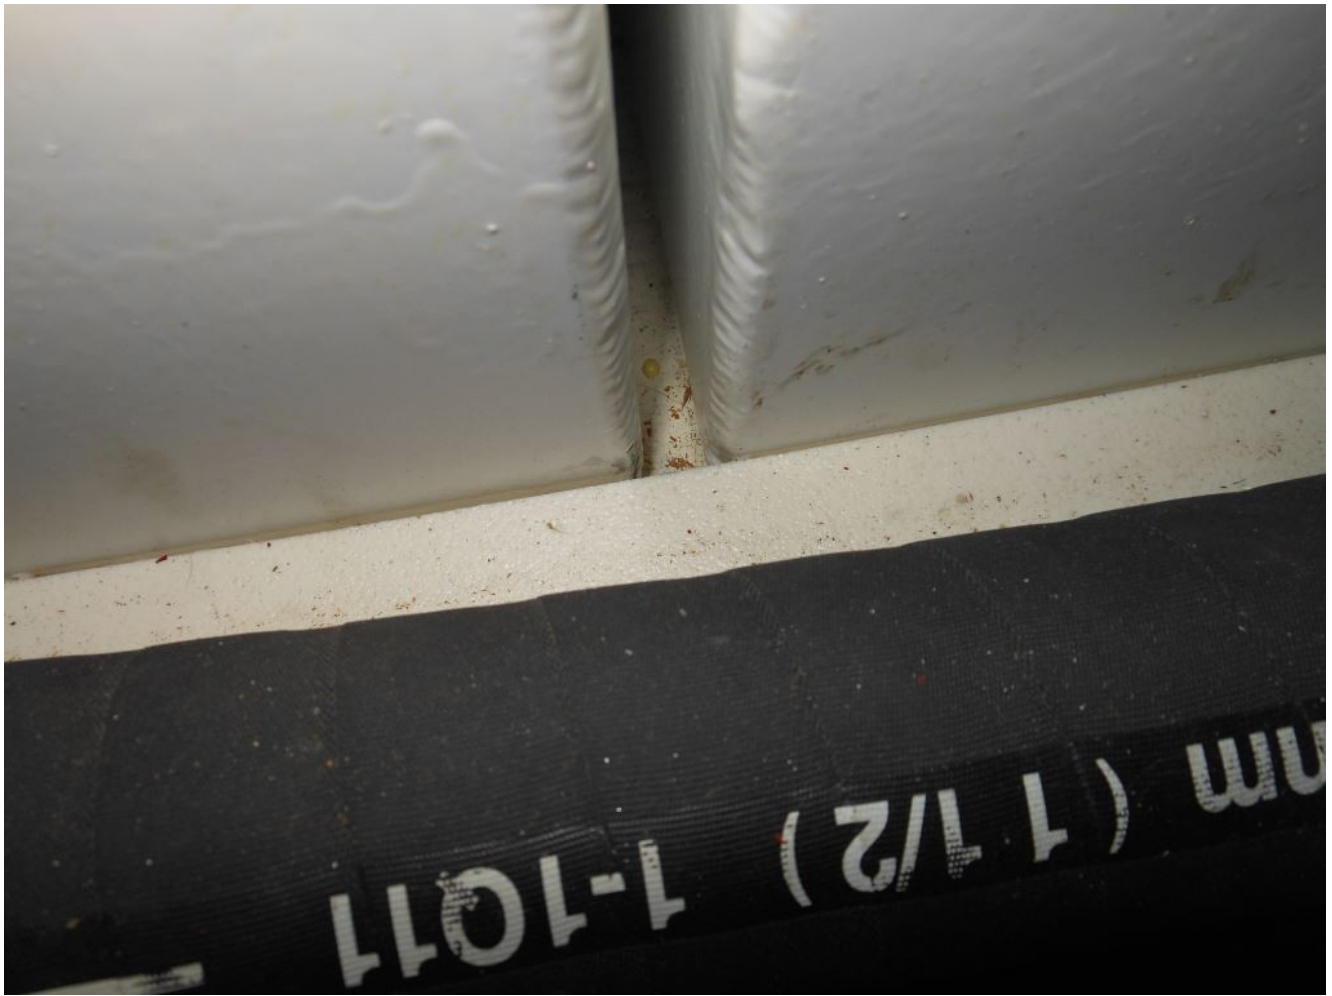
Water entrapment sounds the death knell for many metallic tanks. Gaps and voids that can retain water allow corrosion and rust to gain a toe hold, which could ultimately lead to tank failure. Tanks should never be installed directly against a surface such as a shelf or cleat like that shown here, as the small gap between the two will retain water. Tank installations should be self-draining, avoiding traps like the one shown here.

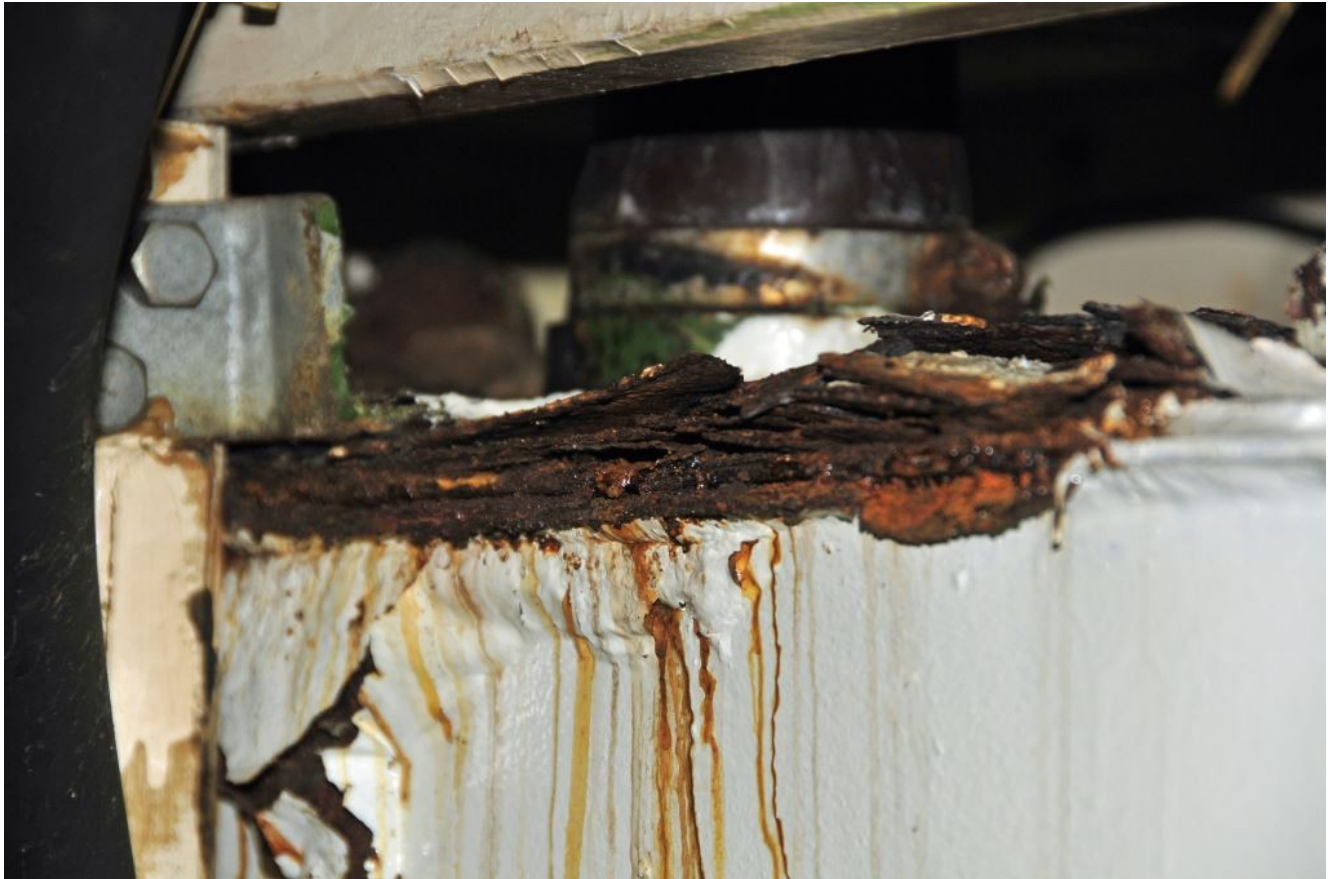
These steel tanks suffer from the classic, deck leak-induced rust and failure scenario. If the tank tops were angled they may have shed water, giving users a clue as to the impending failure. Tanks should be installed in such a way as to enable easy, casual inspection, i.e. they should remain exposed.

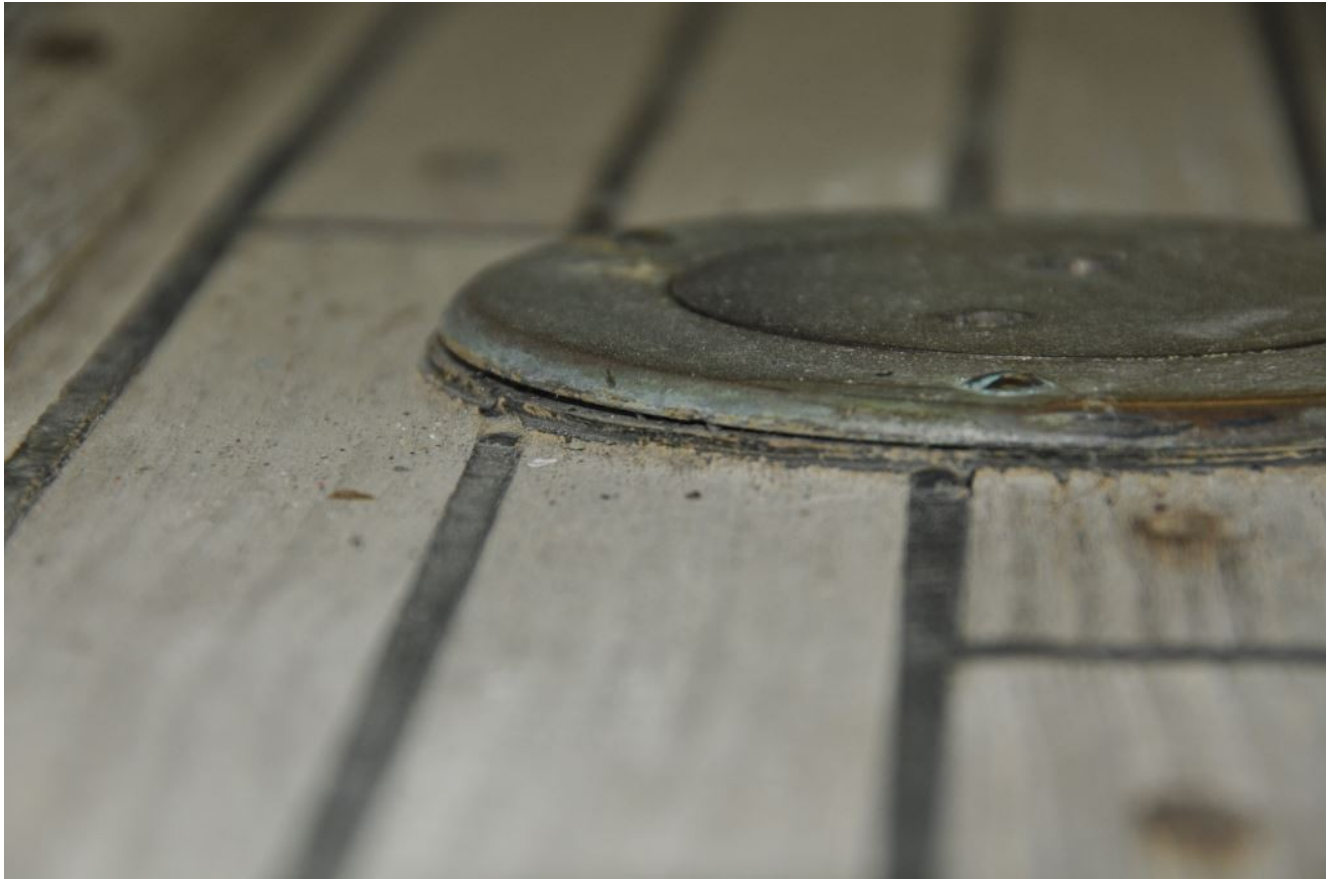
**Deck fills, in teak decks are notorious for leaking water onto tank tops. The gap between this deck fill and its bedding is clear to see. Inspect your deck fills and tank tops regularly.**

visible (such angling is required for compliance with ABYC standards). The number of tanks I've encountered that have failed from the top down, as it were, is simply astounding. Deck fuel fills are notorious for leaking water onto the tops of tanks (why deck hardware leaks, and how to avoid it, is the subject of an upcoming Marine Systems Excellence article), where it often stands, ultimately causing rust or corrosion on steel and aluminum respectively.

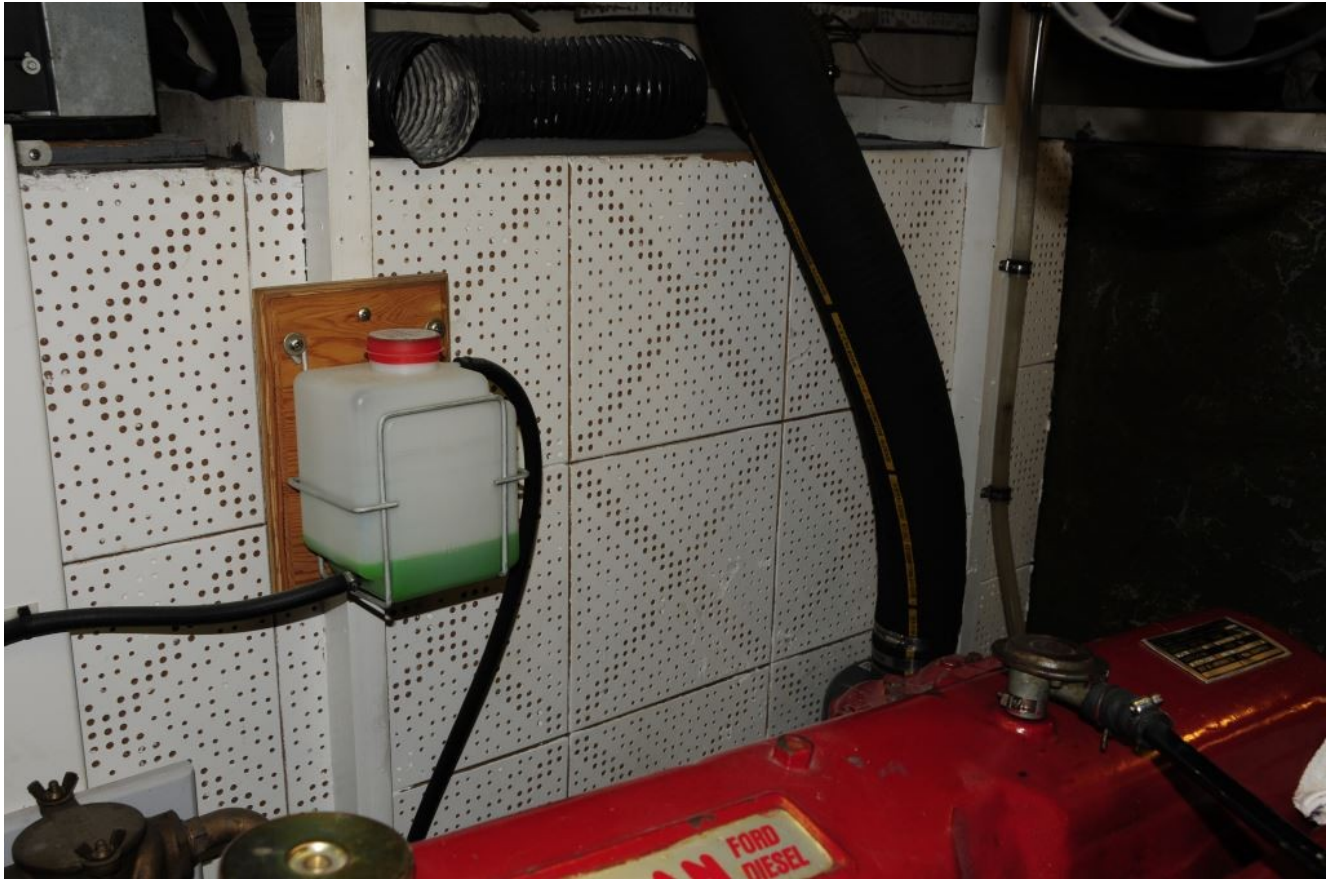
**Many boat builders cover tanks with a fascia or acoustic insulation. While that may provide a small modicum noise reduction, and it may be visually appealing (I don't believe it is, and if it is it's not worth the price paid), it prevents identification of leaks and corrosion. Tanks should remain exposed, particularly metallic tanks.**

A final note on tank installations relates to serviceability and accessibility. Once the tank is installed all “serviceable” components, fill, vent and supply fittings and senders as well as inspection ports should be accessible and ideally they should be visible as well. Covering or sheathing a tank for cosmetic or acoustic purposes is a double edged sword, it may look more attractive, to some, or it may offer (minimal of any) noise reduction in accommodation spaces, however, it also means that leaks, corrosion, deteriorating hose and other issues may go unnoticed. Given the choice, I’d rather see the tank in all its glory.

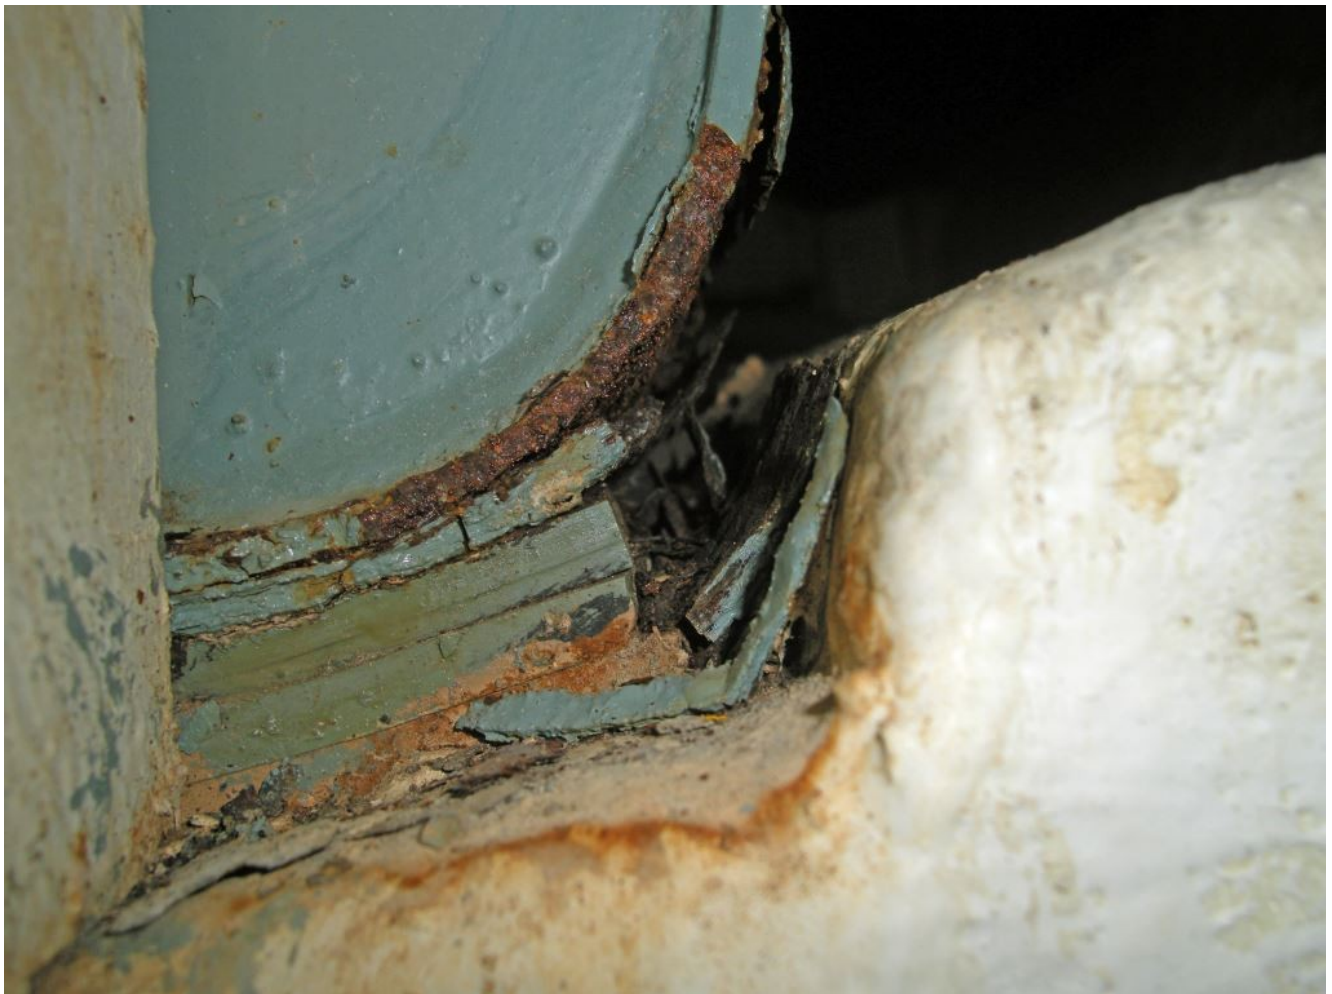
**In spite of the cushion, a strip of hard rubber, this tank rests on, it's suffering from near-terminal corrosion as a result of a deck leak. It is imperative that cushion material, regardless of what form it may take, must be bedded to the tank.**
