# January 2021 Newsletter “Fixed Fire Extinguisher Detail”

## Photo Essay: Fixed Fire Extinguisher Detail

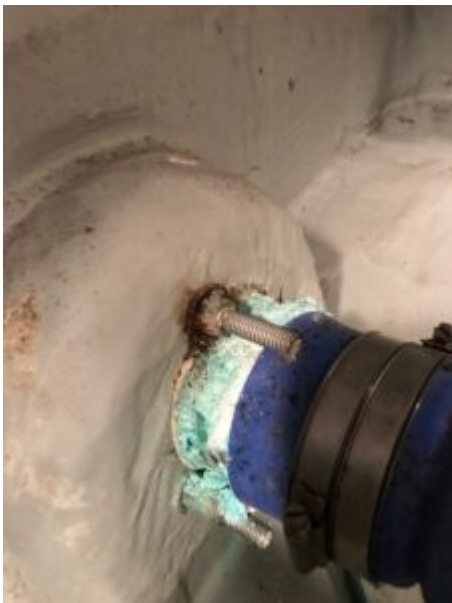
My friend Lee Anderson and I have an identical situation, shown in the photograph below. Lee's boat is a 2005 twin screw Mainship 34 and mine is a 2004 single screw Mainship 30. I have had this corrosion (?) for several years and Lee noticed his for the first time several months ago.

The green ground wire to this part is clean and securely attached to one of the 3 bolts holding the part in place in the shaft log. Zincs on the prop shaft, trim tabs and main zinc on the transom (to which all green wires terminate) are doing their job and are replaced each year. The raw water strainer for engine cooling and the smaller strainer for the A/C have a similar greenish tinge to the surface but no fuzzy material that can be removed. Both strainers have green

When you clean the area shown in the photo with a brass brush the outer fuzzy layer comes off easily but leaves a greenish patina on the fitting's surface. In a week or two the fuzzy layer re-appears and the process of removal repeats itself. The fitting itself seems to be solid but looks can be deceiving. Can you diagnose the cause of the problem and recommend ways to keep it from happening? Thank you in advance for any help you can offer.

The phenomenon you are experiencing is common, it occurs to virtually every copper-based alloy used in marine (and other) applications; the best-known example is bronze deck hardware such as ports and cleats, as well as the Statue of Liberty, copper roofs and many others. Known as verdigris, or cuprous oxide, it's both normal and harmless. Based on your photo, unless the appearance is bothersome to you, it should be of little concern. If, however, you ever see pink associated with underwater or raw water copper alloys such as bronze, that is of concern as it's an indication of another type of corrosion called dezincification, you can read more about it [here](#).

A far greater concern is the rust emanating from beneath the stainless steel through bolt. Stainless steel is a less than ideal material for use in below the waterline applications such as this. Fasteners are especially problematic since most off the shelf varieties are made from 18-8 alloy, the least corrosion-resistant of those suited for marine applications (for stainless steel, 316 is preferred). Used inside the vessel they are fine, however, they can be problematic on deck where they are prone to staining, and they should definitely

not be used for submerged applications such as this. Silicon, zinc-free bronze is a far better choice for this fastening role. For more on this subject see [this article](#).
