# July 2021 Newsletter “Vented Loop Remote Drains”

## Photo Essay: Vented Loop Remote Drains

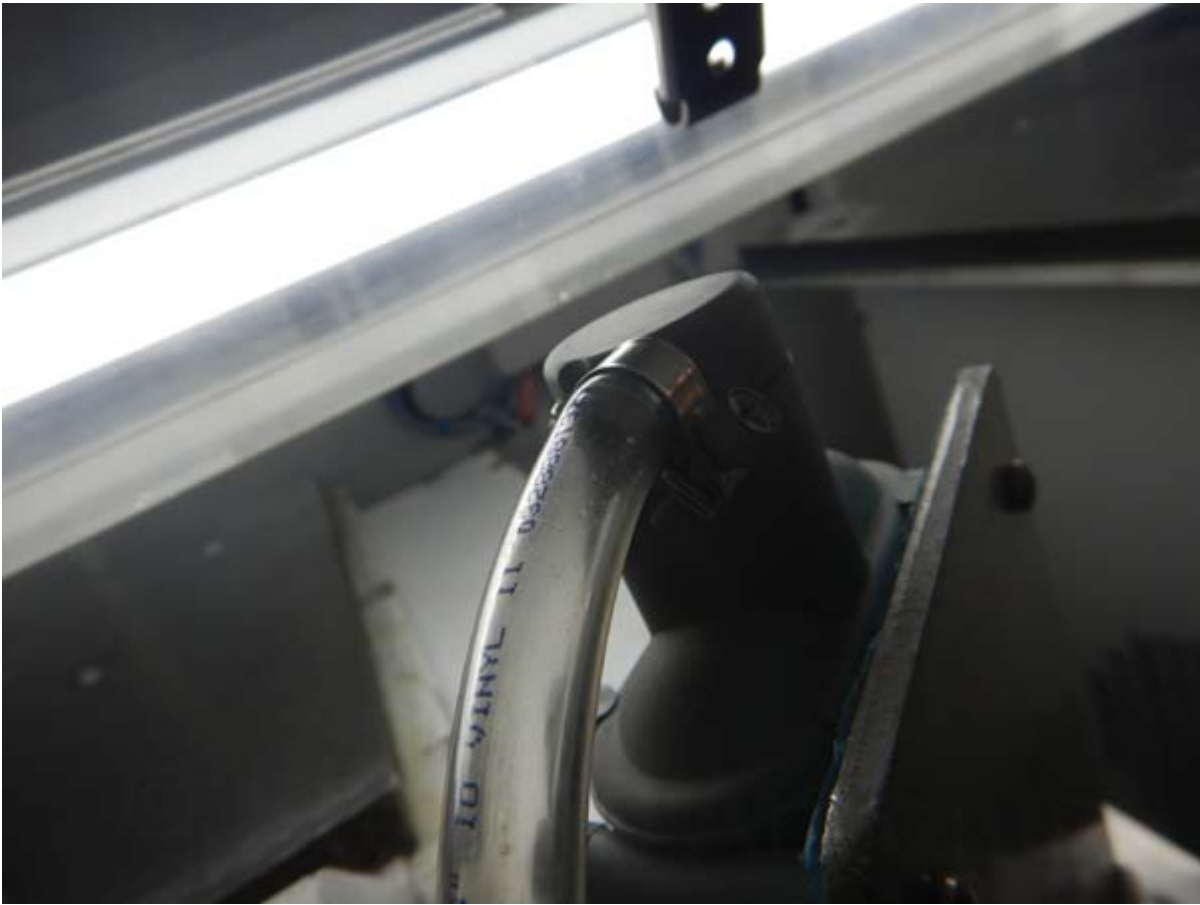
In the accompanying images, a genset vented loop remote hose has kinked. Clear PVC hose, like that which is used here, is prone to this phenomenon, especially when warm. If you choose to remotely vent a vented loop, do so using crush/kink-proof hose, such as Type A or B marine fuel hose, making sure it is routed well above bilge water and terminated in a location where you will notice leakage, which is your signal to repair or replace the vented loop or its check valve. Additionally, it's critically important that the hose be routed so that it drains completely; i.e. it must run continuously down-hill from the vent, so water, and salt, cannot accumulate within.

As simple as vented loops are, they do occasionally fail, with the most common mode being external leakage of water, and since they are often mounted above machinery, like engines and gensets, there is a natural and understandable temptation on the part of installers to fit a remote hose to the loop, most of which are equipped with a small pipe to hose adapter designed for this purpose, routing that leakage away from sensitive gear. As commendable as this effort may be, it's fraught with the potential for disaster. If, for instance, the vent hose is routed to the bilge, and the bilge accumulates water, enough to submerge the end of the hose, water, instead of air, will be drawn into the vented loop, thereby preventing it from breaking the siphon, which in turn could lead to flooding. More insidious is the kinked or crushed remote hose scenario. In that case, the hose may be routed far from bilge water, however, if air cannot pass through it, because it, once again is crushed or kinked, a siphon may be established. I've encountered both scenarios, including those that led to a flooded new genset and flooded year-old propulsion engine.

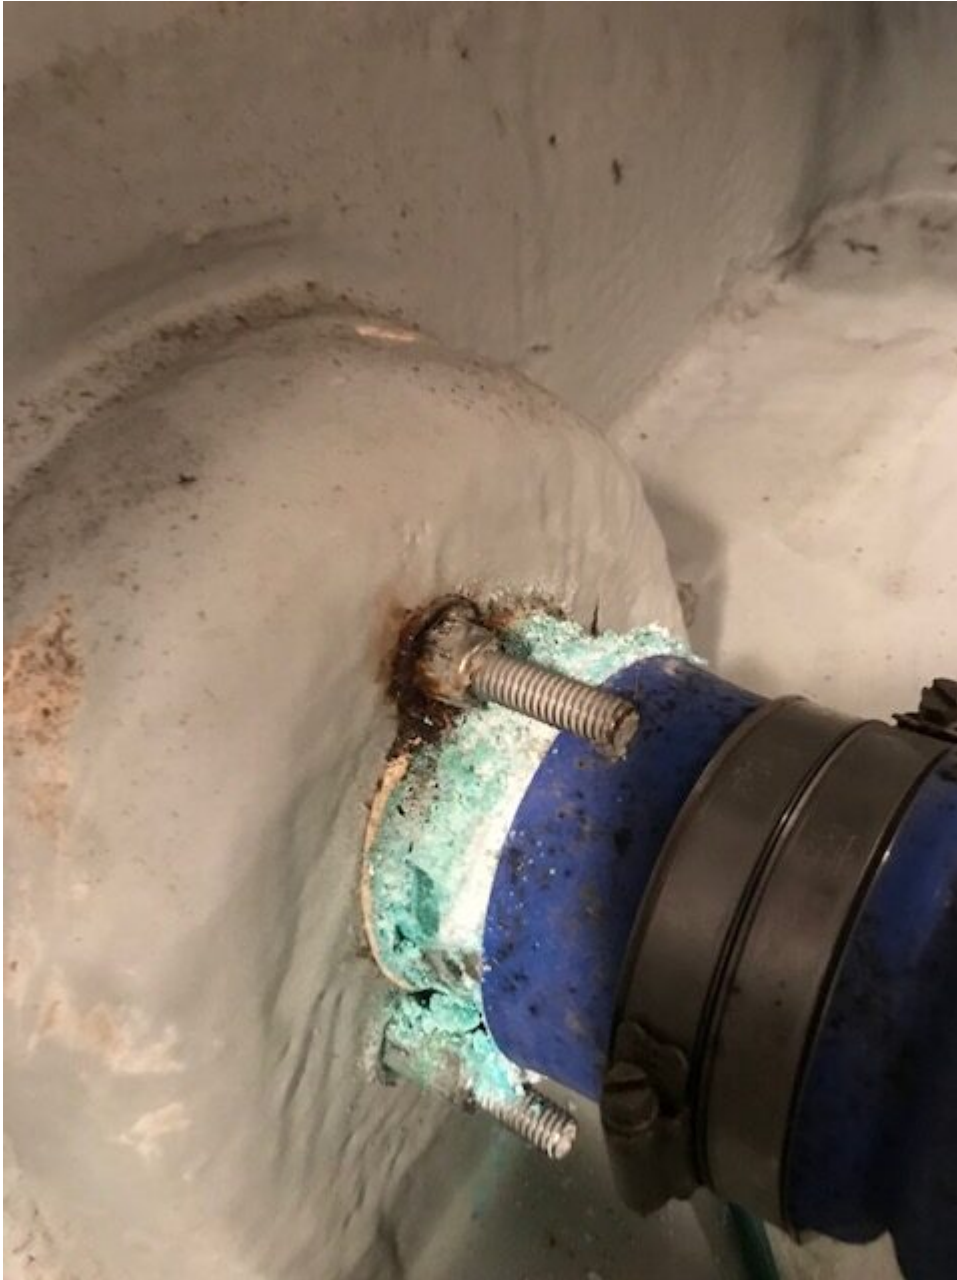
I have had this corrosion (?) for several years and Lee noticed his for the first time several months ago. The green ground wire to this part is clean and securely attached to one of the 3 bolts holding the part in place in the shaft log. Zincs on the prop shaft, trim tabs and main zinc on the transom (to which all green wires terminate) are doing their

When you clean the area shown in the photo with a brass brush, the outer fuzzy layer comes off easily but leaves a greenish patina on the fitting's surface. In a week or two the fuzzy layer re-appears and the process of removal repeats itself. The fitting itself seems to be solid but looks can be deceiving. Can you diagnose the cause of the problem and recommend ways to keep it from happening? Thank you in advance for any help you can offer.

The phenomenon you are experiencing is common, it occurs to virtually every copper-based alloy used in marine (and other) applications; the best-known example is bronze deck hardware such as ports and cleats, as well as the Statue of Liberty, copper roofs and many others. Known as verdigris, or cuprous oxide, it's both normal and harmless. Based on your photo, unless the appearance is bothersome to you, it should be of little concern. If however, you ever see pink associated with underwater or raw water copper alloys such as bronze that is of concern as it indicates another type of corrosion called dezincification, you can read more about it here.

Of far greater concern is the rust emanating from beneath the stainless steel through bolt. Stainless steel is a less than ideal material for use in below the waterline applications such as this. Fasteners are especially problematic since most off the shelf varieties are made from 18-8 alloy, the least corrosion-resistant of those suited for marine applications

(for stainless steel, 316 is preferred). Used inside the vessel they are fine, however, they can be problematic on deck where they are prone to staining, and they should definitely not be used for submerged applications such as this. Silicon, zinc-free bronze is a far better choice for this fastening role. For more on this subject see this article.
