# May 2016 Newsletter

**Photo Essay: Ring Terminal Order**

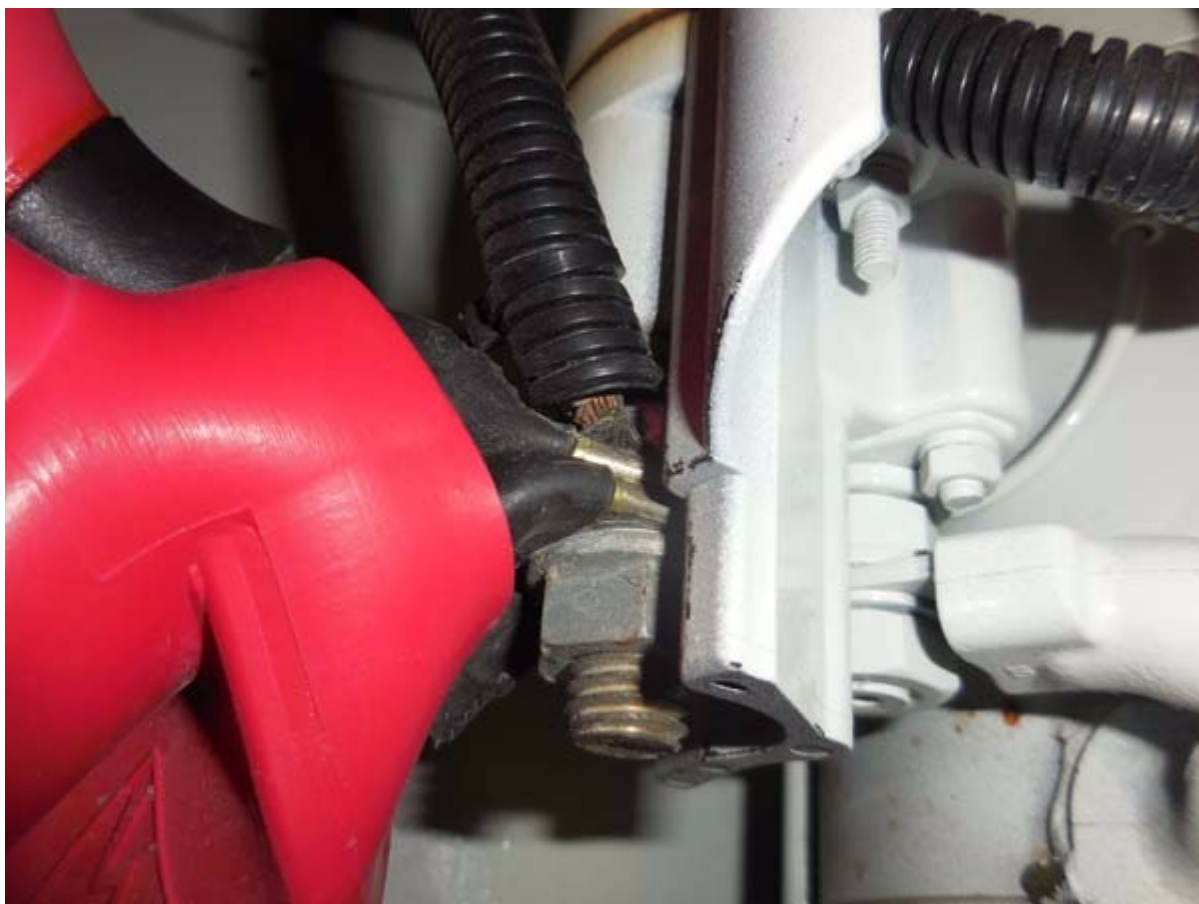
ampacity or current-carrying ability of the terminals *when stacked*. When more than one ring terminal is installed on a stud, the maximum allowable is four, the largest and therefore highest ampacity terminal must be installed first, with successively smaller, lower ampacity terminals being placed afterward. Failure to follow this protocol can lead to high resistance, which in turn leads to lower voltage supplied to the component, and heat generation.

In the example shown here, ring terminals on a starter's positive post are installed in the incorrect order, the smallest one has been installed first. This is extremely common, particularly where starters are concerned, as the engine ships from the manufacturer with one or two small ring terminals already installed on this stud, often for instrumentation, ignition and pre-heating systems. The boat builder then installs the heavy primary cable onto this stud without first removing these smaller ring terminals, establishing the potential for poor starter performance, and terminal/stud overheating.

Beyond that, however, after the terminal is attached to the wire, there are additional nuances involved in achieving a reliable, and safe electrical terminal installation. Installing a ring terminal, or multiple terminals, using screw or stud fasteners, requires that the installer understand guidelines established by the American Boat and Yacht Council (ABYC), which specifically cover this process; the first, and perhaps most important, calls for the inside diameter of the ring terminal to match the outside diameter of the fastener's shank. While that may appear self-evident, it's an all too often violated standard.

Check the positive (and negative if it's an isolated ground unit) starter post on your starter for this insidious problem.
