# May 2024 Newsletter – Not A Cord Grip

## Photo Essay: Not a Cord Grip

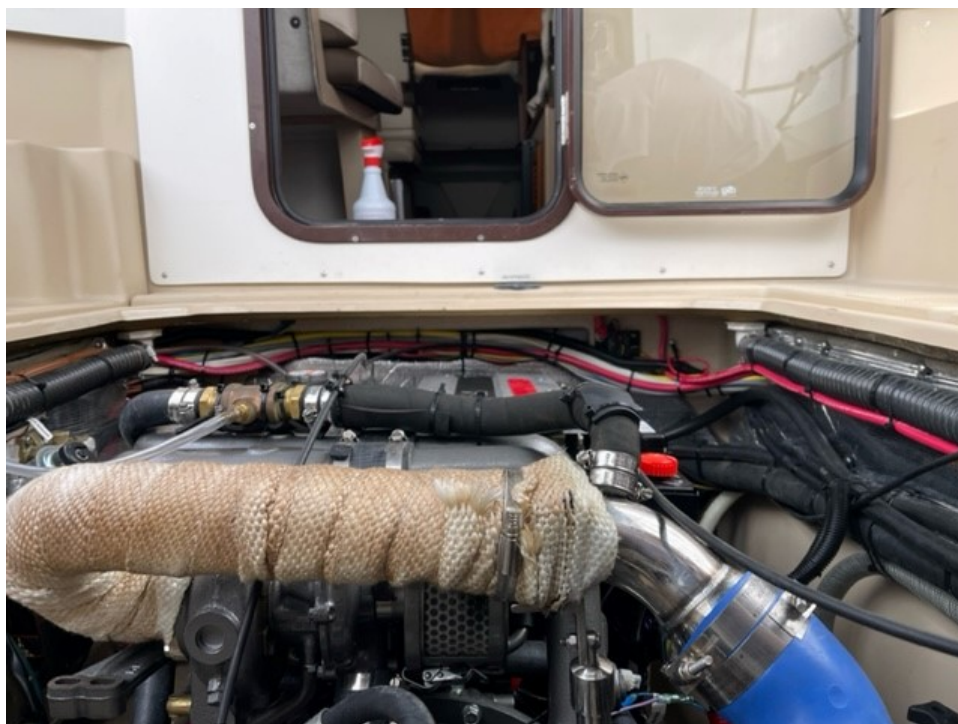
I am looking for help and advice on my boat's newly installed exhaust system. This year I had my 25' Ranger Tug re-powered and I am concerned about the placement of the mixing elbow water injection. See picture. Looking at the picture, it appears to me that the design is marginal and there is a possibility of water backing up into the turbo.

I would suspect while the engine is running that the exhaust system would work fine. However, when starting or stopping the engine if there is any water in the upper elbow and the boat is listing to port or rocking water could enter the turbo.

Based on the photo alone, which is not necessarily definitive, the down angle of the mixing nozzle does not look abnormal. Many engine manufacturers specify a required minimum angle where water is injected into the exhaust gas stream, John Deere's is 25 degrees, Cummins' is 15 degrees. I'm not certain if Yanmar provides such a specification, however, if they do then using a digital level I'd confirm this installation meets that requirement (and in the absence of a Yanmar spec, I'd say 15 deg. would be the minimum). Additionally, the highest point of the riser must be a minimum specified distance above the waterline, which again is specified by the engine manufacturer. There's no way to know what that is from the photo, however, this should be checked. Again, my observation is purely anecdotal based on the photo.

There are four other observations worth sharing. The first, the insulation covering the dry exhaust section appears to be inadequate. At full throttle, under load, the surface of that insulation should not exceed 200 degrees Fahrenheit. I'd prefer to see a purpose-made insulation wrap or blanket that can be easily removed for inspection. More on exhaust system

The second, unless it's beyond the frame, I do not see a wet exhaust temperature alarm sensor. These are typically strapped to the exhaust hose immediately after the mixing elbow, the blue silicone hose in your case. This is an ABYC requirement, it will alert you to a pending overheat scenario long before any damage occurs. More on those here.

The third, what looks like shift and throttle cables are routed close to, if not touching the exhaust. These cables should be routed away from the exhaust, especially the dry exhaust section.

The fourth, there is a bronze T installed in the raw water injection hose, laying on top of the engine, to which a clear PVC hose has been attached. I'm not certain what the clear hose is used for (stuffing box injection perhaps, or is it an anti-siphon device?), however, it is not rated for raw water applications.

Finally, in cases of repowers, my recommendation is that installers be tasked by having them to agree to all relevant ABYC Standards, as well as engine manufacturer installation requirements.
