October 2021 Newsletter

“Steering”

Photo Essay: Steering

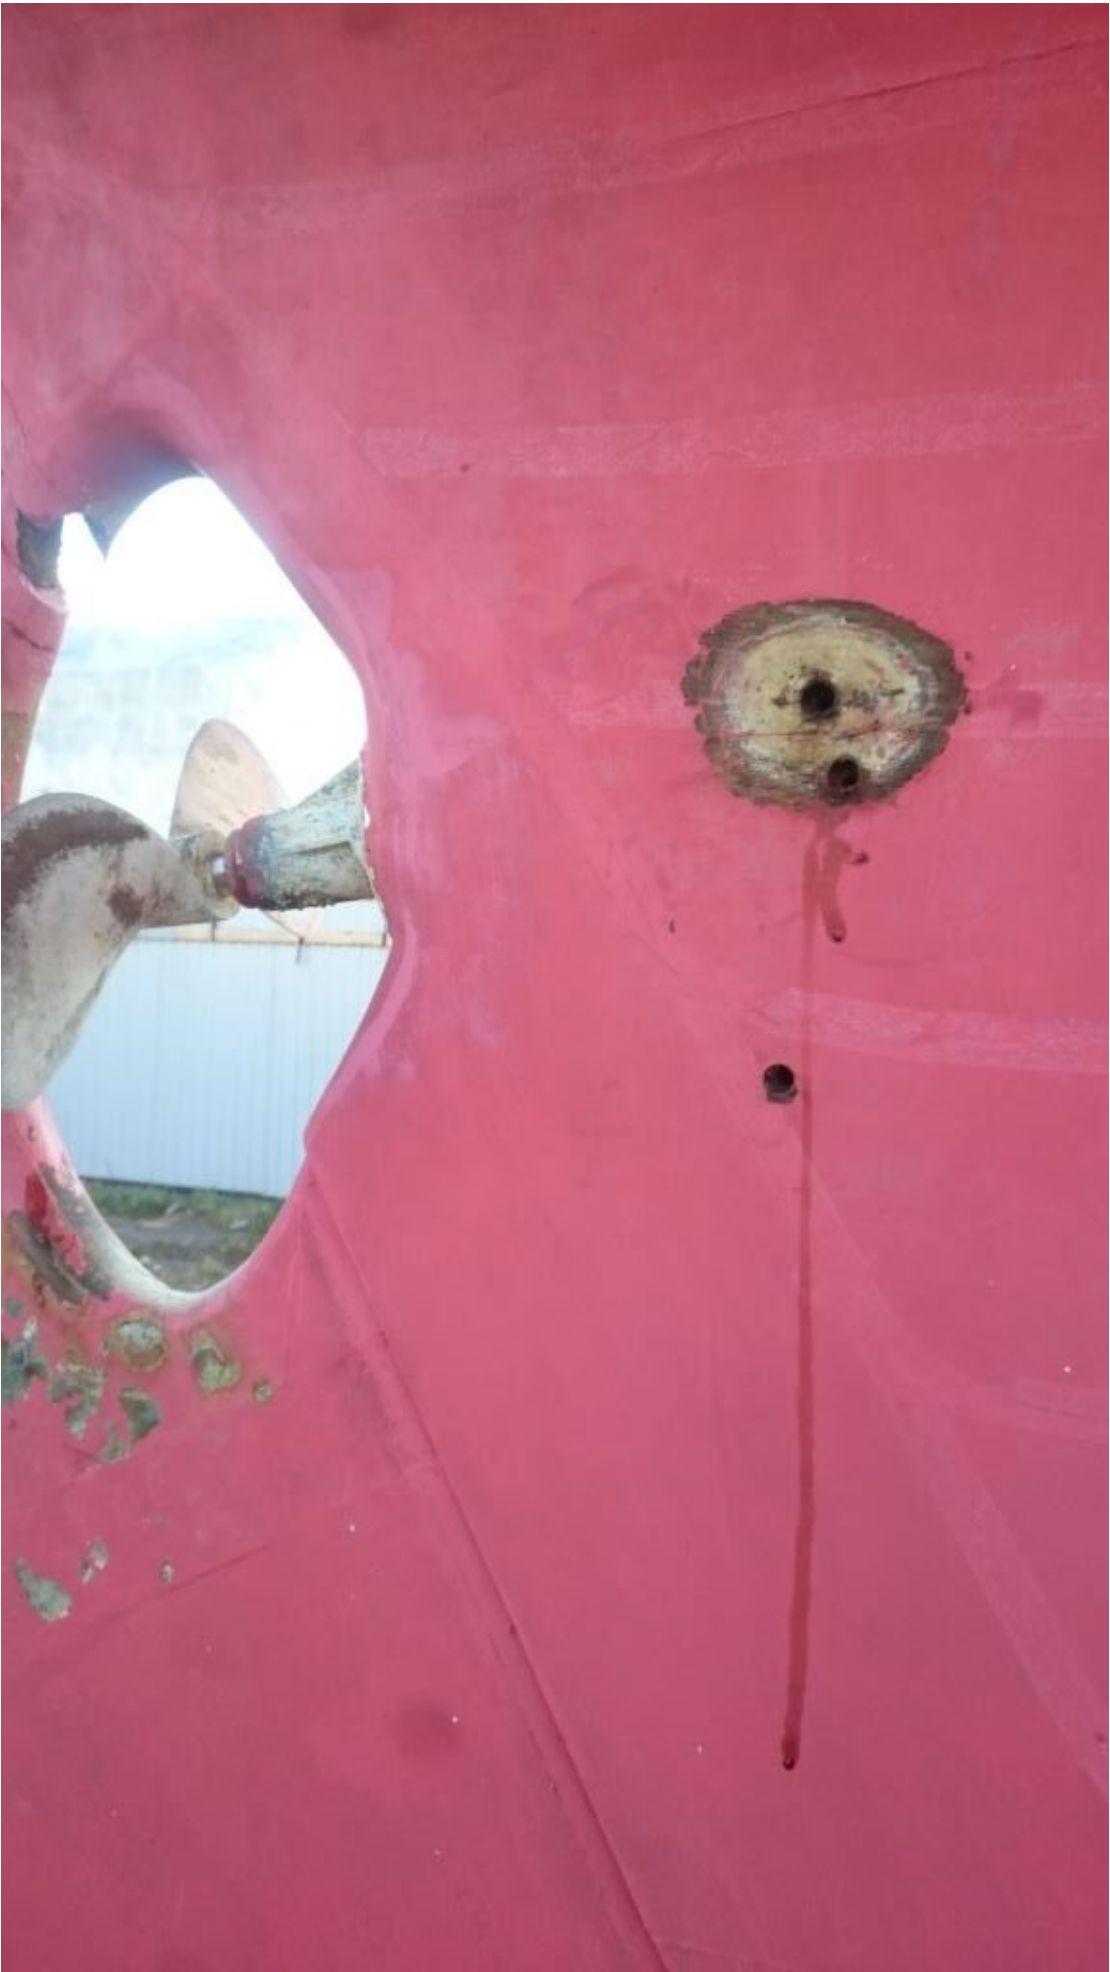
The case is as follows: When the boat was lifted out of water in fall 2016 there was a white round area with a diameter of about 20 centimeters (8 inches, 200 mm) at the stern planking close to stern tube, which proved to be contaminated wood caused by electrical current (photo attached).

First, it is generally accepted, at least here in the States, that it is more harmful than helpful to bond a timber vessel. Bonding systems that are connected to anodes produce an alkaline solution at the cathode, the protected metal. I believe you alluded to some of that damage, and it's shown in your photos. The process is known as delignification, wherein the lignin, the pulp between wood grain, is damaged by the alkaline. This can be accelerated by stray current, and it seems as if that's what you've experienced.

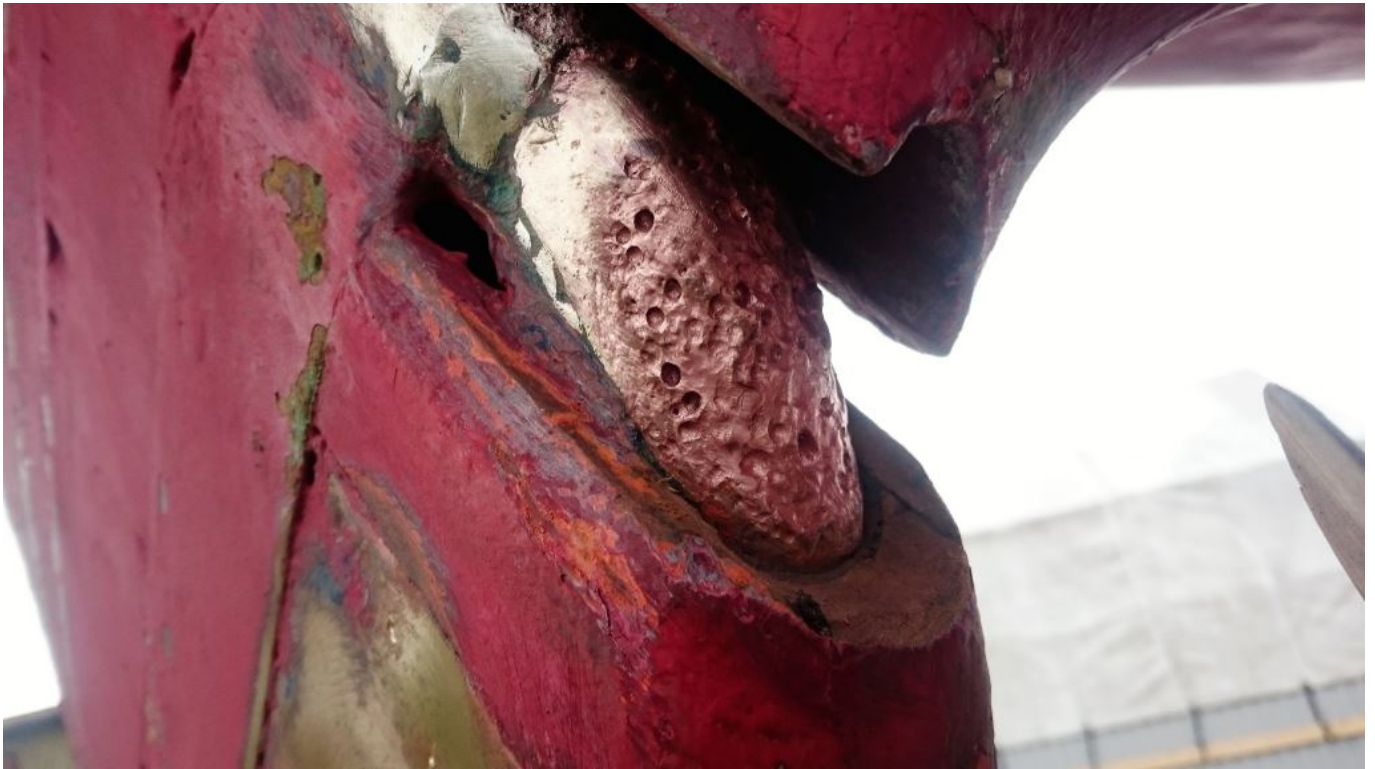
Severe damage had occurred at the 4-5 mm inch equivalent bronze plates that strengthen the rudder around the propeller opening. At the front edge closest to the propeller some 1 cm inch equivalent of the plate had totally disappeared and a wider area corroded (photo attached).

The photos of the stern tube, and rudder plates indicate to my eye that these have a high zinc content, i.e. they are very yellow and thus appear to be brass rather than bronze. Because of its susceptibility to a process known as dezincification, brass (with a zinc content over 15%, less is preferred) should never be used in below the waterline applications. Thus, regardless of the presence of stray current or not, use of this alloy is problematic. For more on this subject see this article.

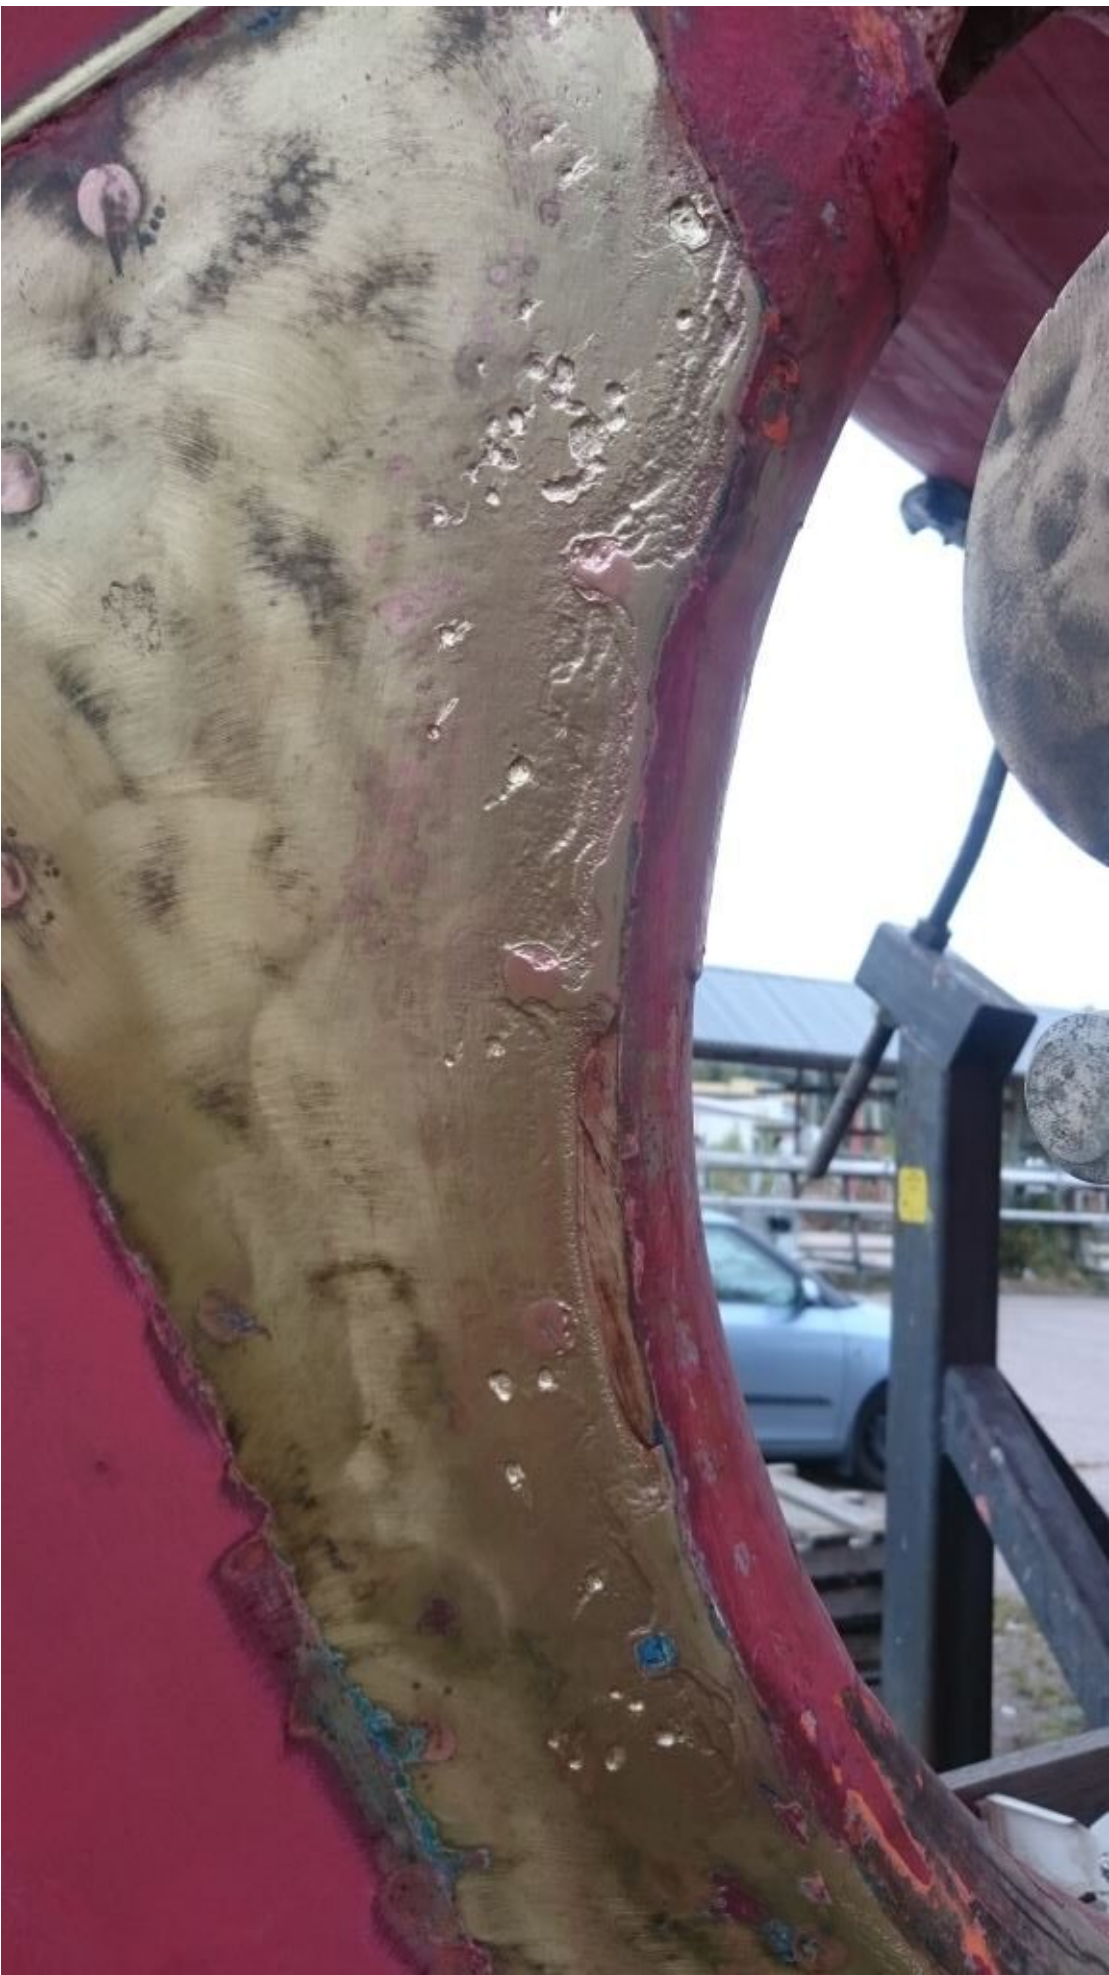
An even more severe damage was on the rudder shaft, at the bend where it turns inside the wooden rudder. The shaft material is called delta-metal containing 54-59 % of copper. 39-42 % of zinc. 1-1,5 % of iron and 0,2-0,5 % of lead. In the picture attached I have cleaned that area and it shows the copper left when the other metals have corroded away. Fortunately the "wings" that turn the rudder higher on the shaft and the shaft itself outside that area were undamaged so this is not a structural problem. The corroded area does not go deep inside the shaft.

The ruder shaft corrosion, again because of its pink color, is indicative of dezincification. However, the aggressive pitting is also indicative of stray current corrosion. In addition to ensuring the vessel's wiring is sound and free of obvious leaks into bilge or the surrounding water, there are several tests that should be carried out, the most important of which is a reference electrode test, more on that here. Using a silver silver-chloride reference cell, the protection level of various underwater metals can be tested. If they are bonded then the test would be conducted on the bonding system, otherwise they would be tested individually. Clearly the voltage measured between the engine and rudder is concerning, its source must be identified and stemmed.
