October 2021 Newsletter

“Steering”

Photo Essay: Steering

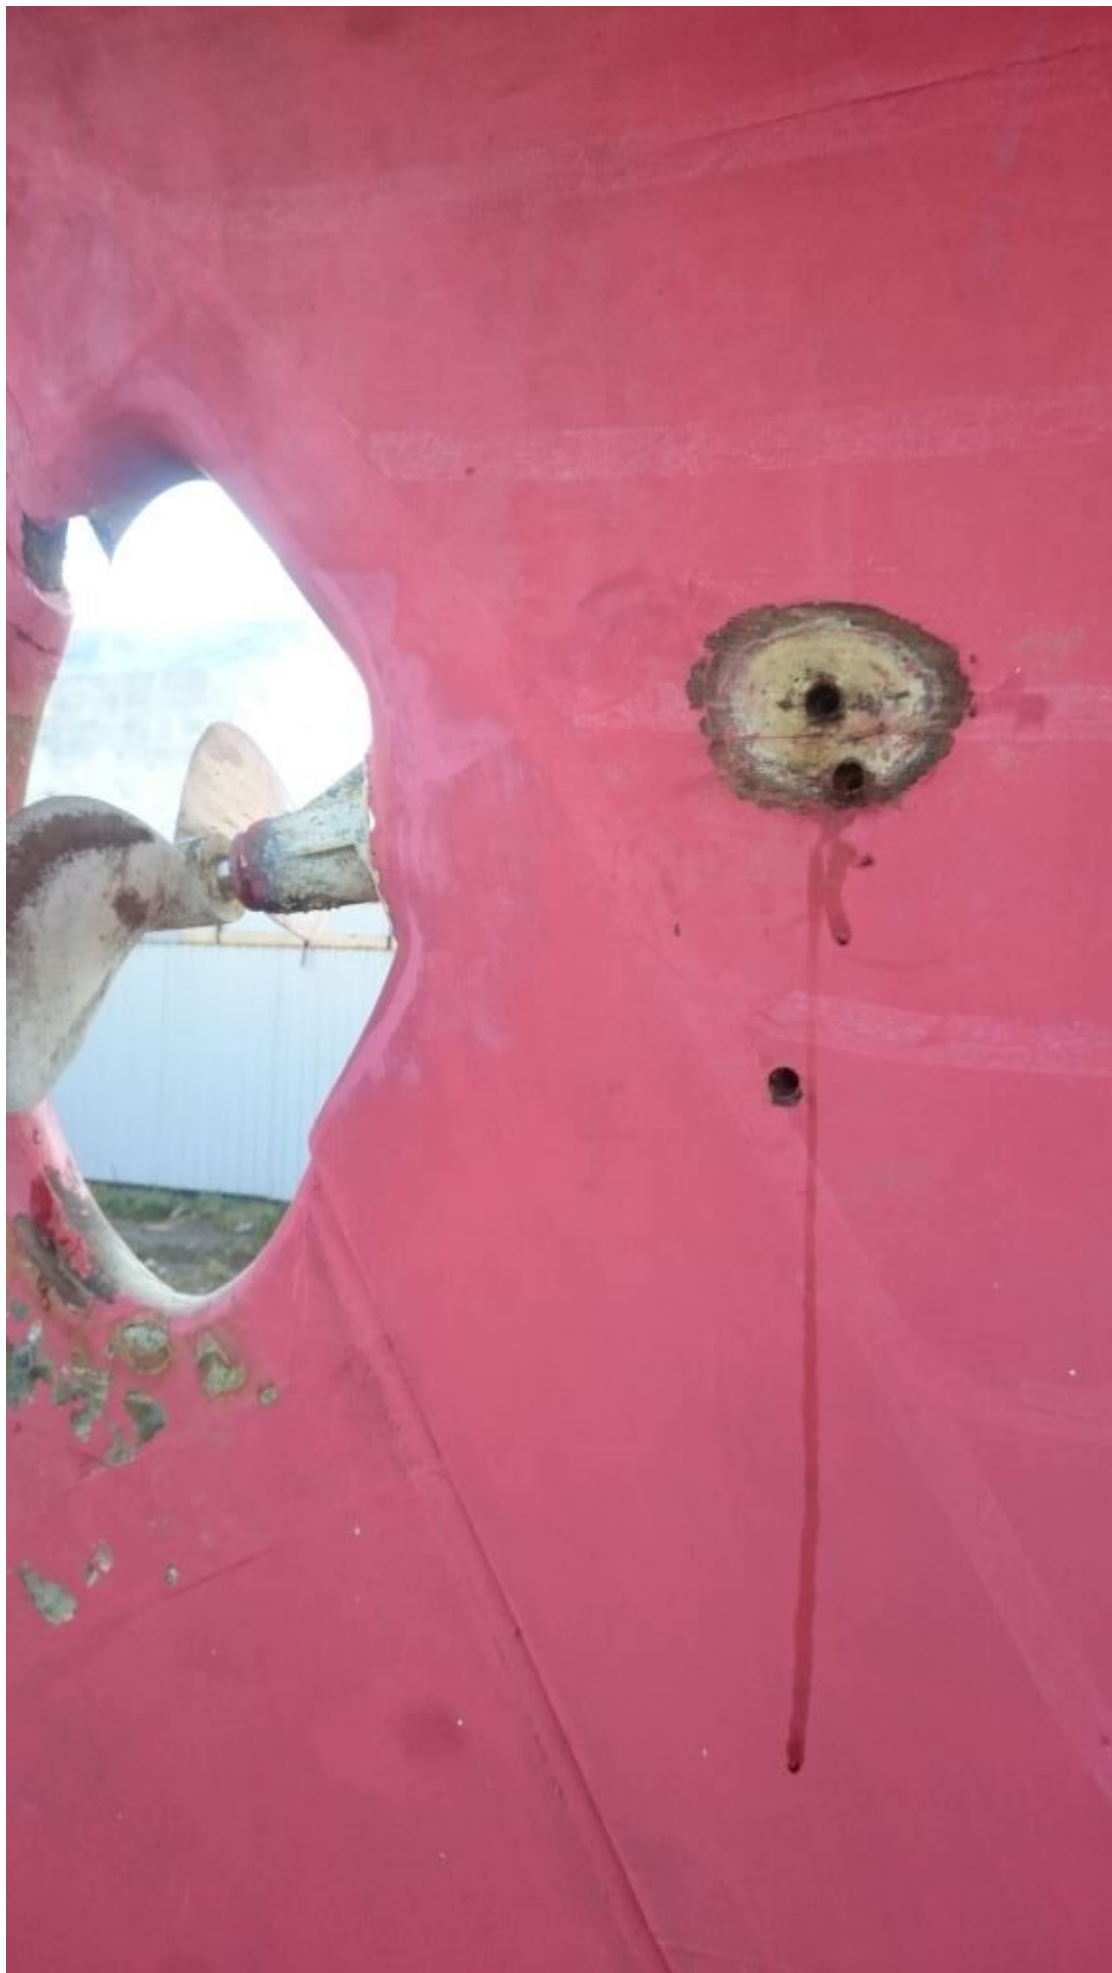
The case is as follows: When the boat was lifted out of water in fall 2016 there was a white round area with a diameter of about 20 centimeters (8 inches, 200 mm) at the stern planking close to stern tube, which proved to be contaminated wood caused by electrical current (photo attached).

First, it is generally accepted, at least here in the States, that it is more harmful than helpful to bond a timber vessel. Bonding systems that are connected to anodes produce an alkaline solution at the cathode, the protected metal. I believe you alluded to some of that damage, and it's shown in your photos. The process is known as delignification, wherein the lignin, the pulp between wood grain, is damaged by the alkaline. This can be accelerated by stray current, and it seems as if that's what you've experienced.

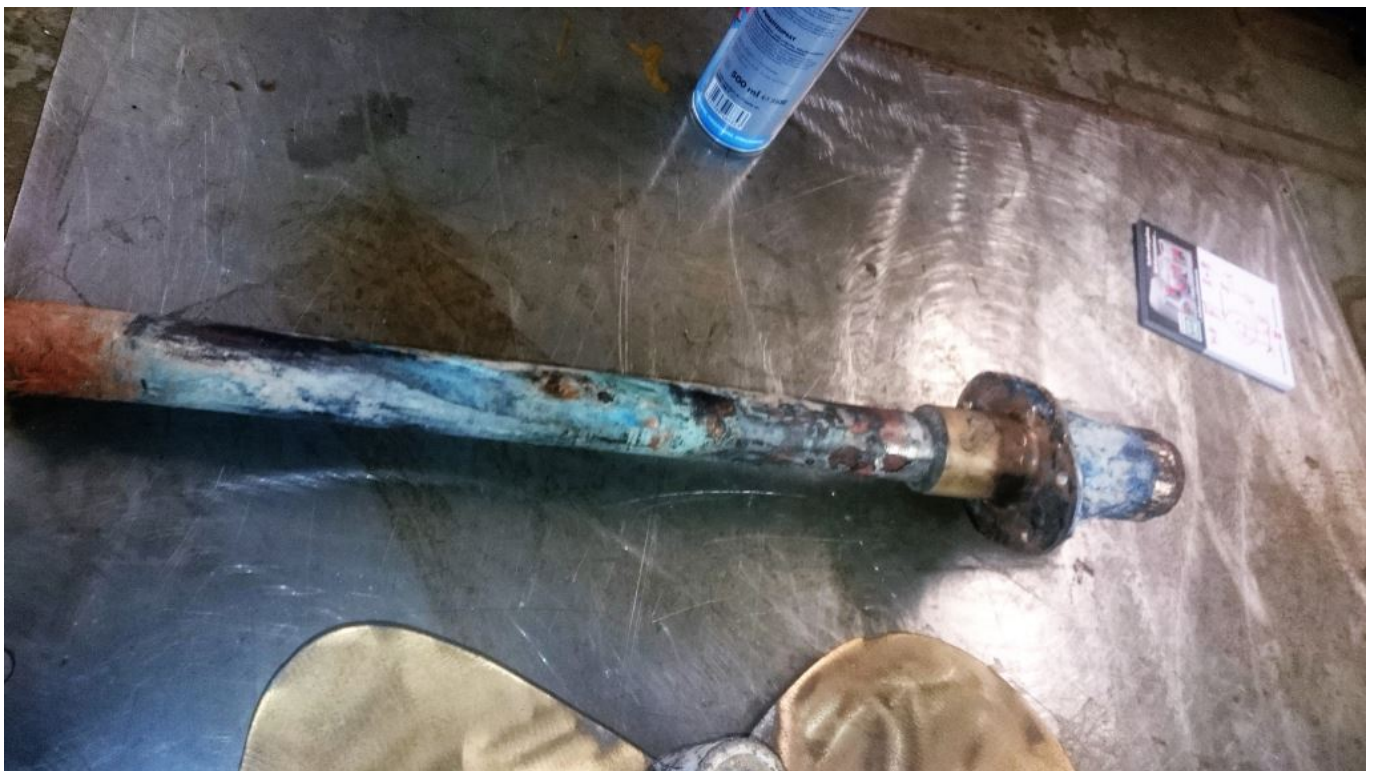
When I unscrewed one of the silicon bronze screws at that place, some water started running out of the hole. The tip of the screw was bright and a bit bended, it had been in direct contact with the bronze stern tube. I tested the stern tube for leaks, and it showed out that there was a hole in the stern tube at the place where there had been a contact with the screw. At the bronze propeller there was some pitting, or very small bubbles and underneath of those the bronze had turned to red copper. (Attached is a photo of the badly corroded stern tube after we took it out to replace with a new. You see also part of the propeller after it has been cleaned – no severe corrosion there.)

The photos of the stern tube, and rudder plates indicate to my eye that these have a high zinc content, i.e. they are very yellow and thus appear to be brass rather than bronze. Because of its susceptibility to a process known as dezincification, brass (with a zinc content over 15%, less is preferred) should never be used in below the waterline applications. Thus, regardless of the presence of stray current or not, use of this alloy is problematic. For more on this subject see this article.

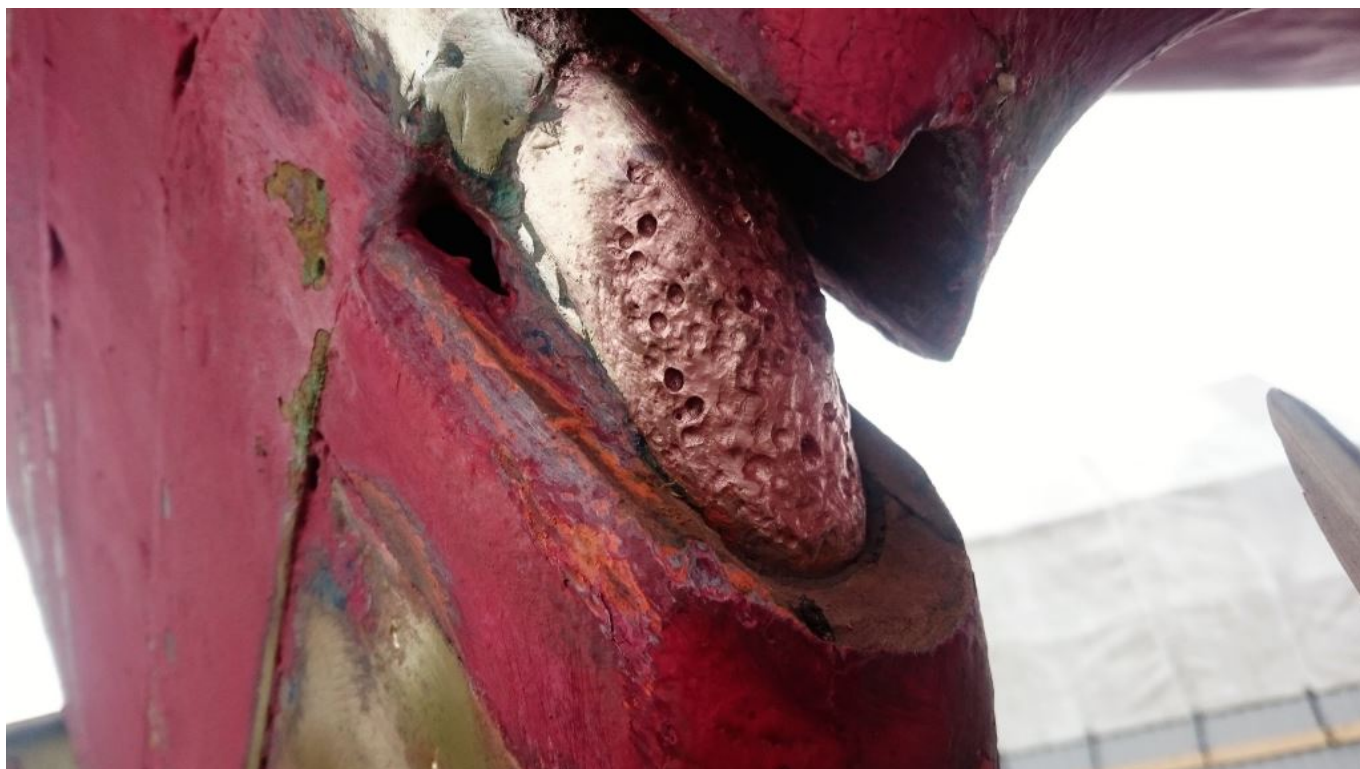
Severe damage had occurred at the 4-5 mm inch equivalent bronze plates that strengthen the rudder around the propeller opening. At the front edge closest to the propeller some 1 cm inch equivalent of the plate had totally disappeared and a wider area corroded (photo attached).

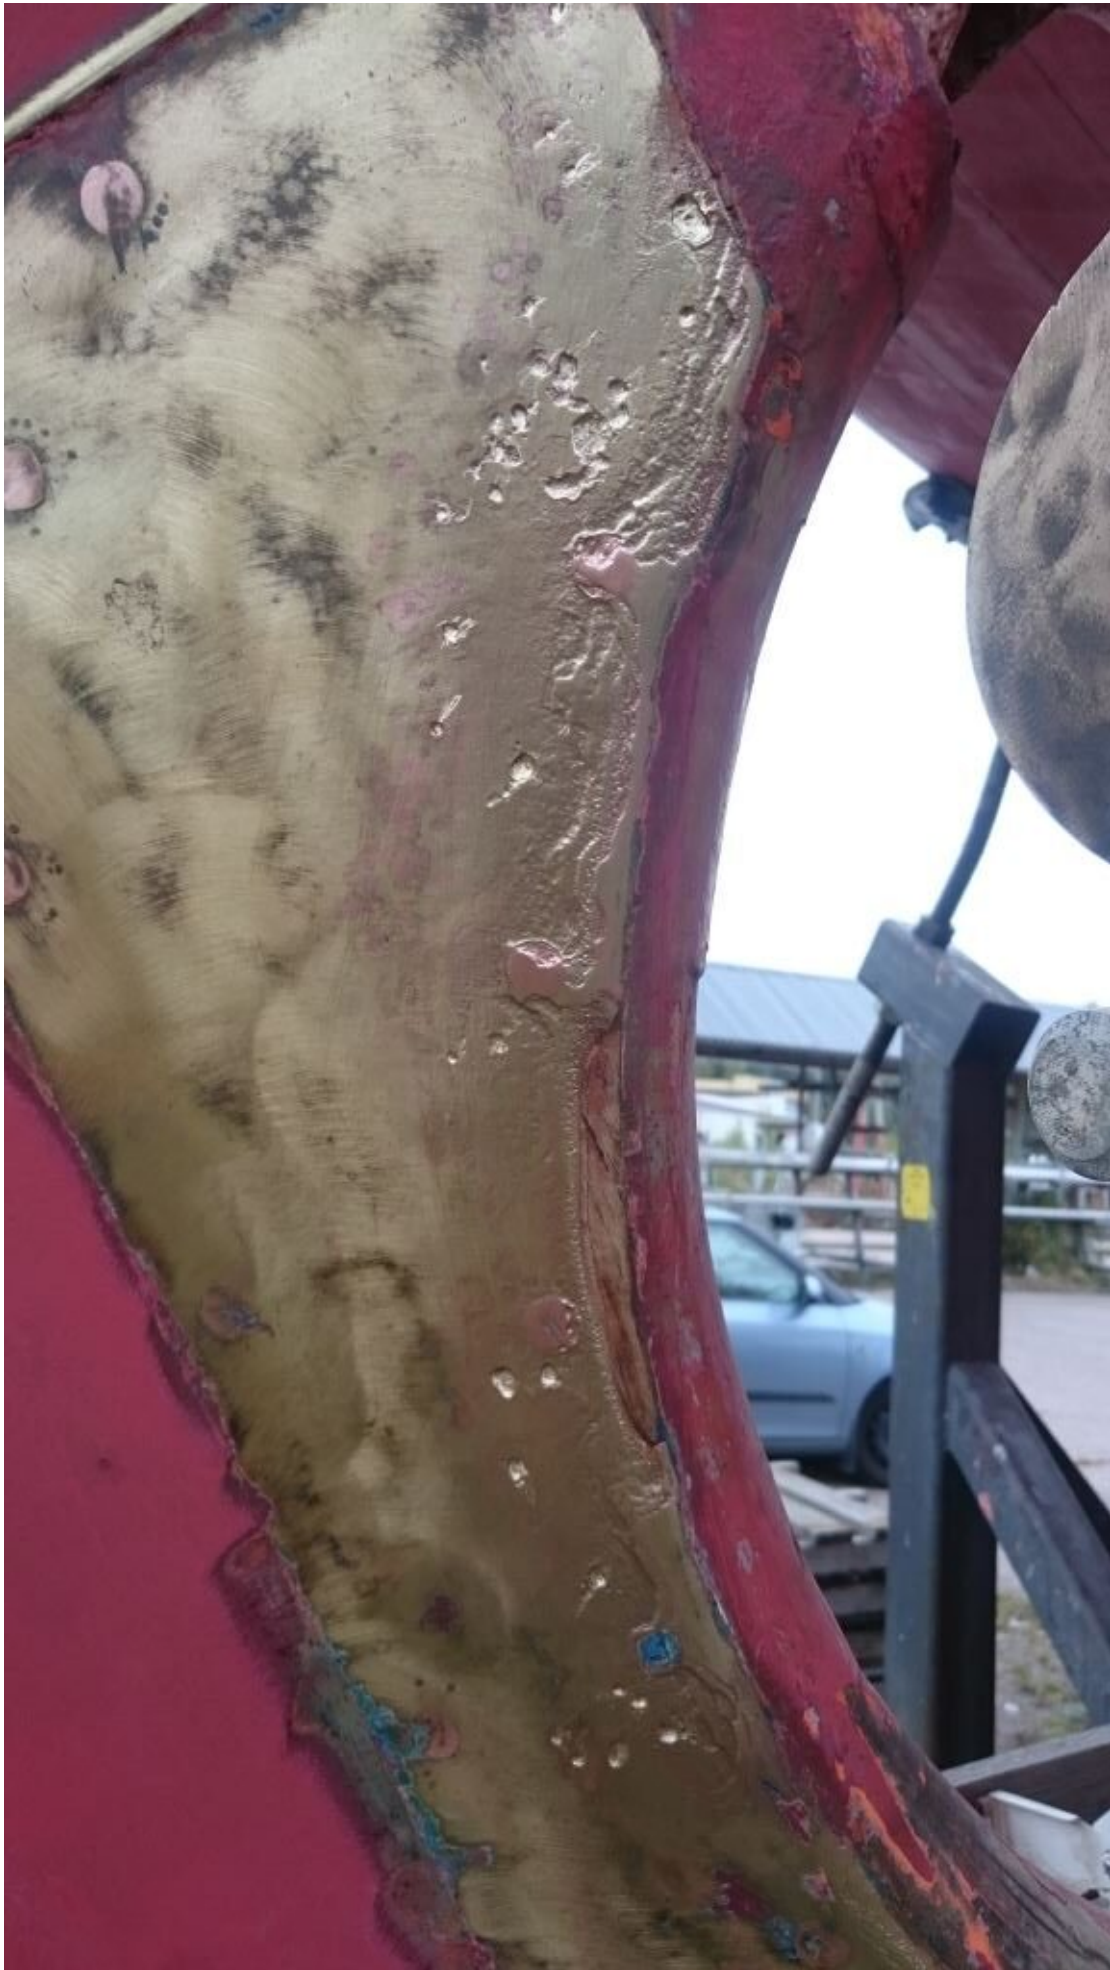
An even more severe damage was on the rudder shaft, at the bend where it turns inside the wooden rudder. The shaft material is called delta-metal containing 54-59 % of copper. 39-42 % of zinc. 1-1,5 % of iron and 0,2-0,5 % of lead. In the picture attached I have cleaned that area and it shows the copper left when the other metals have corroded away. Fortunately the "wings" that turn the rudder higher on the shaft and the shaft itself outside that area were undamaged so this is not a structural problem. The corroded area does not go deep inside the shaft.

The ruder shaft corrosion, again because of its pink color, is indicative of dezincification. However, the aggressive pitting is also indicative of stray current corrosion. In addition to ensuring the vessel's wiring is sound and free of obvious leaks into bilge or the surrounding water, there are several tests that should be carried out, the most important of which is a reference electrode test, more on that here. Using a silver silver-chloride reference cell, the protection level of various underwater metals can be tested. If they are bonded then the test would be conducted on the bonding system, otherwise they would be tested individually. Clearly the voltage measured between the engine and rudder is concerning, its source must be identified and stemmed.
