Paint and Aluminum – How to Ensure a Good Mix

Ensuring the Longevity of Paint When Applied Over Aluminum Components

April 2011

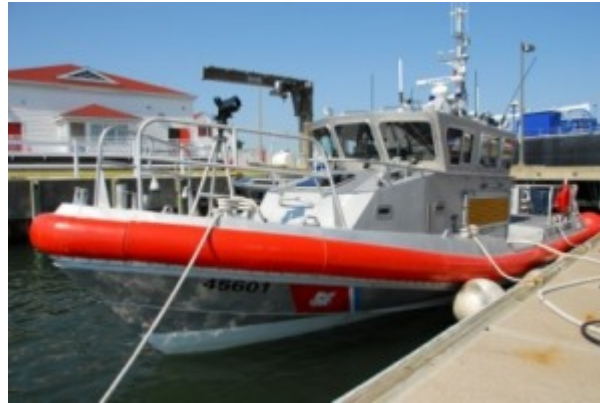
When left uncoated, aluminum is, with some caveats, naturally corrosion resistant

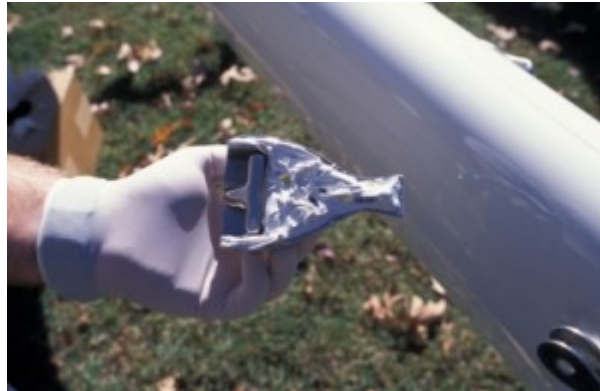
Liberal bedding all hardware that is installed on painted aluminum surfaces with a polyurethane bedding compound will, for the most part, prevent the paint failure from occurring

The solution to this problem takes on just one form, prevention. Once the corrosion has set in any paint that has already blistered or lifted is doomed, it must be removed and spot repaired or the entire structure must be repainted. Preventing the problem is exceptionally easy, each and every piece of hardware, every screw and fastener must be bedded in a high quality polyurethane or polysulfide bedding compound. The painted surface and the hardware should each be cleaned and degreased using 3M General Purpose Adhesive Cleaner or mineral spirits. Then, apply bedding compound to the surface that will make contact with and likely "break" the paint coating. Fastener threads should also be cleaned and coated, this will prevent galvanic corrosion and the subsequent seizure of the fastener threads. Install the hardware, wipe excess sealant and clean using the

aforementioned product. The sealant will fill paint breaches that occur when the hardware is torqued, preventing water entry and the subsequent pultice corrosion.

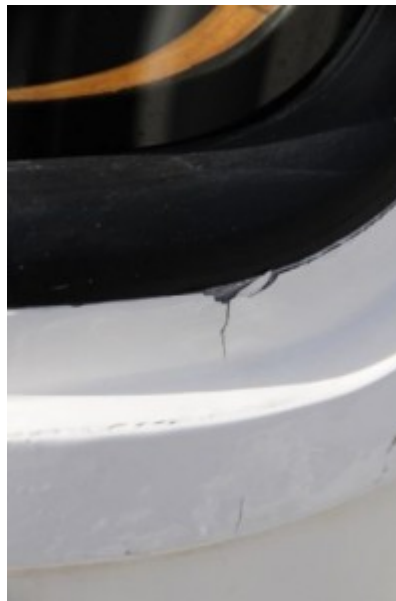
Sharp edged designs have difficulty holding sufficient paint thickness, which ultimately exposes the aluminum, which in turn leads to water migration under the coating

If the paint is breaching because of “sharp edge failure”, the solution to this problem is a redesign or modification of the assembly, aluminum surfaces over which paint is applied should be rounded or radiused to prevent thin coating areas. Sharp corners, points or edges must be eliminated.
