# Paint and Aluminum – How to Ensure a Good Mix

## Ensuring the Longevity of Paint When Applied Over Aluminum Components

April 2011

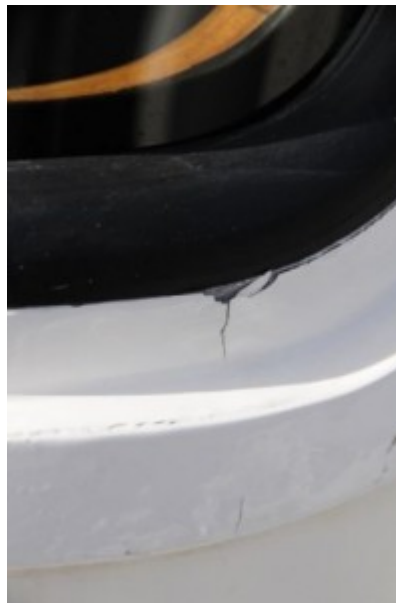
**Sharp edged designs have difficulty holding sufficient paint thickness, which ultimately exposes the aluminum, which in turn leads to water migration under the coating**

If the paint is breaching because of “sharp edge failure”, the solution to this problem is a redesign or modification of the assembly, aluminum surfaces over which paint is applied should be rounded or radiused to prevent thin coating areas. Sharp corners, points or edges must be eliminated.
