# Paint and Aluminum – How to Ensure a Good Mix

## Ensuring the Longevity of Paint When Applied Over Aluminum Components

April 2011

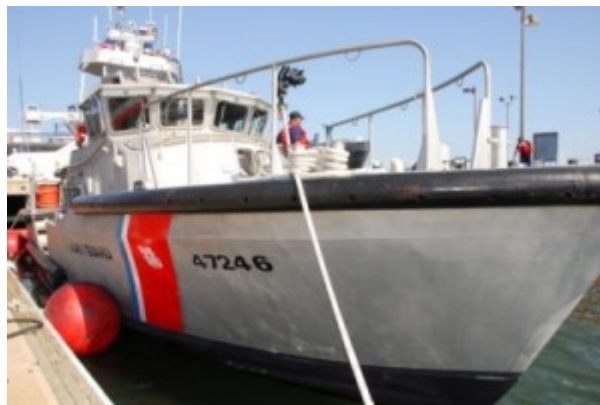
**Military, commercial, scientific and a few recreational vessels built using aluminum alloy often utilize the un-painted approach, and with good reason**

The next time one passes your way, take a close look at the US Coast Guard's heavy weather rescue vessel, the venerable 47-foot Motor Life Boat or MLB. Or, any of their other aluminum response craft including the very latest 45-foot Response Boat Medium or RBM, one of which I recently sea trialed (its all electronic control system utilizes a joy stick rather than helm wheel, which is perfect for today's teenage recruits). Check out the paint job on these aluminum vessels. What you'll notice is, other than the familiar diagonal red, white and blue Coastie stripe and bottom antifoulant, these vessels are un-painted. Although the Coast

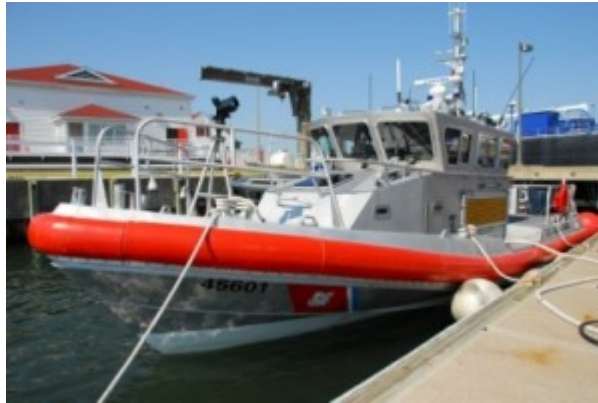
**When left uncoated, aluminum is, with some caveats, naturally corrosion resistant**

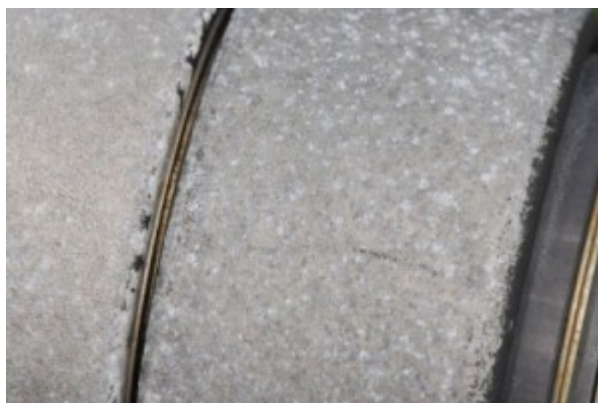
**While the natural state aluminum is desirable from a corrosion point of view, many believe the appearance less than attractive**

The drawback to this chemical process is the appearance; left to its own devices aluminum also develops shallow pits and a gritty, powdery texture. The byproduct of aluminum's exposure to oxygen is alumina or aluminum oxide, the grit or powder, which acts as a passivation layer. In and of itself this material isn't harmful and the process is somewhat self-arresting, unless it's abraded or cleaned away, at which point it begins anew. The abrasiveness of aluminum oxide should not be underestimated; it's used in the production of sanding media as its hardness is second only to that of diamonds. Every effort should, therefore be made to prevent it coming in contact with glass, paint, varnish and other sensitive surfaces. Never dry wipe one of these surfaces if contaminated with aluminum oxide.

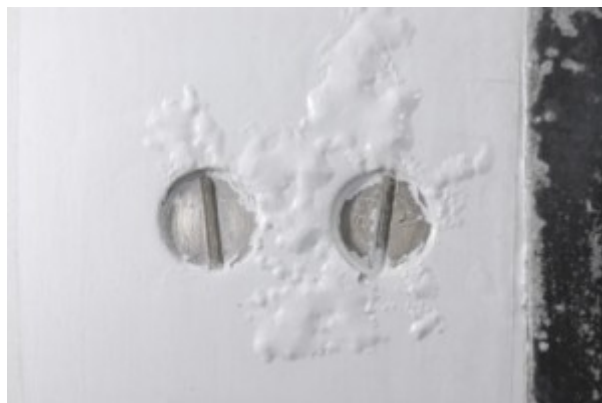
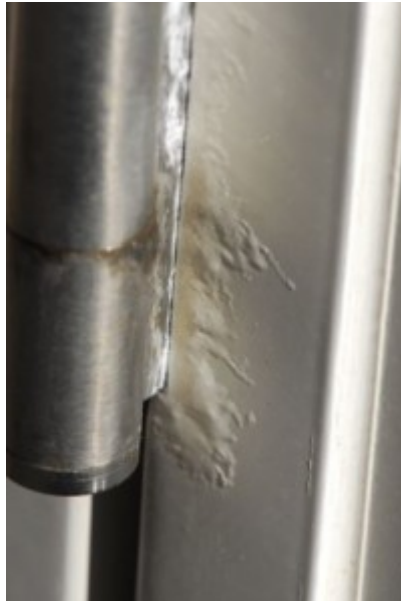
**Blisters such as these are a clear sign that corrosion is occurring under the surface. However, it's a symptom of the paint coating having been breached.**

When I encounter this all too common problem the theory most often put forth by professionals and consumers alike is that the aluminum was improperly or inadequately prepared or primed prior to the application of paint. After all, the failure is one of adhesion; the paint has failed to “stick” to the aluminum, right? Although this scenario does occur, it is in fact much less common than anecdotal reports would indicate. In most cases the cause of the corrosive wound is a result of an “injury”; the paint’s coating is breached, allowing water to reach a material, aluminum, which is initially reactive with air. Once the process begins it’s nearly impossible to stop.

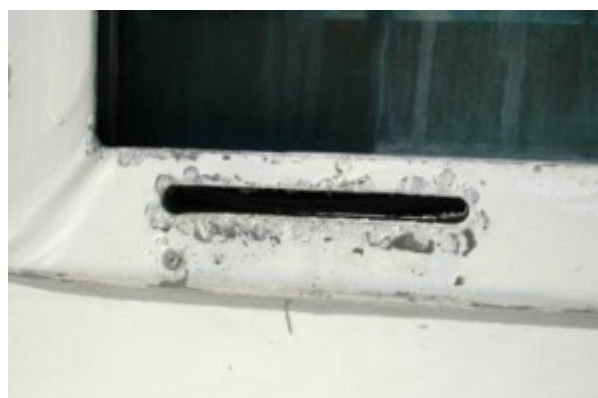
**Sharp, un-radiused corners are notorious for becoming the spawning grounds for corrosion**

If the paint is breaching because of “sharp edge failure”, the solution to this problem is a redesign or modification of the assembly, aluminum surfaces over which paint is applied should be rounded or radiused to prevent thin coating areas. Sharp corners, points or edges must be eliminated.

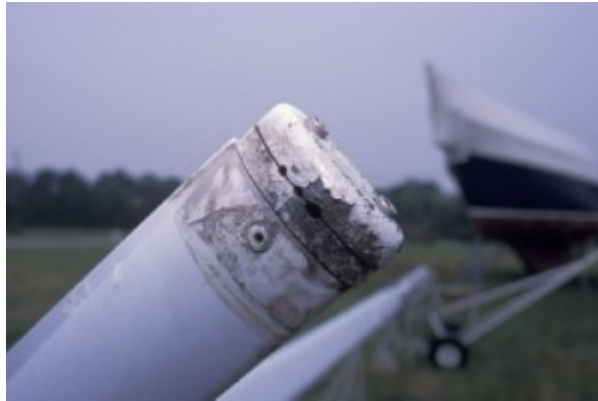
**It's no coincidence that the paint failures occur adjacent to hardware, in areas of abrasion or where the surface remains wet, such as, in this case, under a spreader boot.**

Take a look at the painted aluminum hardware on your boat or aboard the next vessel you visit. Almost invariably the blisters and bubbles begin adjacent to hardware or fasteners or in high traffic areas, hatch frames/sills for instance. The surface preparation and paint application are rarely the cause of the failure; it's the damage to the coating caused by the hardware during the installation process, or traffic, each screw head, striker plate, each canvas snap, pad eye, hatch

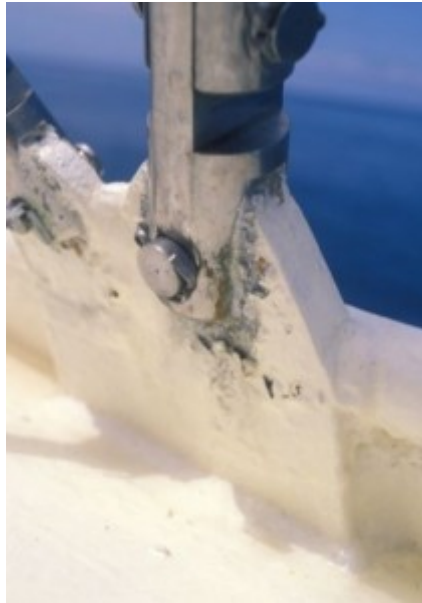
**The turnbuckle on the sailing vessel's rig has abraded the paint on the chain plate, leading to severe corrosion. In this case, the interaction between the aluminum and the stainless steel are adding yet another dimension to the process, galvanic corrosion, which will be discussed in an upcoming column**

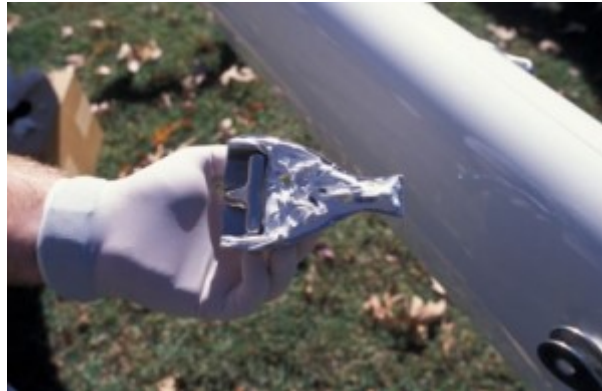
**Liberal bedding all hardware that is installed on painted aluminum surfaces with a polyurethane bedding compound will, for the most part, prevent the paint failure from occurring**

The solution to this problem takes on just one form, prevention. Once the corrosion has set in any paint that has already blistered or lifted is doomed, it must be removed and spot repaired or the entire structure must be repainted. Preventing the problem is exceptionally easy, each and every piece of hardware, every screw and fastener must be bedded in a high quality polyurethane or polysulfide bedding compound. The painted surface and the hardware should each be cleaned and degreased using 3M General Purpose Adhesive Cleaner or mineral spirits. Then, apply bedding compound to the surface that will make contact with and likely "break" the paint coating. Fastener threads should also be cleaned and coated, this will prevent galvanic corrosion and the subsequent seizure of the fastener threads. Install the hardware, wipe excess sealant and clean using the

aforementioned product. The sealant will fill paint breaches that occur when the hardware is torqued, preventing water entry and the subsequent pultice corrosion.

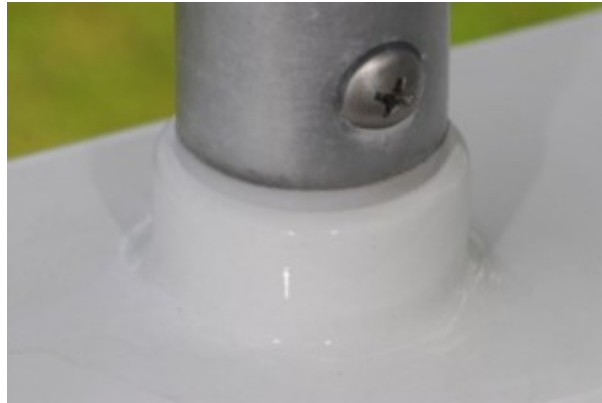
**Inserting a non-metallic insulator between painted aluminum and other hardware, regardless of its alloy, can prevent paint damage. However, while beneficial, this approach may still lead to paint failure as a result of water entrapment**

Conscientious aluminum boat and hardware builders and installers often insert non-metallic shims or insulators between hardware and painted aluminum structures in an attempt to mitigate damage to the paint as well as stemming corrosion resulting from interaction between dissimilar metals (I'll cover this subject in an upcoming column). While this approach can be effective and has its place, the insulator will prevent or minimize paint damage caused by hardware, it does have its drawbacks. In high load scenarios insulators may be crushed or damaged, leading the mechanical failure of the assembly. Additionally, water can migrate between the insulator and the painted surface, where it will be retained. Because two part linear polyurethane paints are not designed for continuous immersion, water in this condition will eventually lead to blistering and failure. If insulators are used, they too should be bedded.

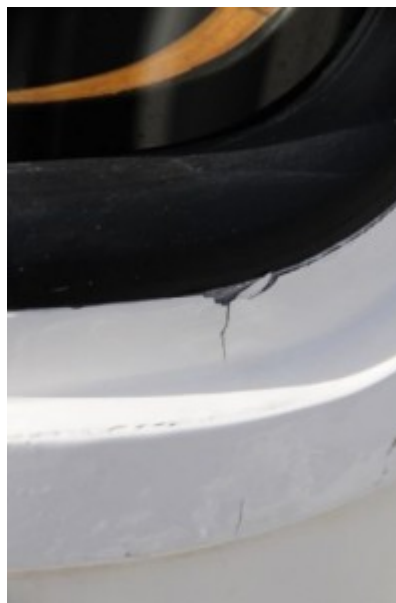
**Sharp edged designs have difficulty holding sufficient paint thickness, which ultimately exposes the aluminum, which in turn leads to water migration under the coating**

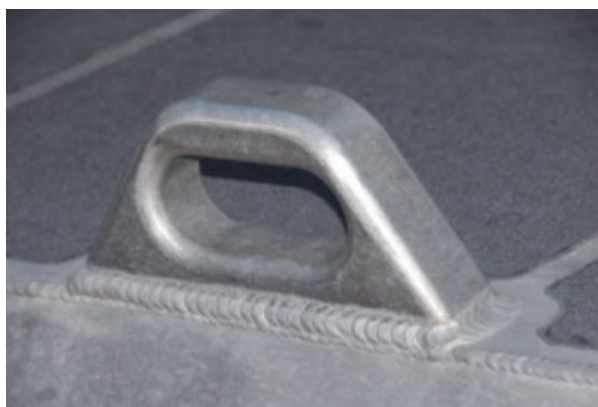
**If you don't mind the appearance, un-painted aluminum offers the greatest corrosion resistance with the least amount of maintenance**
