# Paint and Aluminum – How to Ensure a Good Mix

## Ensuring the Longevity of Paint When Applied Over Aluminum Components

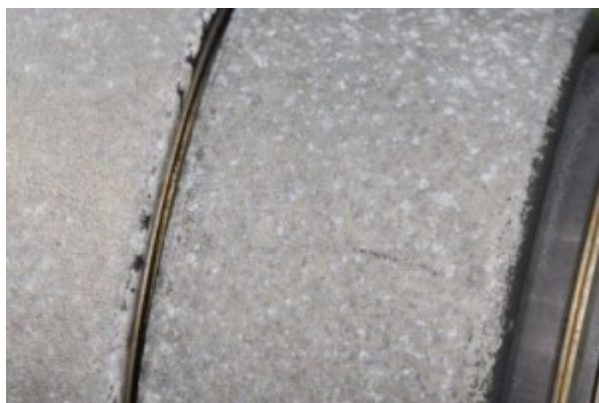
**While the natural state aluminum is desirable from a corrosion point of view, many believe the appearance less than attractive**

The drawback to this chemical process is the appearance; left to its own devices aluminum also develops shallow pits and a gritty, powdery texture. The byproduct of aluminum's exposure to oxygen is alumina or aluminum oxide, the grit or powder, which acts as a passivation layer. In and of itself this material isn't harmful and the process is somewhat self-arresting, unless it's abraded or cleaned away, at which point it begins anew. The abrasiveness of aluminum oxide should not be underestimated; it's used in the production of sanding media as its hardness is second only to that of diamonds. Every effort should, therefore be made to prevent it coming in contact with glass, paint, varnish and other sensitive surfaces. Never dry wipe one of these surfaces if contaminated with aluminum oxide.

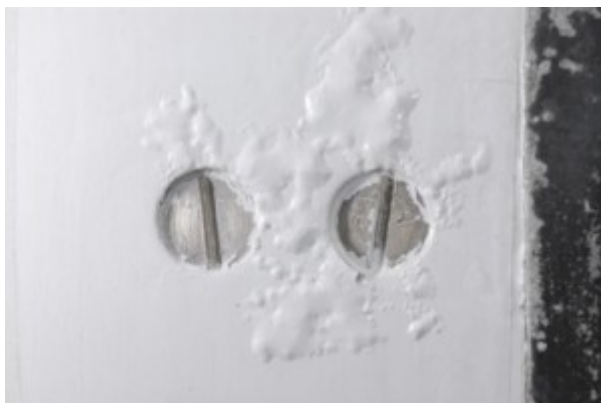
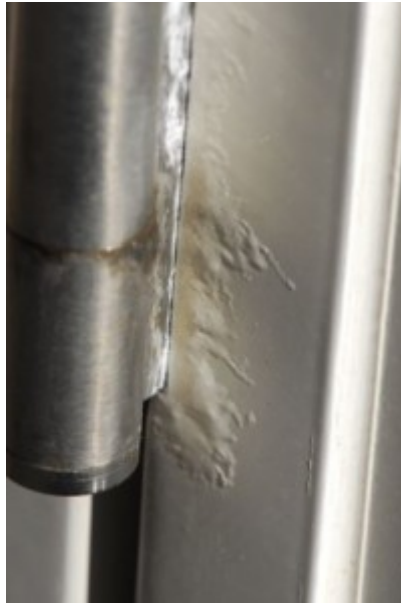
**Blisters such as these are a clear sign that corrosion is occurring under the surface. However, it's a symptom of the paint coating having been breached.**

When painted, aluminum's surface is essentially starved of oxygen and as such it's incapable of developing and/or maintaining its corrosion resistant oxide coating. Provided the paint coating remains contiguous and unbroken this presents no problems, no oxygen and no water means corrosion can't occur. However, once the coating is breached, no matter how small or seemingly insignificant that transgression of the coating may be, it establishes the recipe for a corrosion cascade. Water ultimately enters the breach, where it reaches and reacts with the aluminum, creating aluminum oxide. The reaction initially has access to air via the breach through which the water passes, however, as the aluminum oxide is formed it expands and lifts the paint, allowing the water to travel further and further from the initial entry point, beneath the paint. Eventually oxygen can no longer reach the area of interaction, creating an environment ripe for poultice corrosion. The result is the formation of an unsightly blister or bulge, beneath which lurks the byproduct of poultice corrosion, aluminum hydroxide. If you've never seen it, aluminum hydroxide looks something like freezer burned vanilla ice cream, it's often gooey until the blister's surface breaks, at which point it will dry out and revert more or less to a powdery state.

When I encounter this all too common problem the theory most often put forth by professionals and consumers alike is that the aluminum was improperly or inadequately prepared or primed prior to the application of paint. After all, the failure is one of adhesion; the paint has failed to “stick” to the aluminum, right? Although this scenario does occur, it is in fact much less common than anecdotal reports would indicate. In most cases the cause of the corrosive wound is a result of an “injury”; the paint’s coating is breached, allowing water to reach a material, aluminum, which is initially reactive with air. Once the process begins it’s nearly impossible to stop.

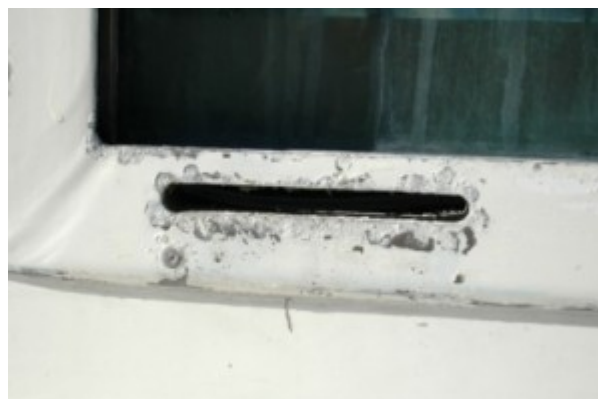
**Sharp, un-radiused corners are notorious for becoming the spawning grounds for corrosion**

If the paint is breaching because of “sharp edge failure”, the solution to this problem is a redesign or modification of the assembly, aluminum surfaces over which paint is applied should be rounded or radiused to prevent thin coating areas. Sharp corners, points or edges must be eliminated.

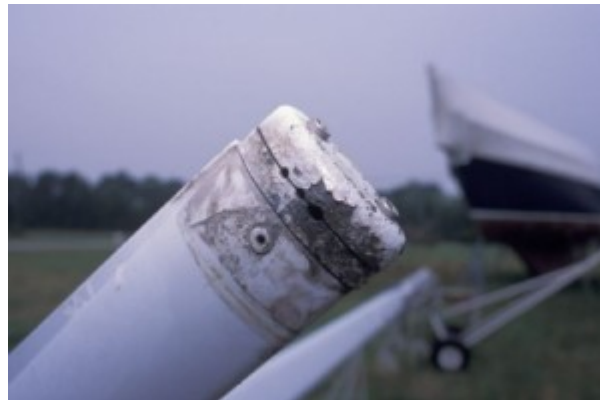
**It's no coincidence that the paint failures occur adjacent to hardware, in areas of abrasion or where the surface remains wet, such as, in this case, under a spreader boot.**

It's important to understand the initial cause of the problem. How does the paint breach occur? Clearly this can be the result of ordinary wear and tear on aluminum components, a careless worker who, as he or she walks by a painted aluminum dinghy crane or door, drags a tool box, hammer or wrench, impact with a metal garden hose nozzle or a dropped boat hook striking a hatch frame. In my experience, however, fully 70% of the aluminum hardware paint failures are a result of hardware installation, with 20% occurring because the metal structure over which the paint is applied contains sharp edges, leading to coatings in these areas whose thickness is inadequate. The remaining 10% are caused by poor preparation or primer application.

Take a look at the painted aluminum hardware on your boat or aboard the next vessel you visit. Almost invariably the blisters and bubbles begin adjacent to hardware or fasteners or in high traffic areas, hatch frames/sills for instance. The surface preparation and paint application are rarely the cause of the failure; it's the damage to the coating caused by the hardware during the installation process, or traffic, each screw head, striker plate, each canvas snap, pad eye, hatch

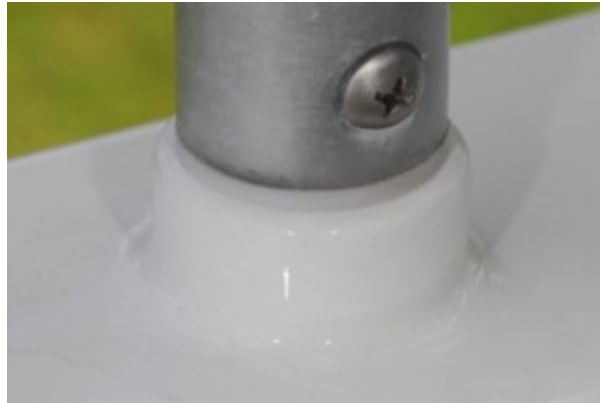
**Inserting a non-metallic insulator between painted aluminum and other hardware, regardless of its alloy, can prevent paint damage. However, while beneficial, this approach may still lead to paint failure as a result of water entrapment**

Conscientious aluminum boat and hardware builders and installers often insert non-metallic shims or insulators between hardware and painted aluminum structures in an attempt to mitigate damage to the paint as well as stemming corrosion resulting from interaction between dissimilar metals (I'll cover this subject in an upcoming column). While this approach can be effective and has its place, the insulator will prevent or minimize paint damage caused by hardware, it does have its drawbacks. In high load scenarios insulators may be crushed or damaged, leading the mechanical failure of the assembly. Additionally, water can migrate between the insulator and the painted surface, where it will be retained. Because two part linear polyurethane paints are not designed for continuous immersion, water in this condition will eventually lead to blistering and failure. If insulators are used, they too should be bedded.

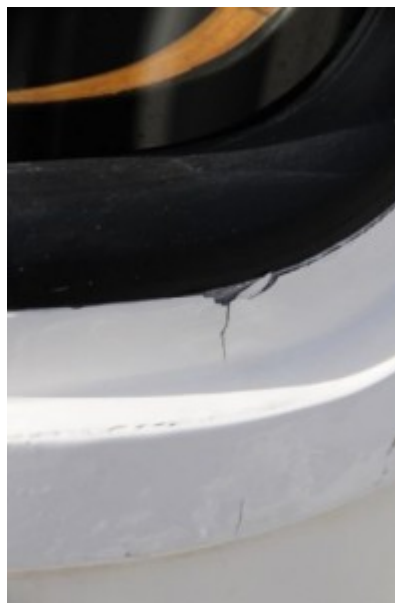
**Sharp edged designs have difficulty holding sufficient paint thickness, which ultimately exposes the aluminum, which in turn leads to water migration under the coating**

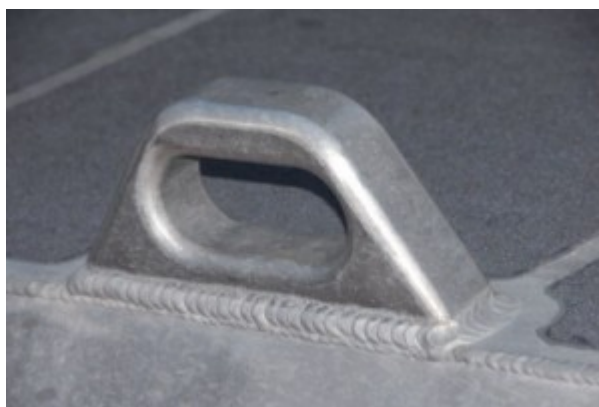
**If you don't mind the appearance, un-painted aluminum offers the greatest corrosion resistance with the least amount of maintenance**
