Reference Electrode Testing; Know Thy Corrosion Protection Level – Editorial: Old vs. New

Reference Cell Testing; Know Thy

Corrosion Protection Level

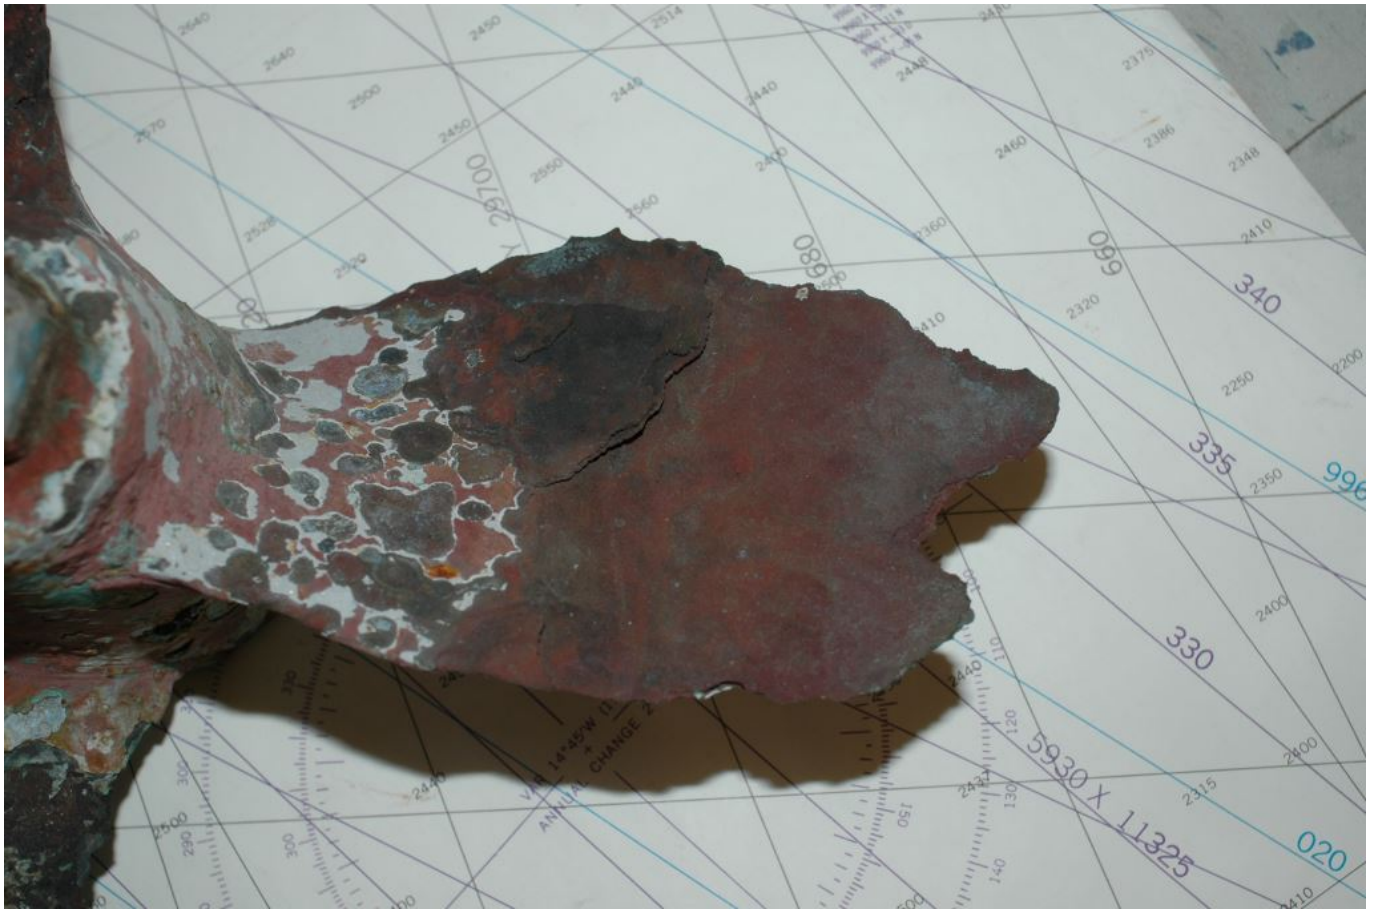
Stray current corrosion is vicious and rapid, it can destroy a propeller like this in a matter of days. While sacrificial anodes may do little to prevent it, a reference cell can be used to help identify its presence and the source.

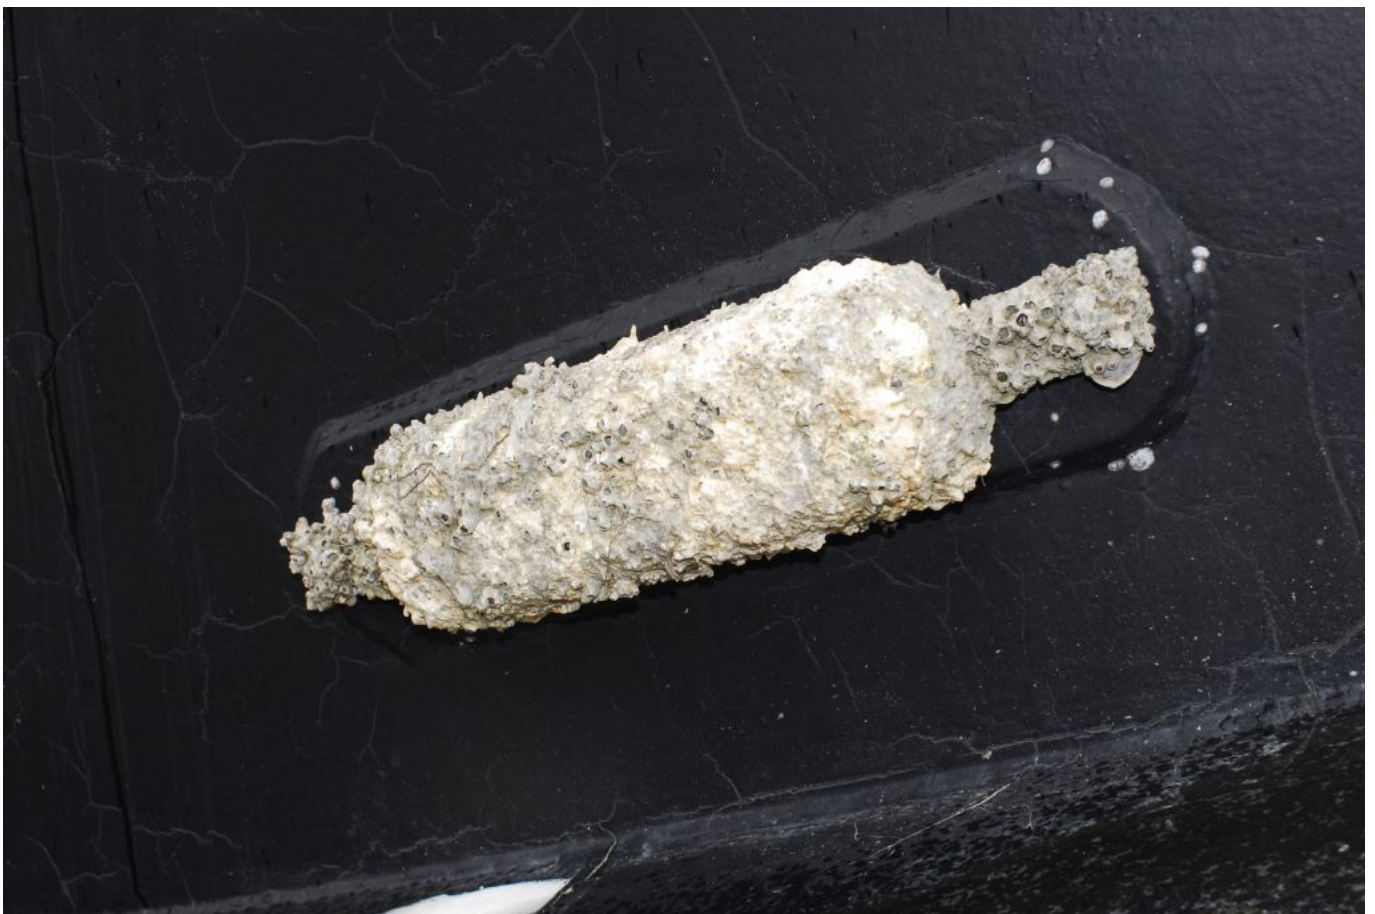
Anodes that seemingly last forever, or those that actually support marine growth like that shown here, are dormant, and thus providing no protection to underwater metals.

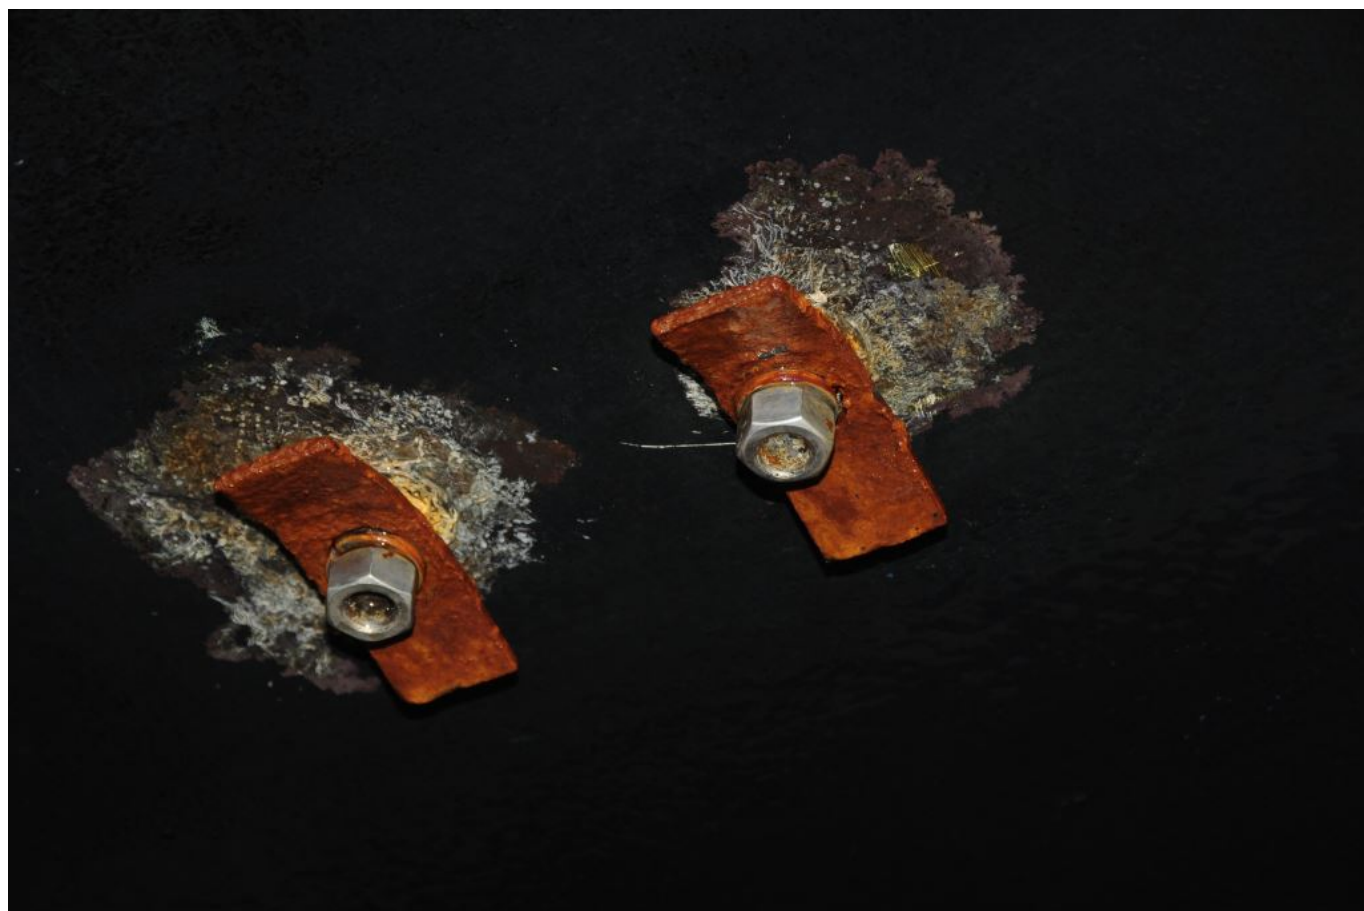
Neglecting anode replacement can be a costly error. Here, all that's left of this anode is its embedded plates, all of its sacrificial metal is long gone.

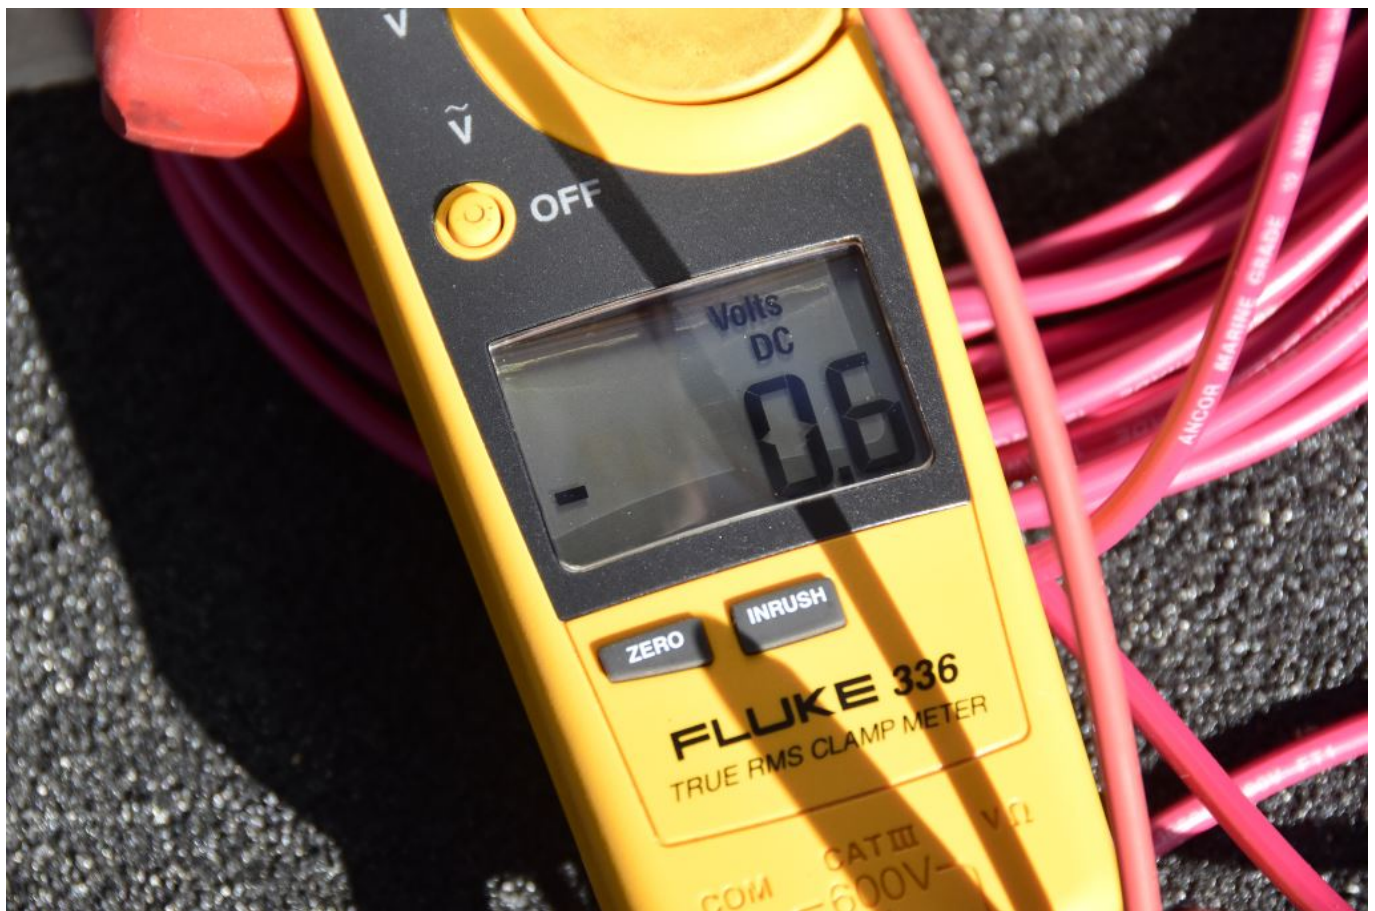
This aluminum vessel's protection level is -600 mV, which is well below the minimum requirement.

It's worth noting that while most metals can't be harmed by over-protection, aluminum is an exception as it's amphoteric, which means it is affected by both acid and base solutions; over-protection creates an alkaline or base solution around protected metals. Therefore, aluminum protection should *not* exceed -1100mV. Over-protection can also be harmful to the hulls of timber vessels adjacent to bonded, protected underwater metals. In a process known as delignification, the alkaline solution attacks the soft material between the grain structure.

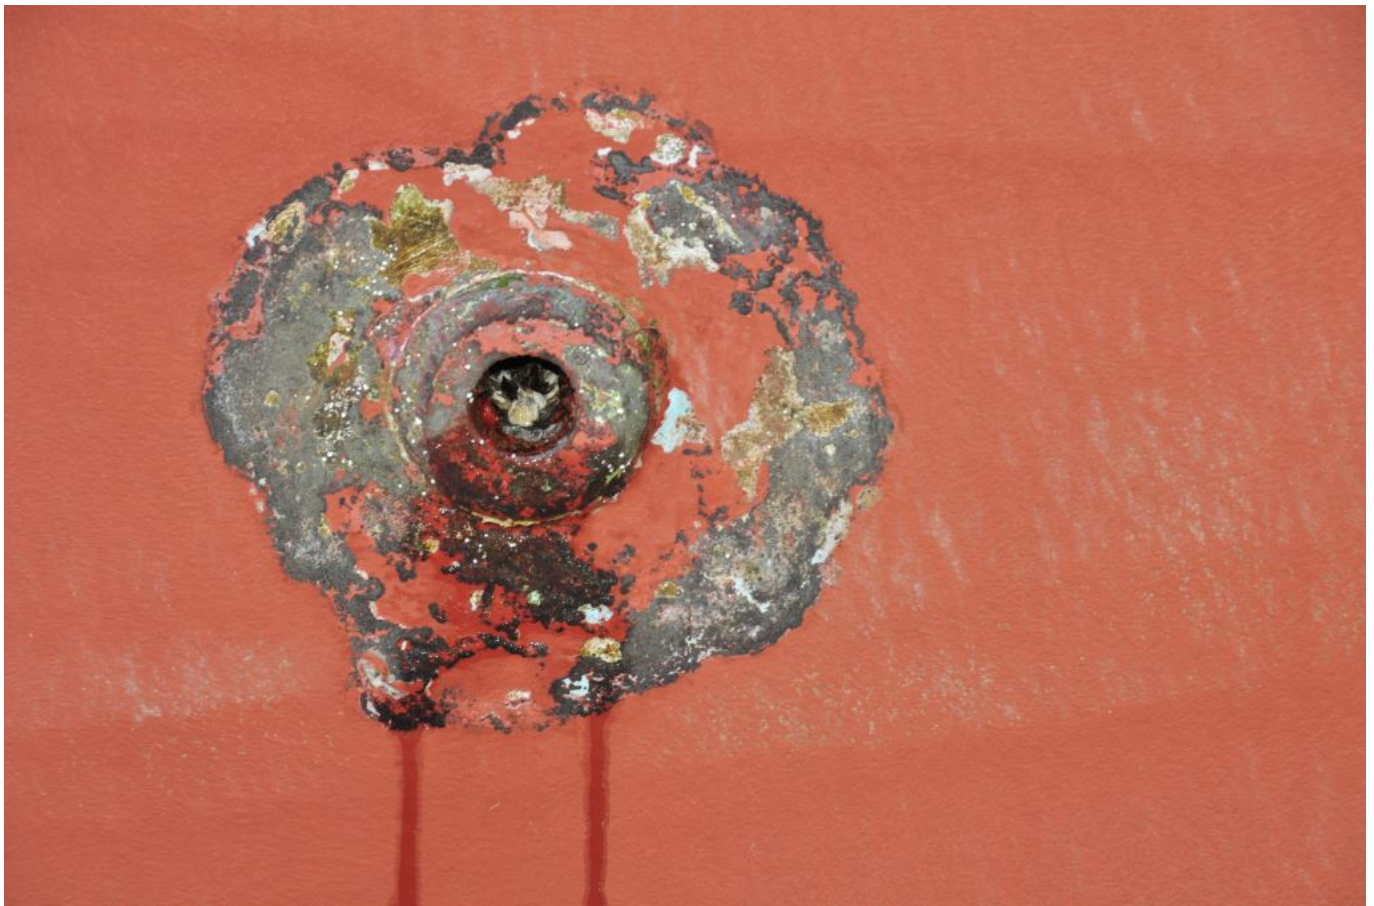
Paint failure around bonded/protected underwater metals is often an indication of over-protection. On fiberglass vessels this is only harmful to the paint and can be mitigated with an epoxy primer.

Finally, over-protection can also cause anti-fouling paint to

blister or lift adjacent to protected underwater metals, which can lead to barnacles and other growth striking on these areas; this can be mitigated by epoxy encapsulating those underwater metals.

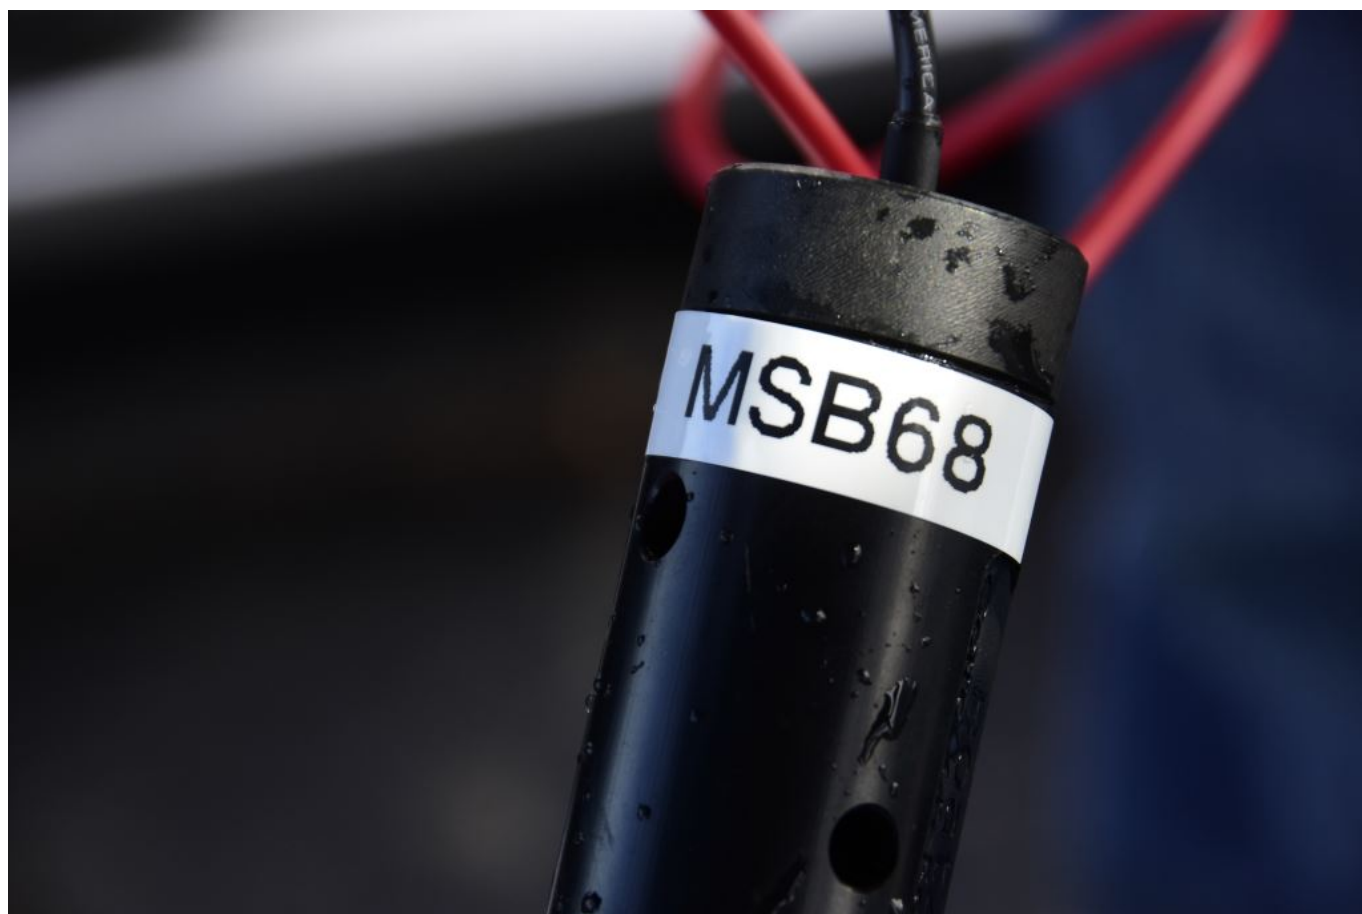
A silver/silver chloride reference electrode. Quality varies, so choose carefully and if the price seems too good to be

true, it probably is.

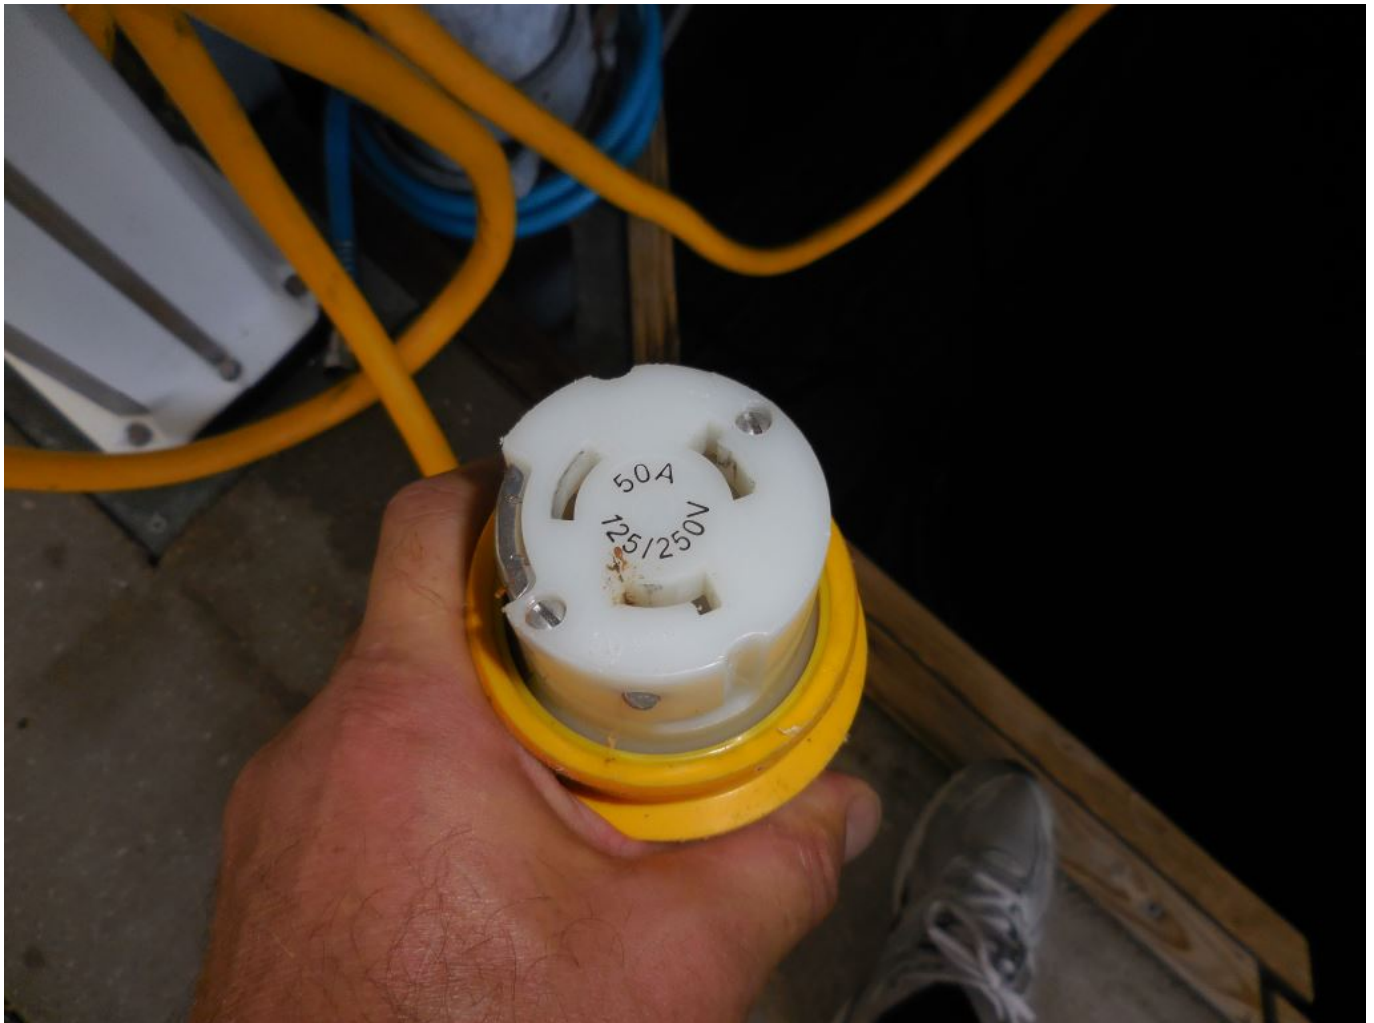
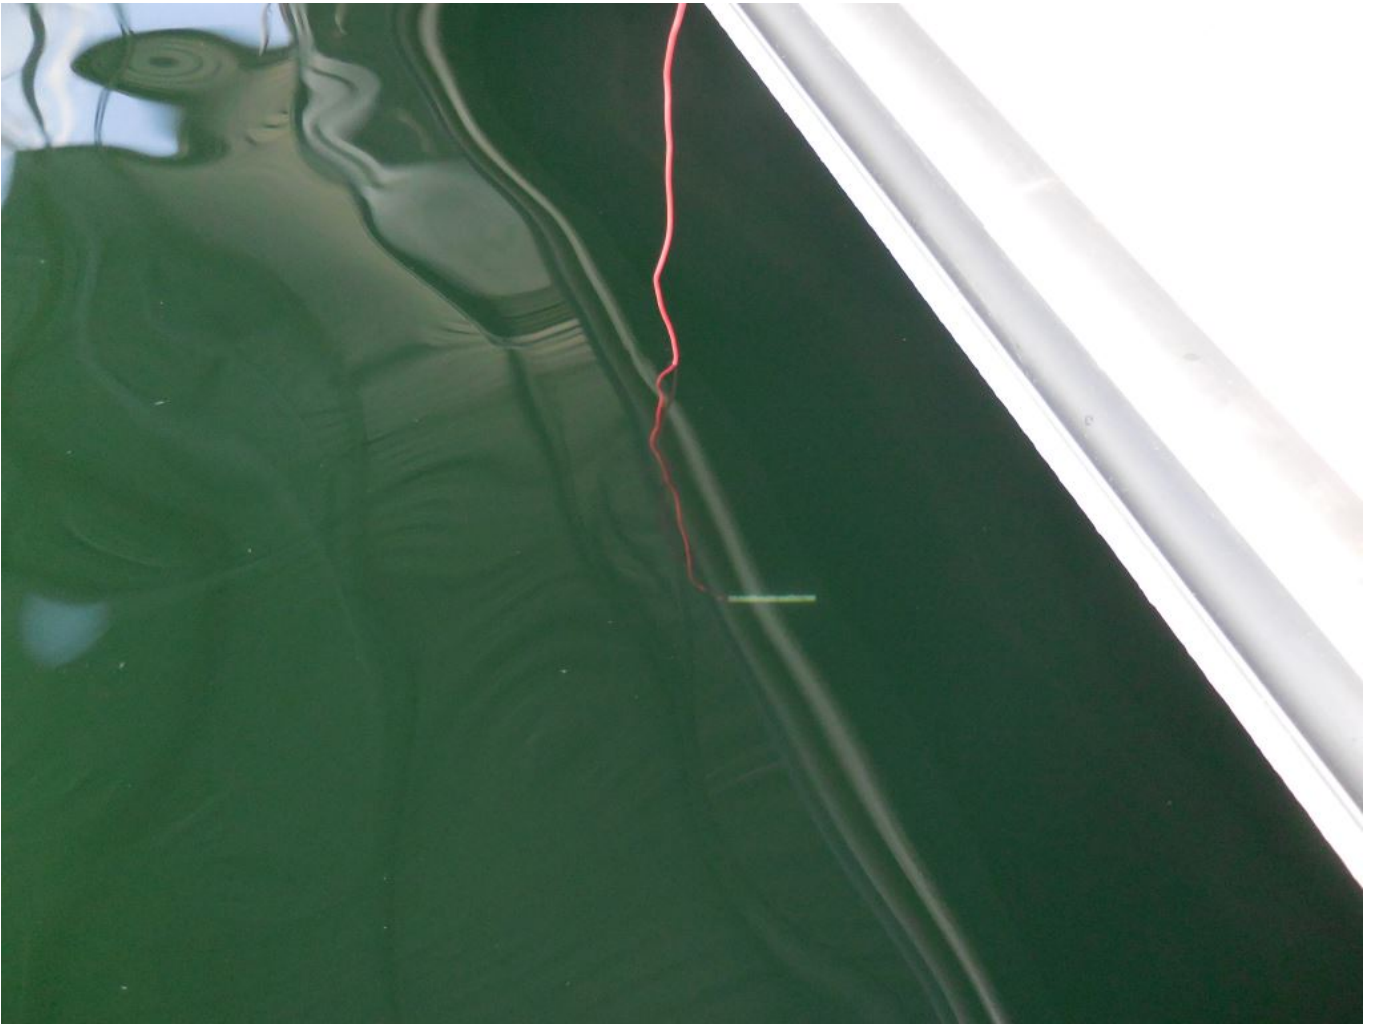
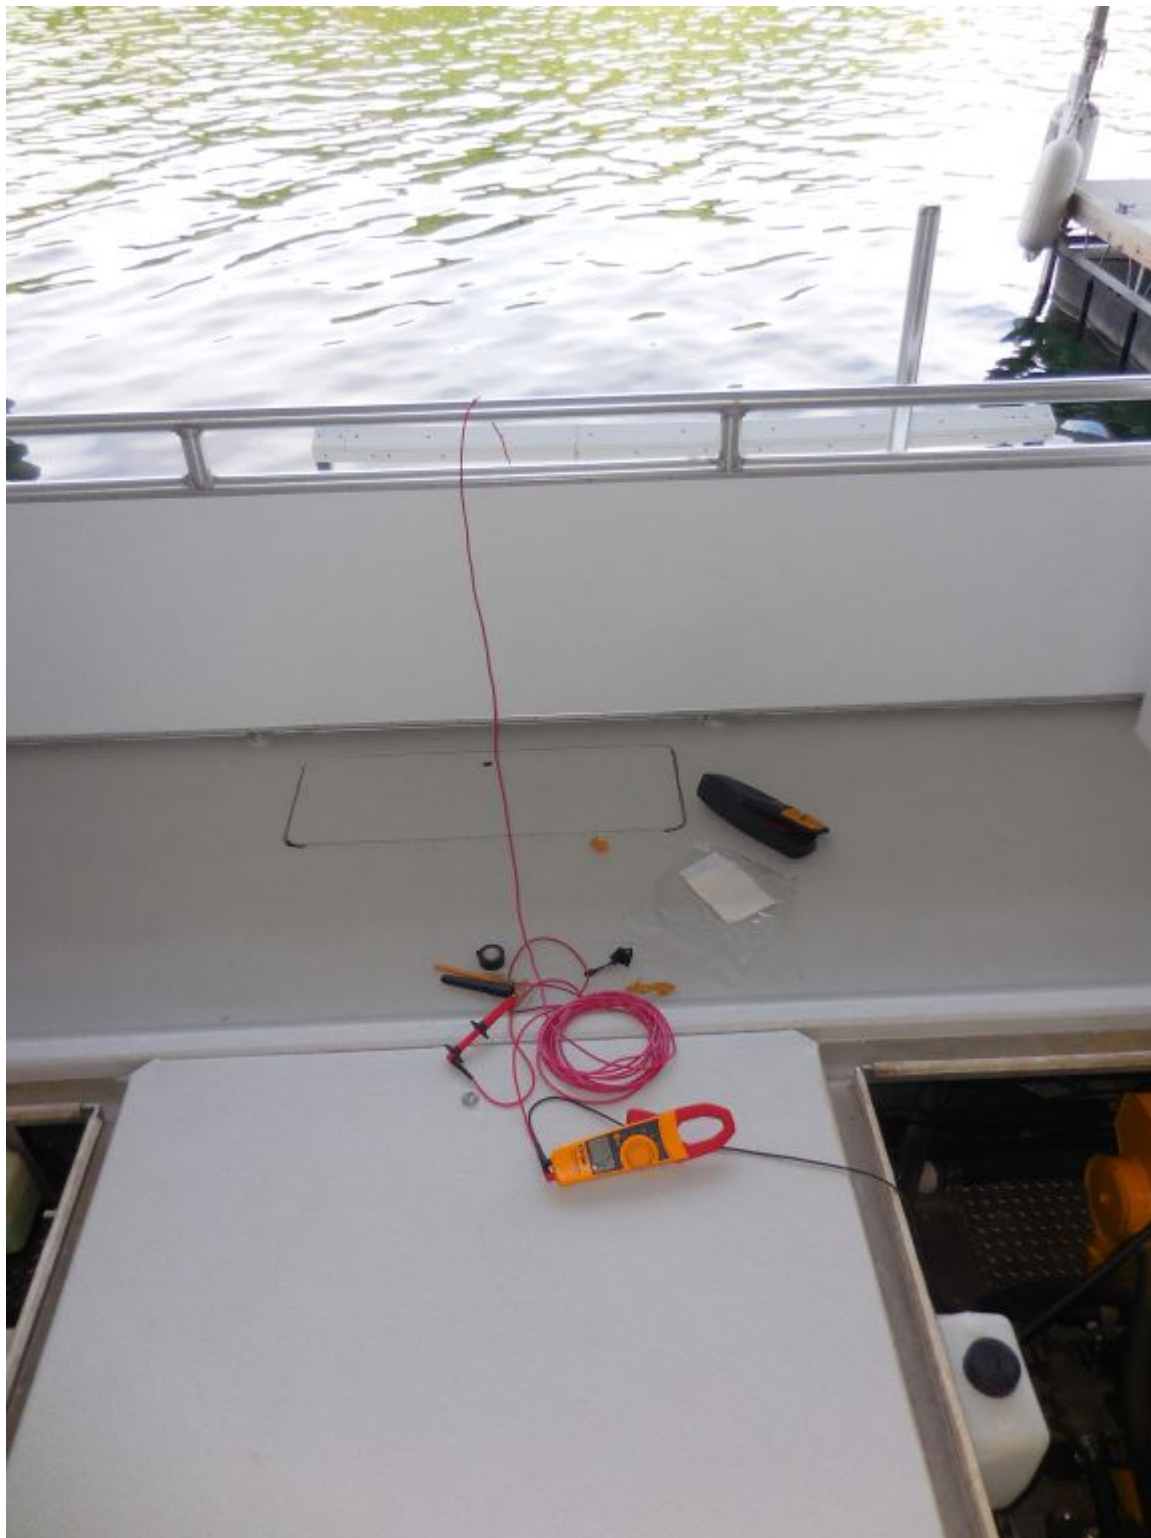
Corrosion analysis underway; testing should take place in still water, initially with shore cord unplugged, and then plugged in. If the readings change after reconnecting the shore cord, a problem exists.

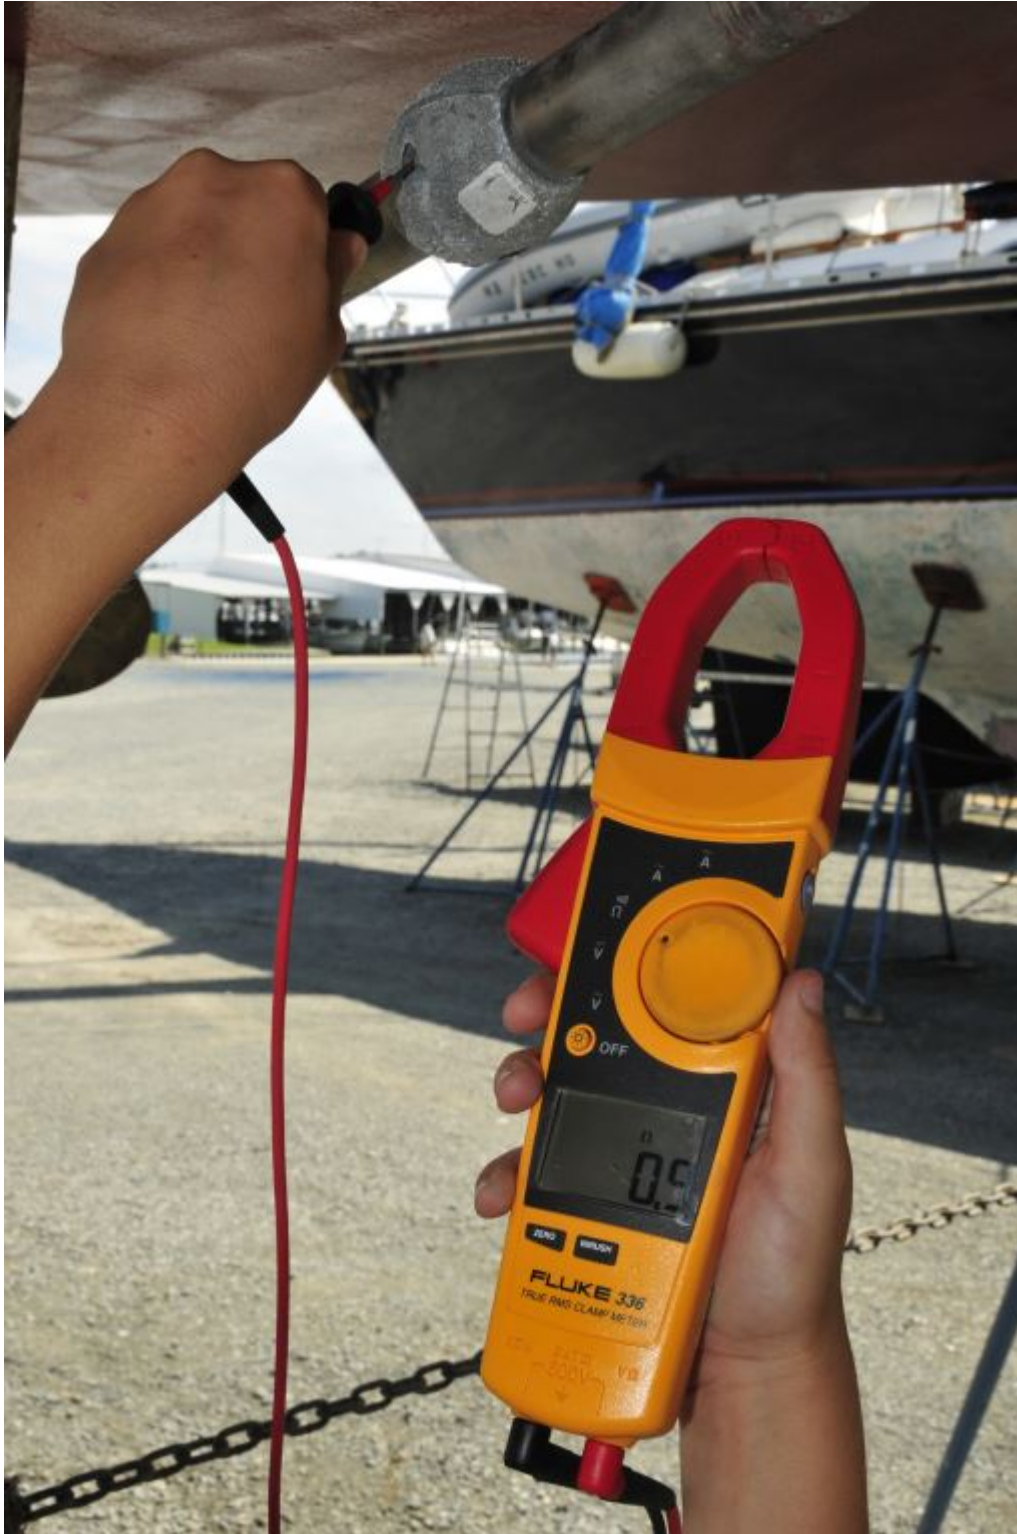
The resistance between an anode, and the metal it's

protecting, must not exceed one ohm. The one here passes the test with 0.5 ohms of resistance.

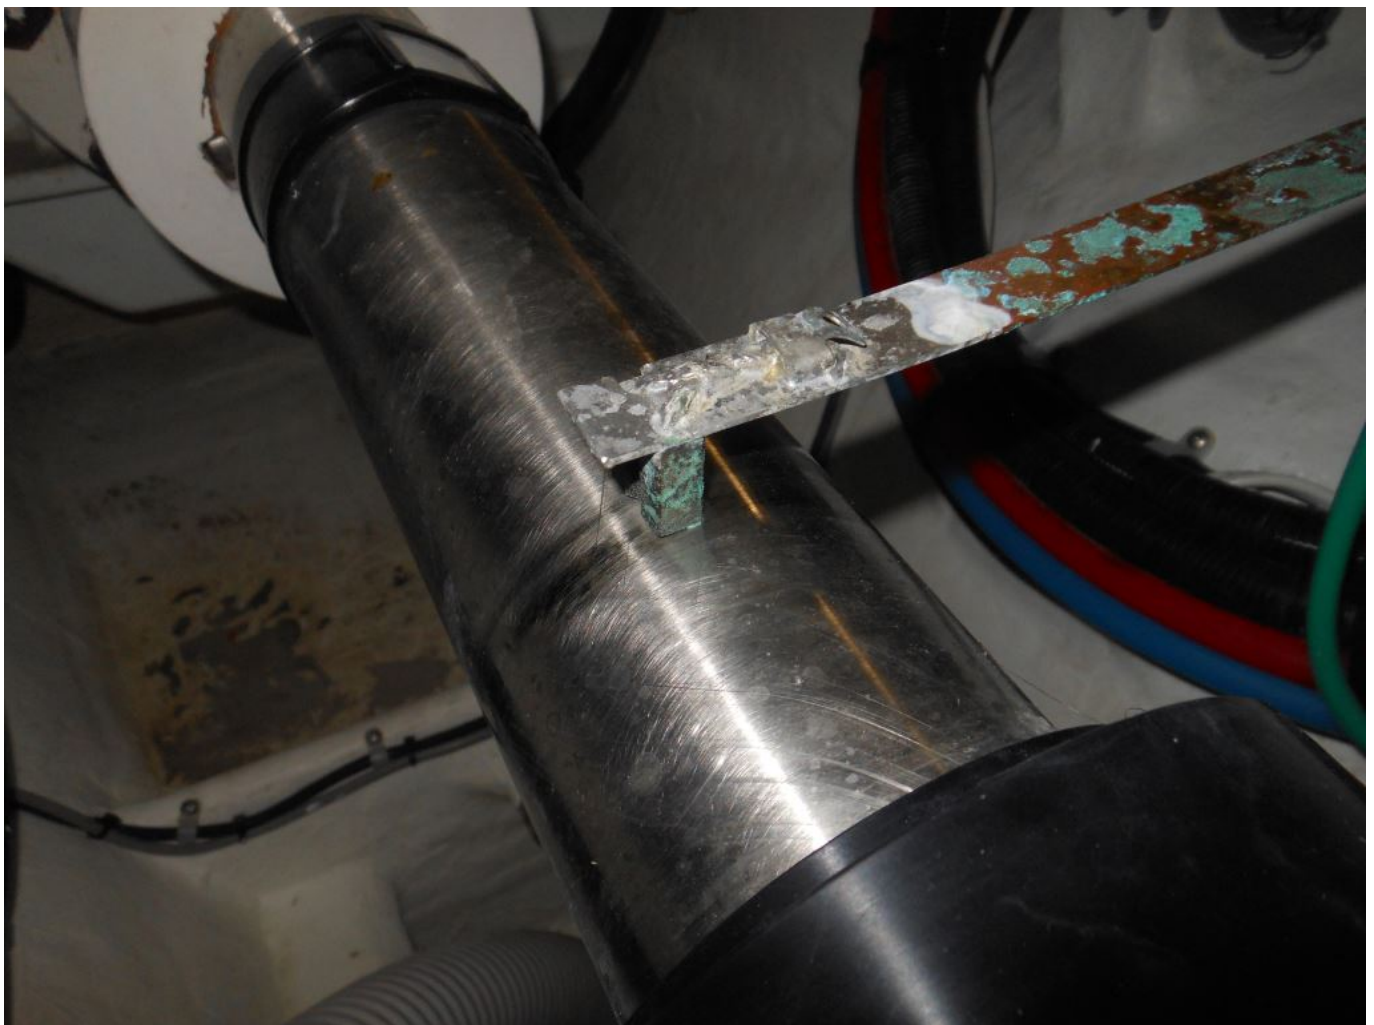
Conventional 'wand and carbon brush' style shaft brushes, are incapable of meeting the sub one ohm resistance threshold, required for cathodic protection systems.

The propeller and shaft are a special case, even though they are connected to the engine via the marine gear ('transmission' in lubber's parlance), and thus the bonding system, the electrical contact is poor at best because the medium is oil-filled. Common, low-cost shaft brushes can make for poor connections at best as well, the threshold for resistance between any protected metal and a sacrificial anode is a scant one ohm, so don't count on ordinary brushes for protection.

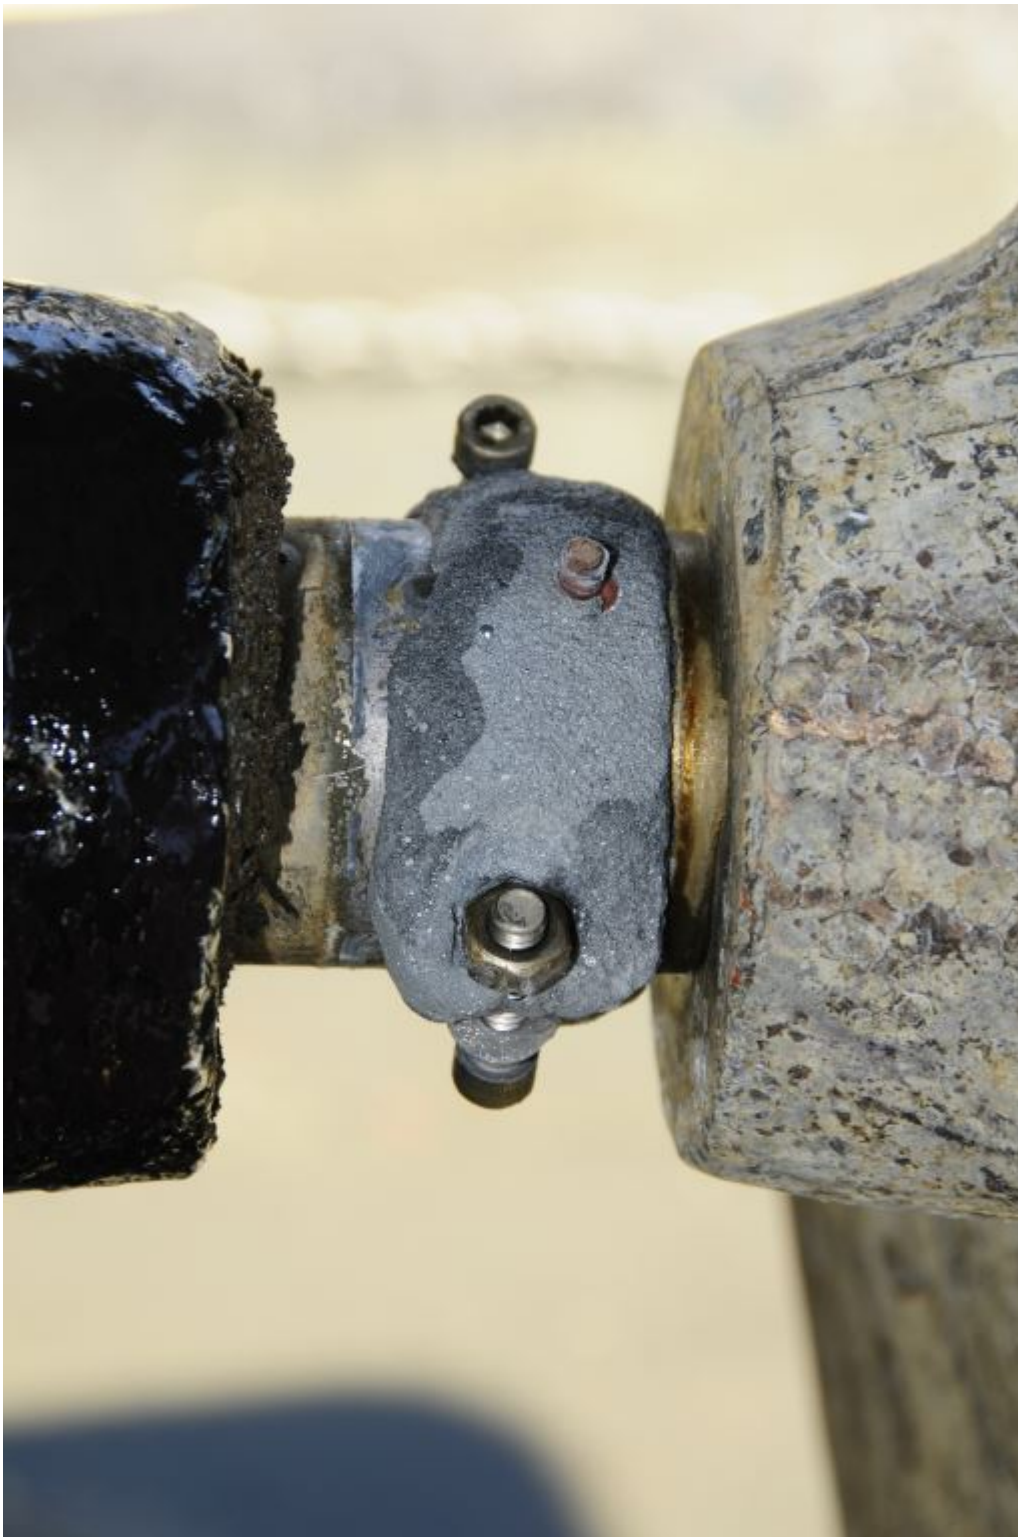
Shafts and props are best served by their own anodes. If this is not possible, then a proper, low resistance, silver slip ring shaft brush should be used.

Shafts and props should have their own anodes and they should

be protected and measured separately, or utilize a properly engineered brush system, one that relies on silver slip rings, which are capable of meeting the one-ohm standard.

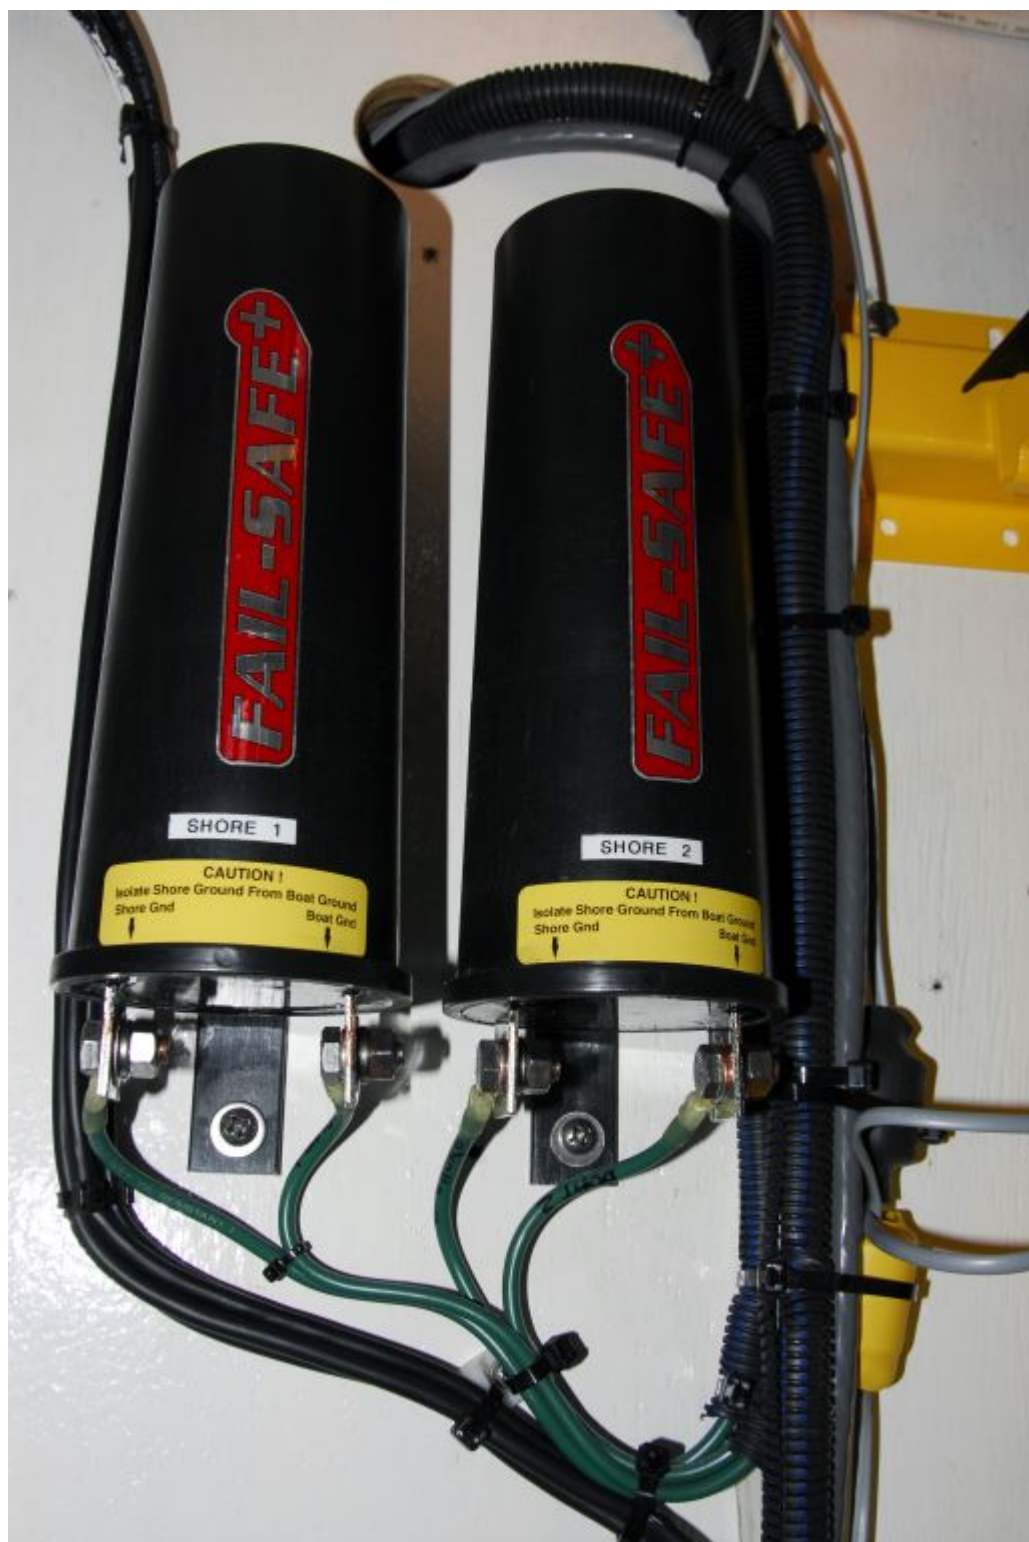
Every vessel that is equipped with shore power should utilize, at the very least, a galvanic isolator, like those shown here, if not an isolation transformer. If your bonding system is not isolated from the dock ground, your anodes could end up protecting vessels that are adjacent to yours.

Repeat the testing after reconnecting the vessel's shore power. If the readings change, the boat is not properly isolated from the shore grounding system, the vessel's galvanic isolator, the device that is supposed to isolate the bonding system from shore power and other vessels, is not working, not wired properly or not present all together, (if there is no change, it may also indicate an open circuit somewhere in the grounding conductor's path, a potentially dangerous scenario, check for continuity between the ground pin on the shore power cord, while unplugged from just the dock, and the AC safety ground aboard, accessed at an outlet).

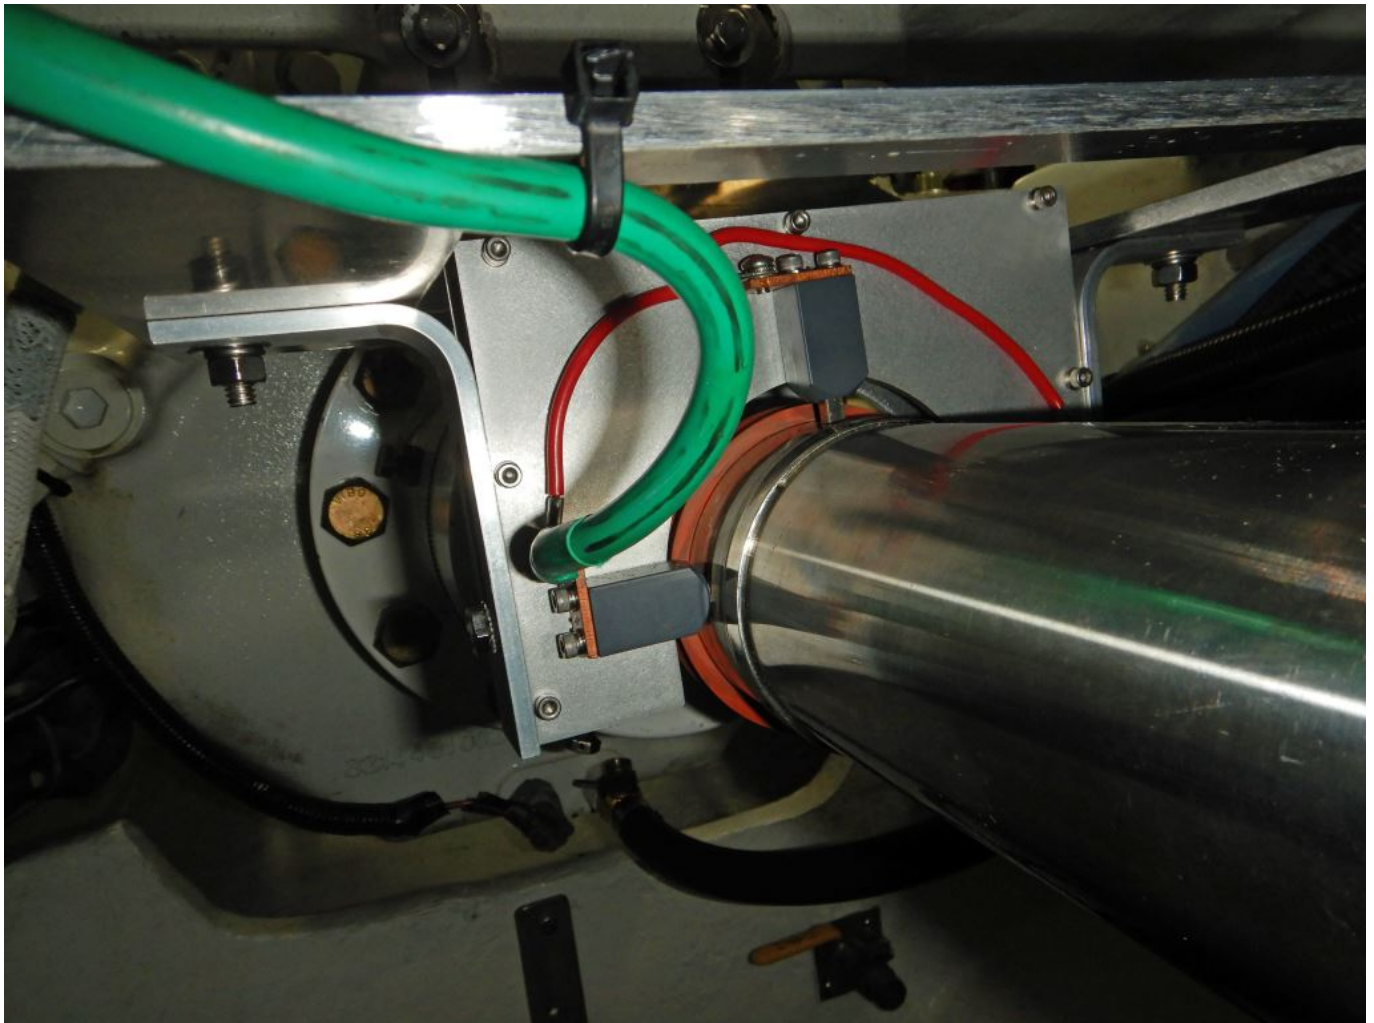
Silver slip ring shaft brushes are capable of meeting the 1 ohm resistance requirement, which is required for cathodically protecting shafts and props with remote anodes.

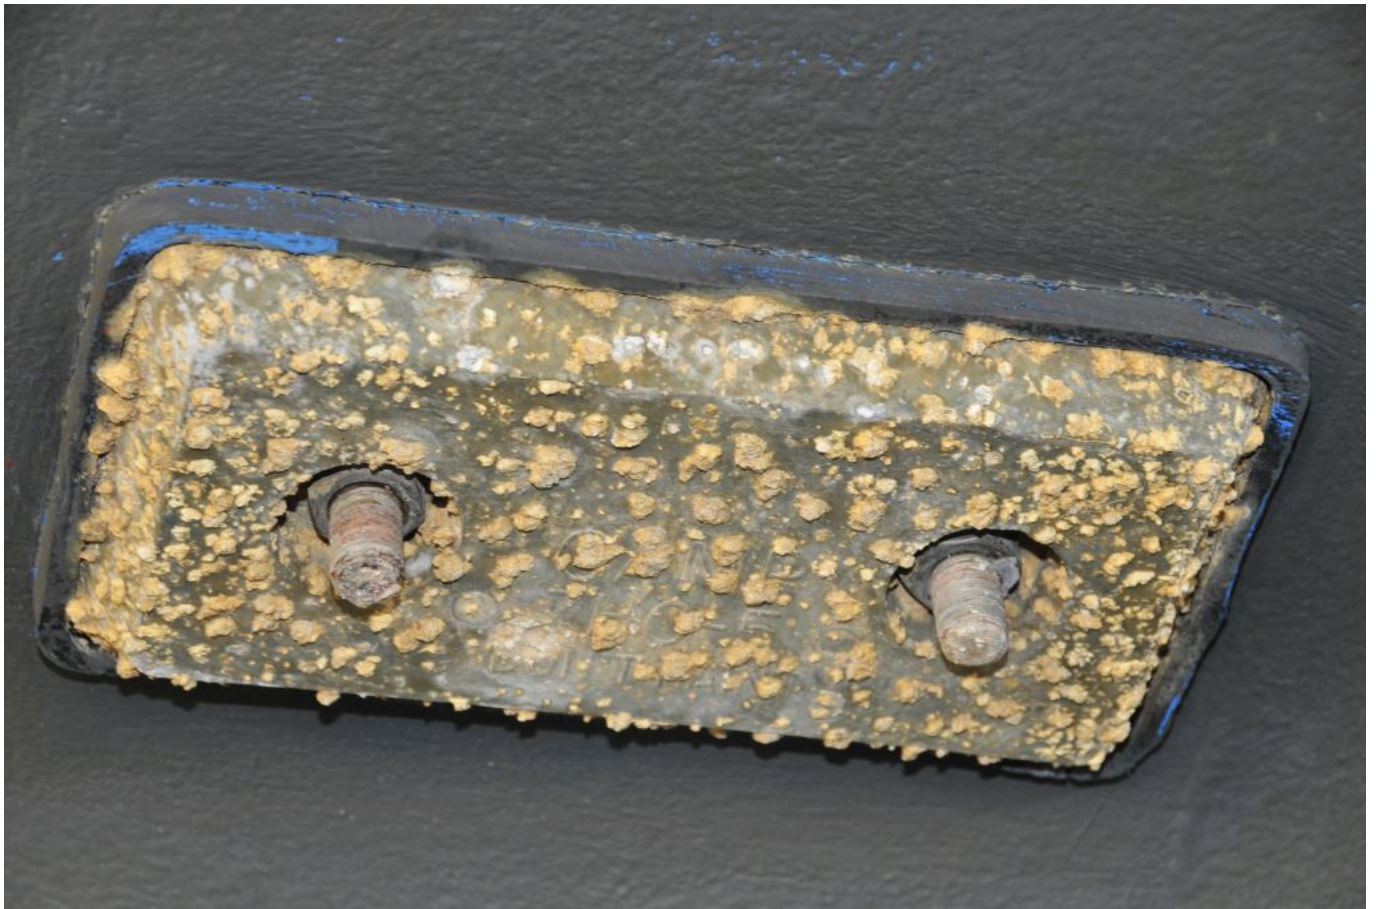
Zinc anodes used in fresh water develop a coating, which renders them useless. If the vessel returns to seawater, the coating can be removed with a non-metallic, stiff bristle brush.

Finally, as far as anodes are concerned, zinc should be used in seawater only, magnesium in fresh water only, while aluminum may be used effectively in sea, fresh or brackish water. Zinc anodes, when used in fresh or brackish water, develop a coating that causes the anode to go dormant. It can be brushed off using a non-metallic stiff bristle brush.
