Reference Electrode Testing; Know Thy Corrosion Protection Level – Editorial: Old vs. New

Reference Cell Testing; Know Thy

Corrosion Protection Level

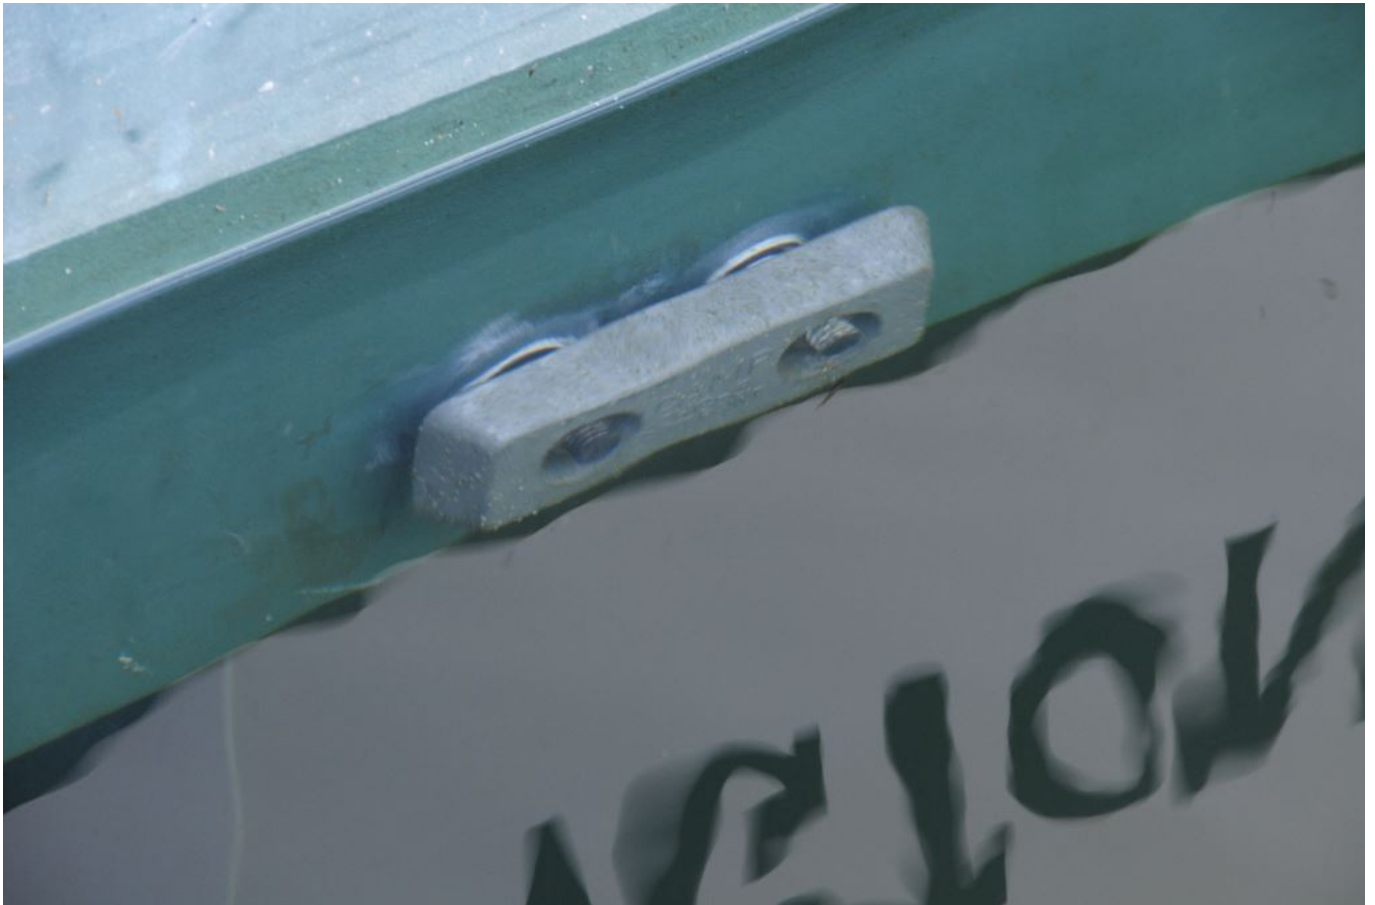
Aluminum anodes are a win-win, they work well in sea, fresh and brackish water.

I'm partial to aluminum anodes on hulls and underwater metals, however, I have had issues with them when used in pencil form, in internal heat exchangers. Aluminum anodes are more reactive than zinc, and as such they often develop a white surface "froth", or aluminum hydroxide. This material does not hinder the anode's performance; however, it can make pencil anodes difficult to remove from their heat exchanger housings.

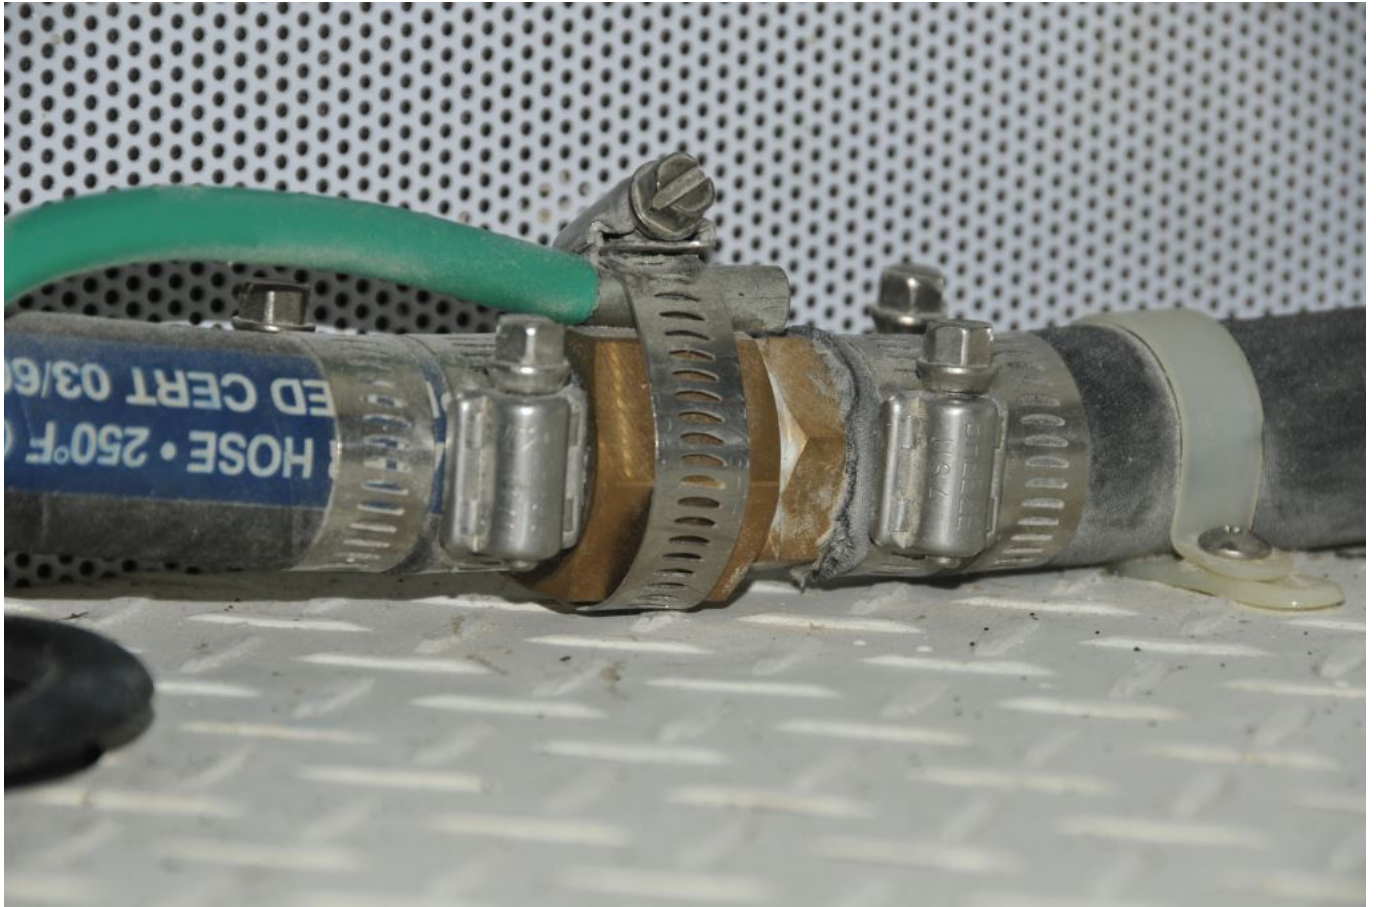
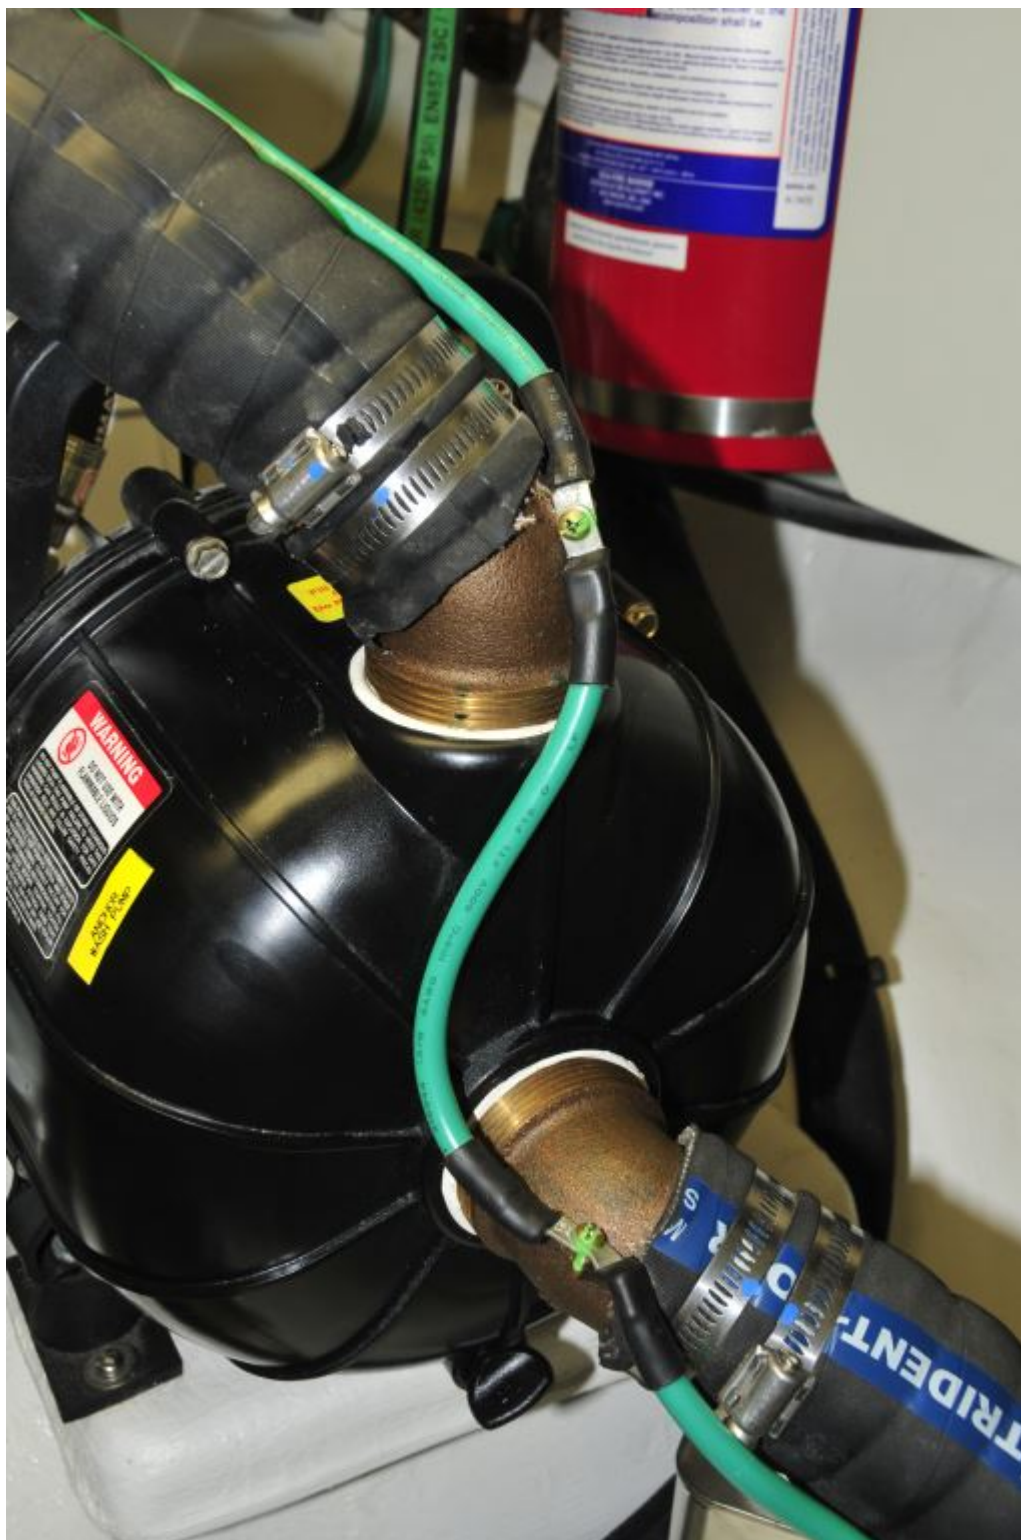
Bonding otherwise isolated, fully internal raw water plumbing components, while not harmful, will afford them no protection from galvanic corrosion. Bonding may provide protection from stray current corrosion if the plumbing is submerged in bilge water.

Because internal metals like heat exchangers are considered to be in a 'different body of water' than hull anodes, the two have no effect on each other, and thus hull anodes will not protect heat exchangers, and vice versa. Furthermore, bonding internal raw water plumbing like metallic pipes, strainers and heat exchangers, will afford them no additional protection from common, every-day, galvanic corrosion, because they are too far from anodes. It may, however, provide them a measure of protection from stray current corrosion, which represents an abnormal scenario, one that occurs rapidly and is especially destructive. For a better understanding of these two types of corrosion see this article. To reiterate, cathodic protection/anodes will provide little if any protection in a stray current corrosion scenario, however, a

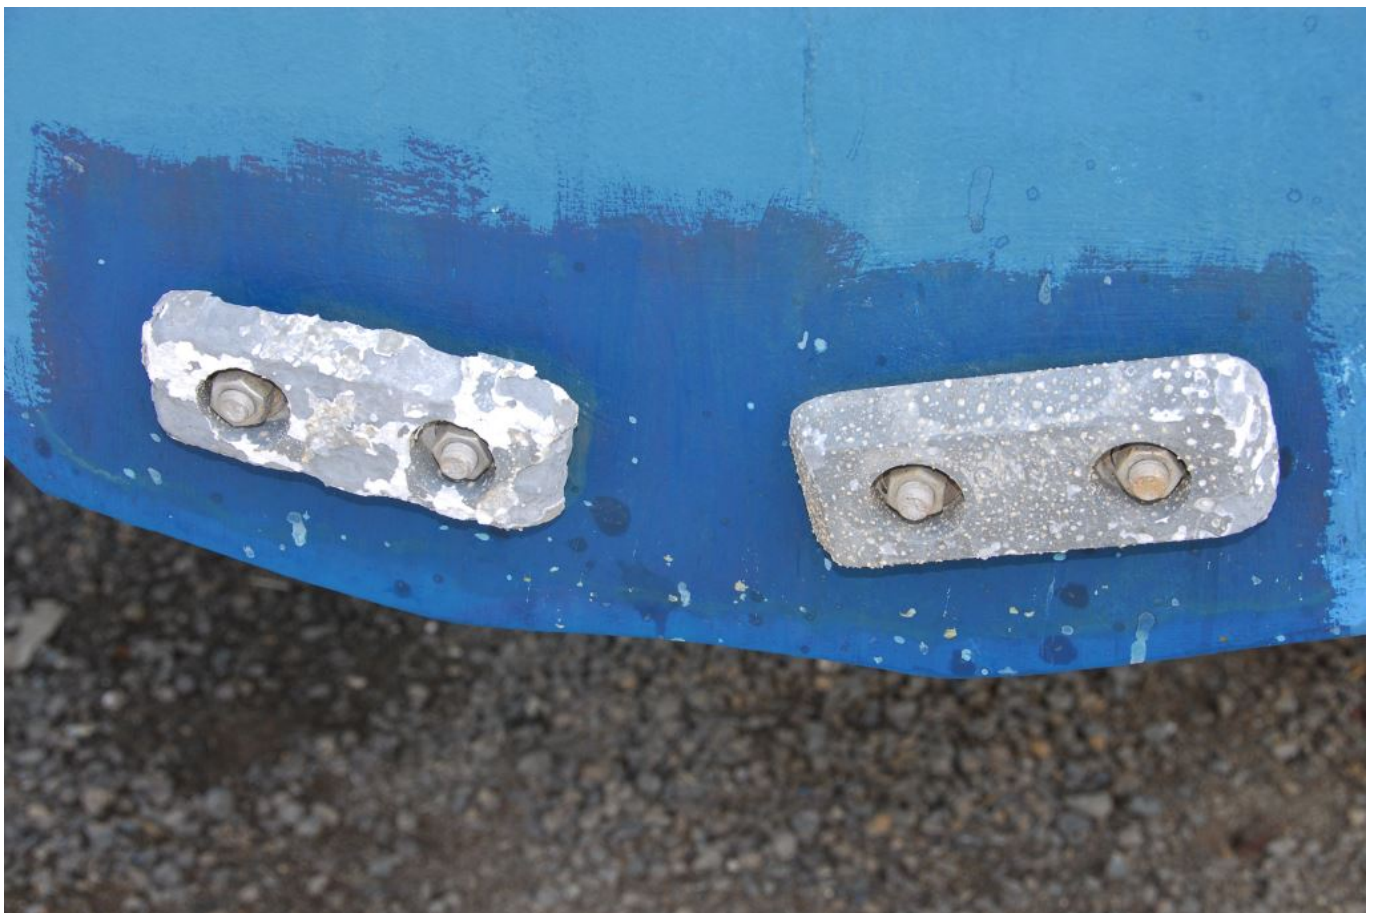
An indication of trouble; like anodes that are connected to a common bonding system, and are adjacent to each other, should

decay at the same rate. If they don't, there's likely a high resistance issue with the one that is not diminishing.

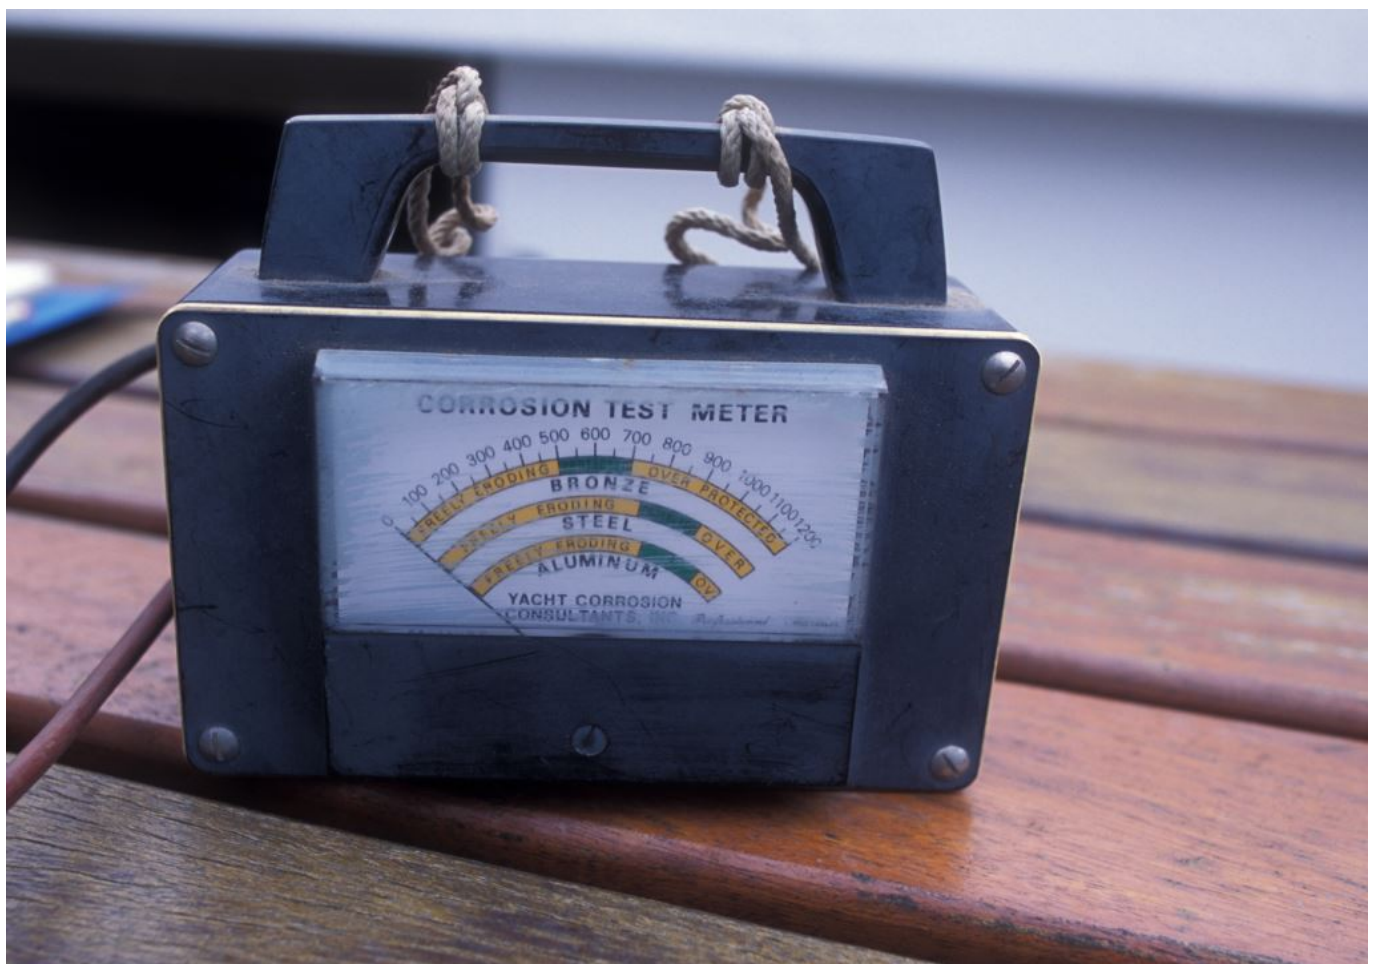
Proprietary corrosion monitors, which are simply graduated analogue ohm meters, are available and easy to use. Beware: This legacy meter shows a protected range for aluminum that is

incorrect, newer models have been corrected. Make certain you confirm the protected range for your metals, rather than simply relying on a gauge face, especially if it has a lot of miles under its keel.
