Safe Shore Power and Electrocutation Prevention

By Steve D'Antonio

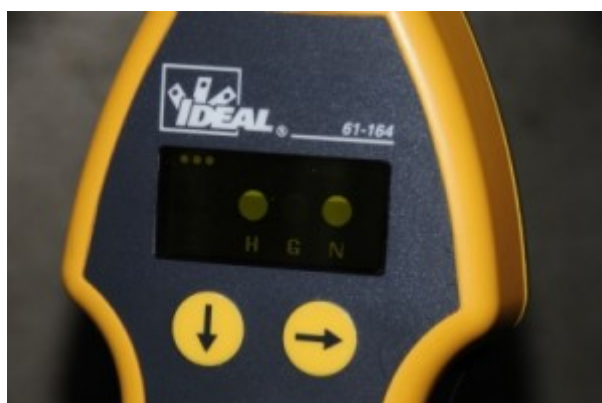
There are several useful tools you or a qualified marine electrician can use to diagnose faults within the AC system aboard your boat. This Ideal circuit tester shows an AC receptacle with a missing ground connection.

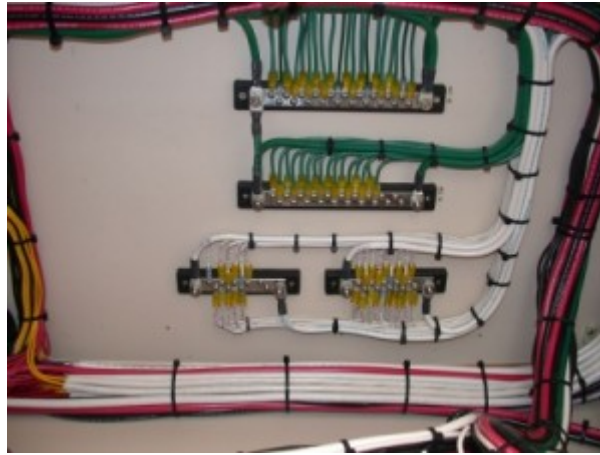
There is no connection between the green grounding and white or neutral AC wiring at these bus bars. Care must be taken at installation and through all future service that, except for a few isolated cases, the two circuits remain separate aboard the vessel.

In addition to the failure-to-bond problem, many vessels are also plagued with other AC electrical land mines. The most notorious of which is the coupled AC neutral conductor (white wire) and the safety grounding (green wire). Unlike a house or other land-based structure, these two conductors should have nothing to do with each other aboard the boat. Rather, they must only be connected ashore. The reason for this idiosyncrasy is the potential for transmission of current through seawater (again, salt or fresh, it doesn't matter. In fact, studies and anecdotal evidence indicates that the lethality of AC current is greater in fresh rather than salt water, although it's a dangerous fault regardless). The reason for this is the directness of the path which current takes when it travels through fresh as opposed to salt water.

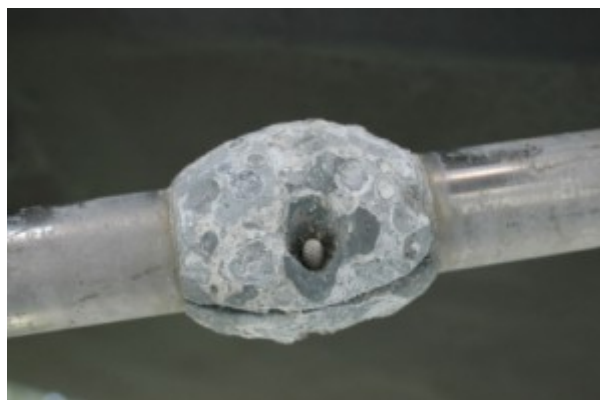
After a year in the water, this zinc anode has done its job of protecting the shaft and prop. However, it is time to replace it with a new one. Be sure to clean the shaft underneath the new zinc to assure the best electrical connection.
