Safe Shore Power and Electrocutation Prevention

By Steve D'Antonio

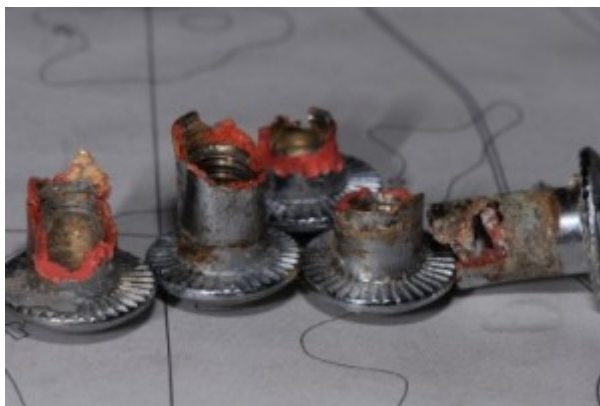
These fasteners are suffering from galvanic corrosion and specifically dezincification. They are chrome-plated brass, which has a high zinc content, and they are unsuitable for marine applications.

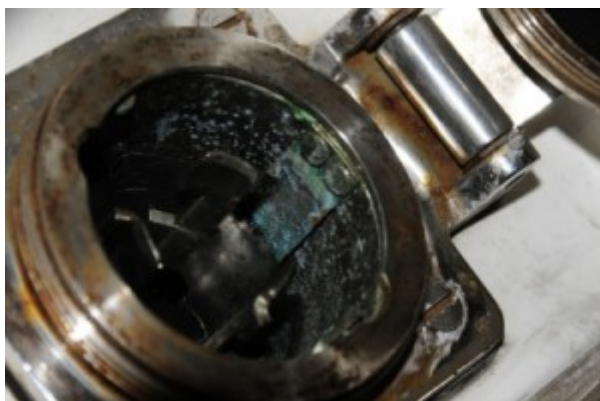
The green tab inside this 50-amp shore power connection should be bright metal. The tab is the ship's connection to shore ground and when it is corroded that connection is compromised, jeopardizing the safety of the crew.

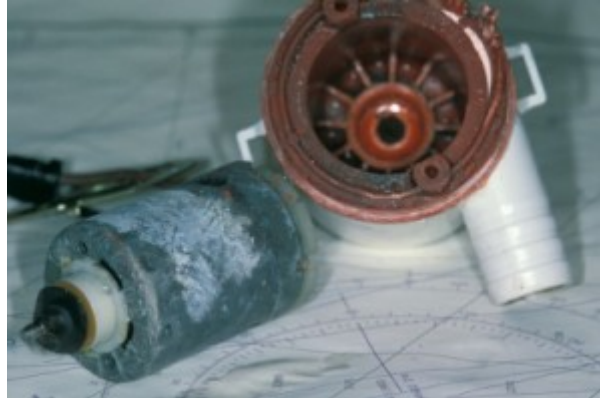
And this could have been the culprit, the failed bilge pump motor was leaking DC current directly into the bilge water which was in contact with an un-bonded through hull, and through the water and to the prop.
