# Safe Shore Power and Electrocutation Prevention

By Steve D'Antonio

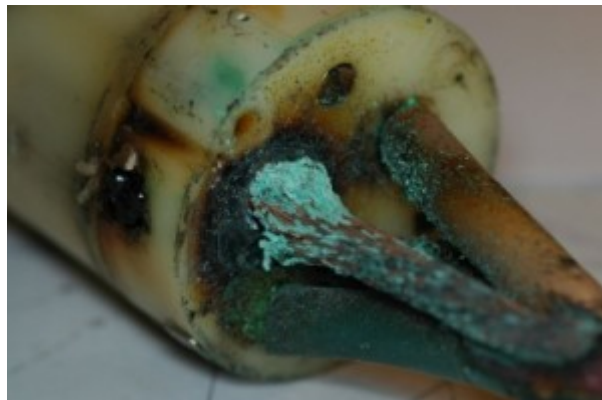
**Beneath the rubber boot, this 50-amp shore power cord is severely corroded, probably as a result of it falling into the water. The insulation of one of the hot or energized wires is almost entirely melted away and is nearly touching the green grounding wire.**

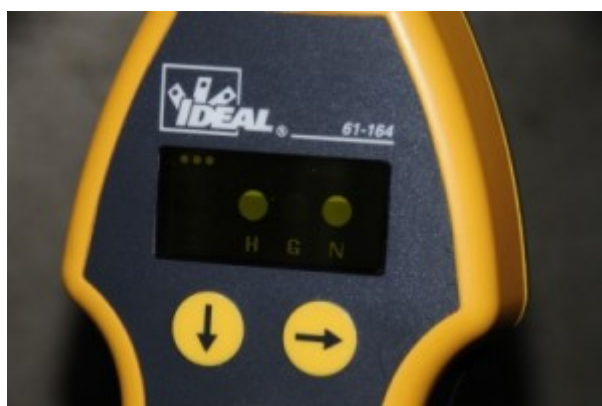
**There are several useful tools you or a qualified marine electrician can use to diagnose faults within the AC system aboard your boat. This Ideal circuit tester shows an AC receptacle with a missing ground connection.**

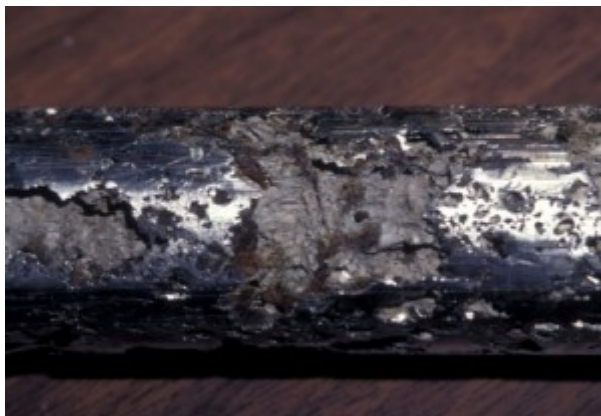
**This stainless steel prop shaft suffered extreme corrosion and was clearly condemned. This is very likely a case of stray current corrosion, which is nearly always associated with DC rather than AC or shore power current.**

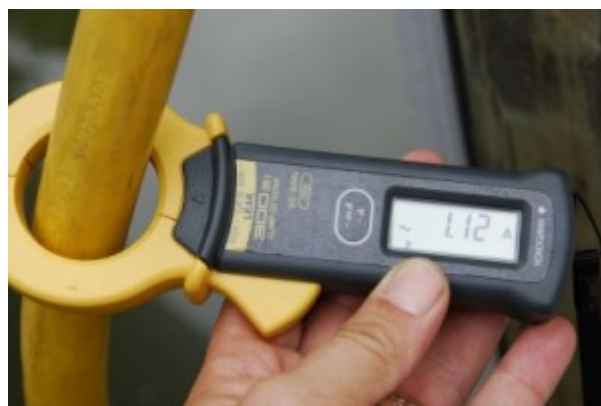
**By utilizing a sensitive amp clamp-style meter, it is possible**

**to find current that is not flowing back through the shore power cord as it should be. This reading should be zero; the 1.12 amps of AC current shown is finding another route back to ground – through the water.**

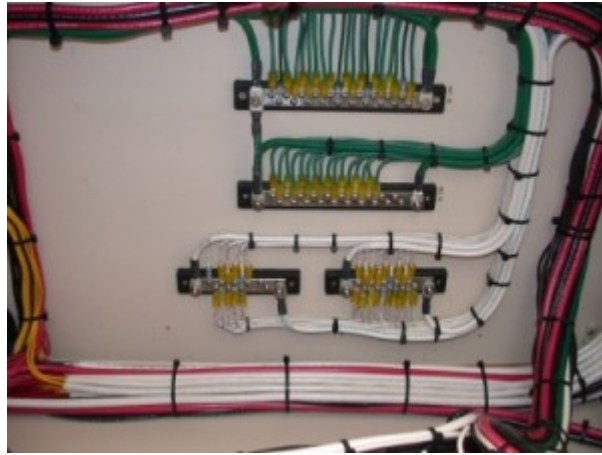
**There is no connection between the green grounding and white or neutral AC wiring at these bus bars. Care must be taken at installation and through all future service that, except for a few isolated cases, the two circuits remain separate aboard the vessel.**

In addition to the failure-to-bond problem, many vessels are also plagued with other AC electrical land mines. The most notorious of which is the coupled AC neutral conductor (white wire) and the safety grounding (green wire). Unlike a house or other land-based structure, these two conductors should have nothing to do with each other aboard the boat. Rather, they must only be connected ashore. The reason for this idiosyncrasy is the potential for transmission of current through seawater (again, salt or fresh, it doesn't matter. In fact, studies and anecdotal evidence indicates that the lethality of AC current is greater in fresh rather than salt water, although it's a dangerous fault regardless). The reason for this is the directness of the path which current takes when it travels through fresh as opposed to salt water.

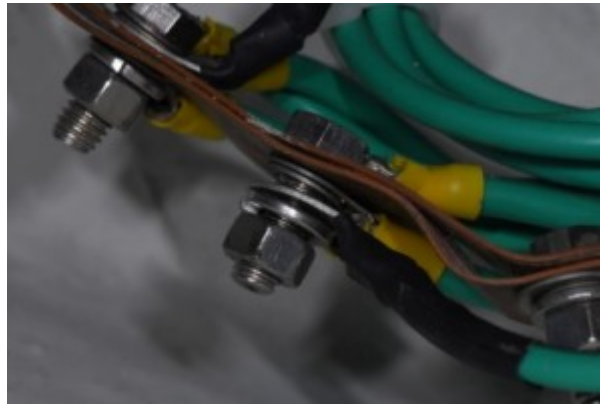
**Ideally, this bonding “bus” should utilize a purpose made bus bar rather than copper strap material. The loose center lug represents potential high resistance, which could prevent this component from functioning properly and safely.**

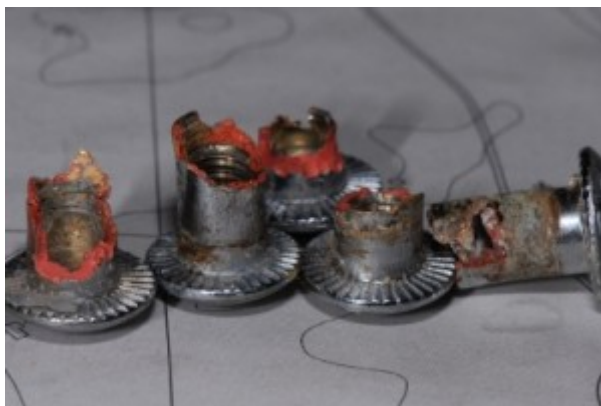
**These fasteners are suffering from galvanic corrosion and specifically dezincification. They are chrome-plated brass, which has a high zinc content, and they are unsuitable for marine applications.**

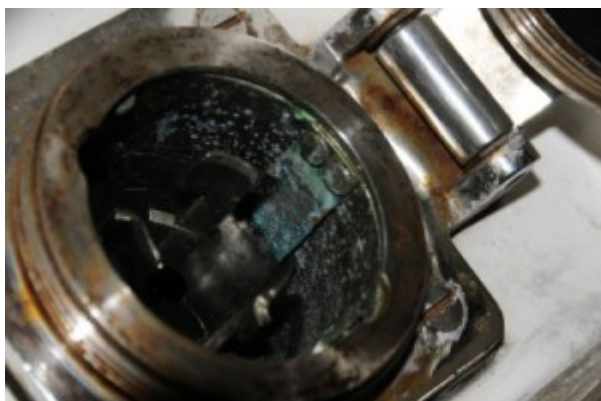
**The green tab inside this 50-amp shore power connection should be bright metal. The tab is the ship's connection to shore ground and when it is corroded that connection is compromised, jeopardizing the safety of the crew.**

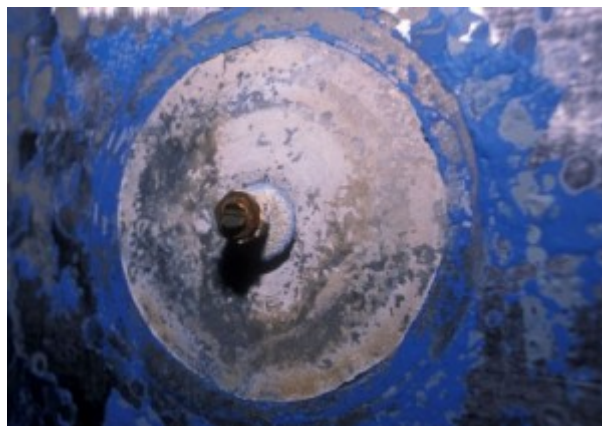
**While anode wastage is a regular maintenance issue, it is part**

**of a comprehensive system designed to prevent electrocution aboard your boat. All parts of this bonding/AC system must be properly installed and in perfect working order.**

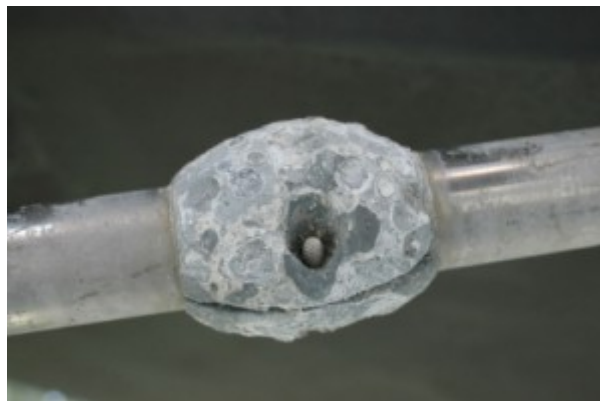
**After a year in the water, this zinc anode has done its job of protecting the shaft and prop. However, it is time to replace it with a new one. Be sure to clean the shaft underneath the new zinc to assure the best electrical connection.**

Now that it's been established that your vessel should be properly wired for AC safety ground and selected onboard hardware bonded, you might ask why anyone would not do this. The problem is, undeniably, when all of the above mentioned safety precautions are taken, the side effect is the increased potential for galvanic corrosion, particularly when plugged into shore power. When you bond underwater metals and dutifully connect them to the AC shore power safety ground, you may have unwittingly invited aboard an unwanted guest, corrosion. The circumstances are simple; you conscientiously bond your boat and inspect the anodes regularly, changing them whenever they are more than 50% depleted.

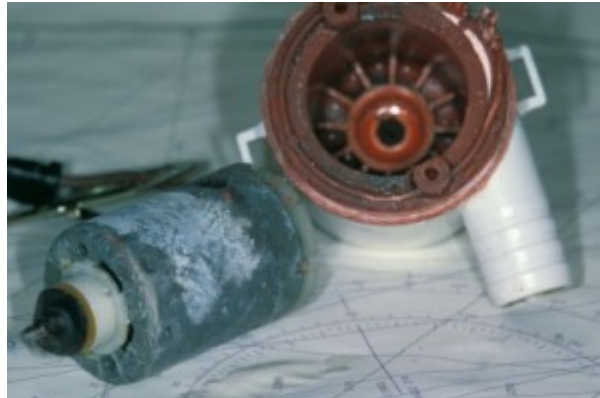
**And this could have been the culprit, the failed bilge pump motor was leaking DC current directly into the bilge water which was in contact with an un-bonded through hull, and through the water and to the prop.**
