# Safe Shore Power and Electrocution Prevention

By Steve D'Antonio

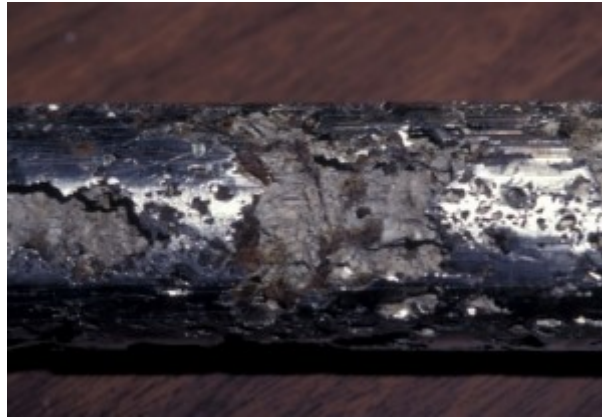
**This stainless steel prop shaft suffered extreme corrosion and was clearly condemned. This is very likely a case of stray current corrosion, which is nearly always associated with DC rather than AC or shore power current.**
