# Safe Shore Power and Electrocution Prevention

By Steve D'Antonio

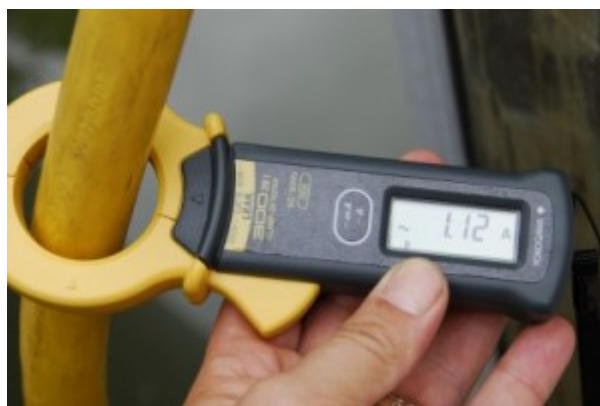
**By utilizing a sensitive amp clamp-style meter, it is possible**

**to find current that is not flowing back through the shore power cord as it should be. This reading should be zero; the 1.12 amps of AC current shown is finding another route back to ground – through the water.**

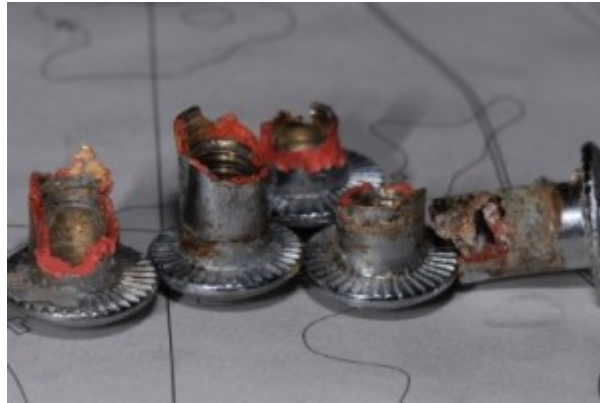
**These fasteners are suffering from galvanic corrosion and specifically dezincification. They are chrome-plated brass, which has a high zinc content, and they are unsuitable for marine applications.**

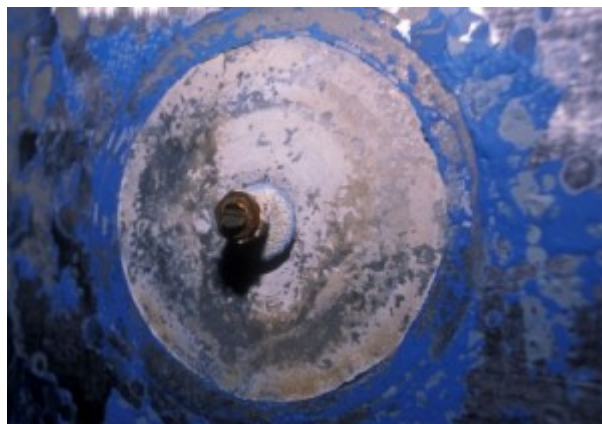
**While anode wastage is a regular maintenance issue, it is part**

**of a comprehensive system designed to prevent electrocution aboard your boat. All parts of this bonding/AC system must be properly installed and in perfect working order.**
