# Selecting Primary Fuel Filters; There's more to it than meets the eye – Editorial: A Loose Bolt, a Cigarette Lighter and Distracted Work

## Selecting Primary Fuel Filters

*There's more to it than meets the eye*

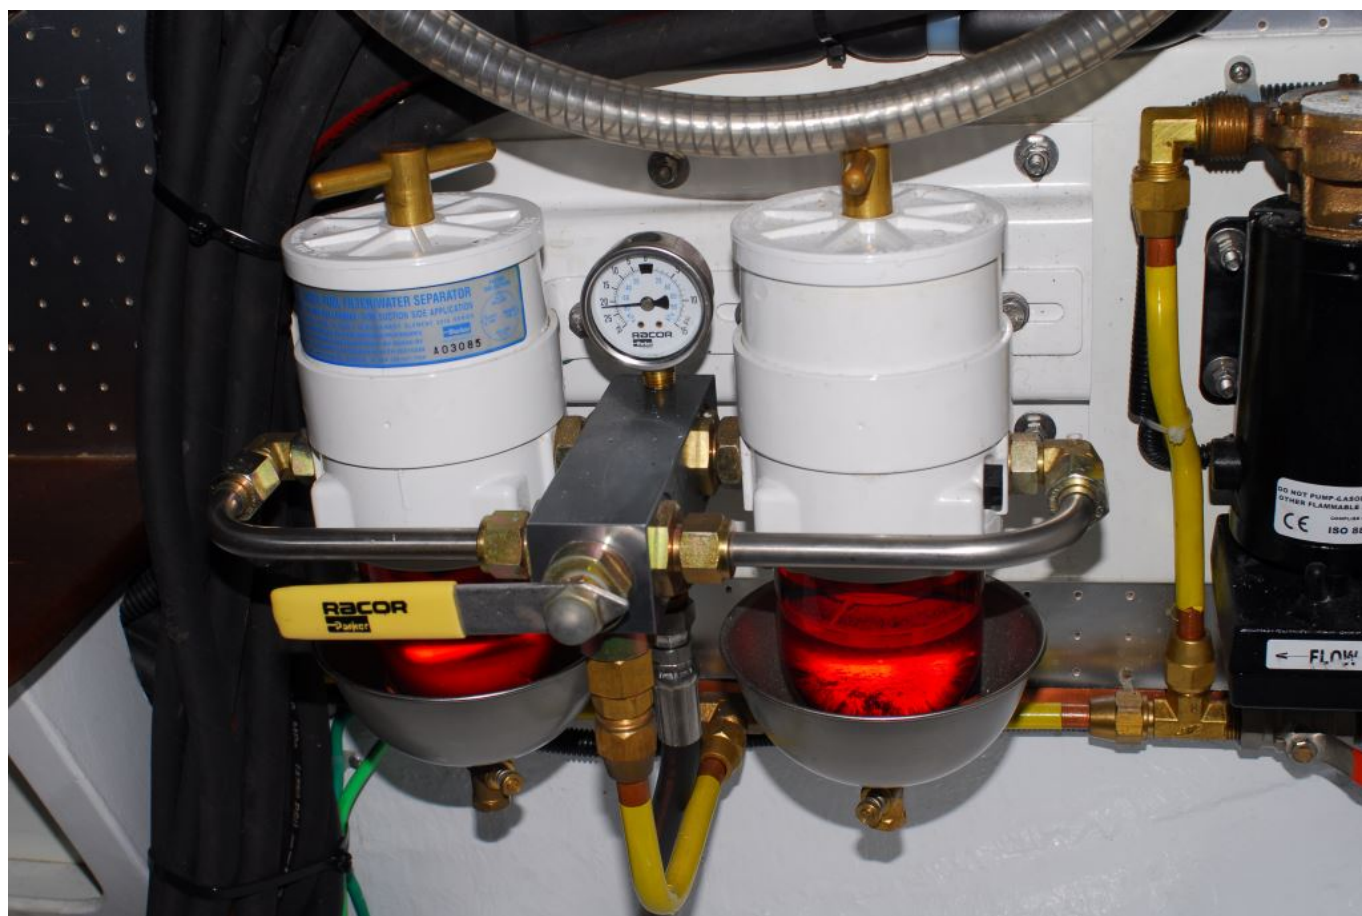
Racor Turbine Series filters offer users a host of advantageous features, and in the tandem arrangement like the

**one shown here, this includes built-in redundancy.**

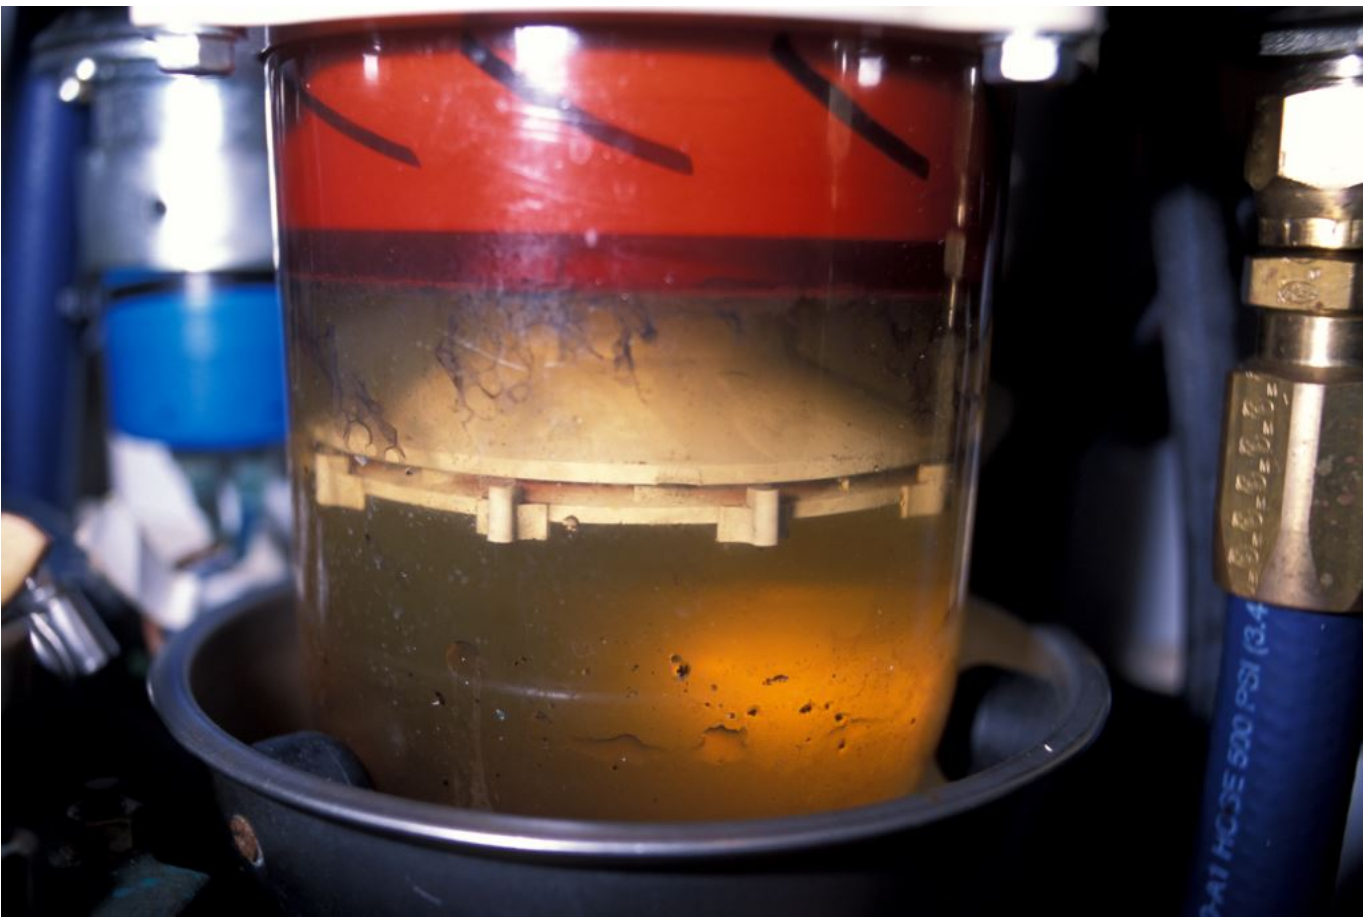
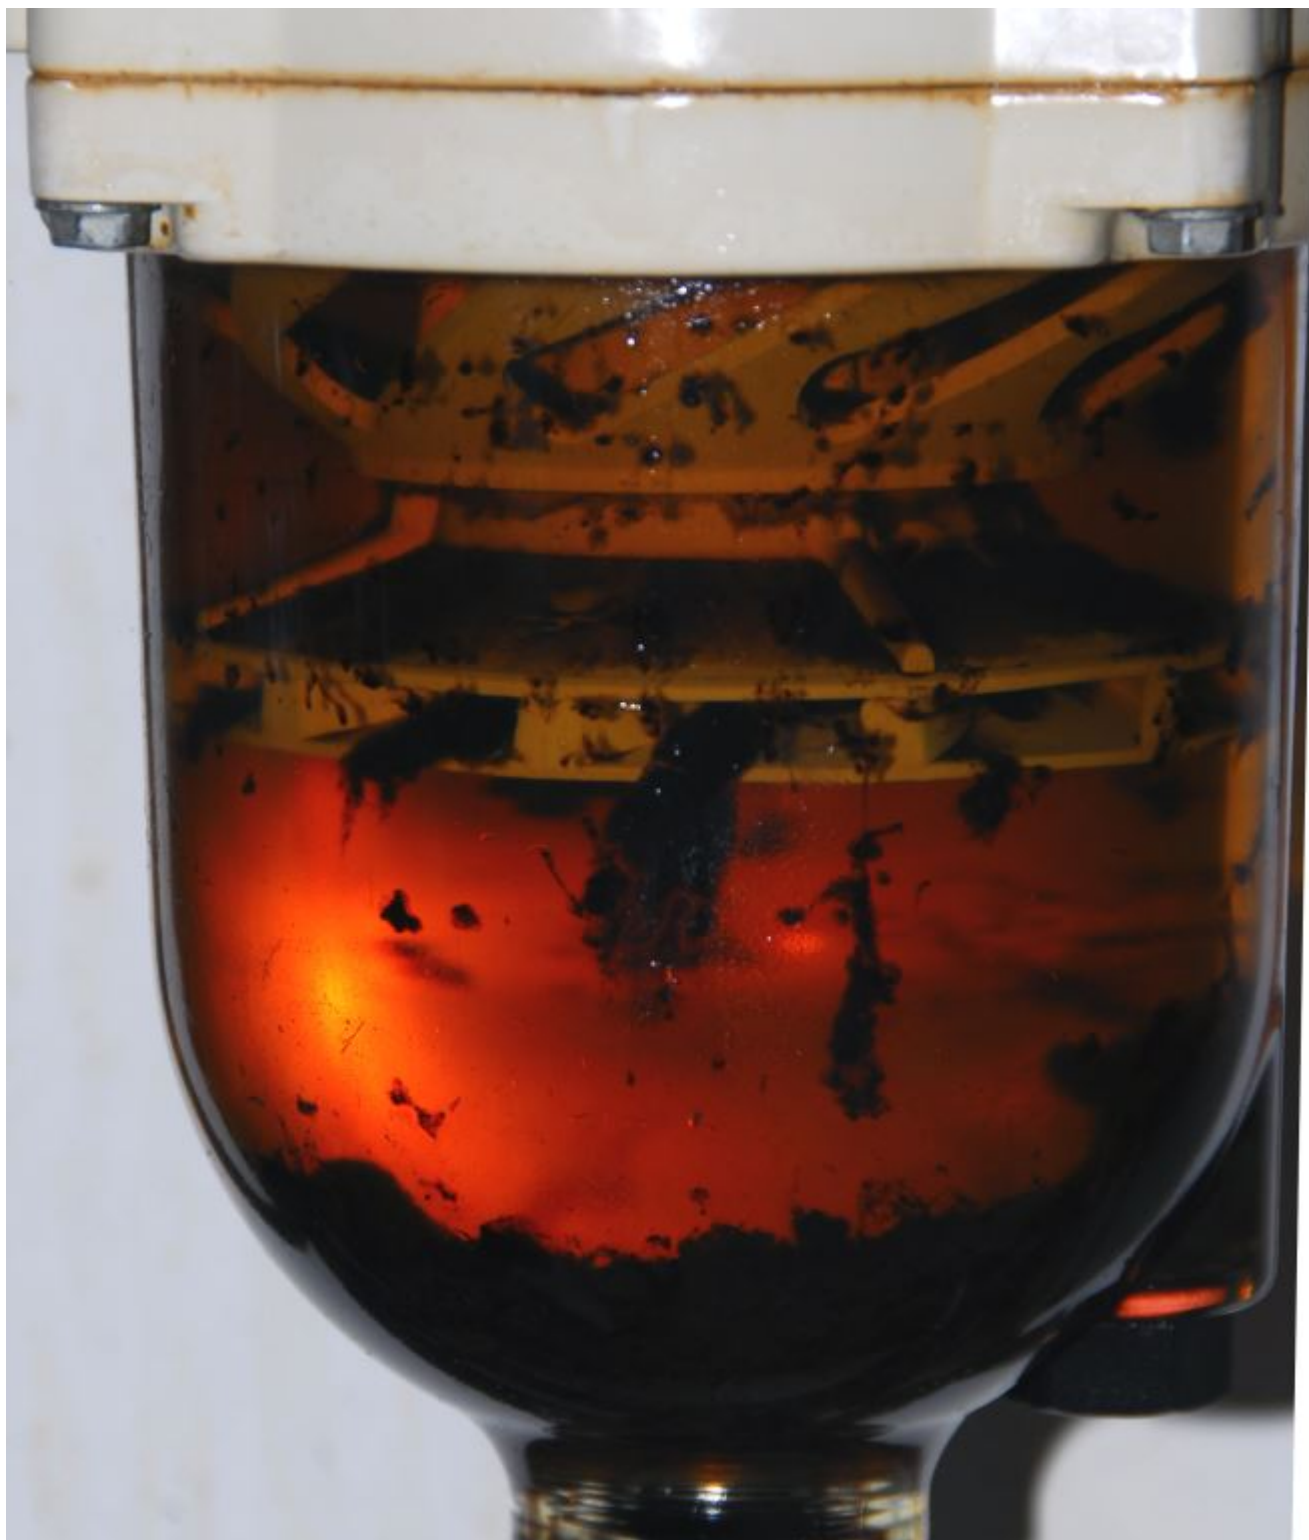
**The dirt and water holding capacity of Turbine filters carries with it near legendary status. The engines served by the filters shown here continued to operate without issue.**

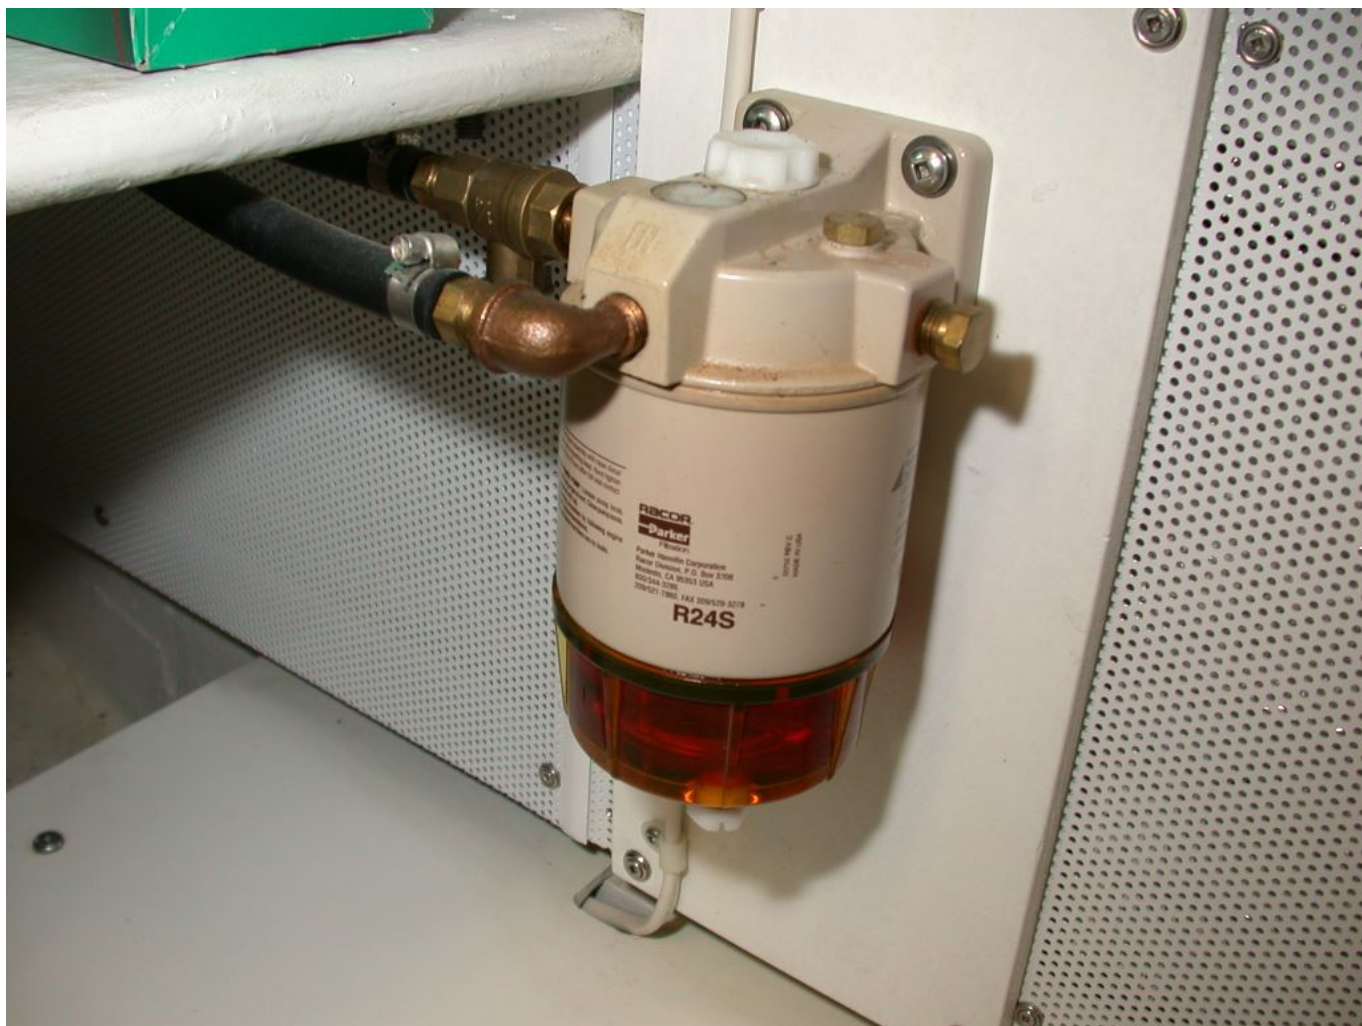
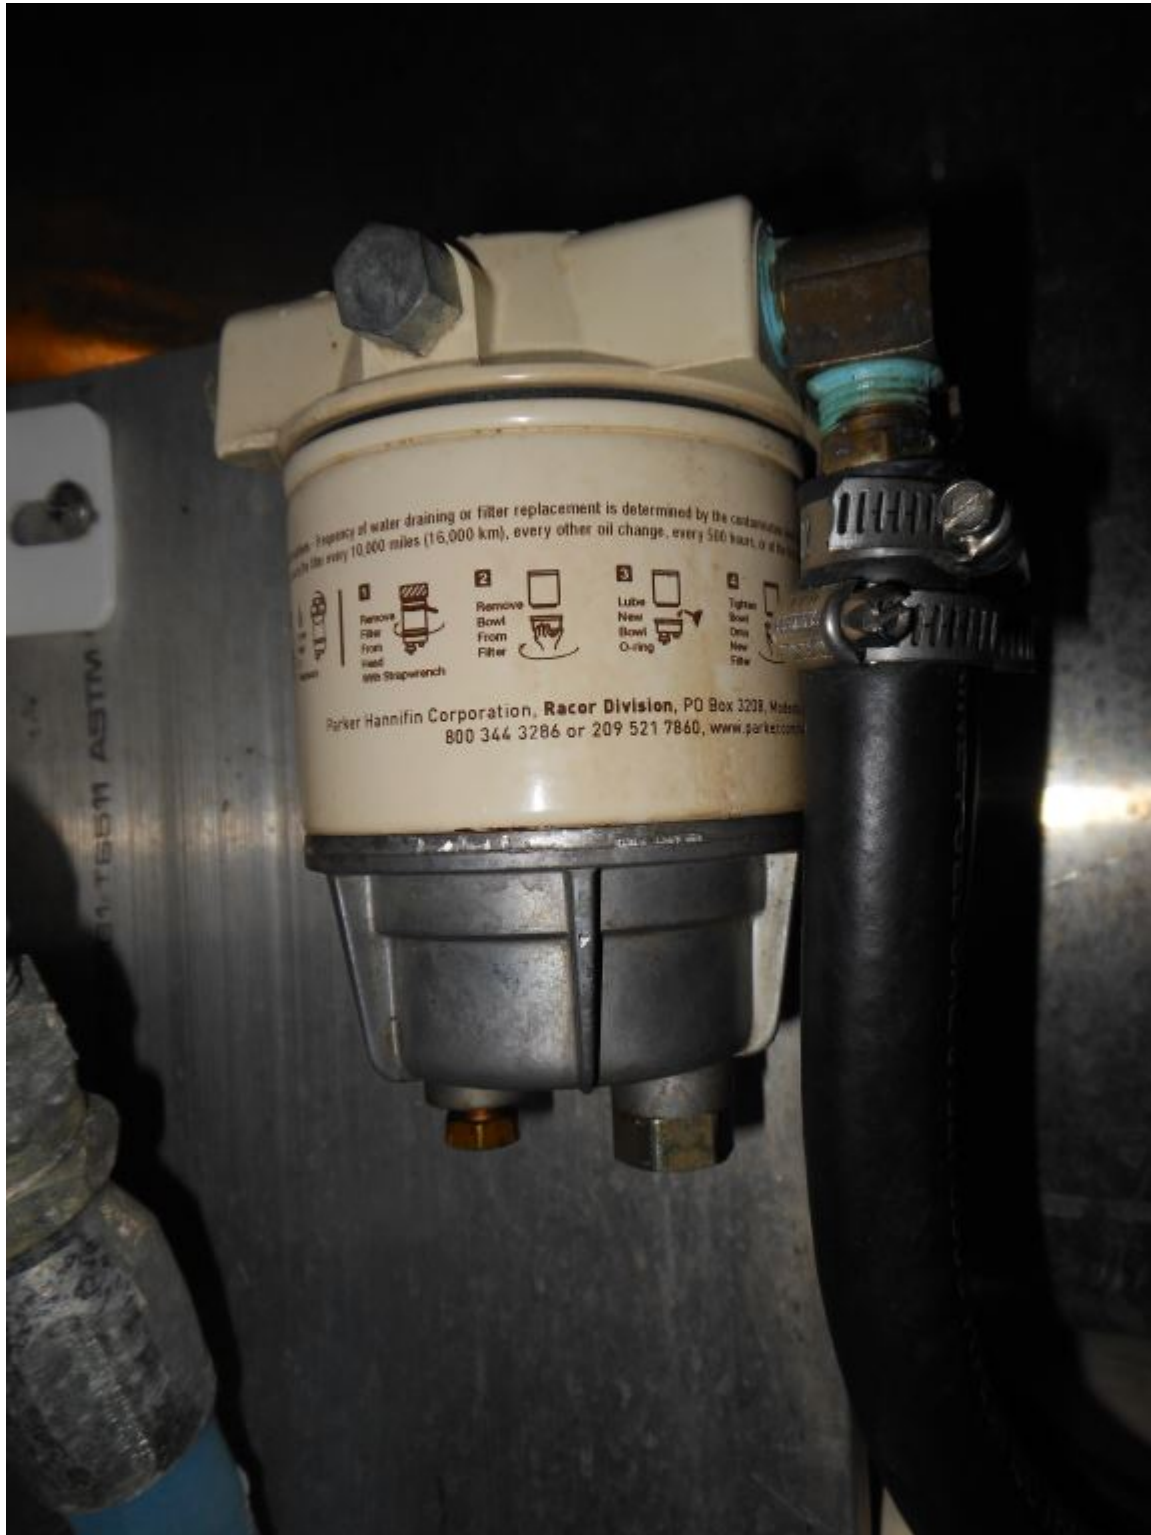
Smaller, non-turbine series filters may meet the fuel flow needs of generators and smaller propulsion engines, however, they are cumbersome to service, and in order to meet flame resistance standards they must forfeit their clear sight bowls, robbing them of one of their most valuable features.

Furthermore, and unlike larger aforementioned Turbine series filters, in order for them to meet the UL Marine/ABYC requirements for flame resistance, these smaller filters cannot include a clear plastic bowl; it must instead be metal, which means it can't be monitored for water or accumulation of debris.

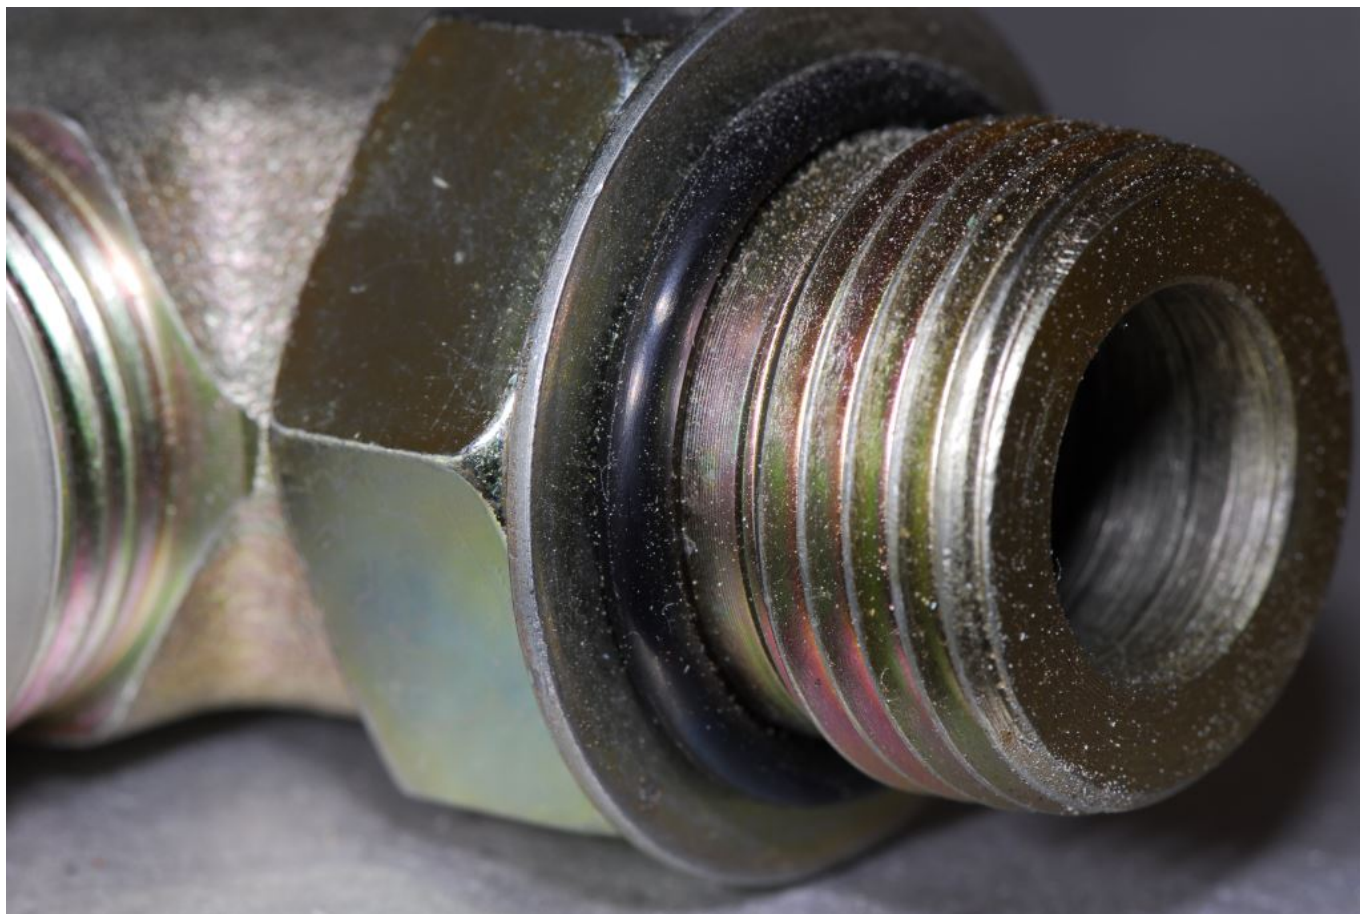
**The spot-face O ring seals used in Racor Turbine filters are virtually leak-proof.**

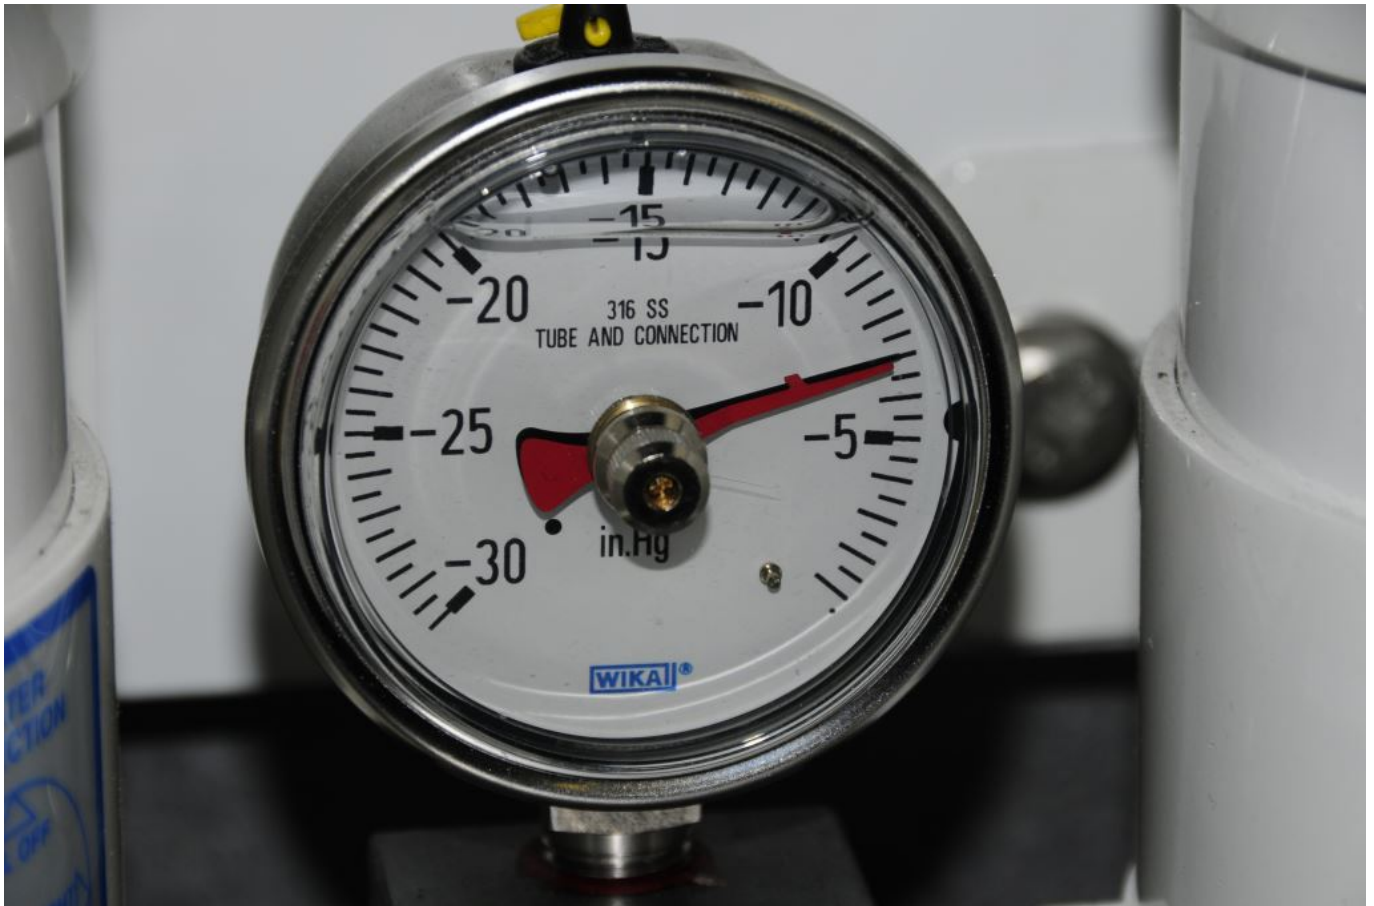
**Without a vacuum gauge, you are flying blind... short of an engine shut-down, they are the only means by which filter condition can be determined. Running without one is tantamount to operating an engine with no coolant temperature, or oil pressure, gauges.**

Far too few primary fuel filter installations take advantage of a small, relatively inexpensive yet invaluable component, a vacuum gauge. Without it, you have no way of knowing how much contamination has accumulated within the filter, and therefore no accurate means of knowing when it should be replaced. If a filter element shows no vacuum restriction, there's no need to

replace it; a vacuum gauge also serves as a useful troubleshooting tool. Additionally, a vacuum gauge can serve as a very handy troubleshooting tool, if an engine is running erratically, or lacks power, the vacuum gauge will almost certainly simplify the troubleshooting task. For more on vacuum gauges see [this article](#).

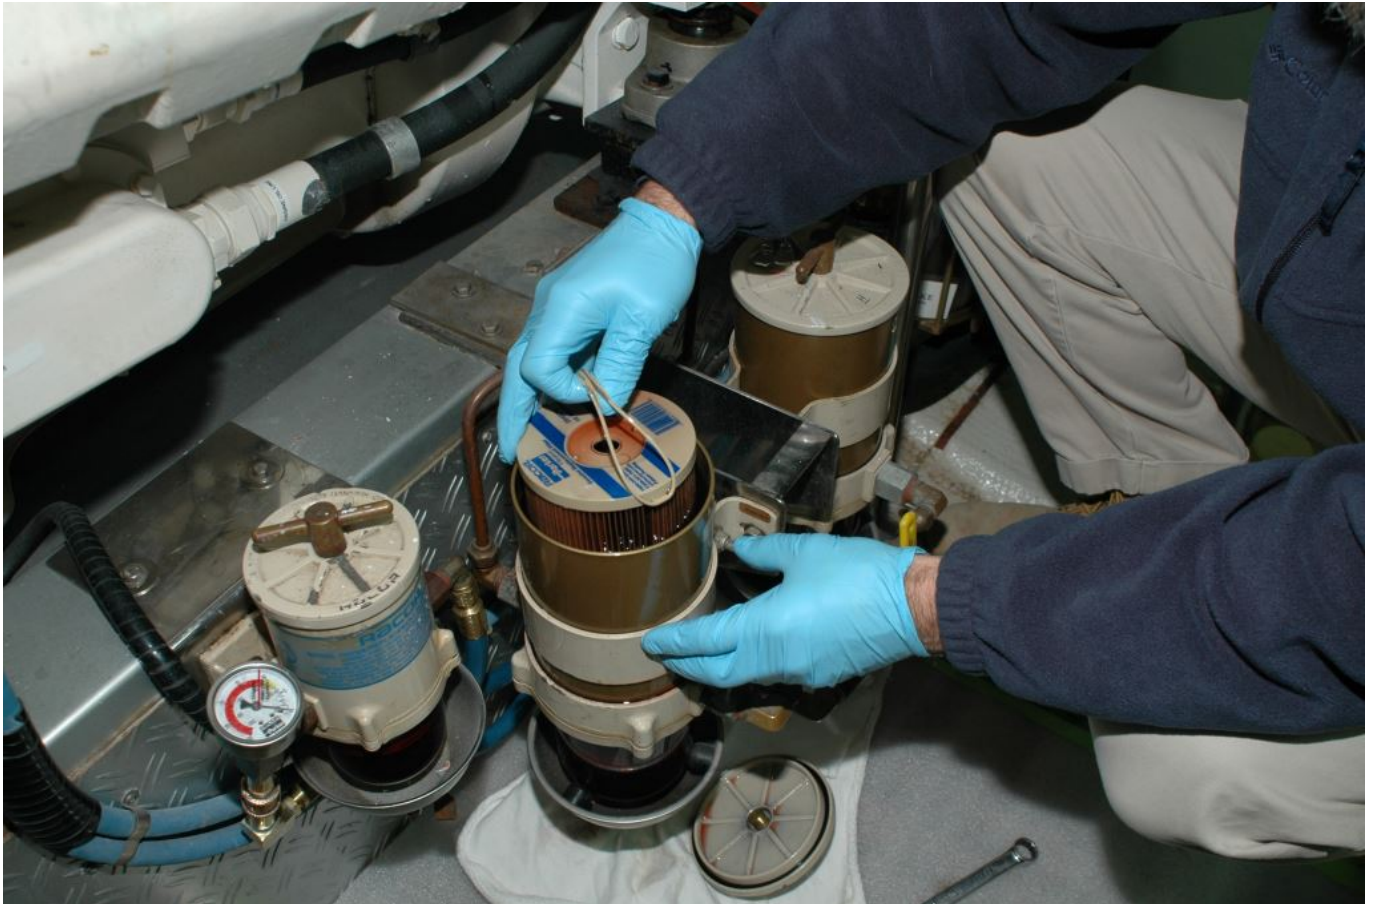
**Few attributes of a fuel filter trump ease of service. When priming primary fuel filters of the sort shown here, be sure to do so only with the new filter element installed, thereby ensuring all fuel that leaves the filter body has passed through the element.**

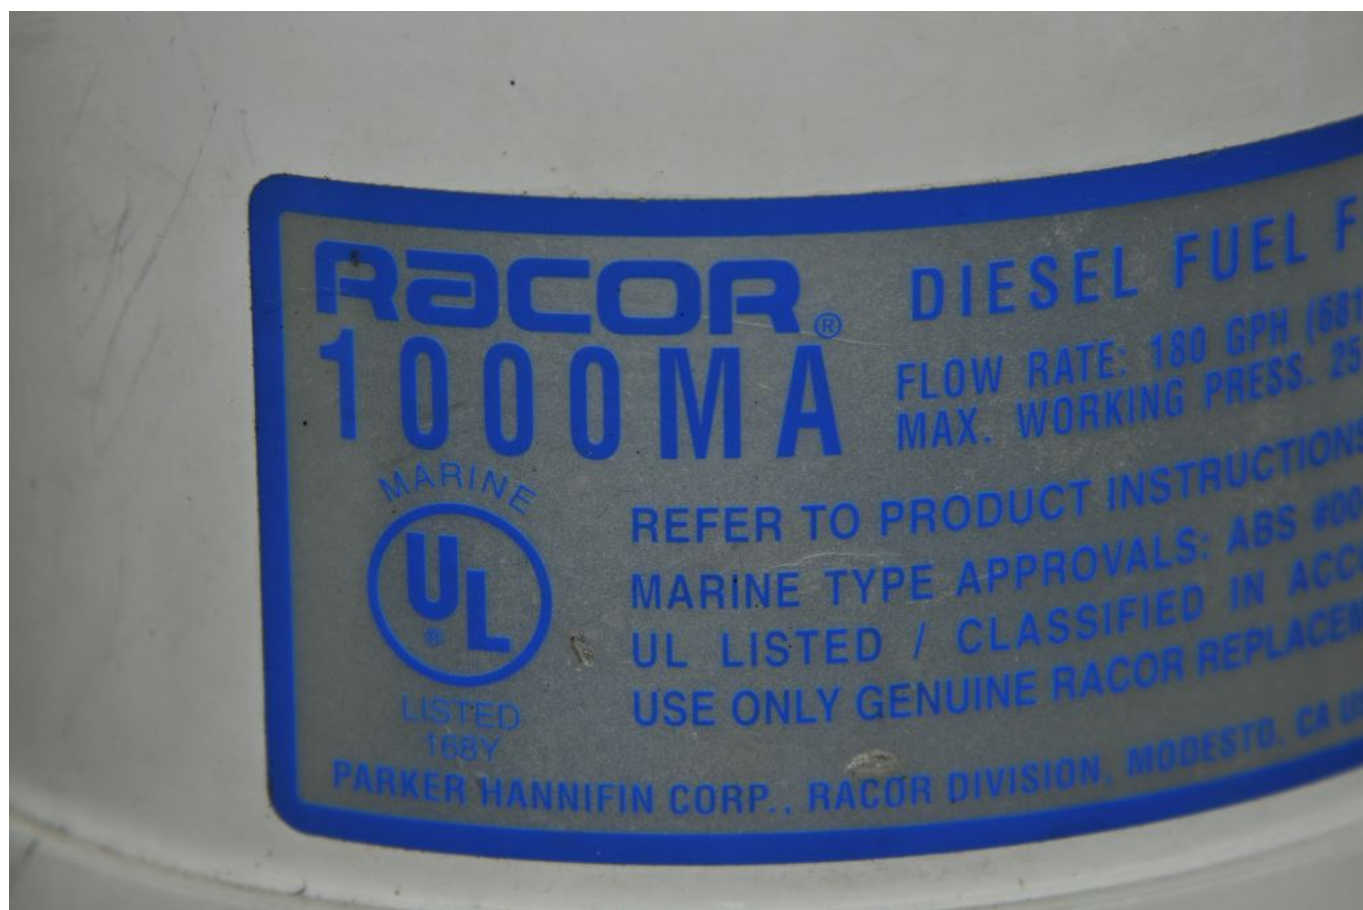
**The blue font label on a MA Series Turbine filter denotes its compliance with ABYC and UL flame resistance standards.**

flame without failing or leaking. Filters with plastic bowls and no heat shield nearly always lack compliance. Many boat builders, yards and DIY installers unknowingly install non-complaint filters, not realizing that they lack flame resistance compliance. Compliant Racor Turbine MA series filters incorporate two critical features; a heat shield for the bowl, and a metallic rather than plastic drain plug, the latter would melt when exposed to flame. Tellingly, the label on the marine-rated Racor Turbine MA series filters is blue; while Racor Turbine filters that lack flame resistance utilize labels with red or black lettering.

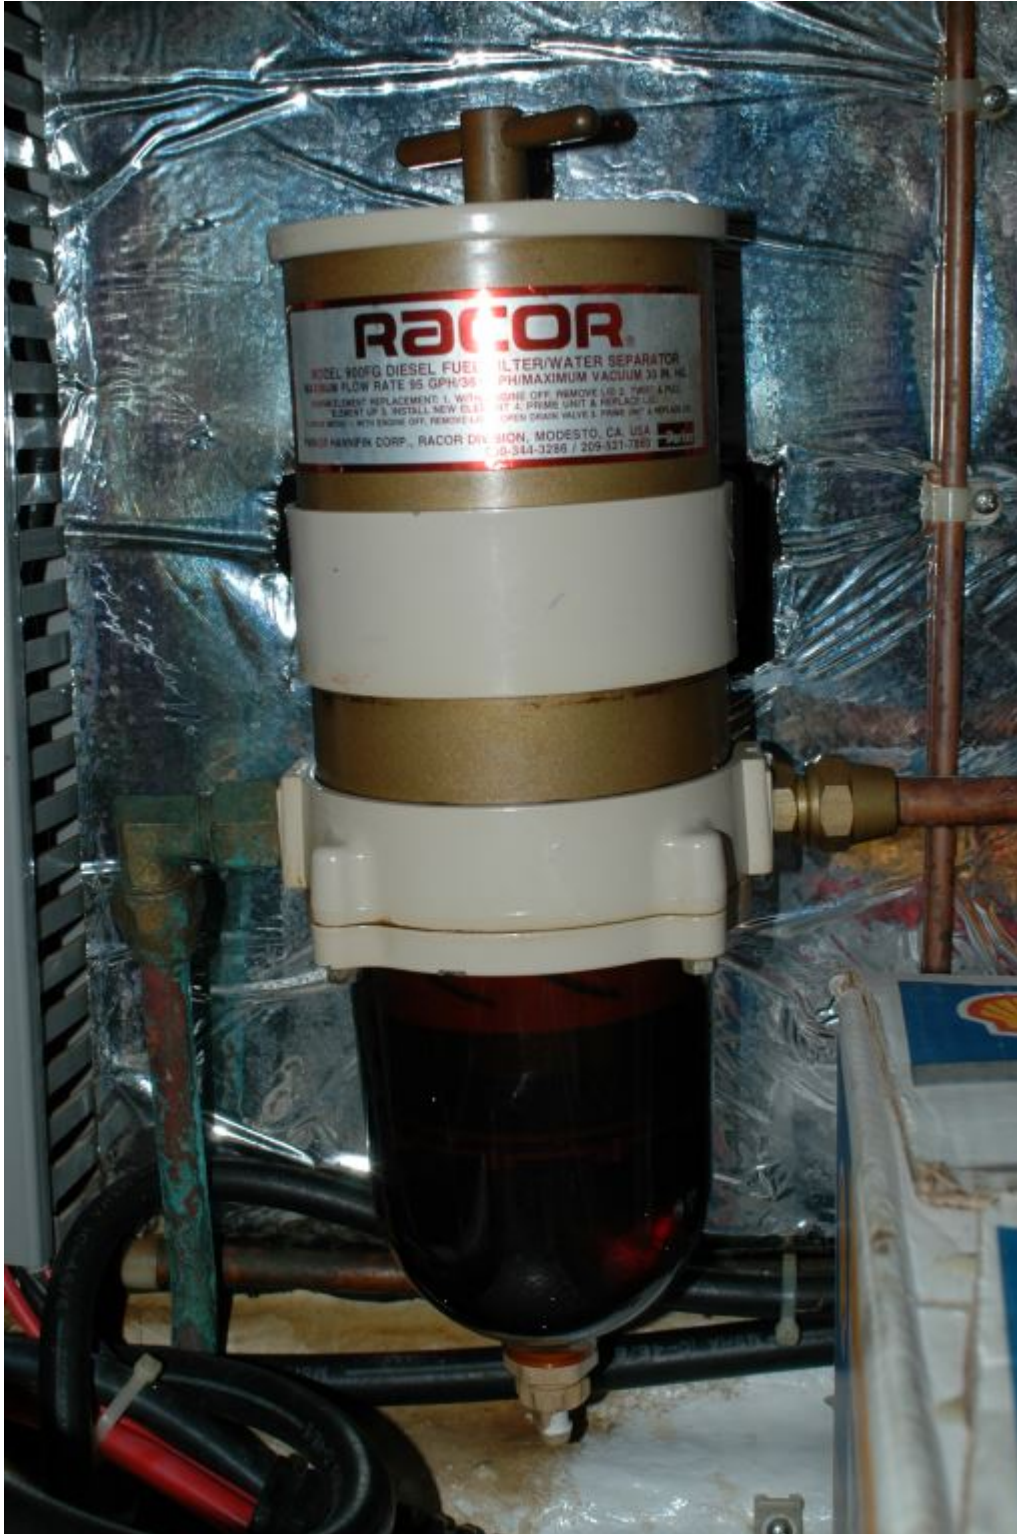
**The lack of a heat shield and the candy-apple-colored label text belie this Racor Turbine Series primary filter's industrial, rather than marine origins.**

For non-inspected vessels, i.e., non-commercial, non-paying passenger carrying, non-compliant filters, those that lack heat shields and metallic drain plugs, can be retrofitted with these parts for a fraction of the price of a complete new,

compliant filter assembly.

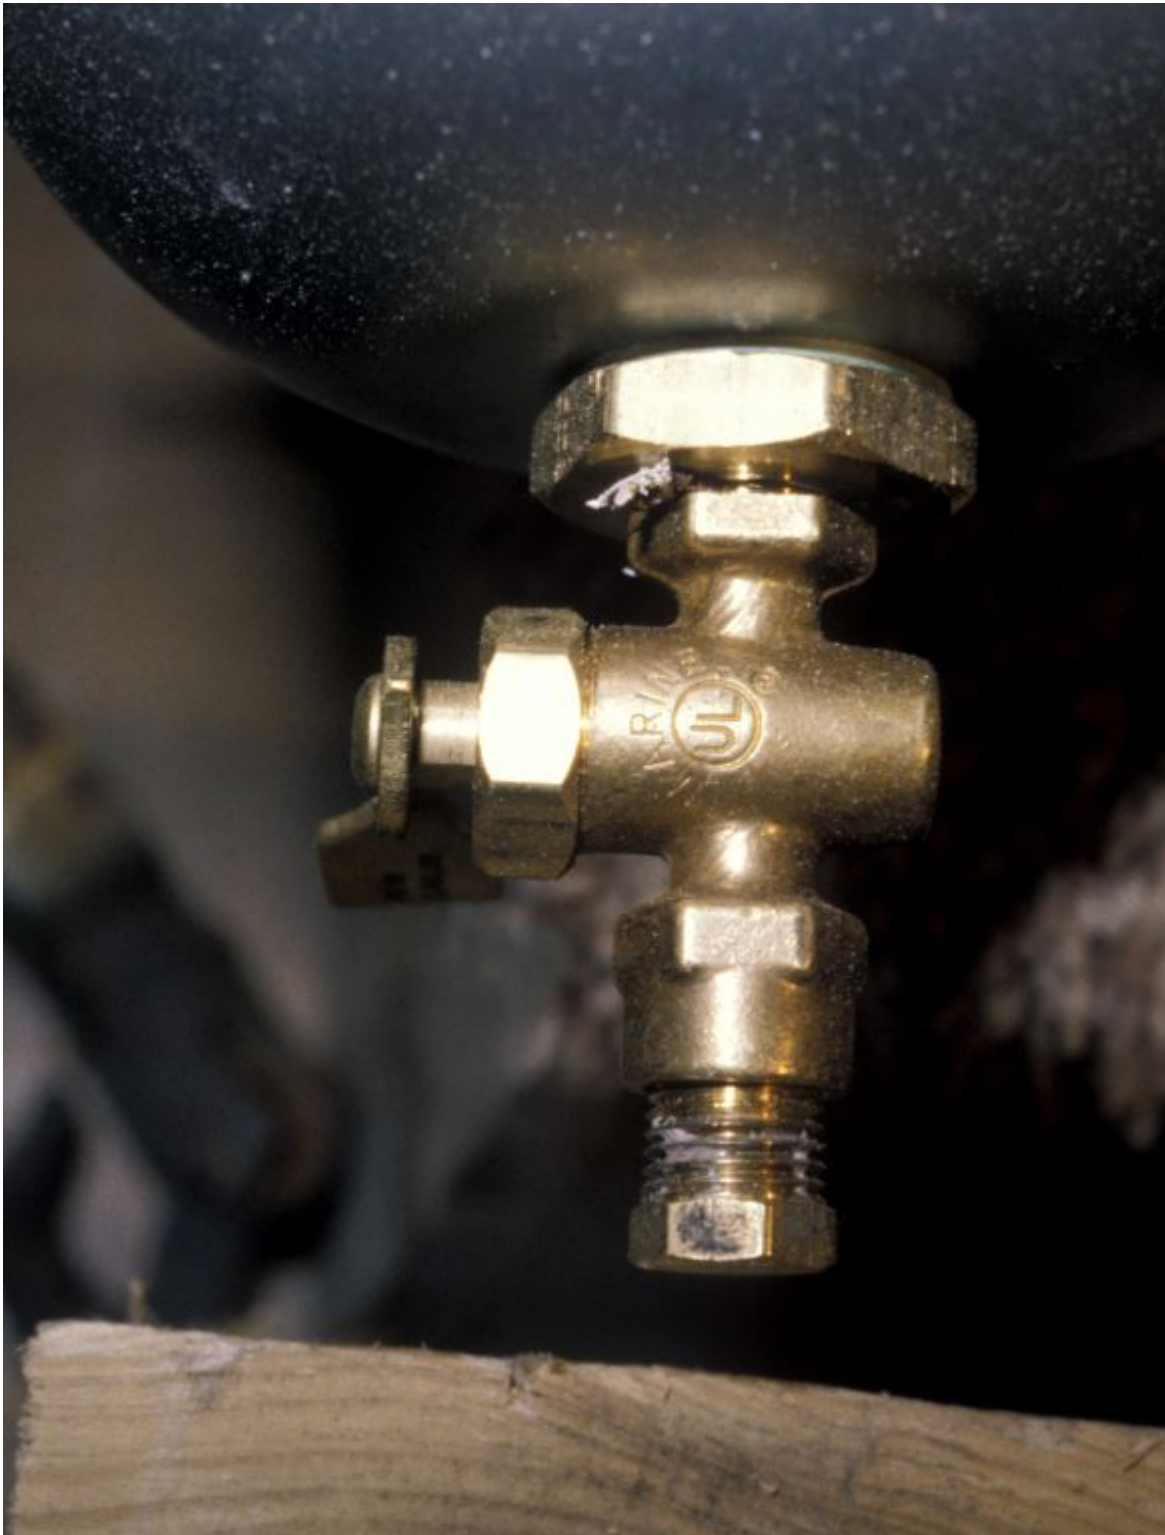
**A UL Listed Marine drain valve must embody two features, a valve barrel whose fuel-tight seal does not rely on spring tension, and a handle that rotates through no more and no less than 90 degrees.**

While many primary filters include provisions for drain valves, few include them out of the box, they must be added, and the Racor MA series is no exception. When doing so, be sure to select, once again, only valves that meet UL Marine and/or ABYC standards. These are characterized by a lack of springs to maintain tension within the valve and fuel-tight integrity, rotation that is no more and no less than 90°, and of course flame resistance, making plastic valves unacceptable.

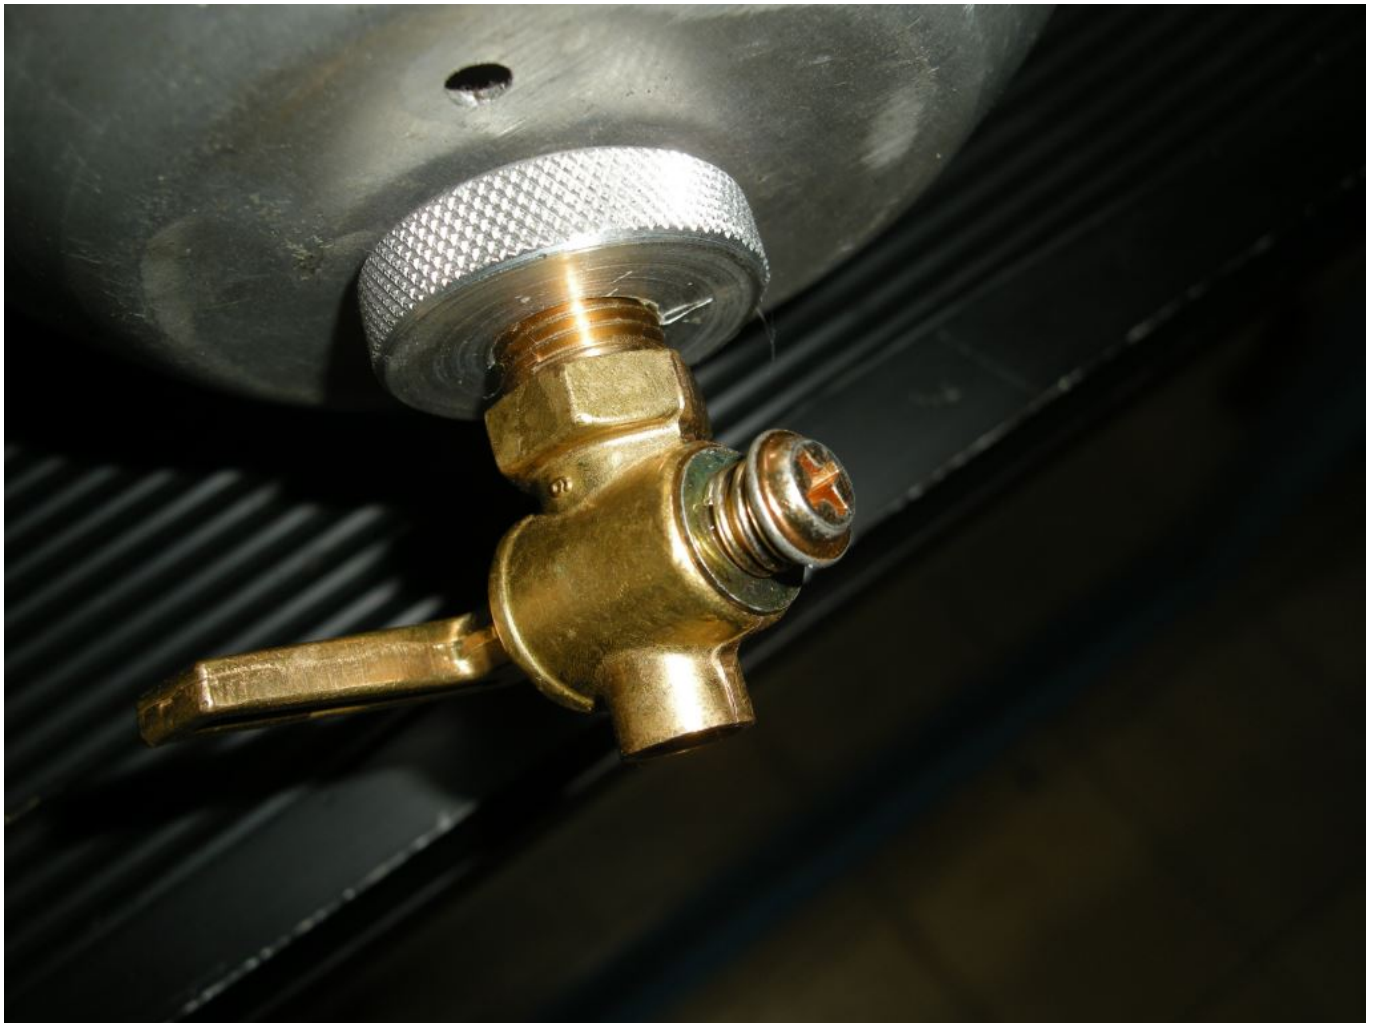
**This drain lacks ABYC compliance for several reasons, it relies on a spring-tensioned seal (the spring is mild steel, which can rust and break), it turns through 360 degrees, and it lacks a pipe plug to prevent spills.**

Finally, valve drains must be capped or plugged to prevent a fuel spill should the valve handle be inadvertently moved. If the filter is located below the fuel level, such an inadvertently opened valve could lead to hundreds or even thousands of gallons of fuel leaking into the bilge. I once observed such a scenario, on a vessel undergoing repairs; the bilge filled with about 100 gallons of fuel. Fatefully, it was hauled at the time (and stored inside a shed), and the

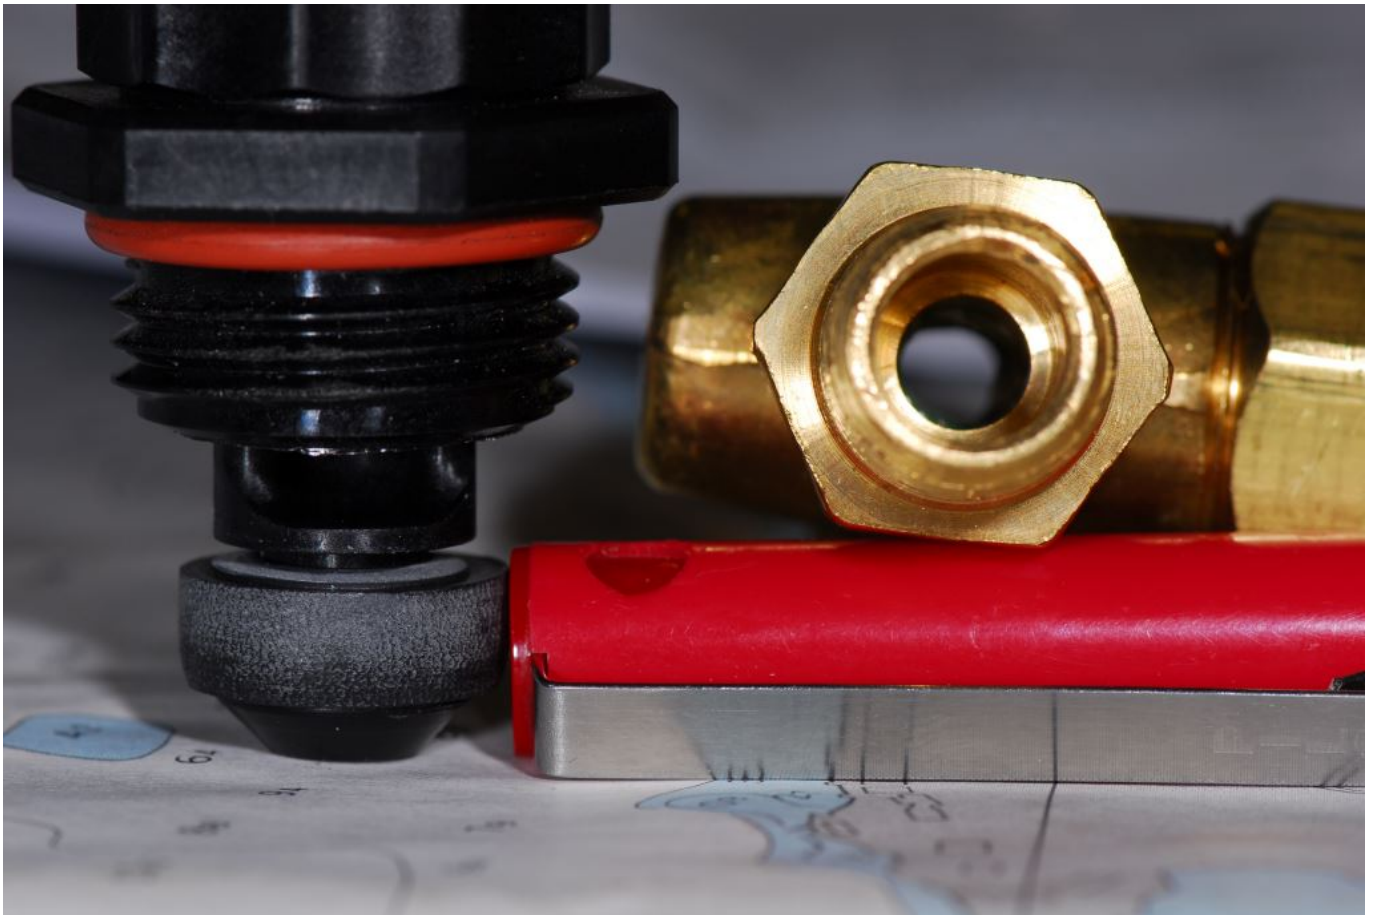
**Plastic drain valves not only lack flame resistance, thanks to their smaller, and 90 degree, orifices they are more easily clogged.**
