Selecting Primary Fuel Filters; There's more to it than meets the eye – Editorial: A Loose Bolt, a Cigarette Lighter and Distracted Work

Selecting Primary Fuel Filters

There's more to it than meets the eye

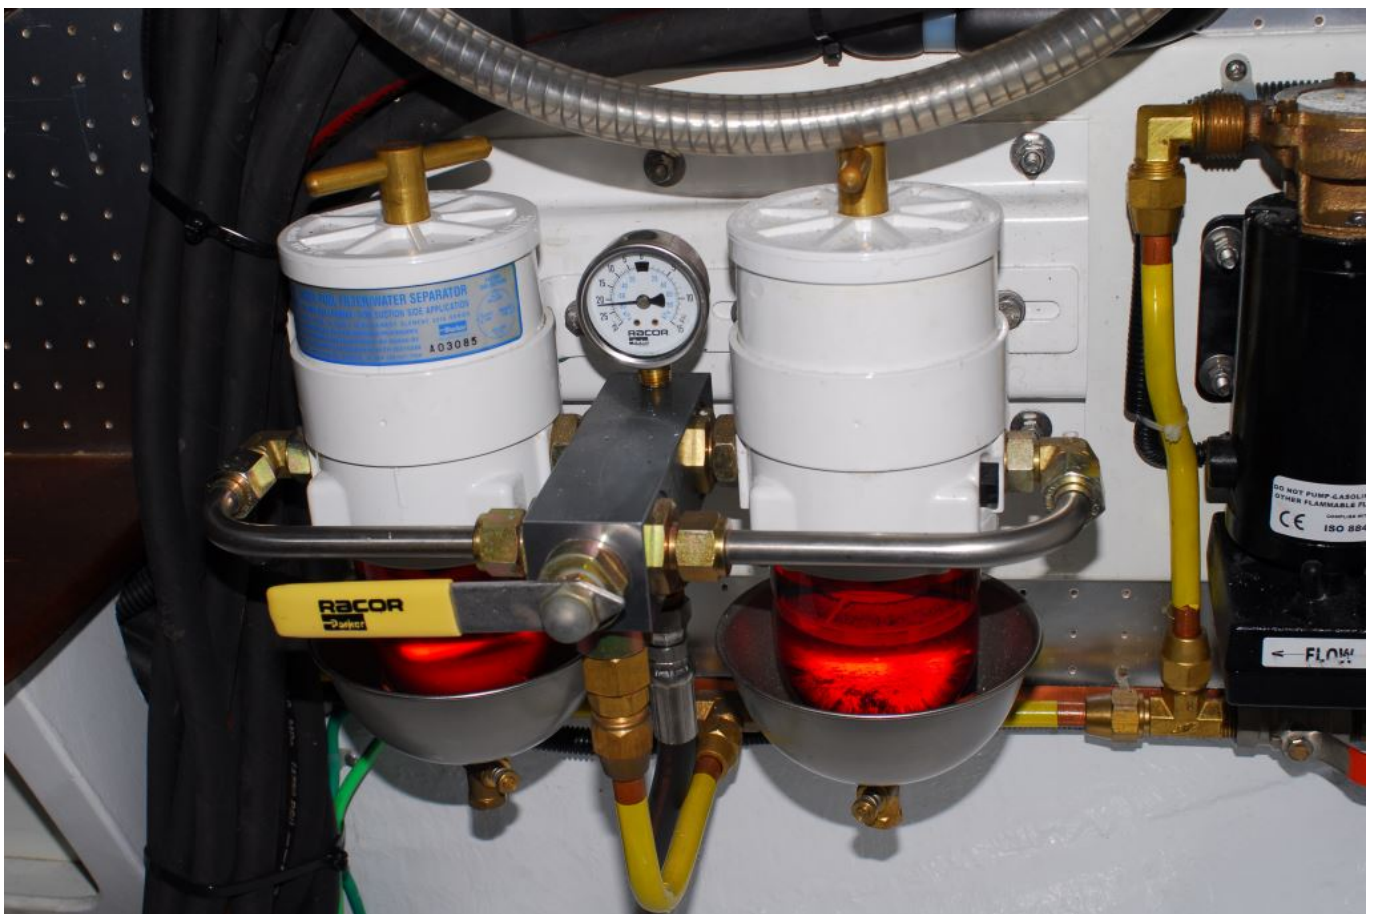
Racor Turbine Series filters offer users a host of advantageous features, and in the tandem arrangement like the

one shown here, this includes built-in redundancy.

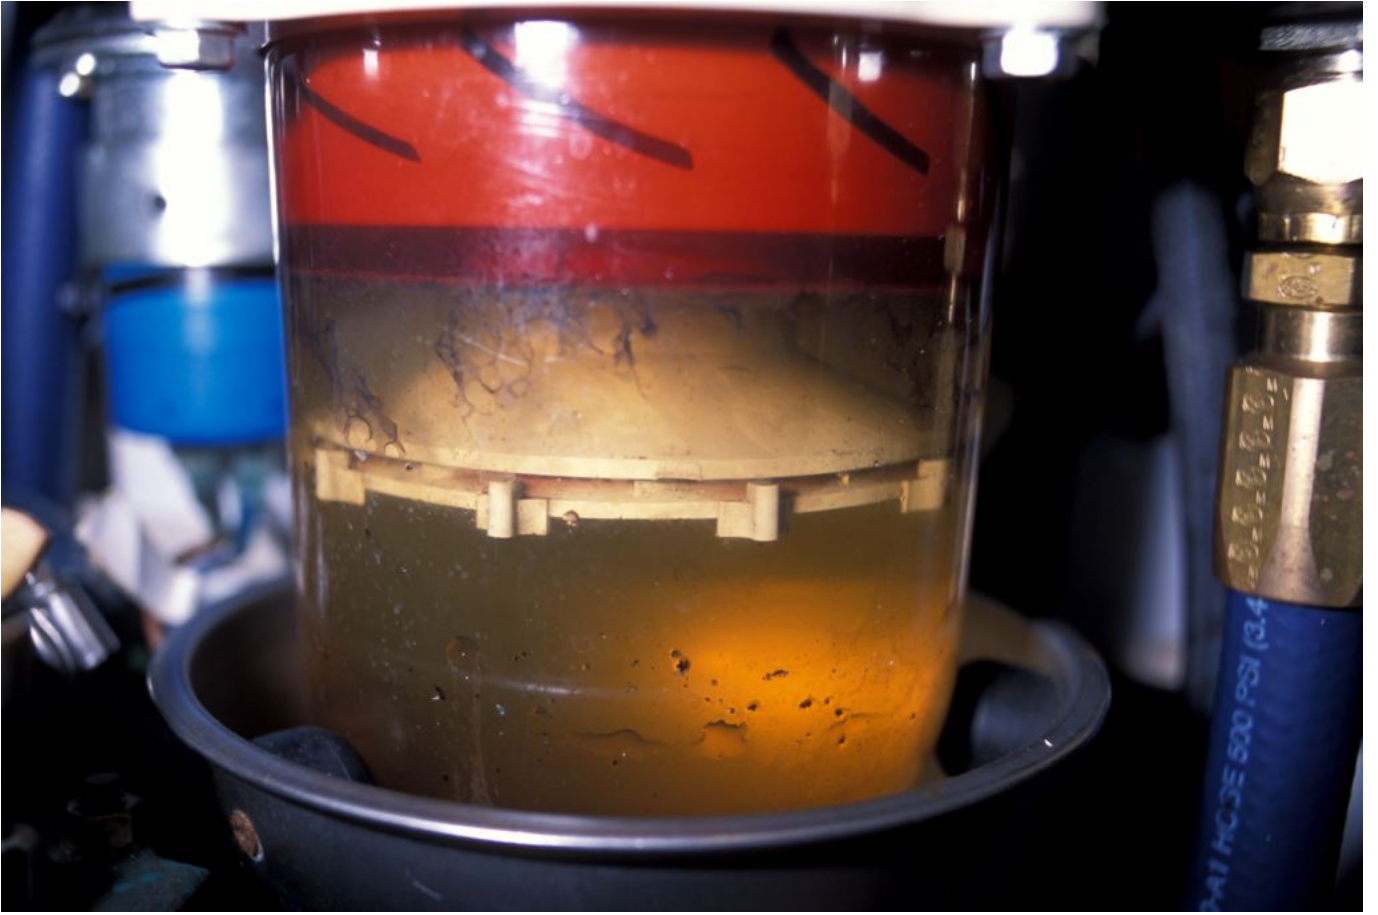
The dirt and water holding capacity of Turbine filters carries with it near legendary status. The engines served by the filters shown here continued to operate without issue.

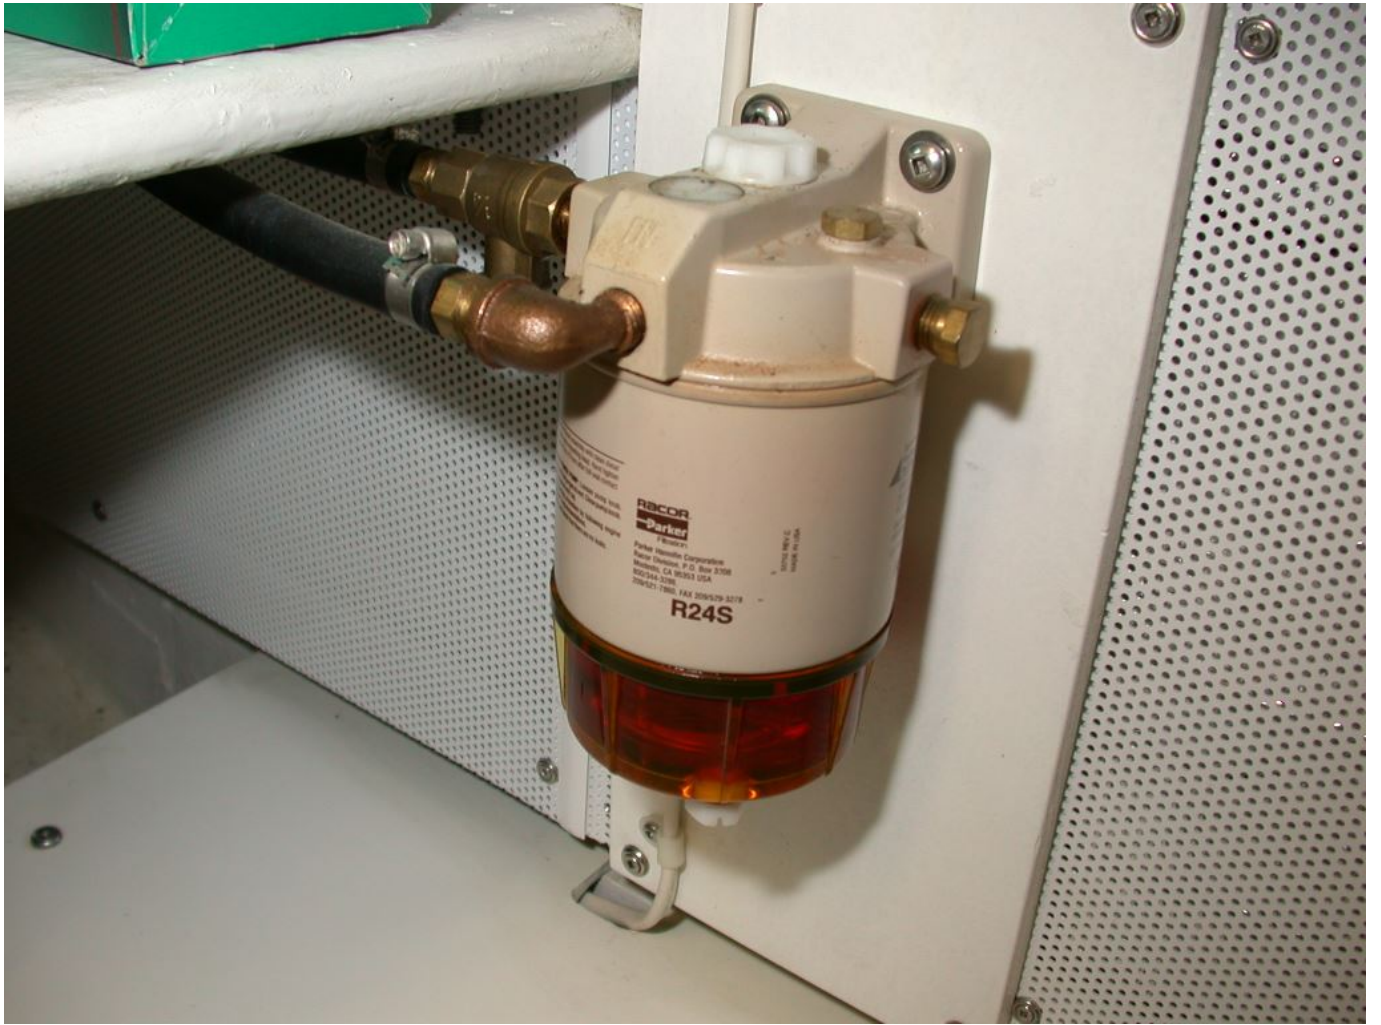
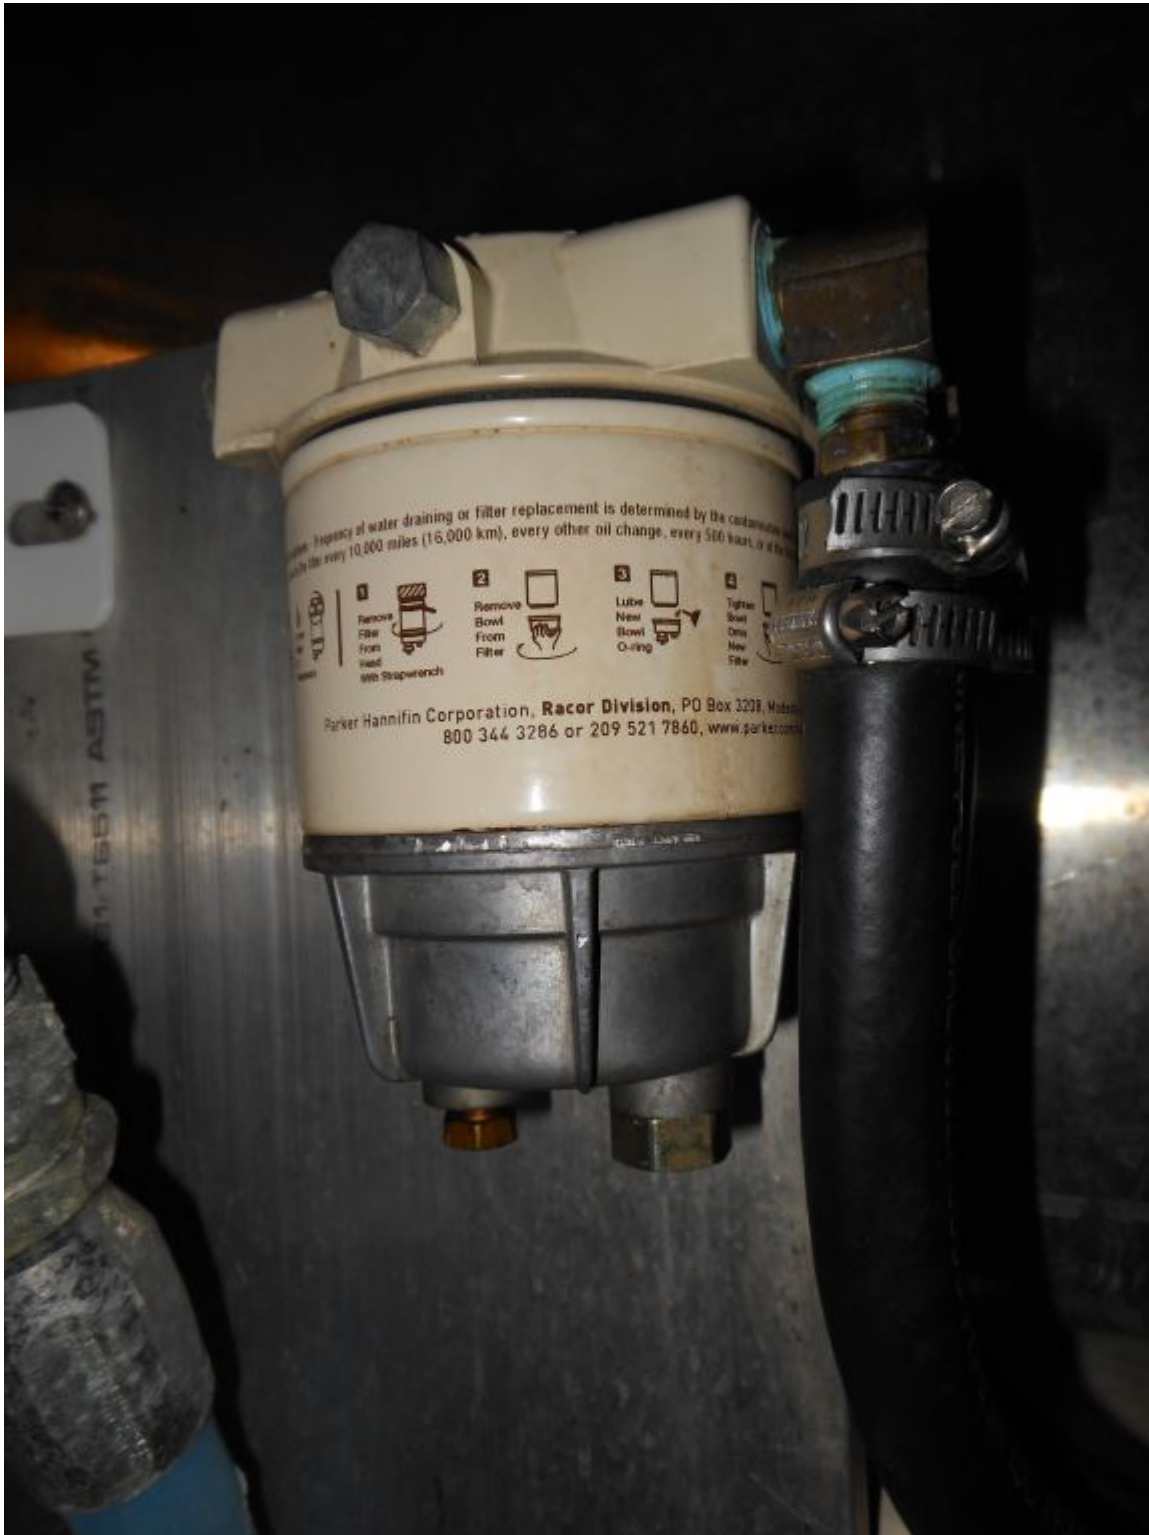
Smaller, non-turbine series filters may meet the fuel flow needs of generators and smaller propulsion engines, however, they are cumbersome to service, and in order to meet flame resistance standards they must forfeit their clear sight bowls, robbing them of one of their most valuable features.

Furthermore, and unlike larger aforementioned Turbine series filters, in order for them to meet the UL Marine/ABYC requirements for flame resistance, these smaller filters cannot include a clear plastic bowl; it must instead be metal, which means it can't be monitored for water or accumulation of debris.

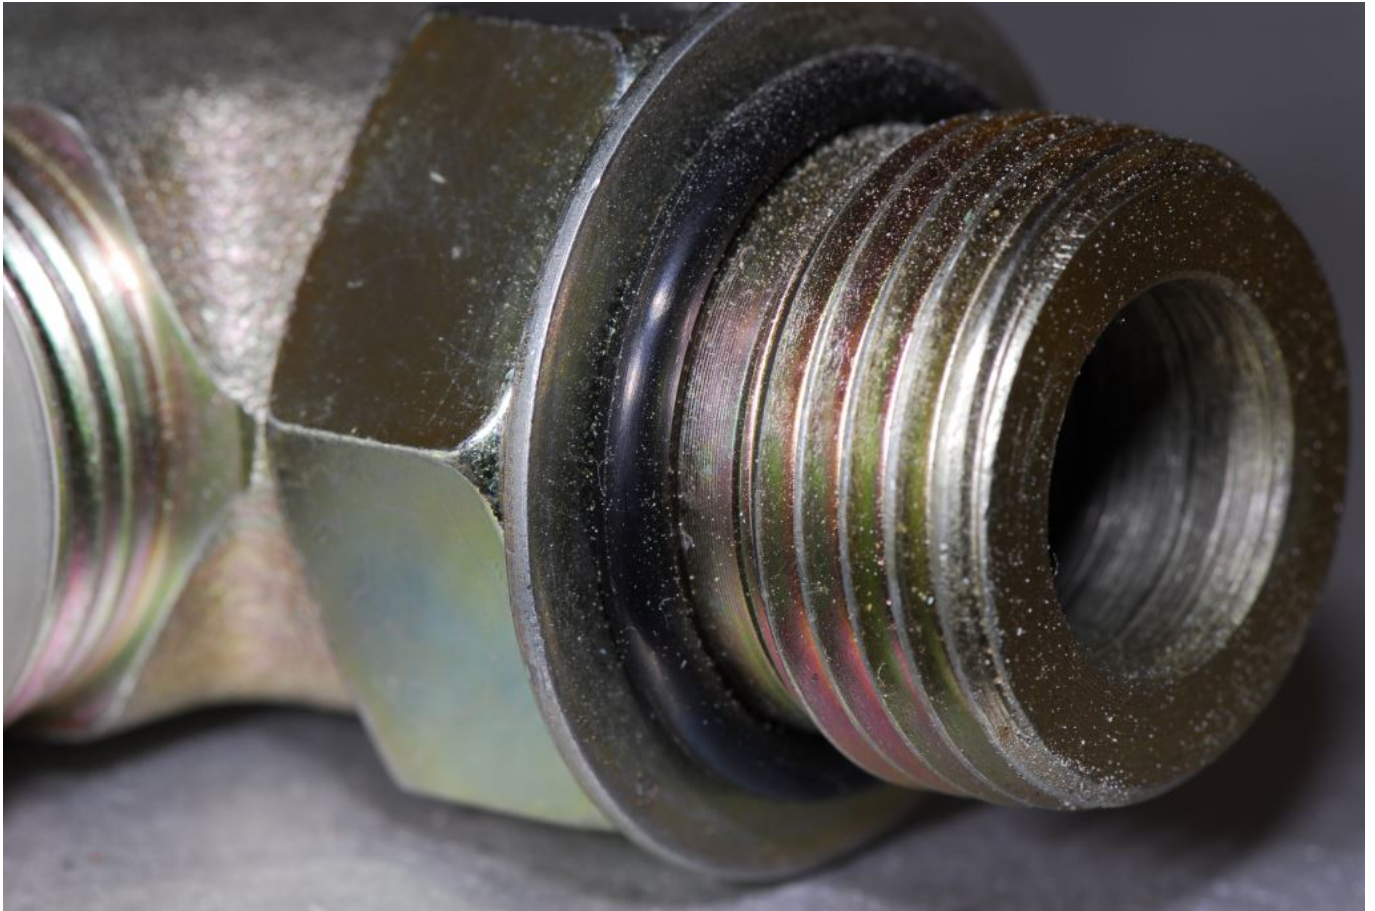
The spot-face O ring seals used in Racor Turbine filters are virtually leak-proof.

series of extremely valuable yet often overlooked traits that include a large, clear bowl, a T handle that makes for easy, tool-free replacement, provisions for a water in fuel indicator – a must in my view – full ABYC and UL Marine compliance for fire resistance, O ring fittings that are virtually guaranteed to be leak free, and readily available replacement elements in the appropriate primary ratings of 10 and 30 microns.

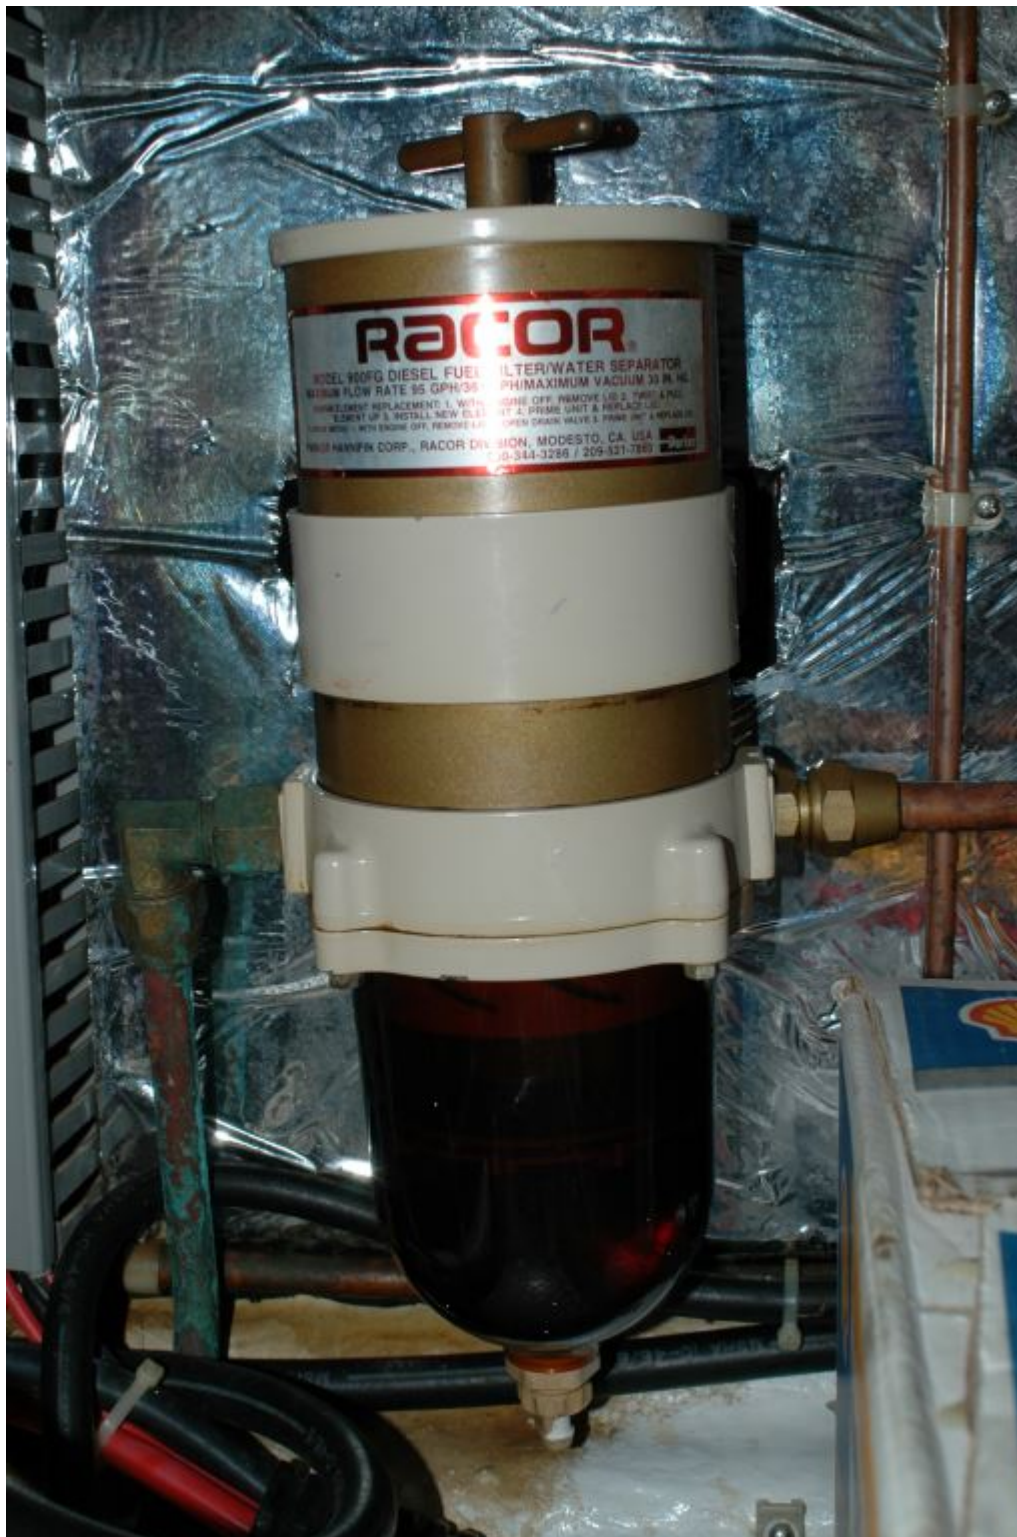
The lack of a heat shield and the candy-apple-colored label text belie this Racor Turbine Series primary filter's industrial, rather than marine origins.

For non-inspected vessels, i.e., non-commercial, non-paying passenger carrying, non-compliant filters, those that lack heat shields and metallic drain plugs, can be retrofitted with these parts for a fraction of the price of a complete new,

compliant filter assembly.

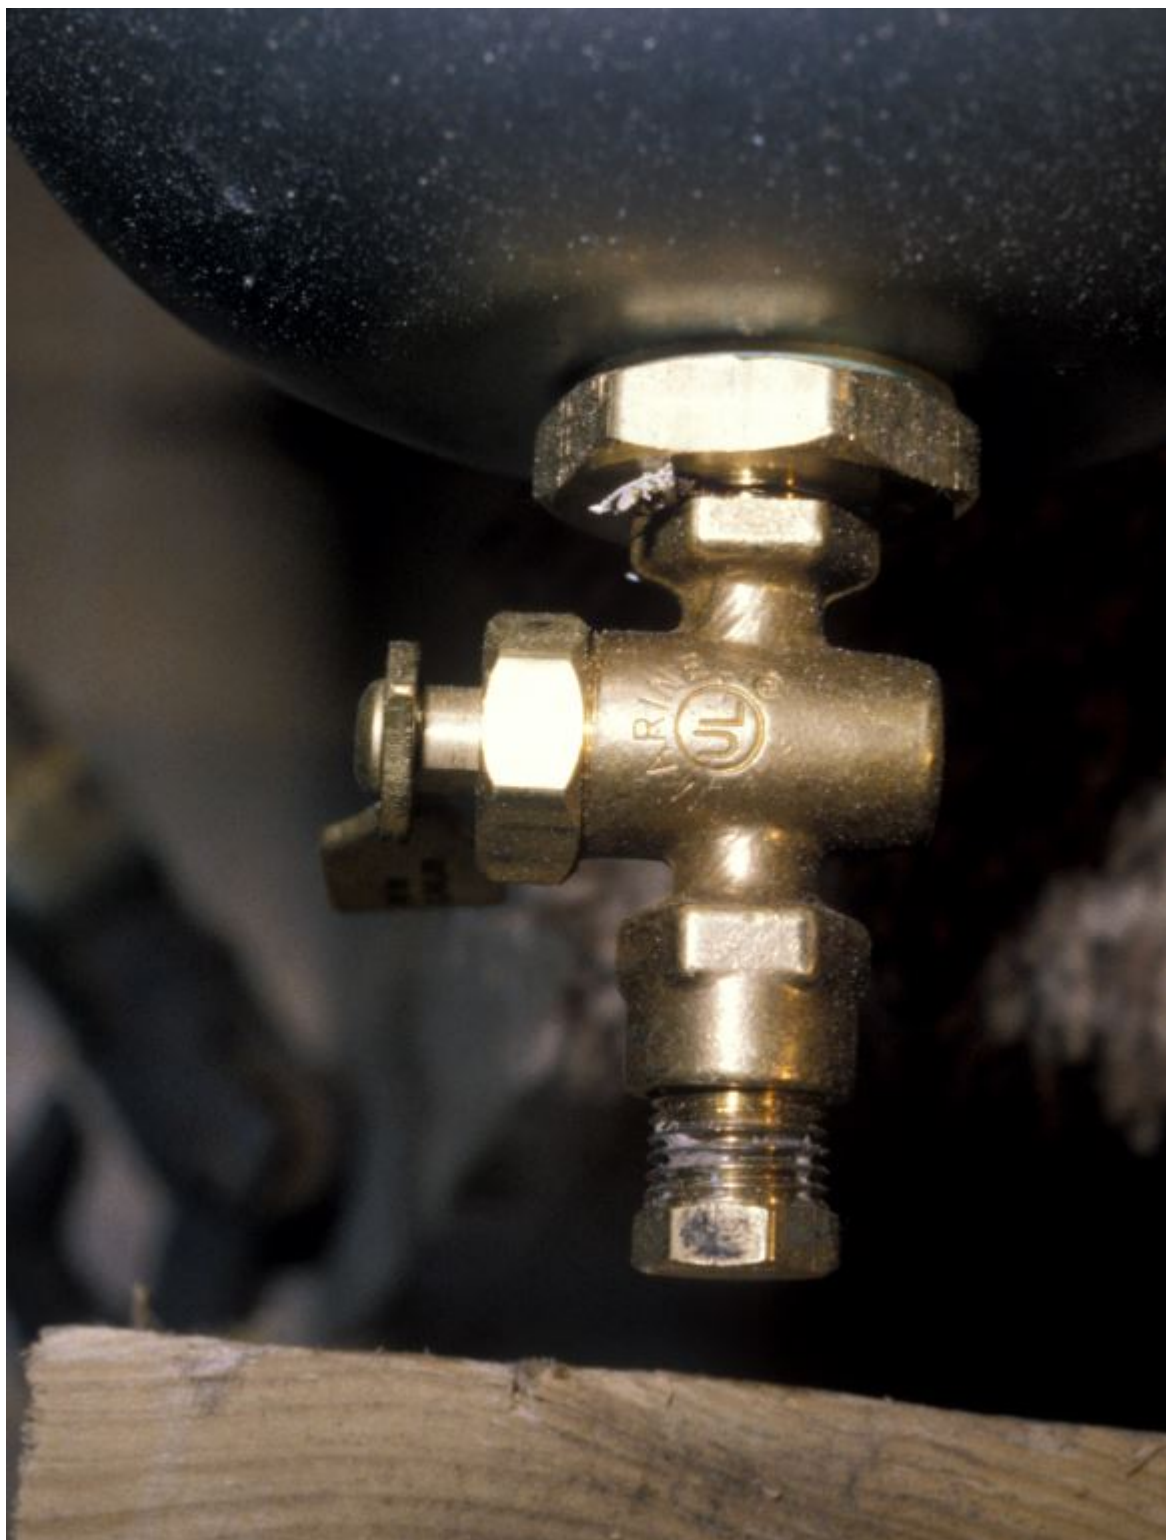
A UL Listed Marine drain valve must embody two features, a valve barrel whose fuel-tight seal does not rely on spring tension, and a handle that rotates through no more and no less than 90 degrees.

While many primary filters include provisions for drain valves, few include them out of the box, they must be added, and the Racor MA series is no exception. When doing so, be sure to select, once again, only valves that meet UL Marine and/or ABYC standards. These are characterized by a lack of springs to maintain tension within the valve and fuel-tight integrity, rotation that is no more and no less than 90°, and of course flame resistance, making plastic valves unacceptable.

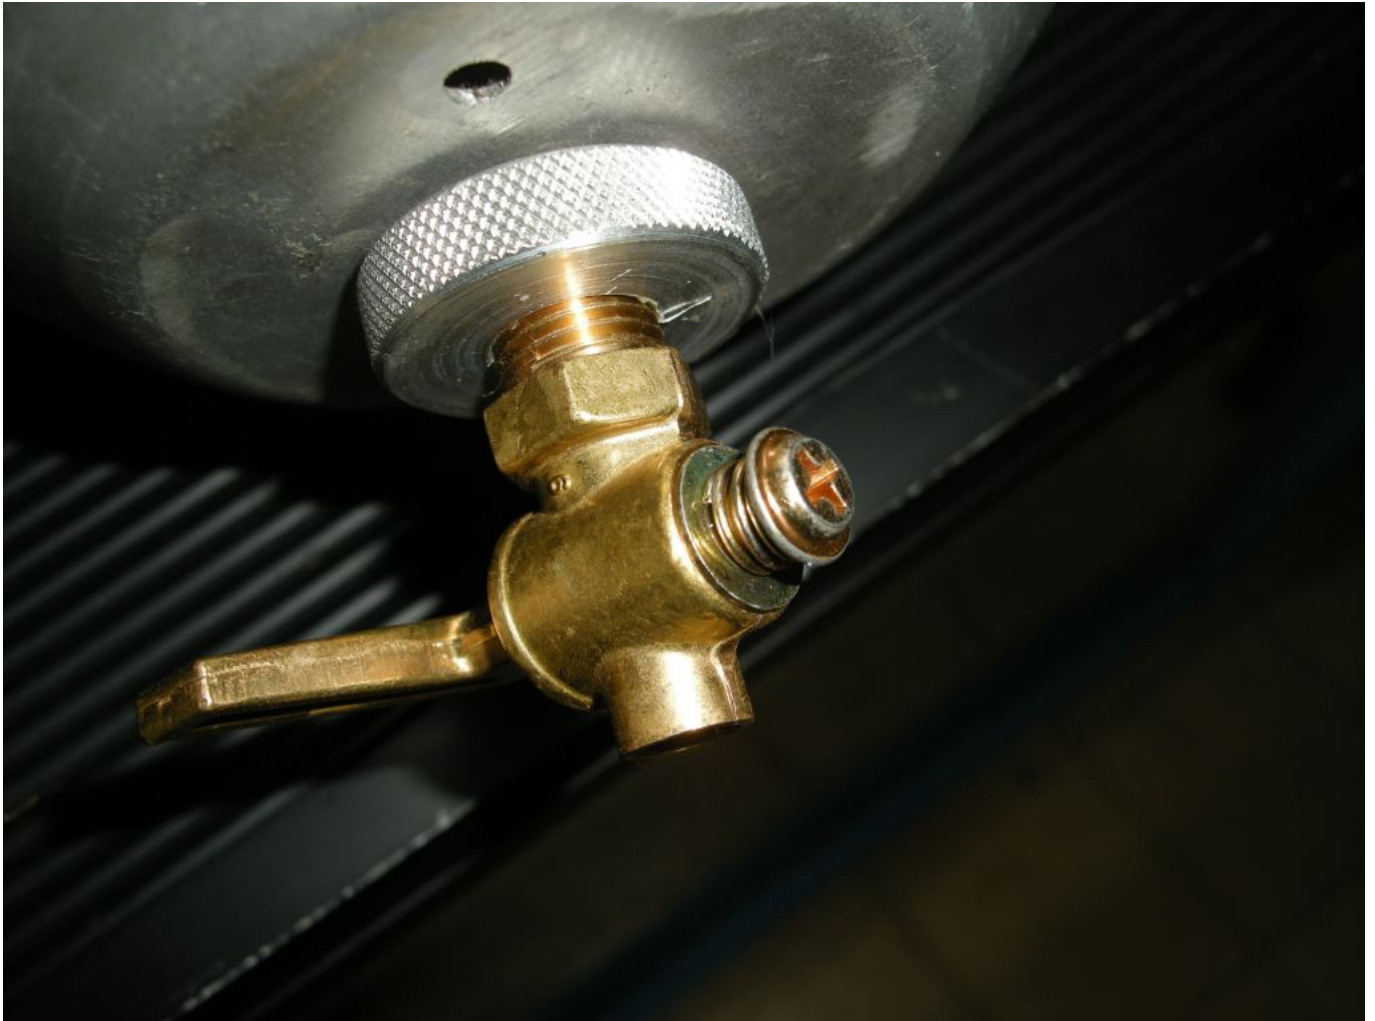
This drain lacks ABYC compliance for several reasons, it relies on a spring-tensioned seal (the spring is mild steel, which can rust and break), it turns through 360 degrees, and it lacks a pipe plug to prevent spills.

Finally, valve drains must be capped or plugged to prevent a fuel spill should the valve handle be inadvertently moved. If the filter is located below the fuel level, such an inadvertently opened valve could lead to hundreds or even thousands of gallons of fuel leaking into the bilge. I once observed such a scenario, on a vessel undergoing repairs; the bilge filled with about 100 gallons of fuel. Fatefully, it was hauled at the time (and stored inside a shed), and the

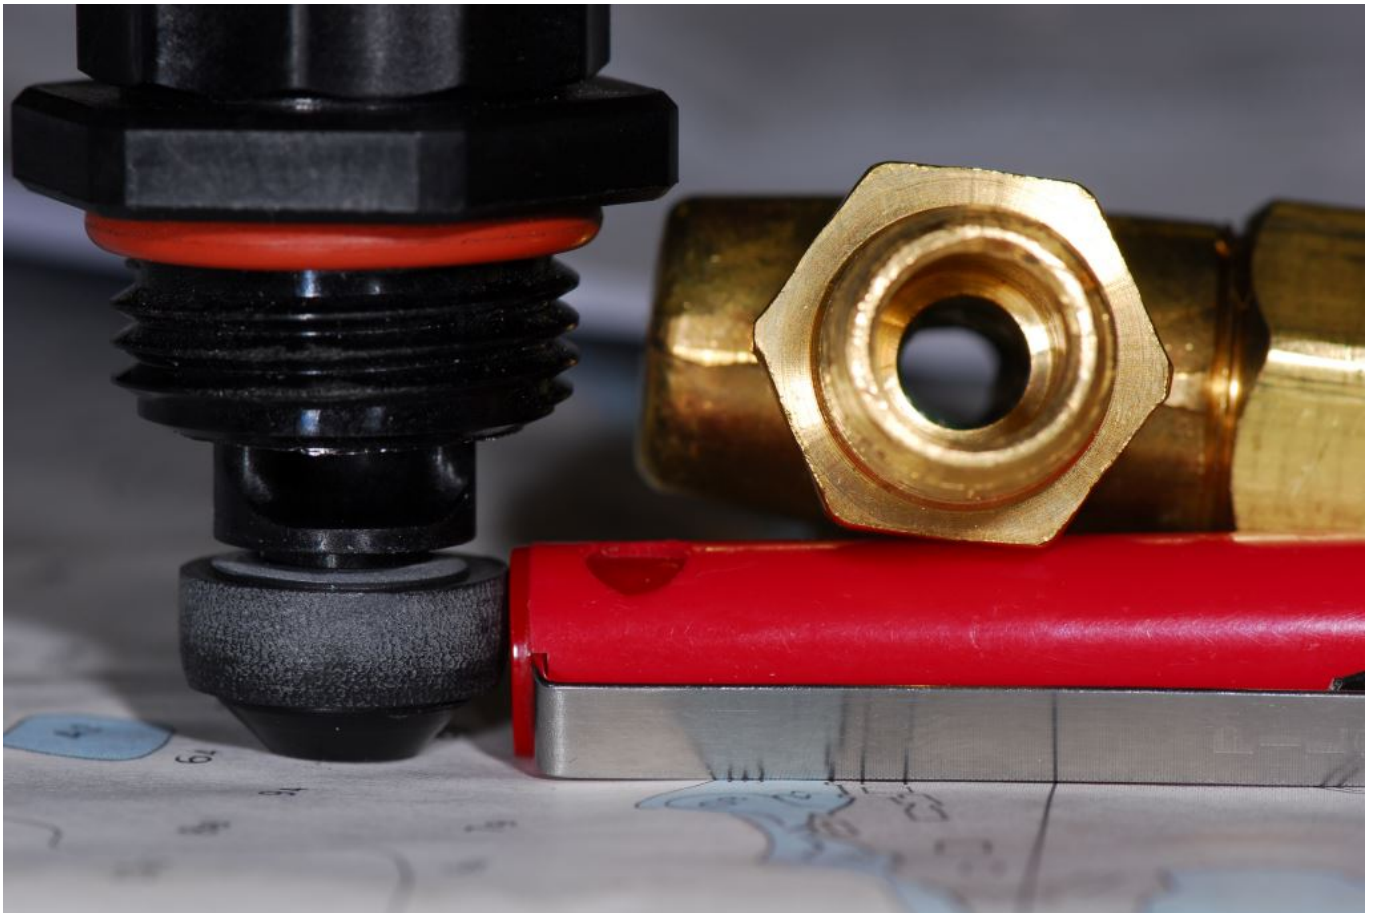
Plastic drain valves not only lack flame resistance, thanks to their smaller, and 90 degree, orifices they are more easily clogged.
