Selecting Primary Fuel Filters; There's more to it than meets the eye – Editorial: A Loose Bolt, a Cigarette Lighter and Distracted Work

Selecting Primary Fuel Filters

There's more to it than meets the eye

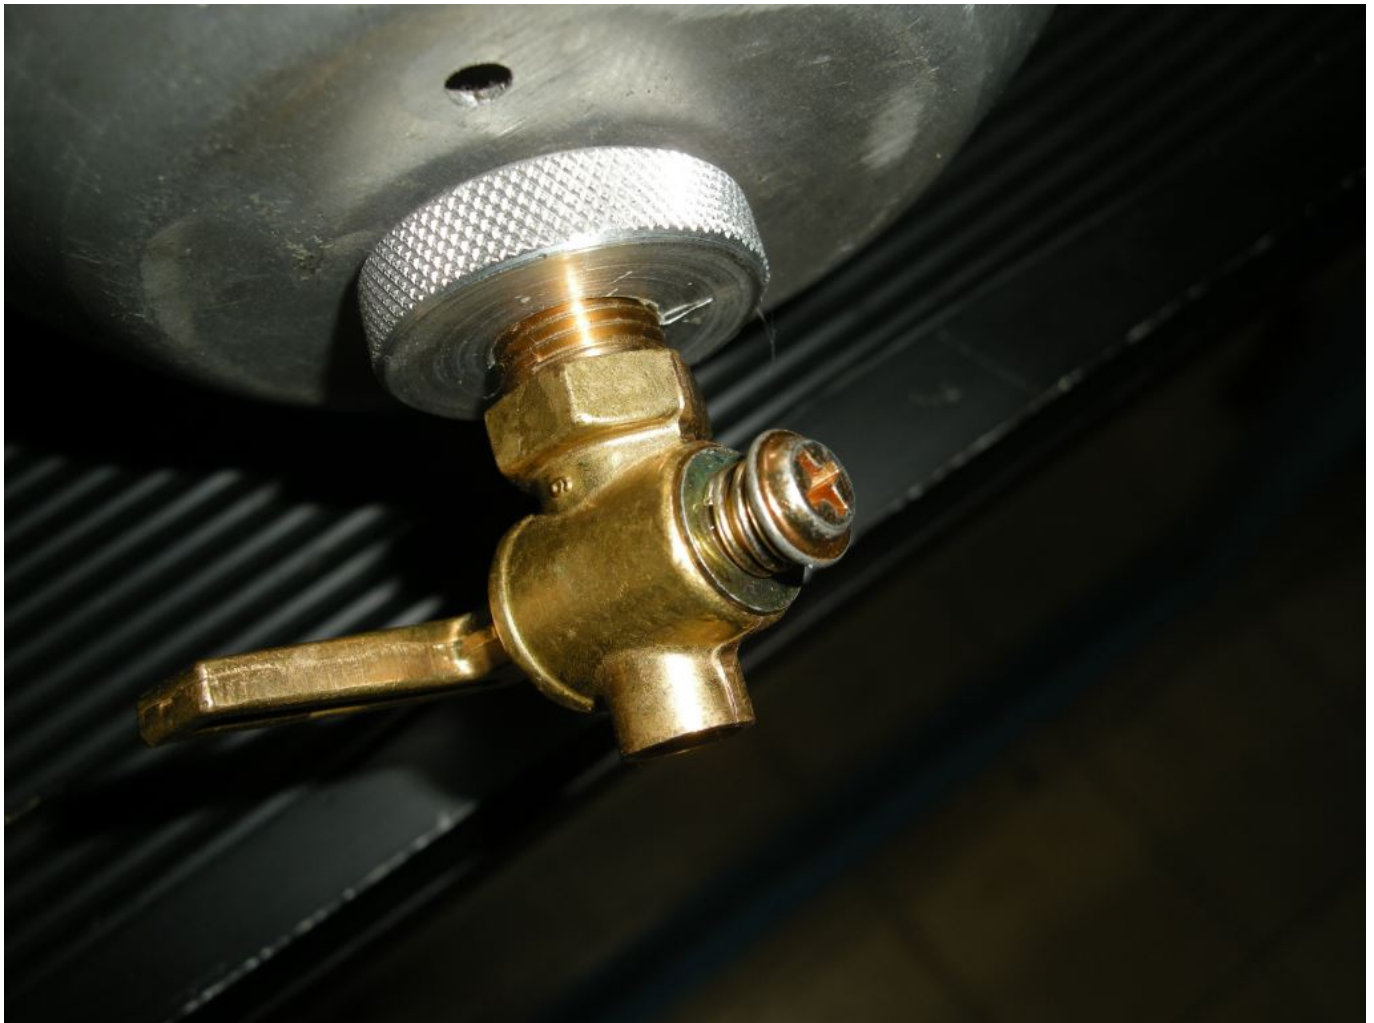
This drain lacks ABYC compliance for several reasons, it relies on a spring-tensioned seal (the spring is mild steel, which can rust and break), it turns through 360 degrees, and it lacks a pipe plug to prevent spills.

Finally, valve drains must be capped or plugged to prevent a fuel spill should the valve handle be inadvertently moved. If the filter is located below the fuel level, such an inadvertently opened valve could lead to hundreds or even thousands of gallons of fuel leaking into the bilge. I once observed such a scenario, on a vessel undergoing repairs; the bilge filled with about 100 gallons of fuel. Fatefully, it was hauled at the time (and stored inside a shed), and the
