Selecting Primary Fuel Filters; There's more to it than meets the eye – Editorial: A Loose Bolt, a Cigarette Lighter and Distracted Work

Selecting Primary Fuel Filters

There's more to it than meets the eye

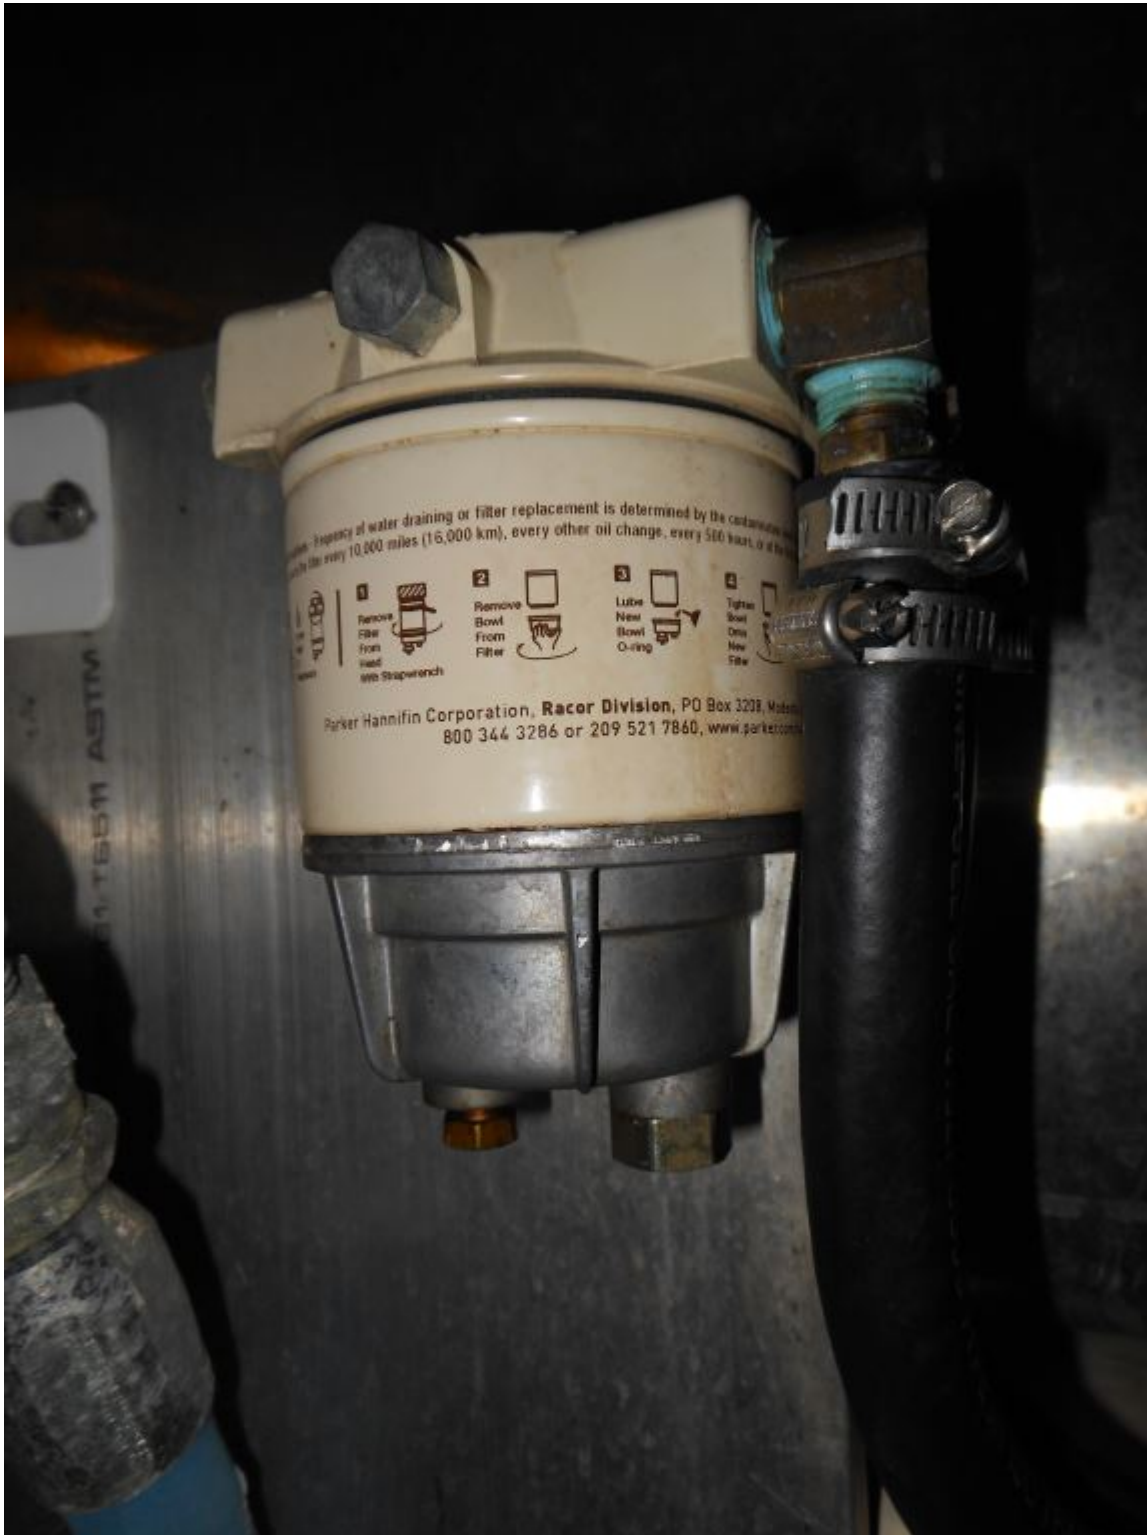
Smaller, non-turbine series filters may meet the fuel flow needs of generators and smaller propulsion engines, however, they are cumbersome to service, and in order to meet flame resistance standards they must forfeit their clear sight bowls, robbing them of one of their most valuable features.

Furthermore, and unlike larger aforementioned Turbine series filters, in order for them to meet the UL Marine/ABYC requirements for flame resistance, these smaller filters cannot include a clear plastic bowl; it must instead be metal, which means it can't be monitored for water or accumulation of debris.

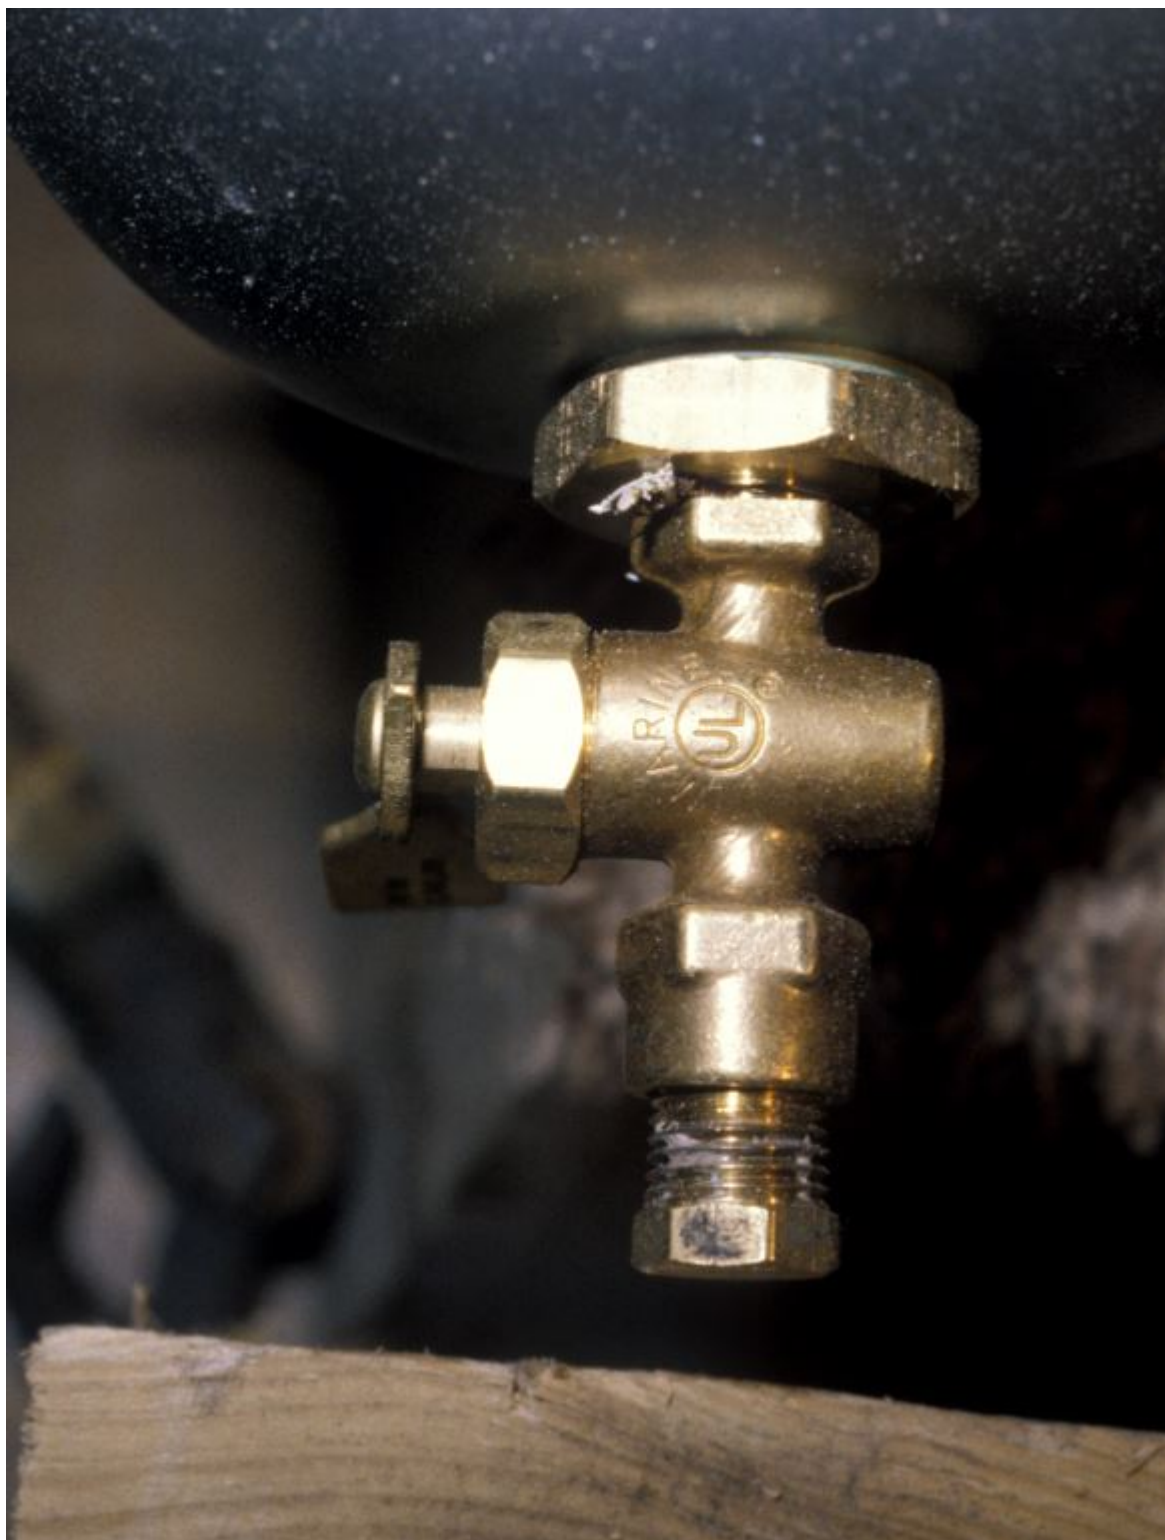
A UL Listed Marine drain valve must embody two features, a valve barrel whose fuel-tight seal does not rely on spring tension, and a handle that rotates through no more and no less than 90 degrees.

While many primary filters include provisions for drain valves, few include them out of the box, they must be added, and the Racor MA series is no exception. When doing so, be sure to select, once again, only valves that meet UL Marine and/or ABYC standards. These are characterized by a lack of springs to maintain tension within the valve and fuel-tight integrity, rotation that is no more and no less than 90°, and of course flame resistance, making plastic valves unacceptable.
