Editorial: Island Lady Fire Analyzed – Feature: Understanding and Preventing Aluminum Corrosion

Understanding and Preventing Aluminum Corrosion

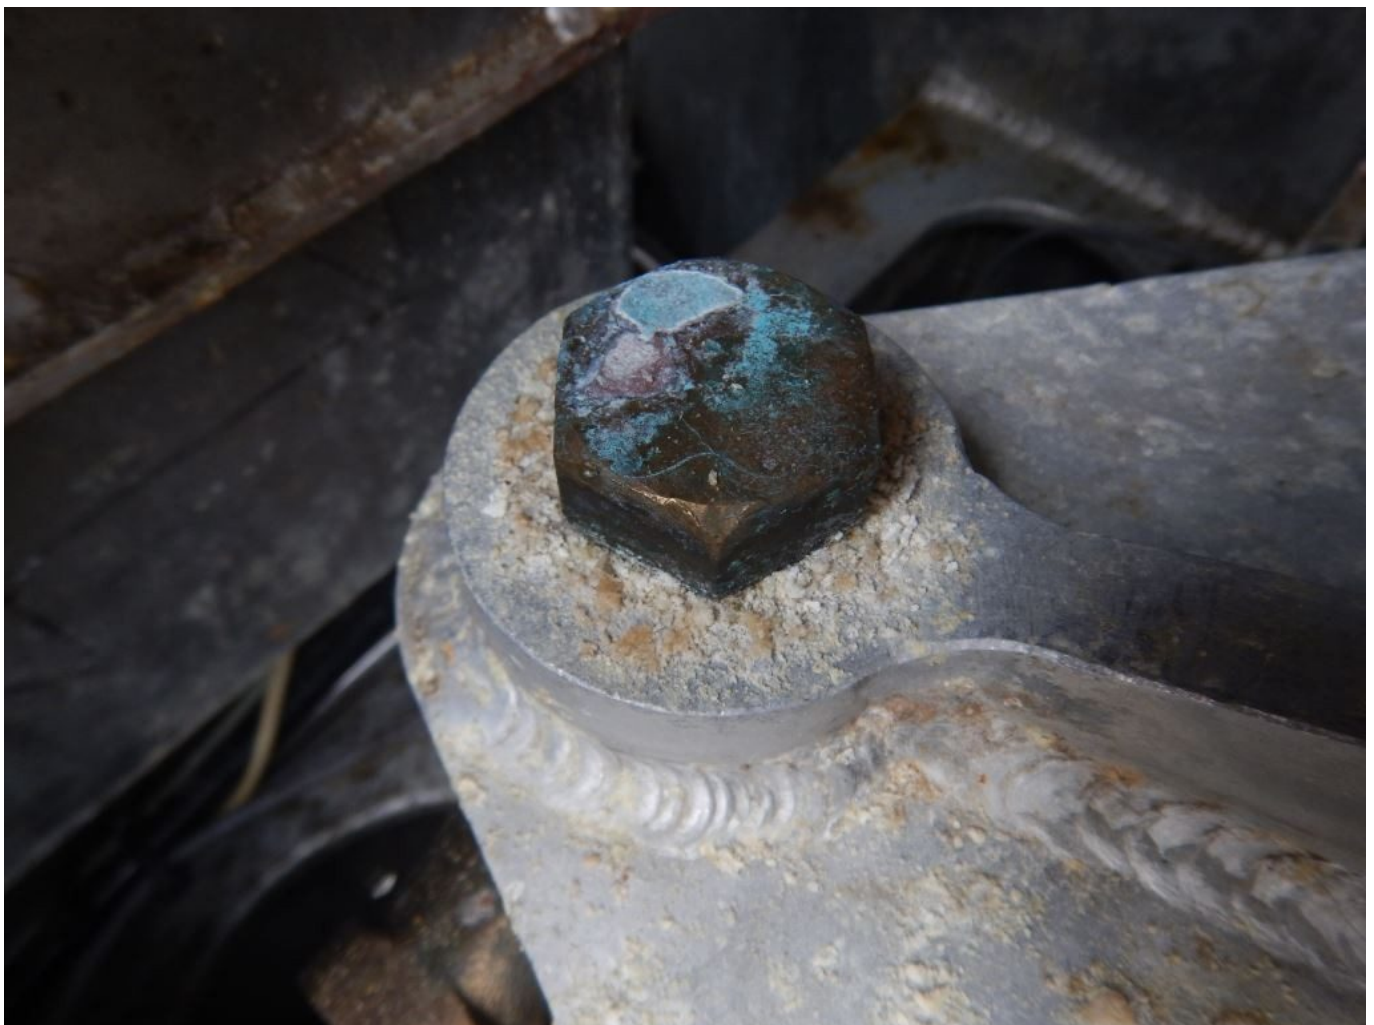
A bronze bolt used in an aluminum steering quadrant, with corrosion byproduct. A stainless steel bolt should have been used in this application.

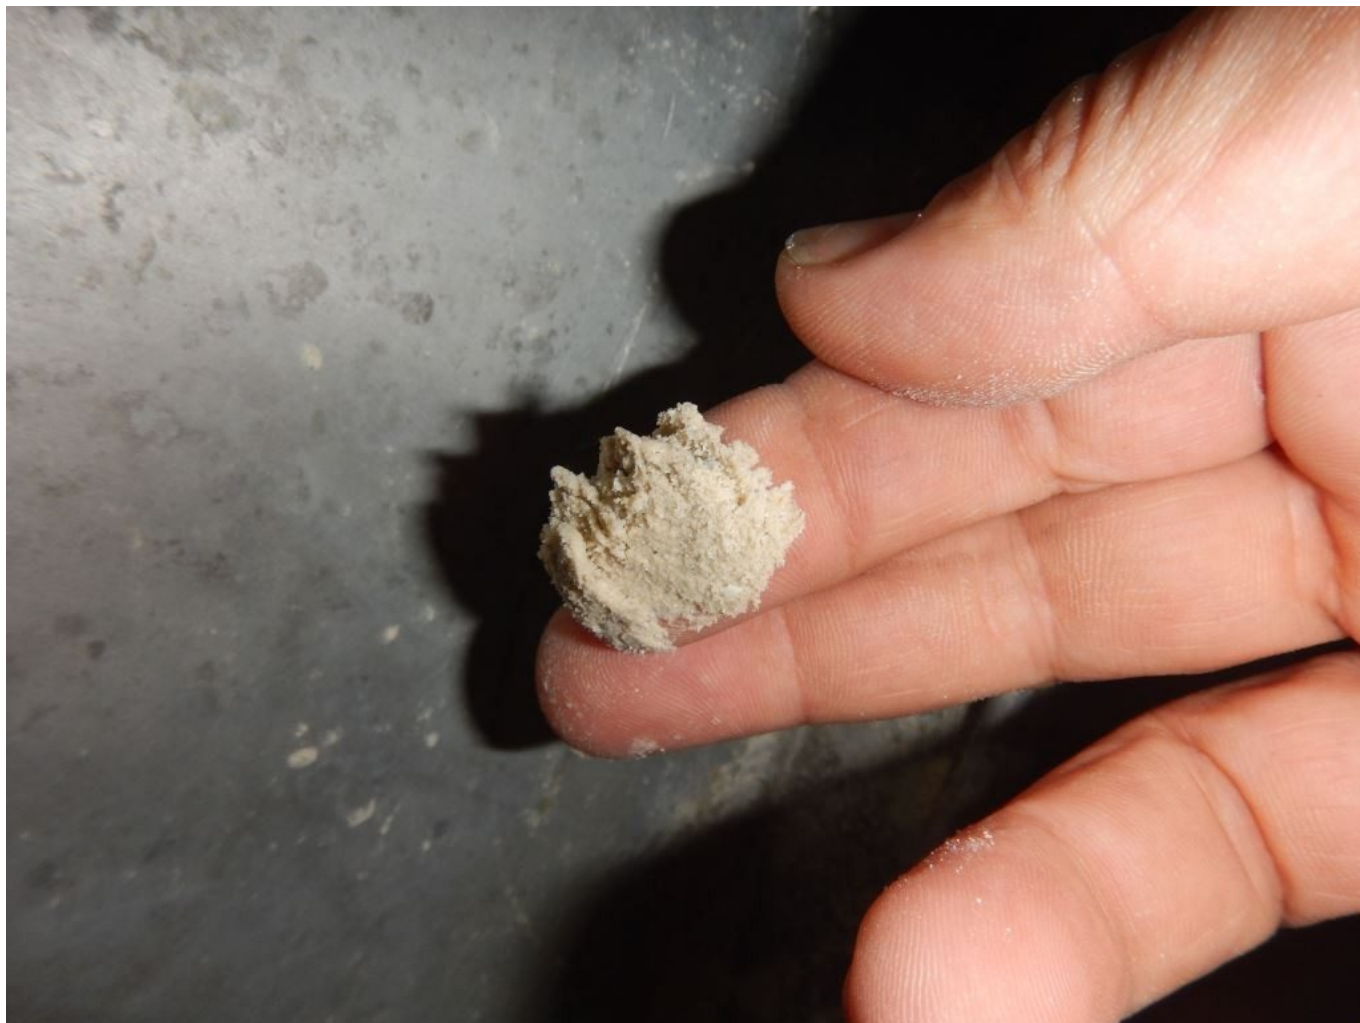
Sand in the bilge of an aluminum hull; anything that retains water against aluminum is considered a poultice corrosion risk. All bilges should be kept clean, and especially those of aluminum vessels.

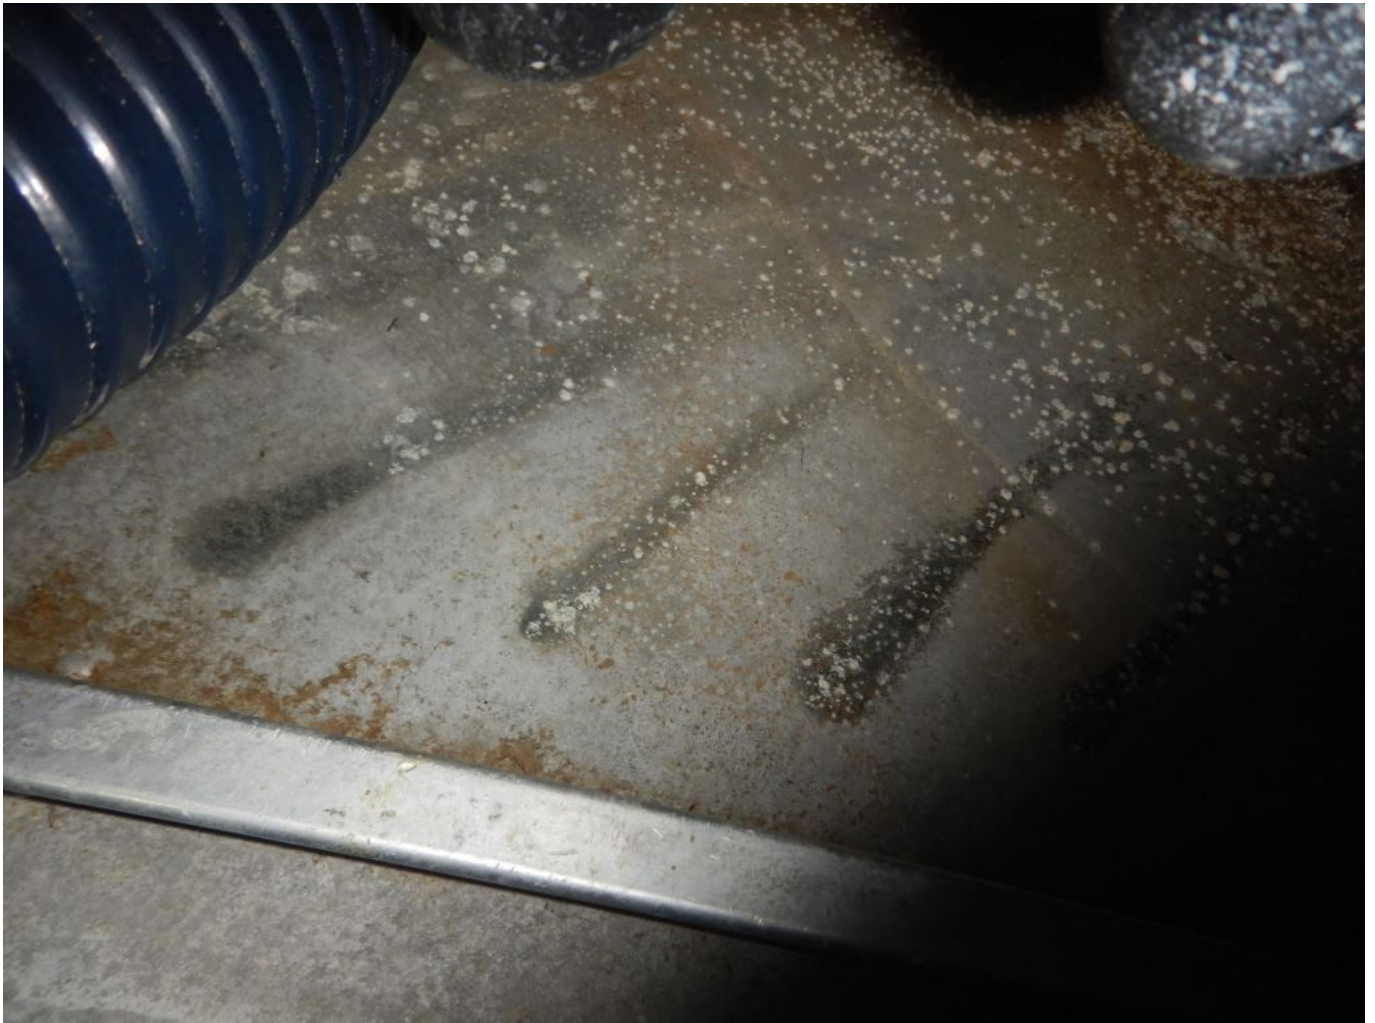
Aluminum hull corrosion, the result of water dripping from a bronze raw water plumbing manifold.

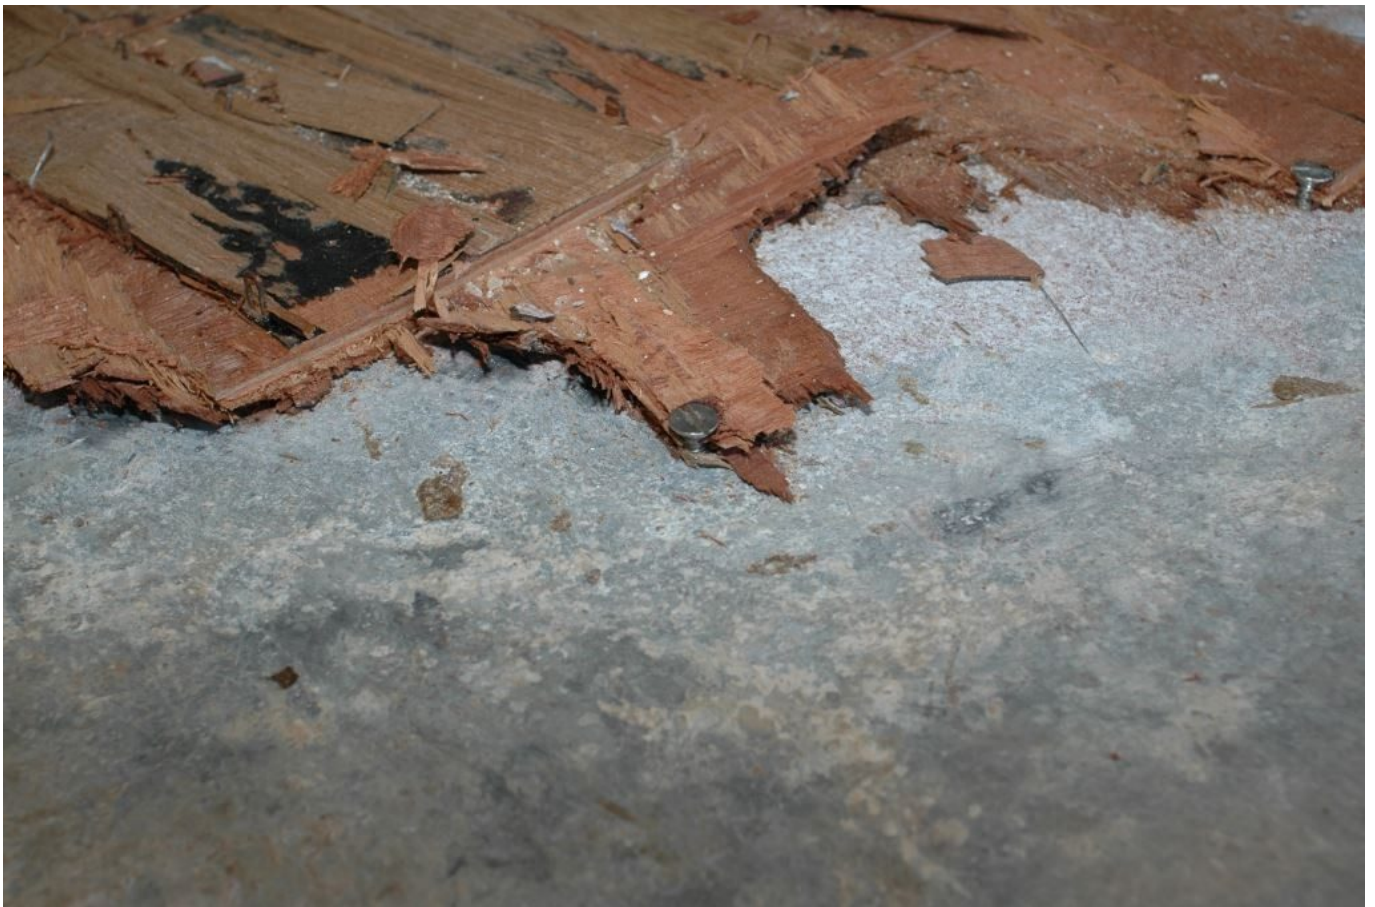
Teak over plywood over aluminum; it's the ideal recipe for poultice corrosion. Hygroscopic materials, those that absorb water, should never be placed in direct contact with aluminum. The caveat includes aluminum tanks, water should never be allowed to be trapped against or under them. For more on this see TANKS

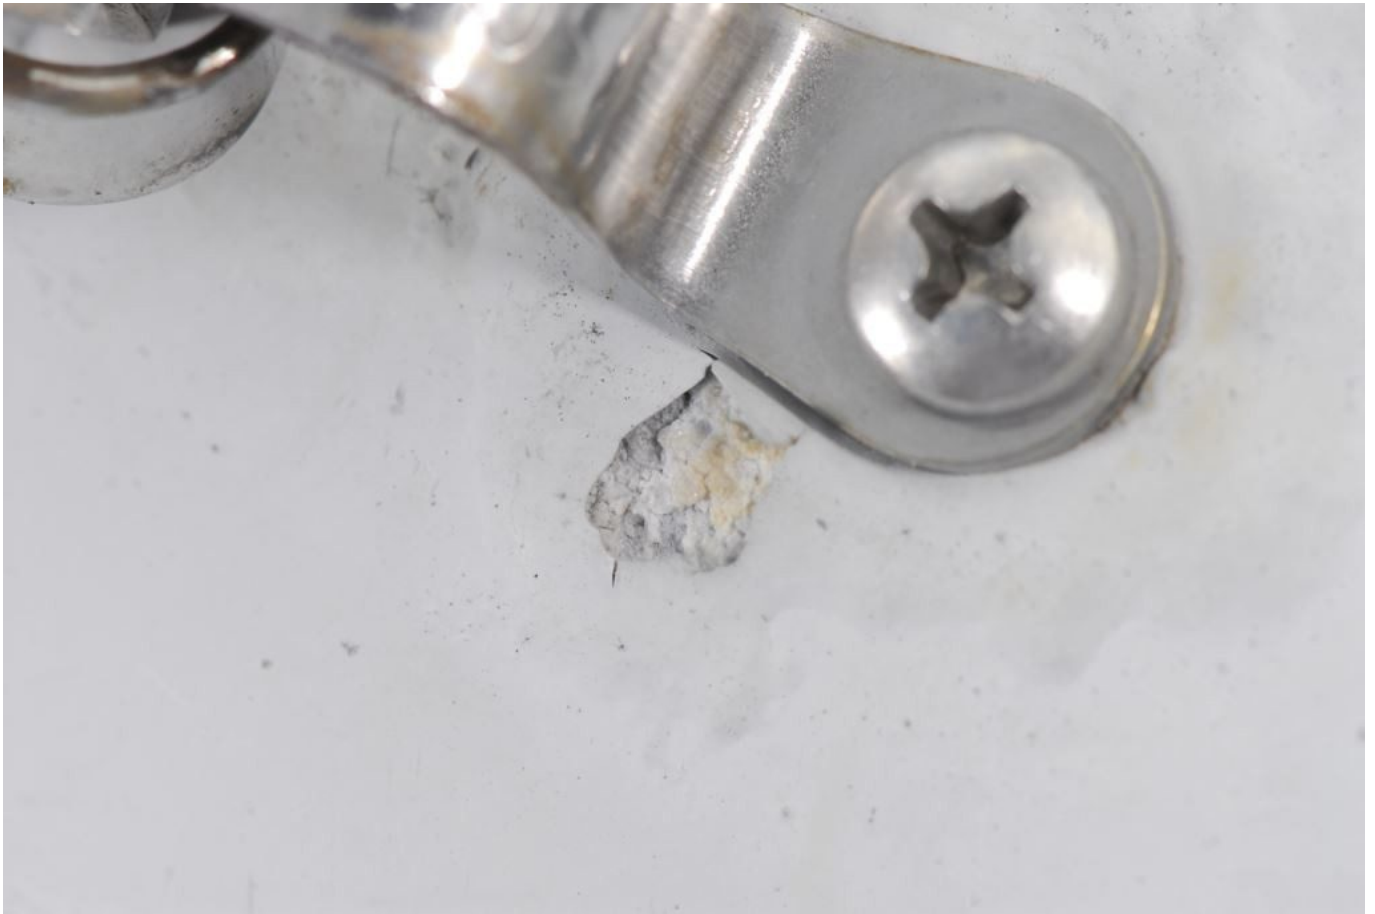
Breaches in coatings over aluminum painted substrate are most often caused by hardware installations. This failure mode can be prevented if the hardware is bedded in polyurethane or other sealant.
