Editorial: Island Lady Fire Analyzed – Feature: Understanding and Preventing Aluminum Corrosion

Understanding and Preventing Aluminum Corrosion

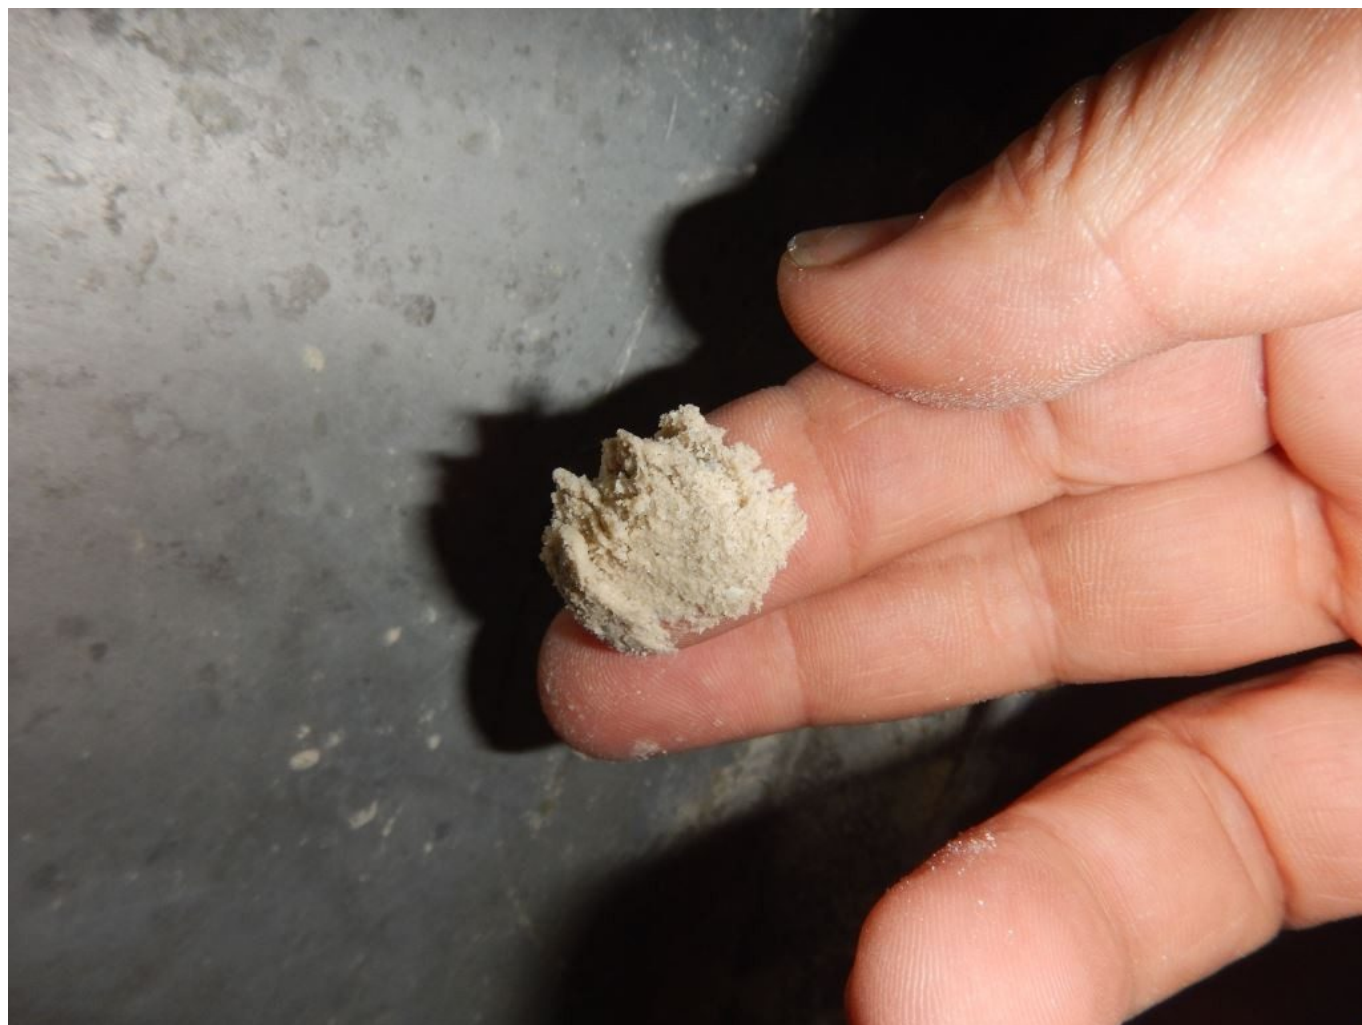
Sand in the bilge of an aluminum hull; anything that retains water against aluminum is considered a poultice corrosion risk. All bilges should be kept clean, and especially those of aluminum vessels.

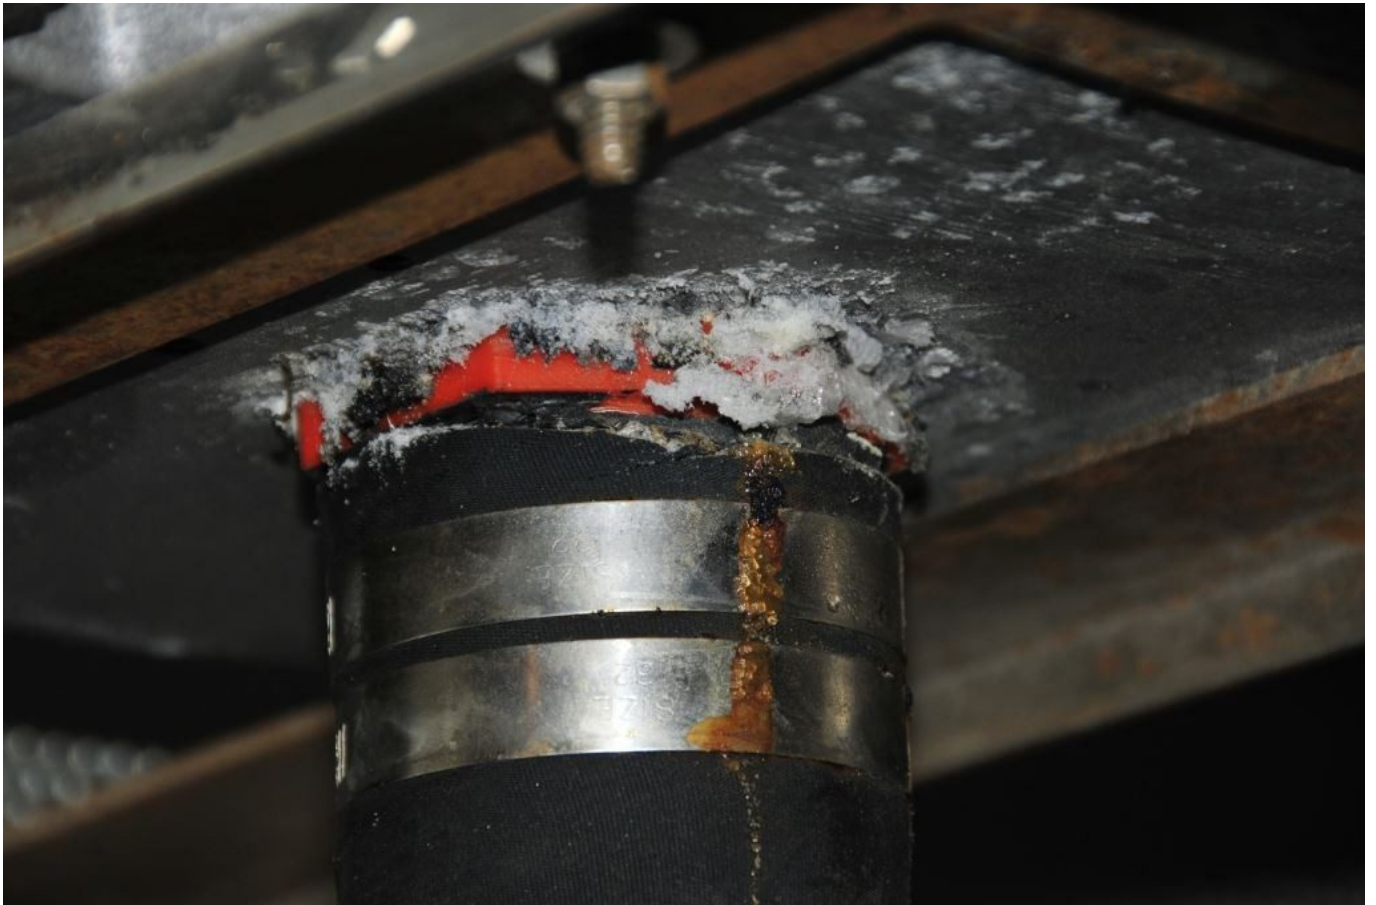
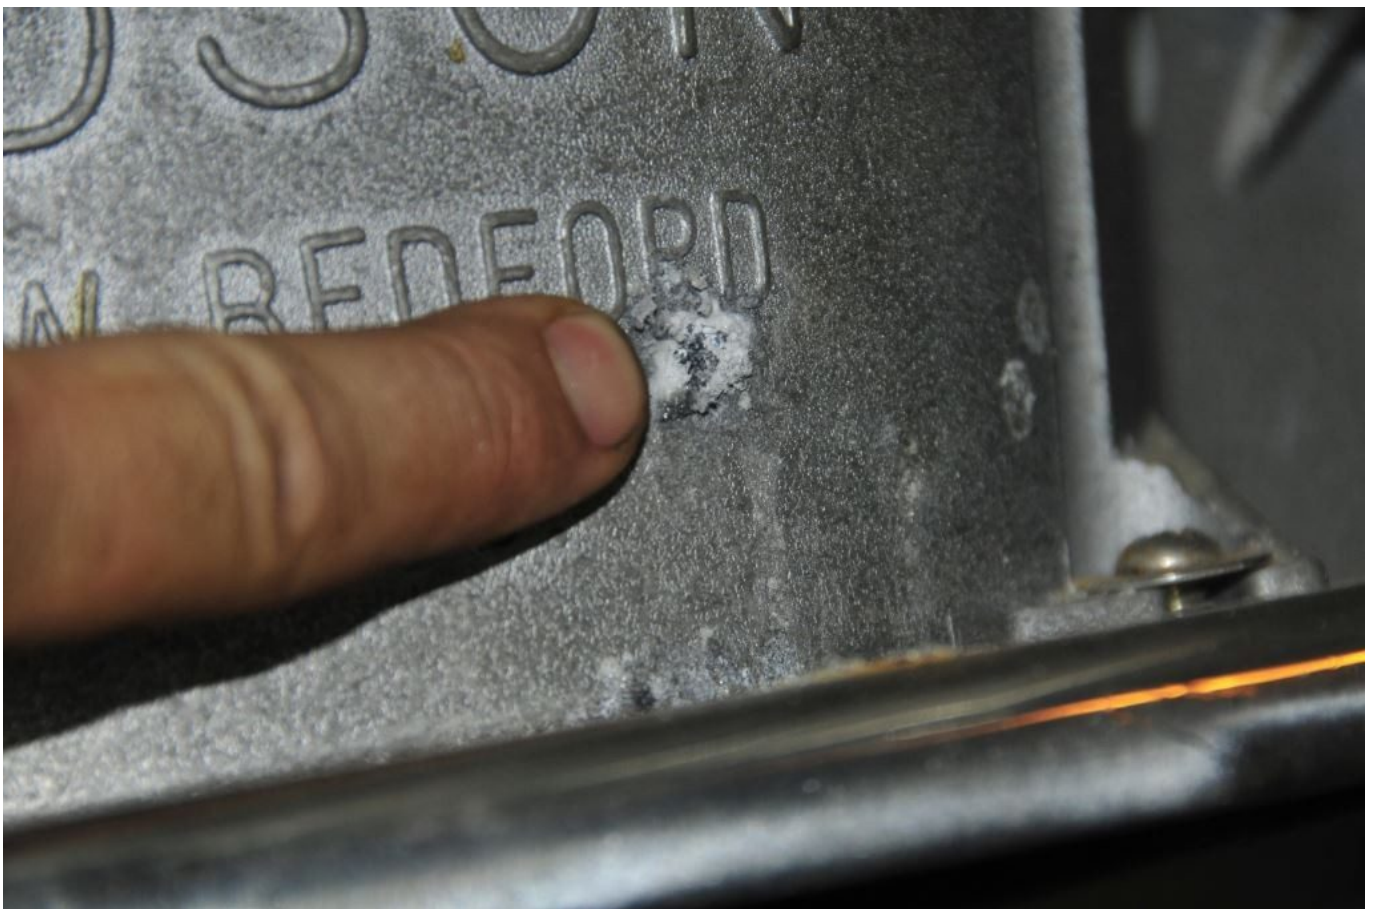
An aluminum body manual bilge pump. Stagnant water trapped

inside this pump created a poultice corrosion chamber.

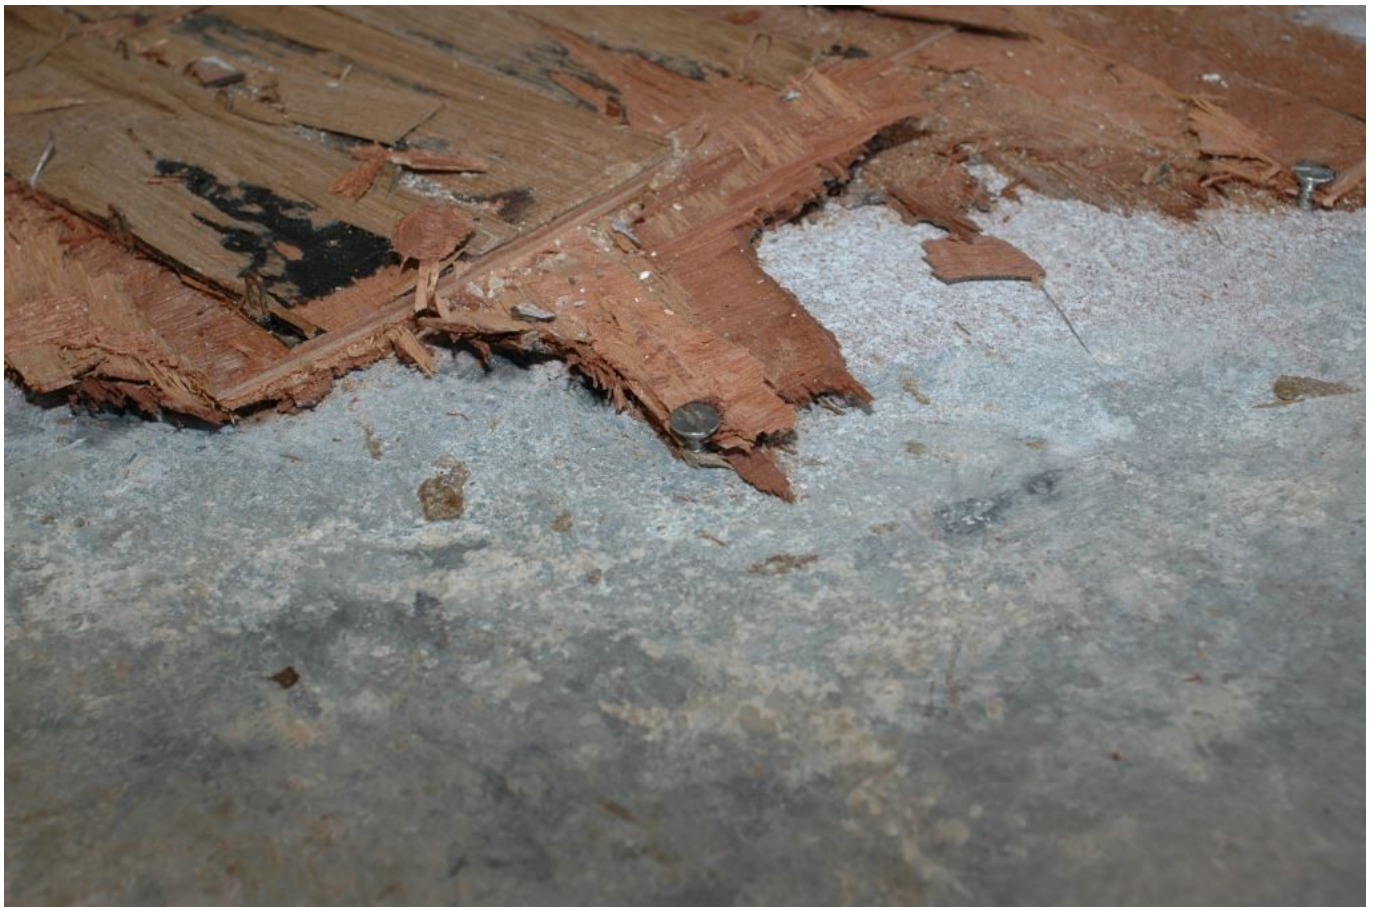
Teak over plywood over aluminum; it's the ideal recipe for poultice corrosion. Hygroscopic materials, those that absorb water, should never be placed in direct contact with aluminum. The caveat includes aluminum tanks, water should never be allowed to be trapped against or under them. For more on this see TANKS
