# Editorial: Island Lady Fire Analyzed – Feature: Understanding and Preventing Aluminum Corrosion

## **Understanding and Preventing Aluminum Corrosion**

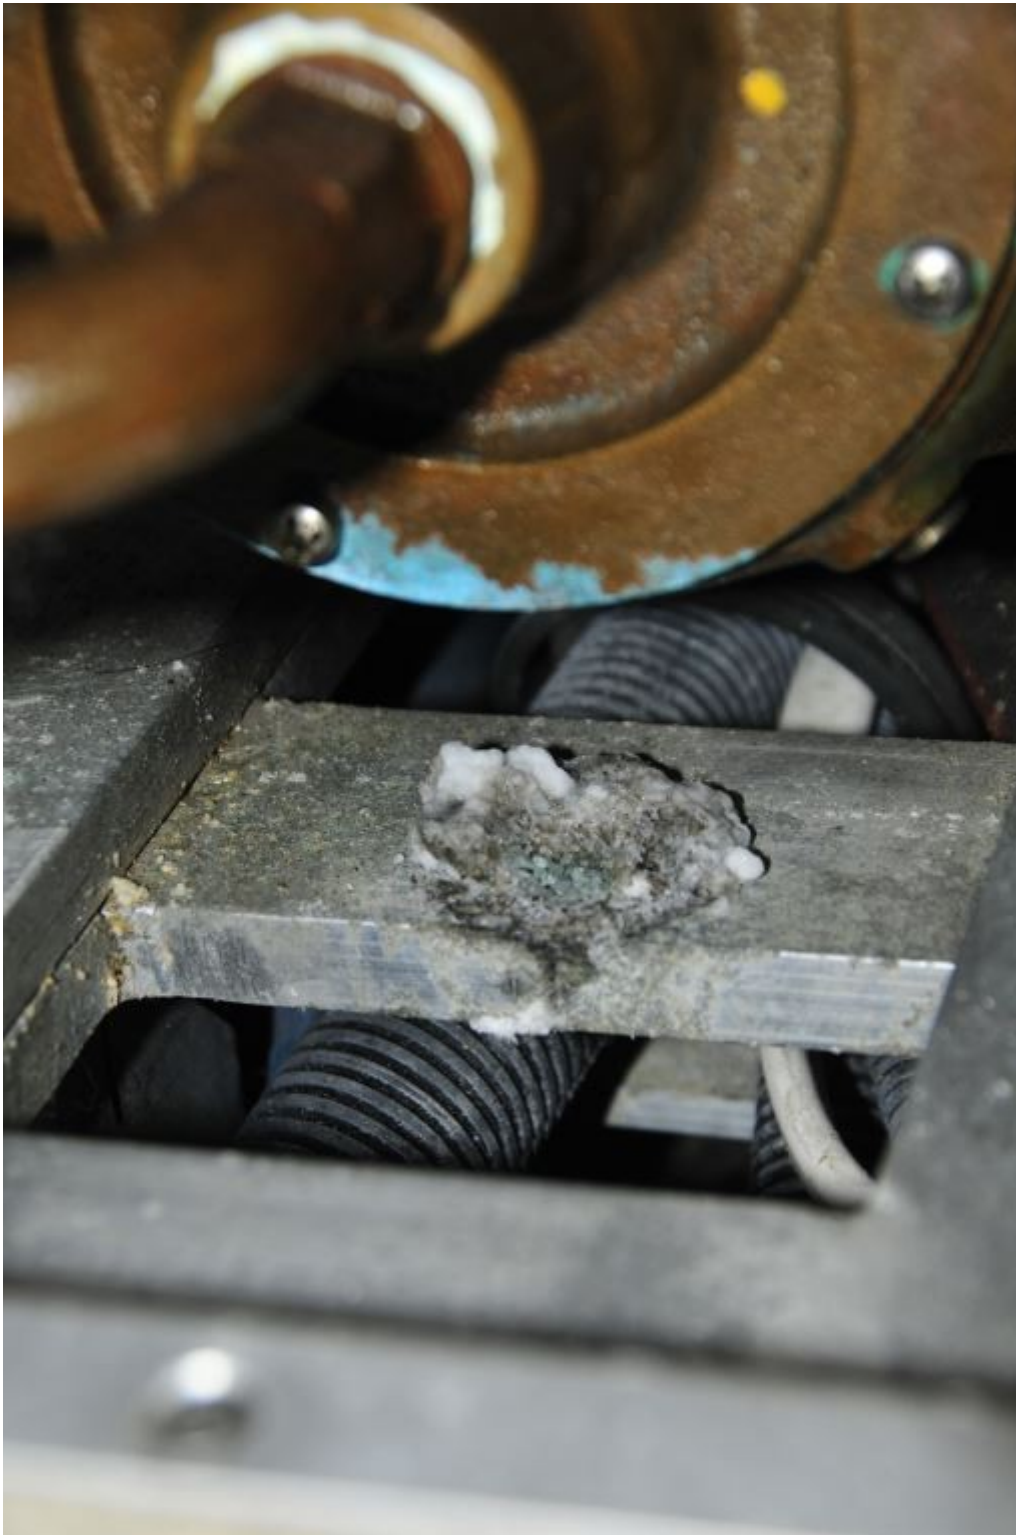
**This bronze pump, leaking onto its aluminum base plate, caused the latter to corrode. The leaking water carried with it salts of copper, which were all that was needed to cause galvanic corrosion.**

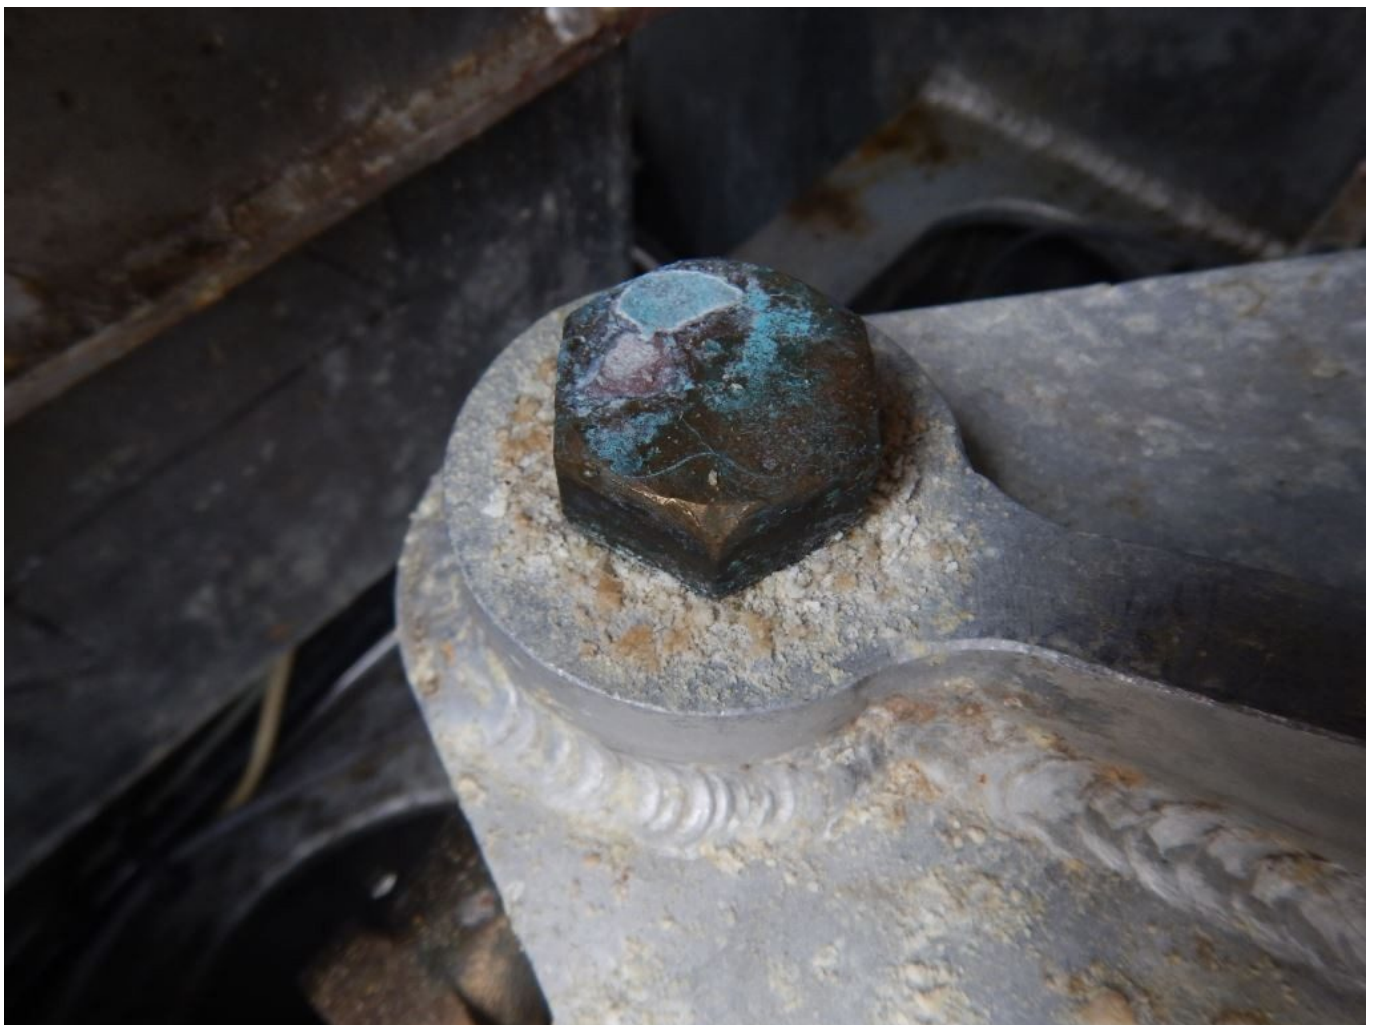
**A bronze bolt used in an aluminum steering quadrant, with corrosion byproduct. A stainless steel bolt should have been used in this application.**

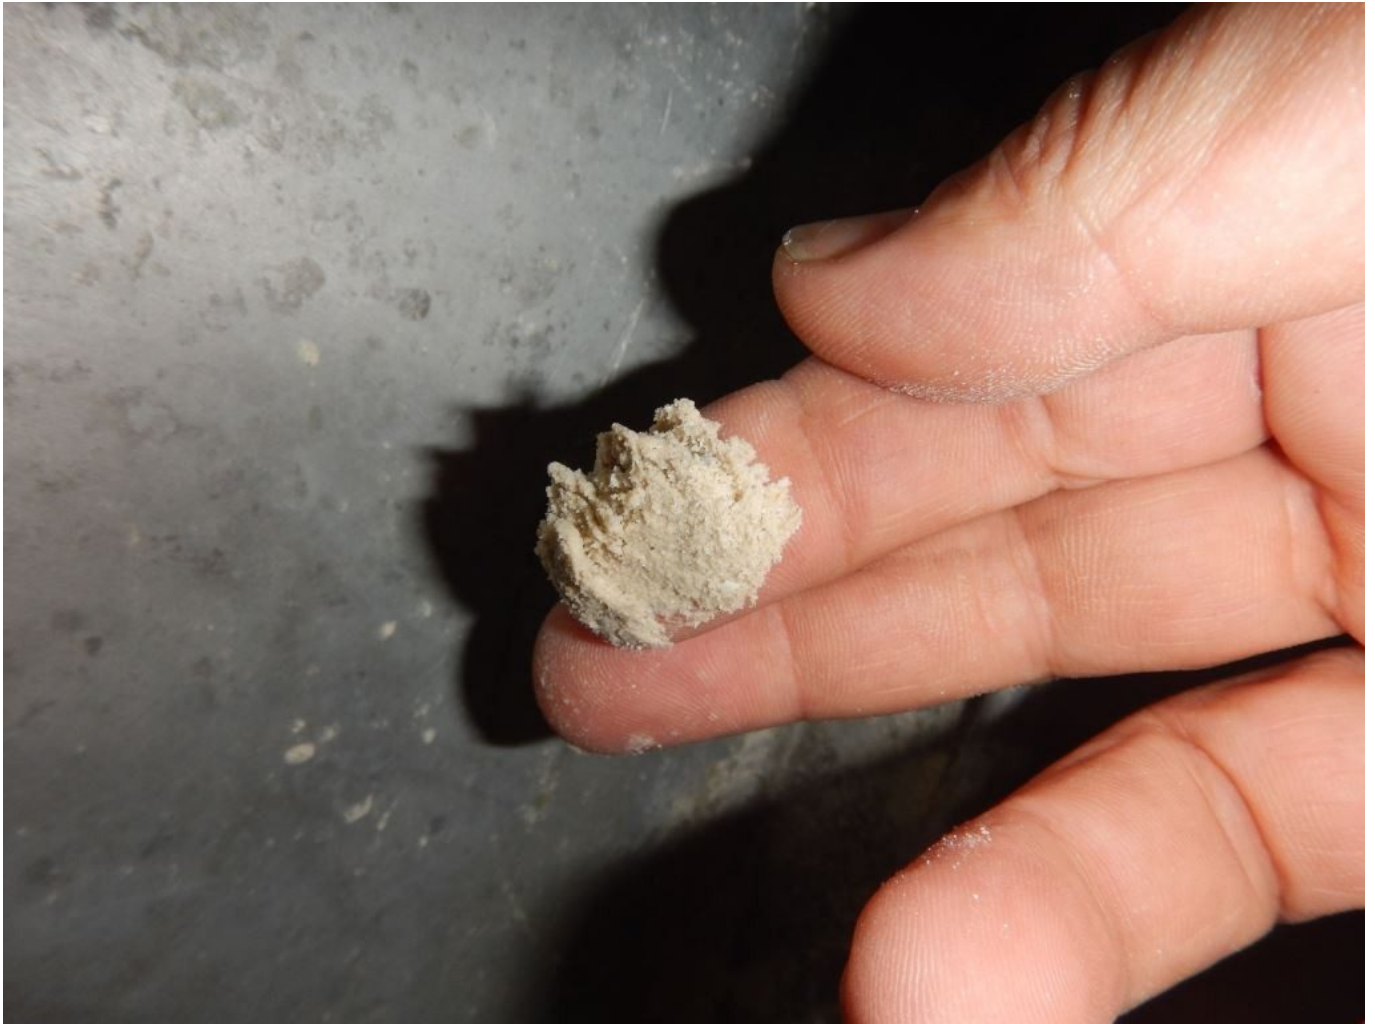
**Sand in the bilge of an aluminum hull; anything that retains water against aluminum is considered a poultice corrosion risk. All bilges should be kept clean, and especially those of aluminum vessels.**

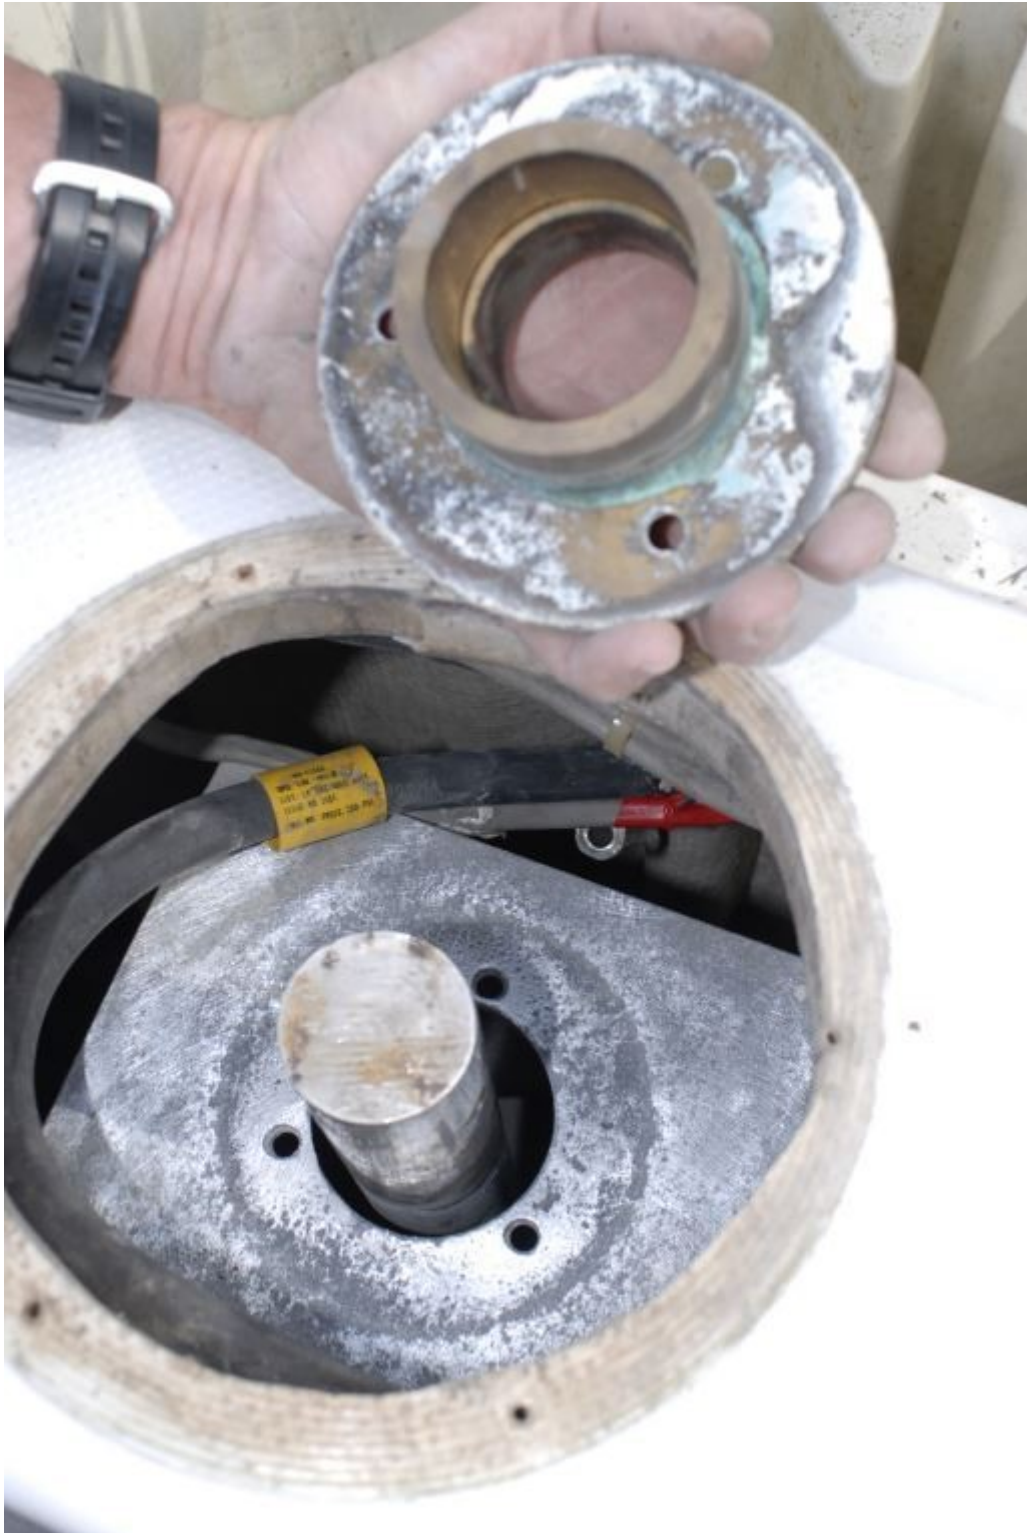
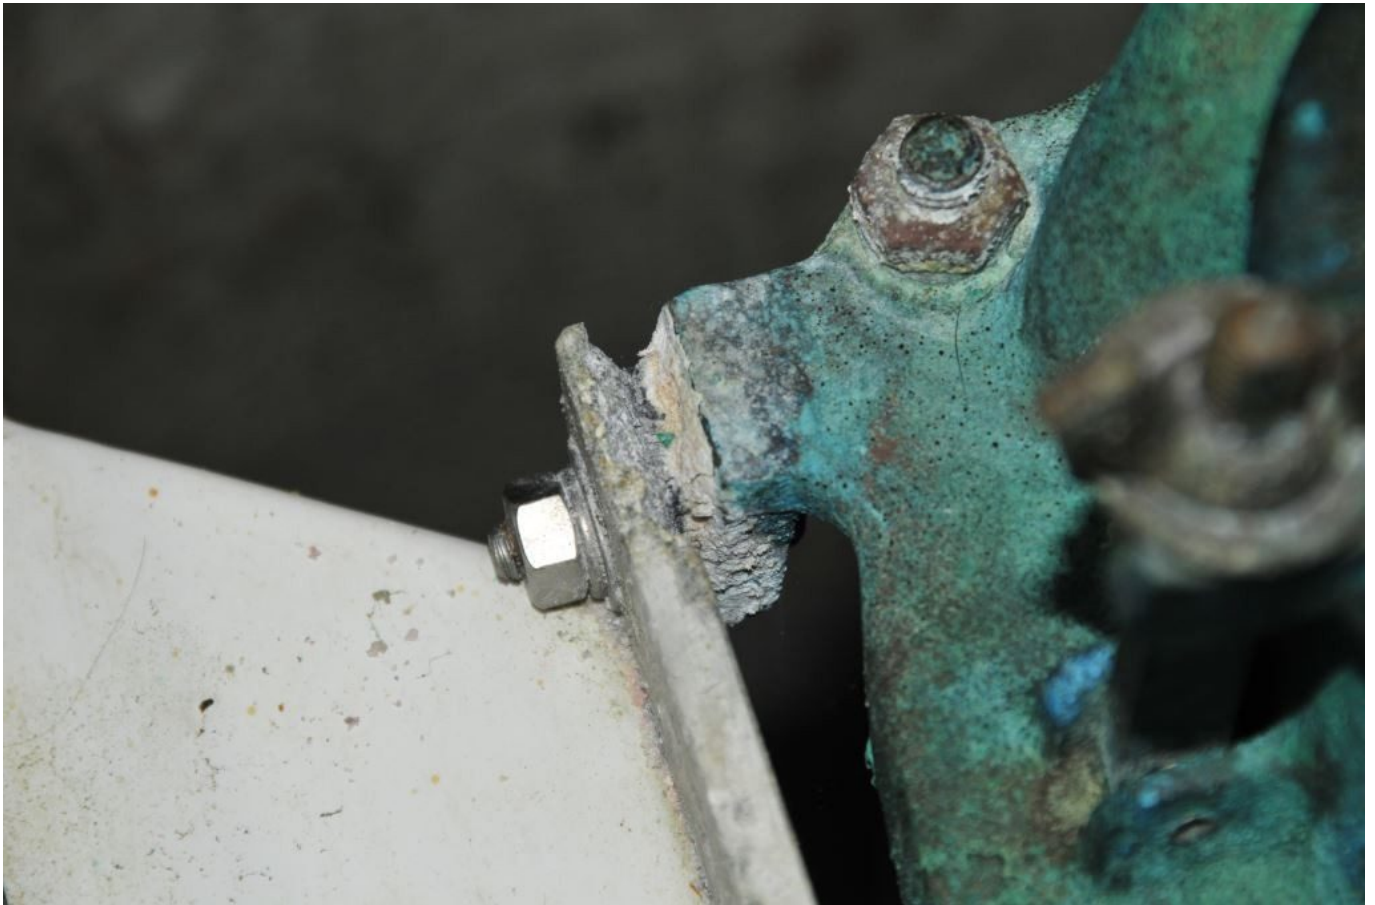
**Among the most common corrosion scenarios, copper and aluminum alloys in direct contact, in a moist environment. Being much less noble, the aluminum suffers the consequences.**

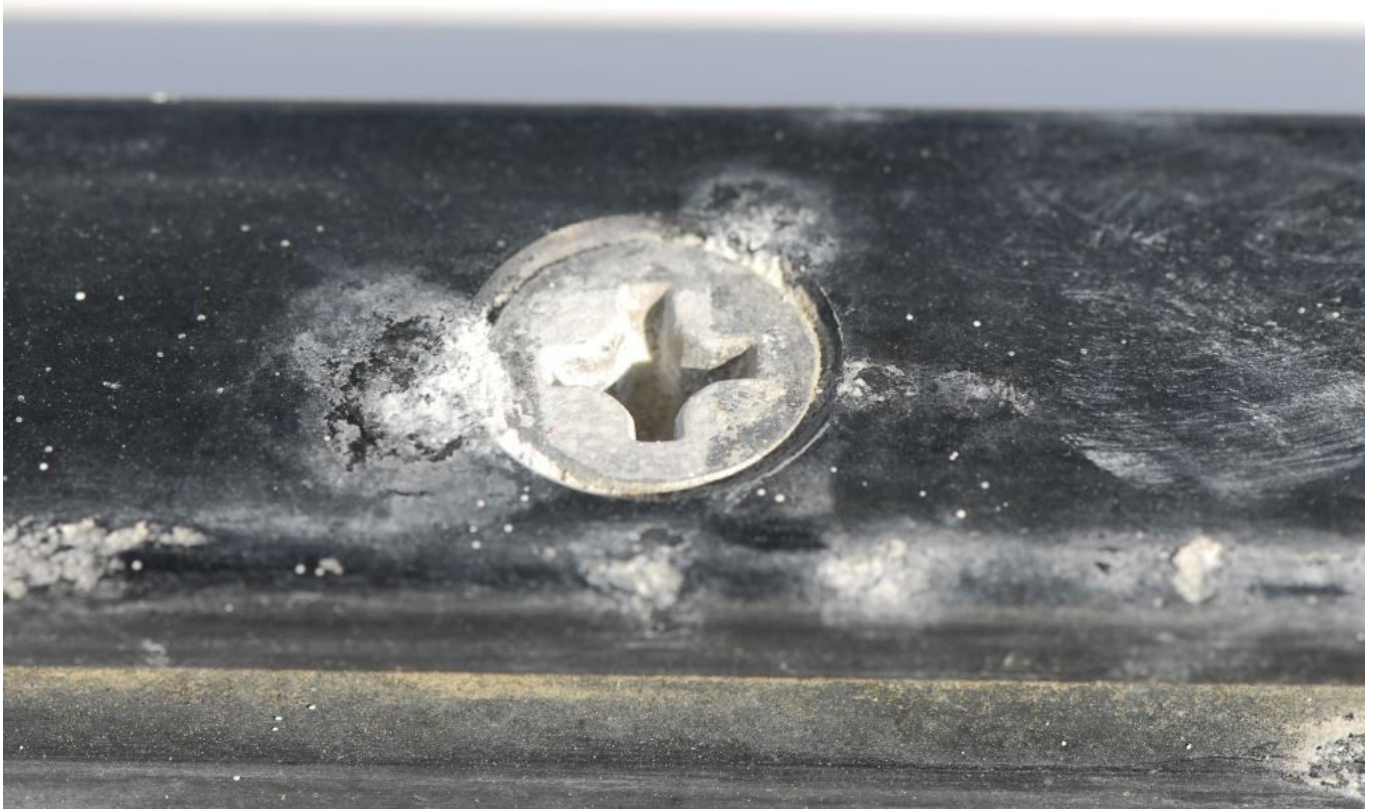
**While stainless steel and aluminum are considered moderately compatible, given enough time in contact and wet, the aluminum will suffer. Thoroughly bedding this fastener would have at least slowed this corrosion cell.**

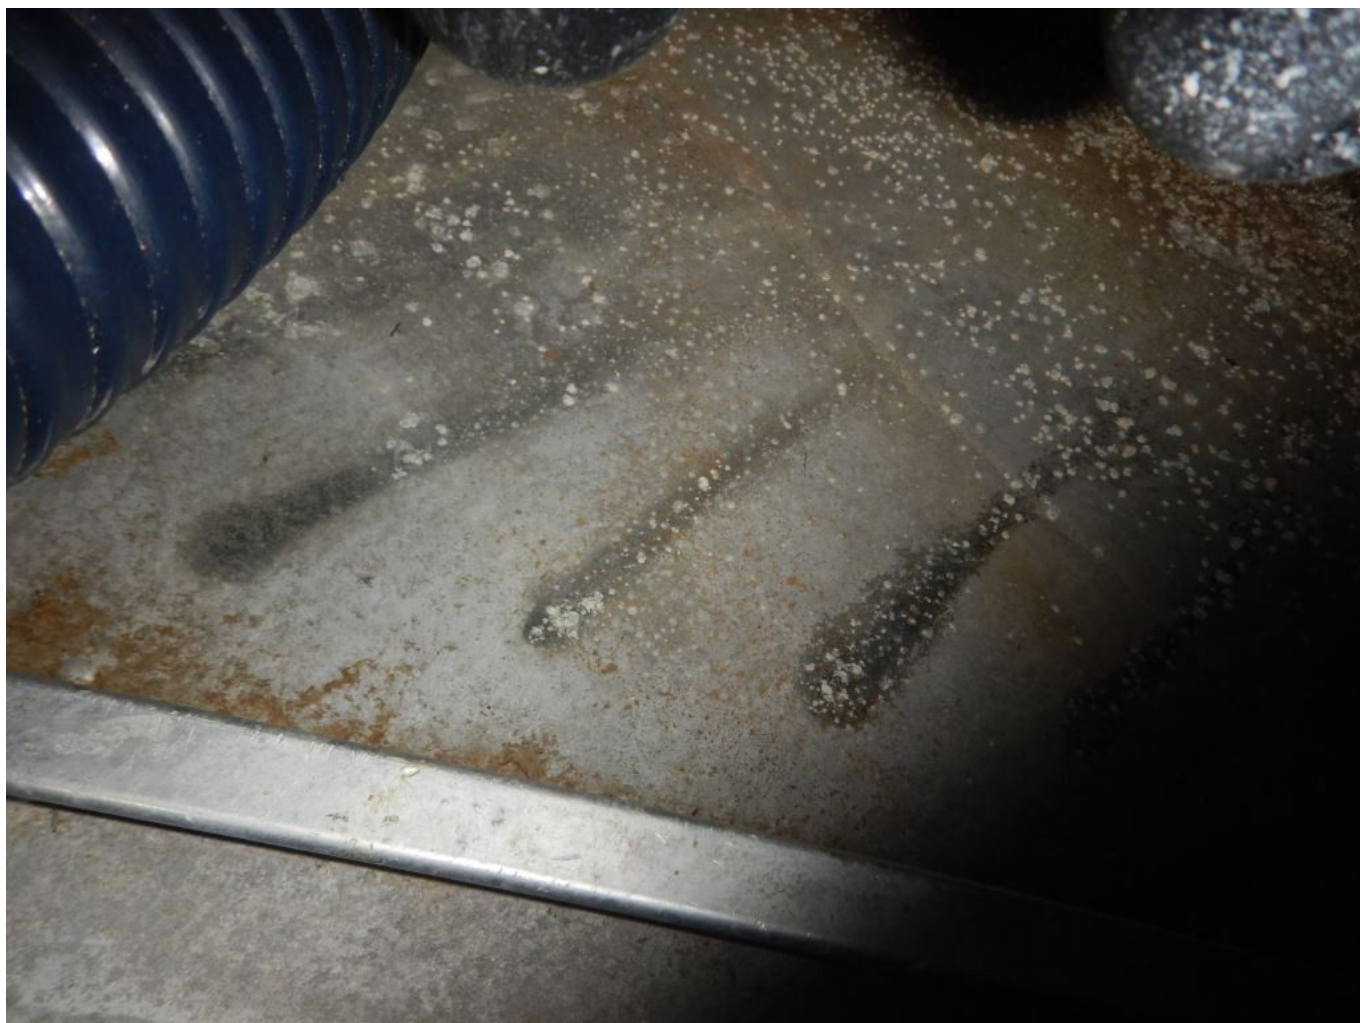
**Aluminum hull corrosion, the result of water dripping from a bronze raw water plumbing manifold.**

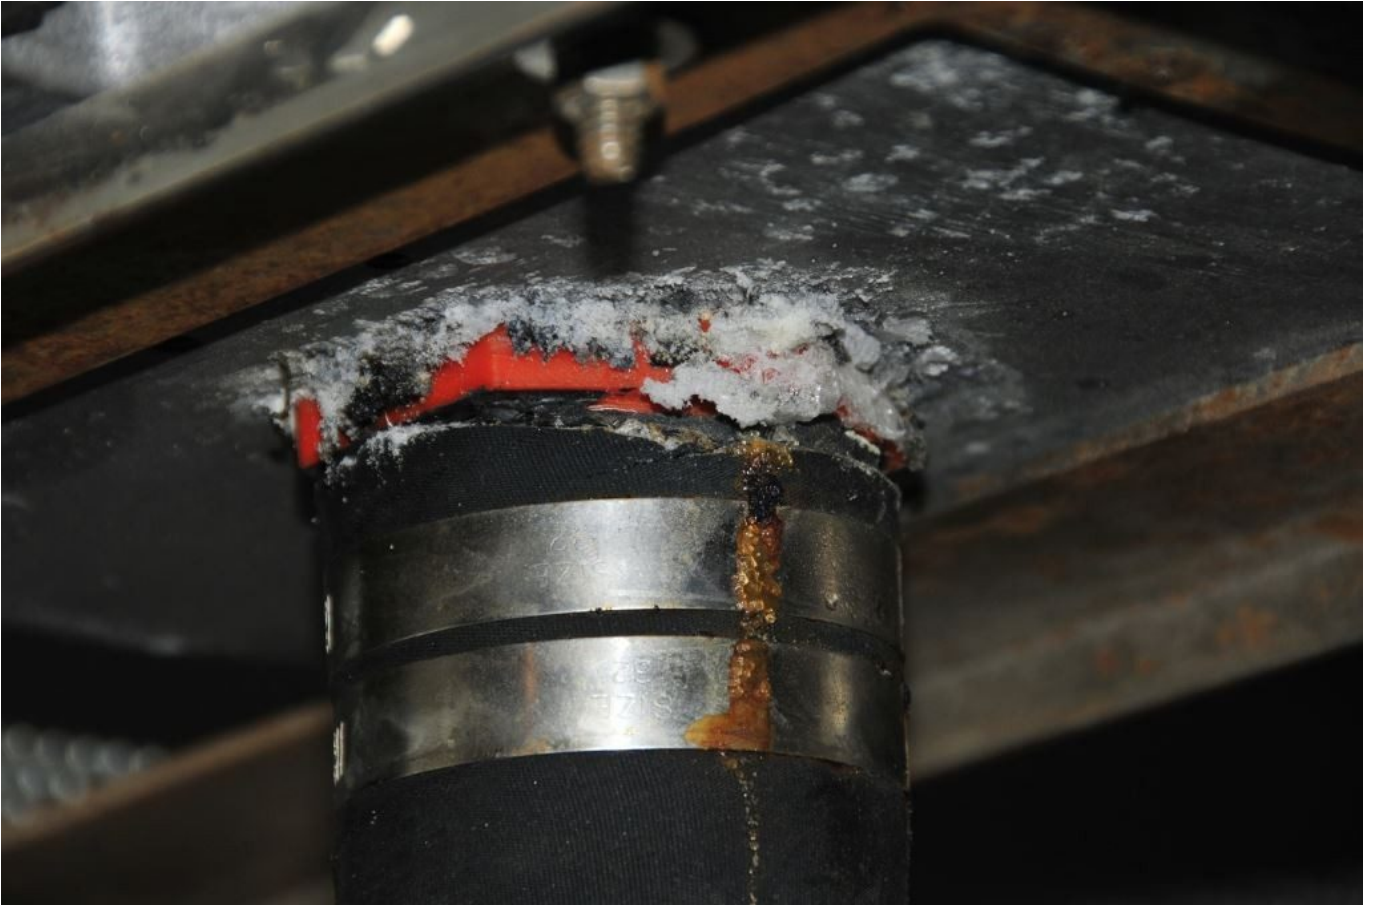
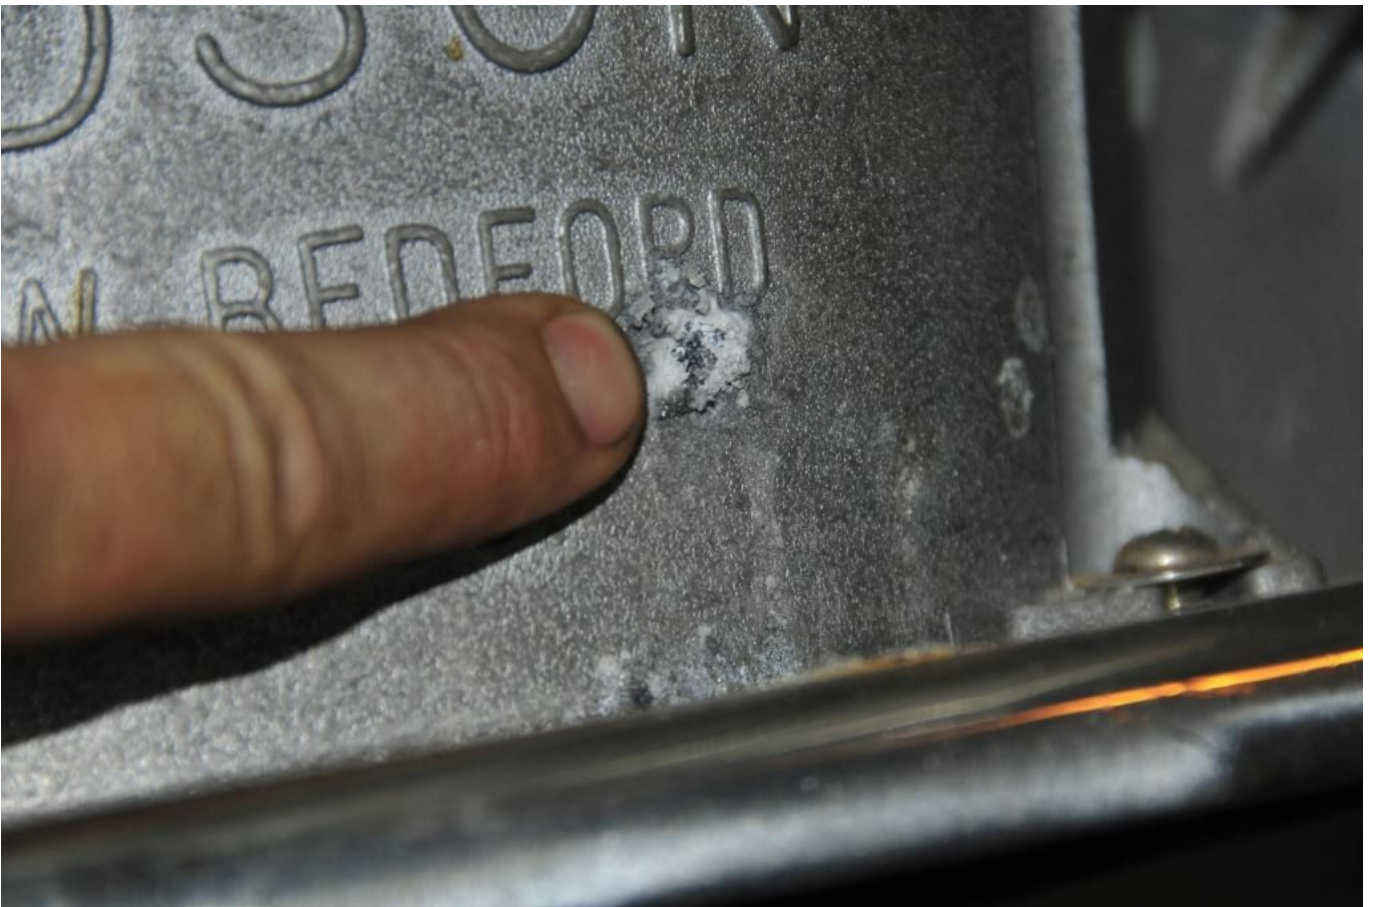
An aluminum body manual bilge pump. Stagnant water trapped

**inside this pump created a poultice corrosion chamber.**

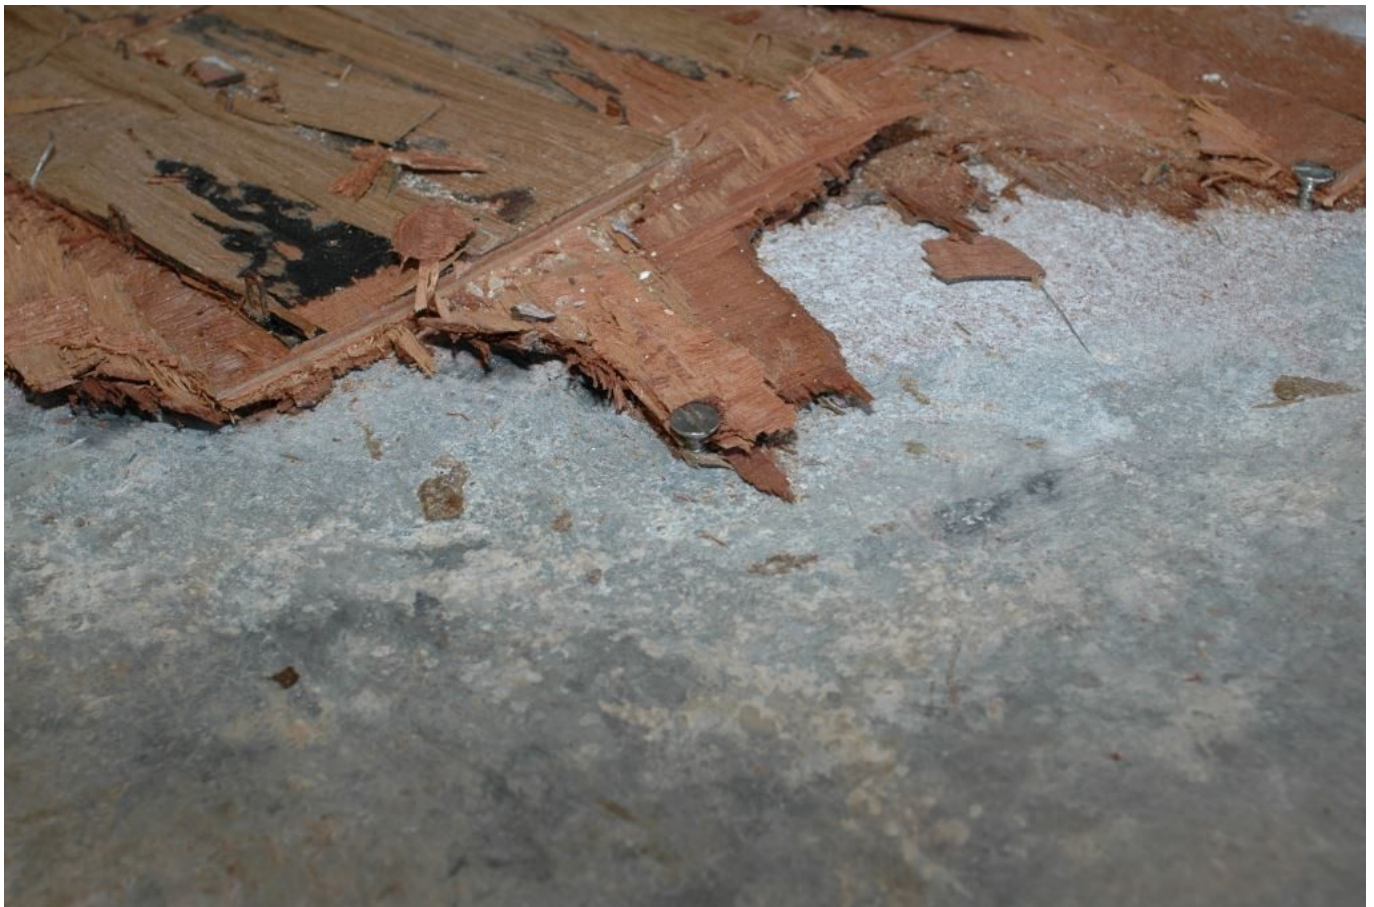
**Teak over plywood over aluminum; it's the ideal recipe for poultice corrosion. Hygroscopic materials, those that absorb water, should never be placed in direct contact with aluminum. The caveat includes aluminum tanks, water should never be allowed to be trapped against or under them. For more on this see TANKS**

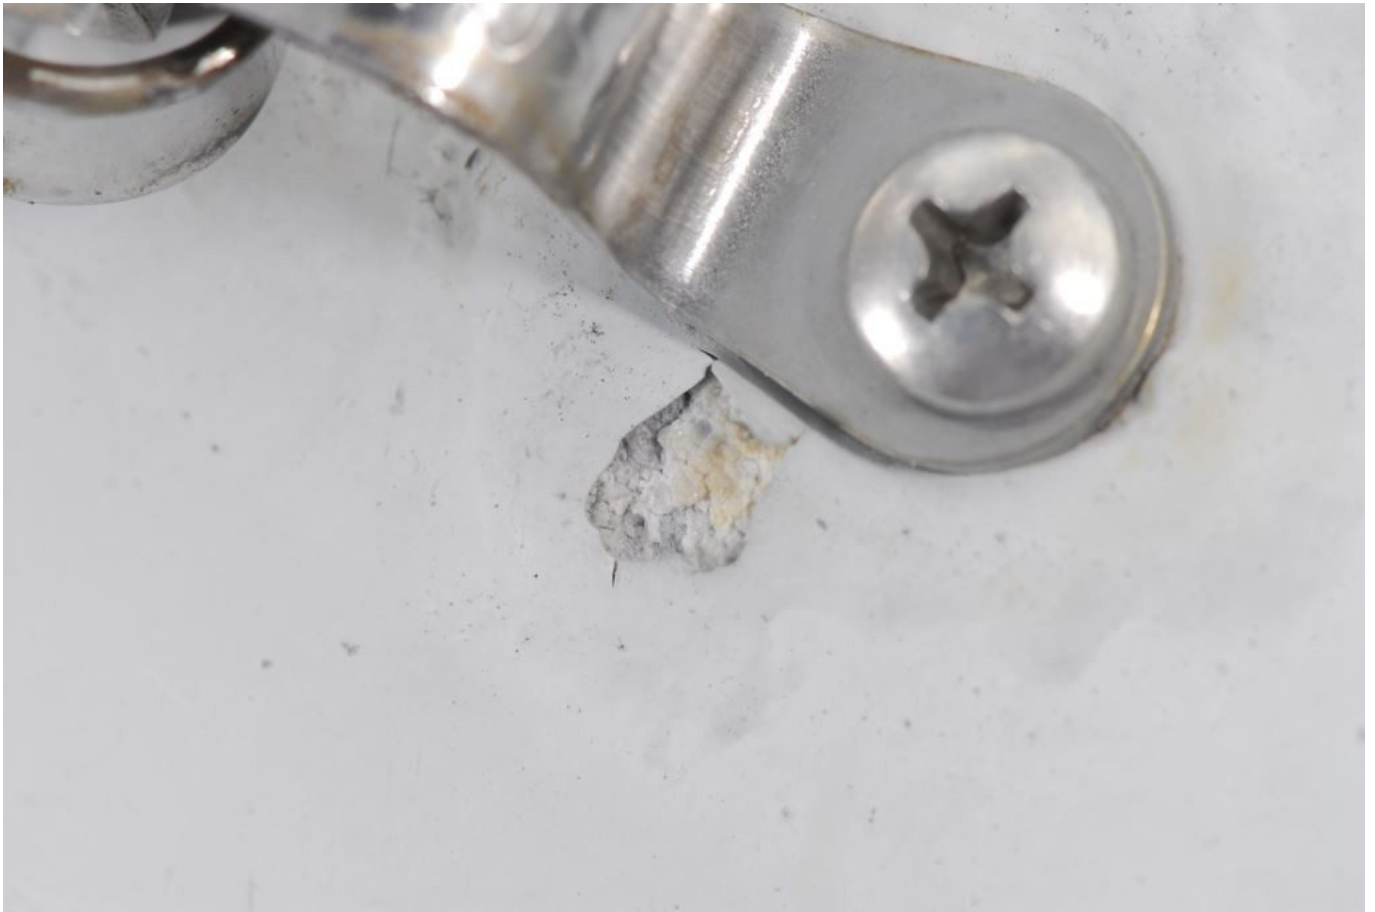
**Breaches in coatings over aluminum painted substrate are most often caused by hardware installations. This failure mode can be prevented if the hardware is bedded in polyurethane or other sealant.**

breaches the coating. Once the aluminum is exposed, the corrosion process begins. Among the most common causes of poultrice corrosion involves the installation of hardware or fasteners over a painted aluminum surface, antennas, brackets, pad eyes, even a single screw head is enough to breach the paint. For more on dealing with and preventing this phenomenon see Paint and Aluminum.
