# **Feature Article: Unraveling the Corrosion Mystery – Editorial: Technical Competence and Job Skills**

## **Unraveling the Corrosion Mystery**

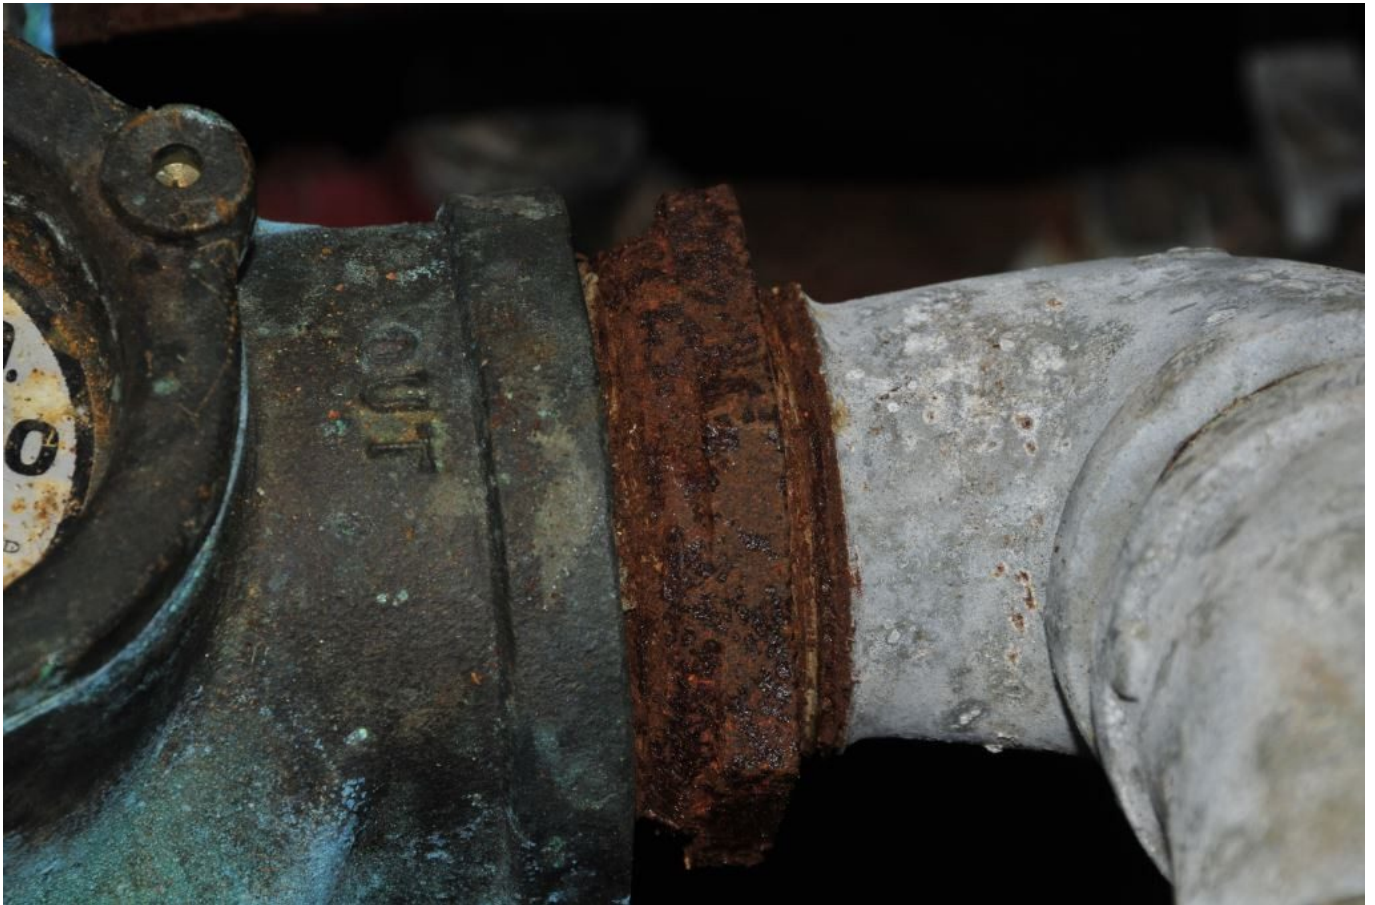
**Galvanic corrosion occurs when dissimilar metals are connected and exposed to an electrolyte like seawater. This strainer installation is a textbook example of what not to do, bronze, mild steel and galvanized steel. Not only are these metals incompatible, mild and galvanized steel should not be used for raw water applications.**

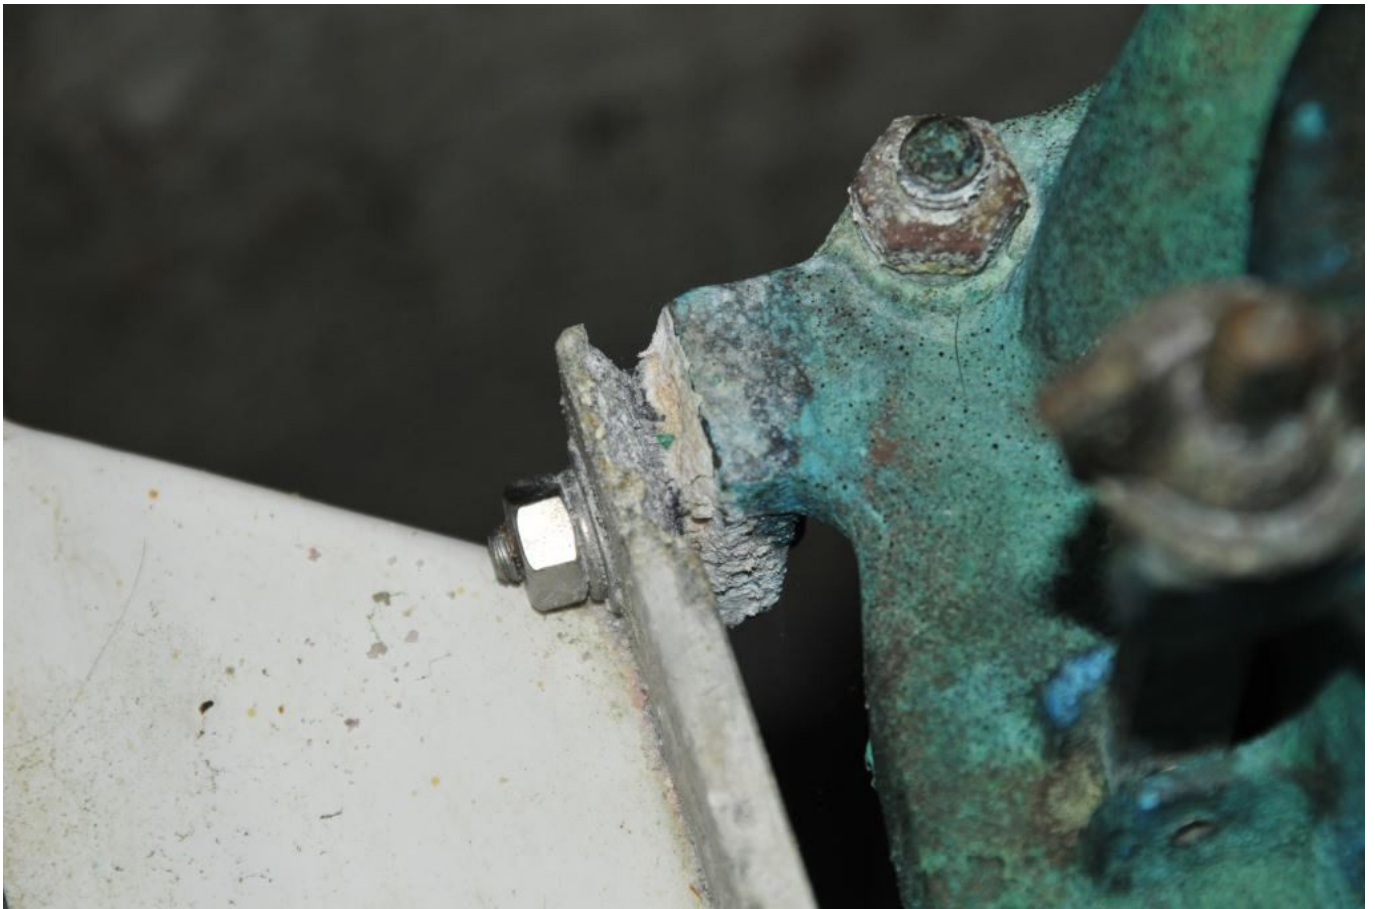
**Aluminum and copper alloys like bronze are among the least compatible metals. Here a bronze raw water strainer is supported by an aluminum bracket. Airborne moisture alone would be enough to cause a problem, albeit slowly, however, every time the strainer is serviced, the two metals get doused with seawater, accelerating the corrosion process.**

Examples of galvanic corrosion that can be found aboard the average vessel include brass hydraulic steering cylinders or bronze seawater strainers supported by aluminum brackets, aluminum fuel filter mounts plumbed with brass fittings (often used on outboard applications, where they are very much exposed to the elements), and to a lesser degree aluminum deck and mast hardware installed using stainless steel fasteners.

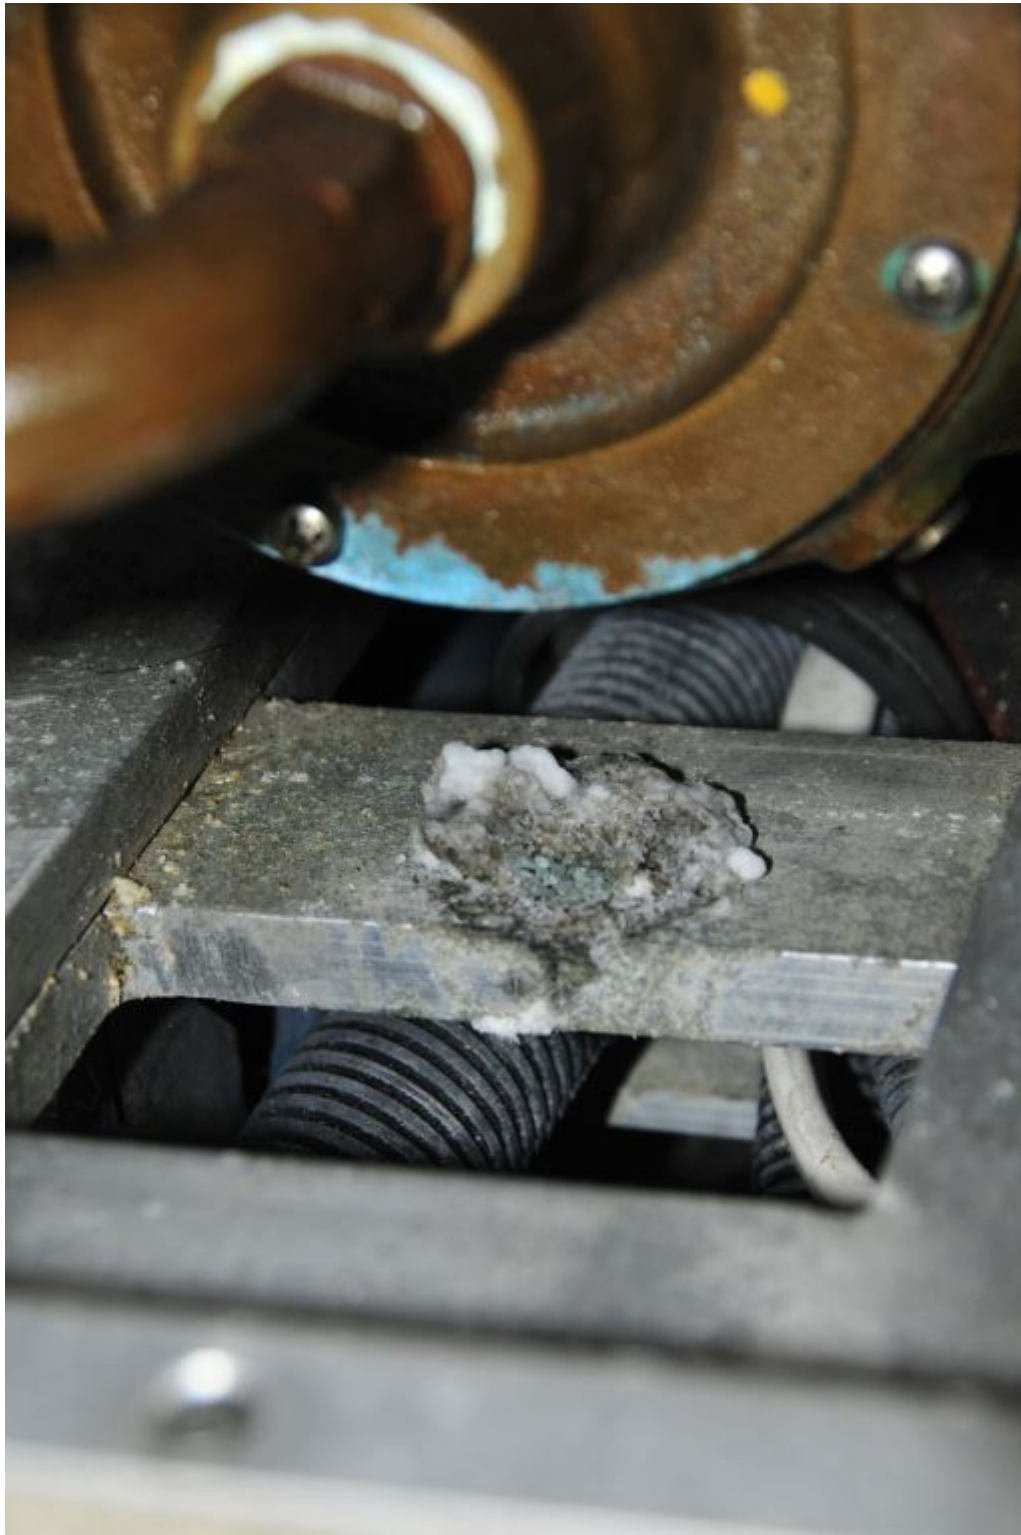
**In some cases galvanic corrosion can occur even if metals are not in direct contact with each other; here water dripping from a bronze pump has corroded its aluminum support structure.**

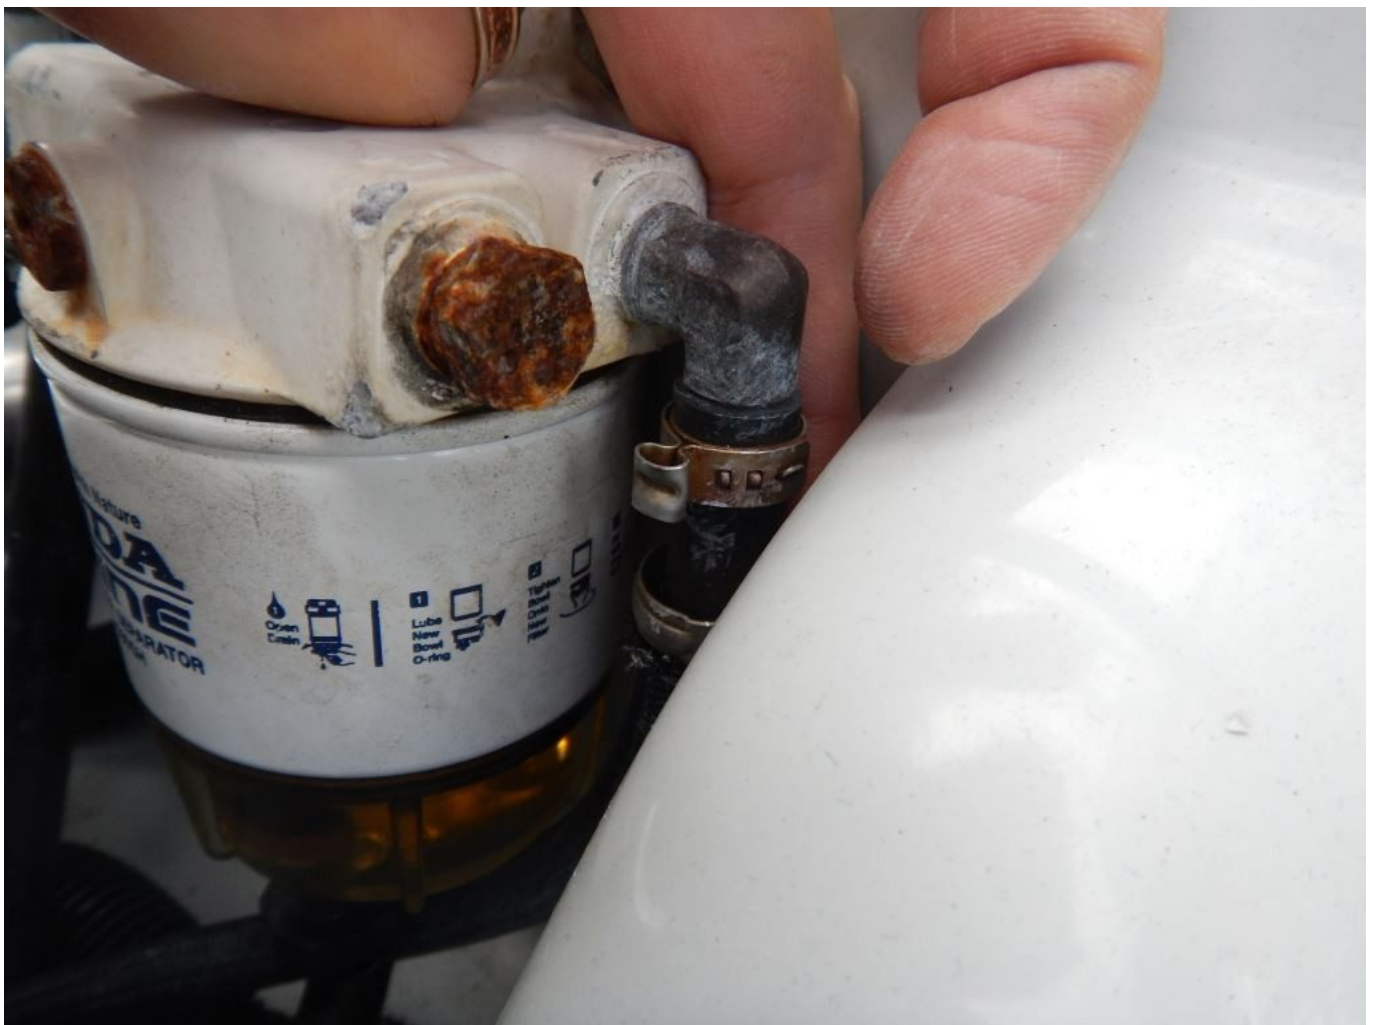
**Aluminum fuel filter housings like the one shown here are often plumbed with galvanically incompatible brass pipe to**

**hose adapters, primarily because the latter are readily available. Mild steel plugs have also been used on this installation, they too are inappropriate, all should be stainless steel, and installed with a fuel resistant thread sealant.**

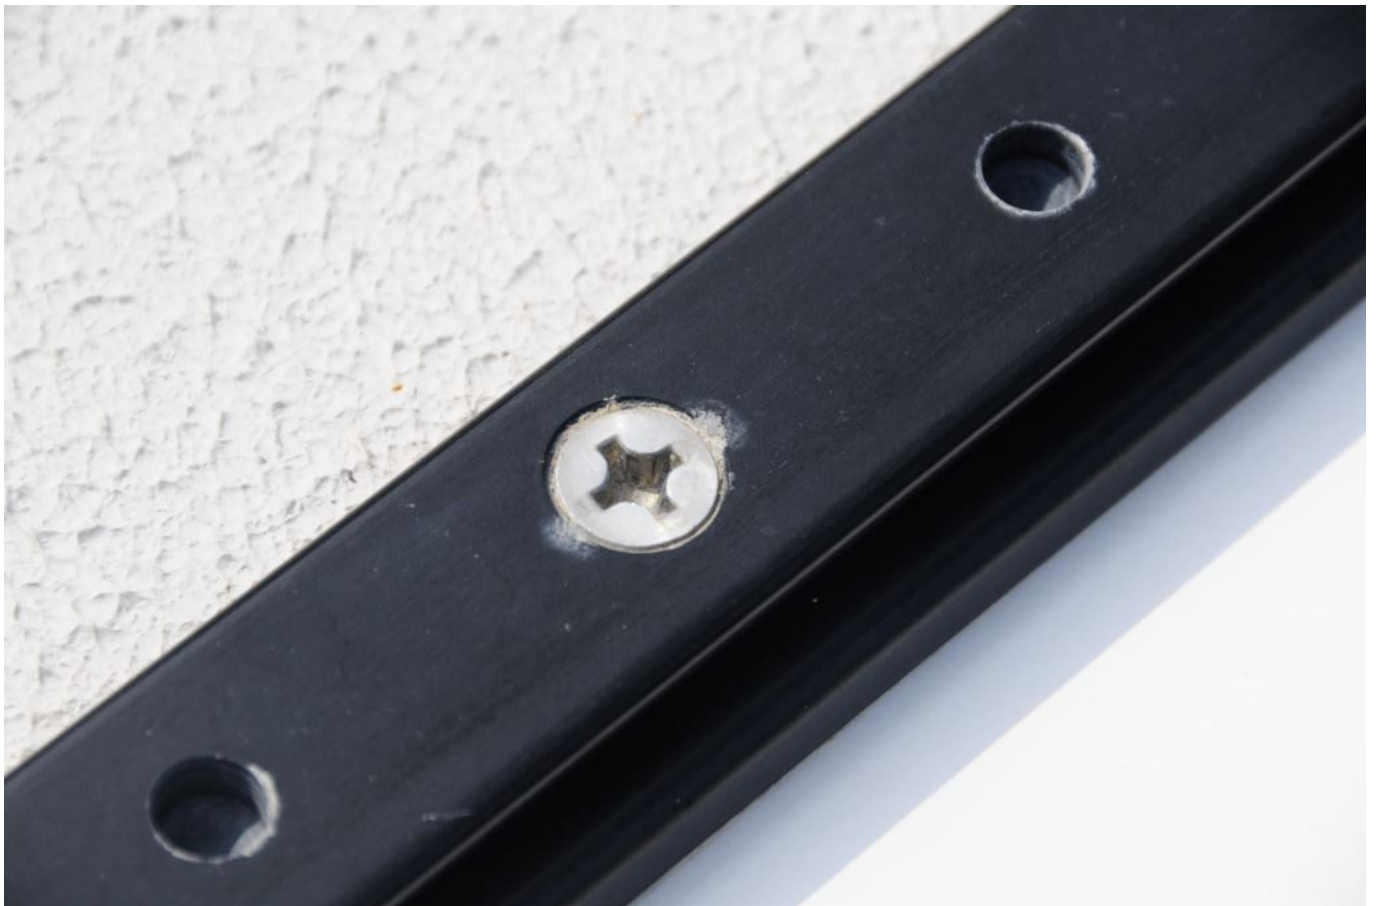
**While less of an issue than some other metal combinations, aluminum can suffer from galvanic corrosion when in contact with stainless steel and water. Here, a recessed stainless steel screw traps water, setting up a galvanic cell; corrosion has already begun to set in on this new nearly boat.**

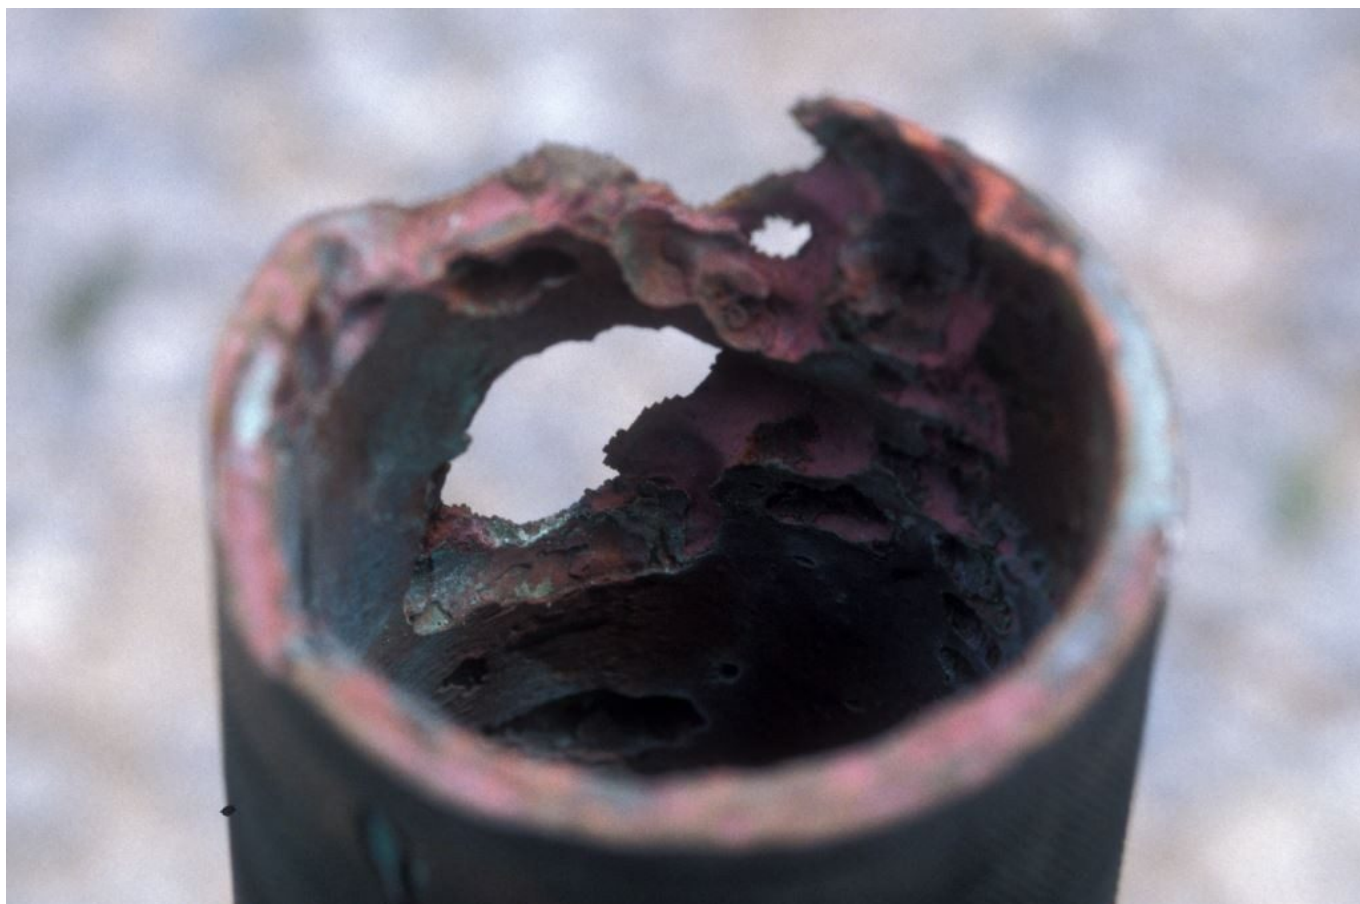
**This zinc-bearing brass stern tube is suffering from dezincification, evidenced by its pinkish hue, which is a form of galvanic corrosion.**

The most effective means of preventing galvanic corrosion is to avoid using dissimilar metals in scenarios where they will come into contact with each other, or where they are otherwise electrically connected. Where this is unavoidable, inserting between them an insulator, which can take the form of a non-conductive material, or in some cases another metal that is benign to both, is yet another form of galvanic corrosion prevention. Non-conductive materials include pre-fabricated fiberglass or epoxy-based sheet (avoid using non-reinforced plastics such as Starboard in highly loaded structural applications), while stainless steel is often used as an insulator between aluminum and copper-based alloys, between aluminum fuel tanks and brass (a copper alloy) valves for instance. While the two are technically still connected, the stainless steel bushing provides the necessary degree of isolation; however, this approach would not be acceptable for submerged or continuously wetted components, and under no circumstances should brass be used in raw or sea water applications, as it will suffer from yet another type of corrosion, dezincification.

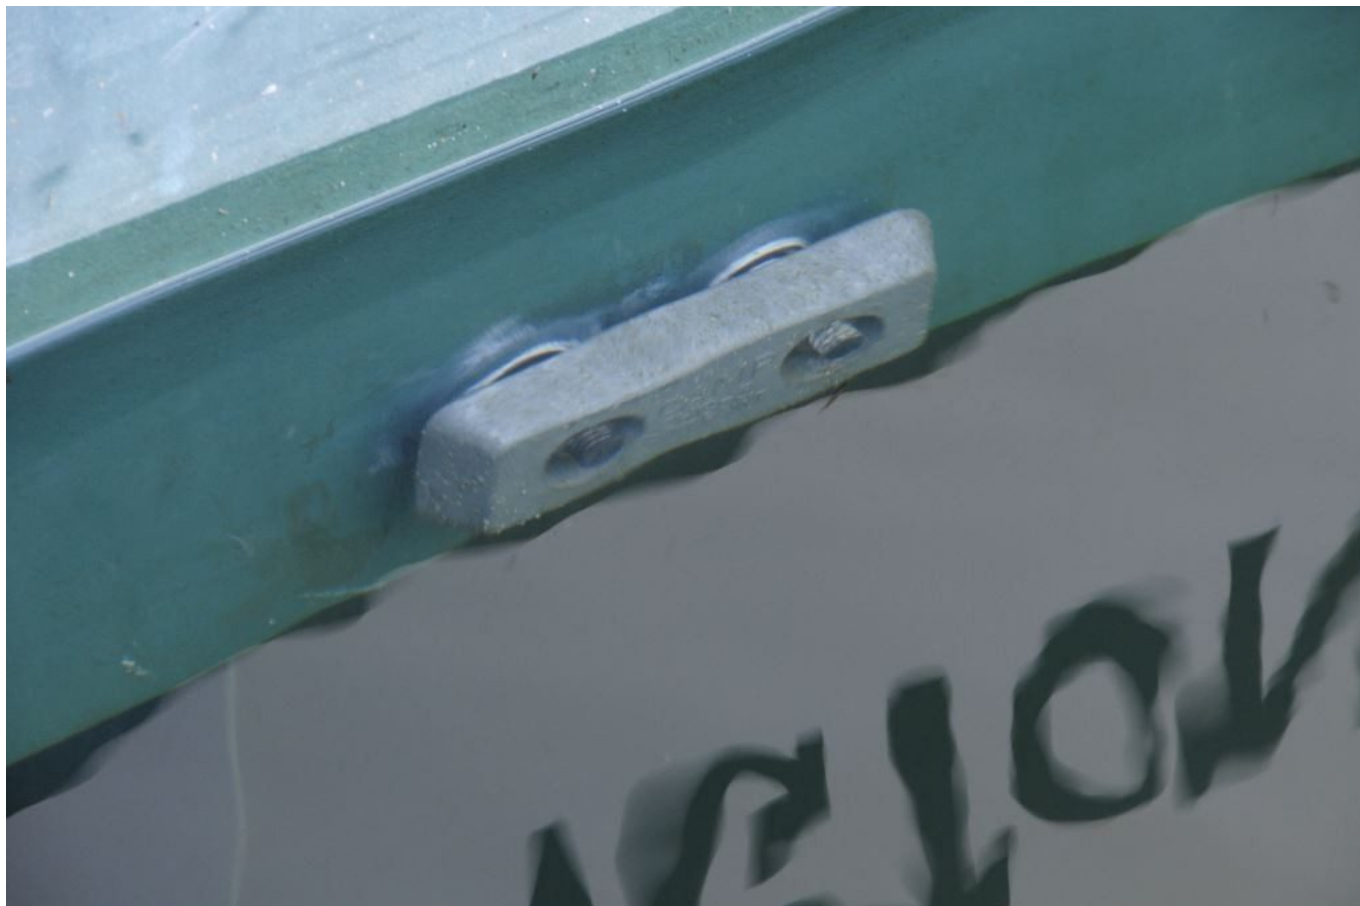
**Hull-mounted anodes, these may be zinc, aluminum or magnesium, can be connected to the bonding system, and thereby provide protection for all connected underwater metals.**

However, the very best example of galvanic corrosion is one that's intentional; sacrificial zinc anodes attached to underwater metals such as propeller shafts, through hull fittings, struts and rudders, and then to the vessel's bonding system , as well as heat exchangers. The ignoble zinc (zinc is one of three possible sacrificial metals that can be used for cathodic protection, the other two are aluminum and magnesium, zinc should only be used in seawater, and magnesium is suited only to fresh water; while aluminum can be used in fresh, brackish or sea water) corrodes, while protecting the metal to which it's attached. To learn more about anode selection, see [this article](#).

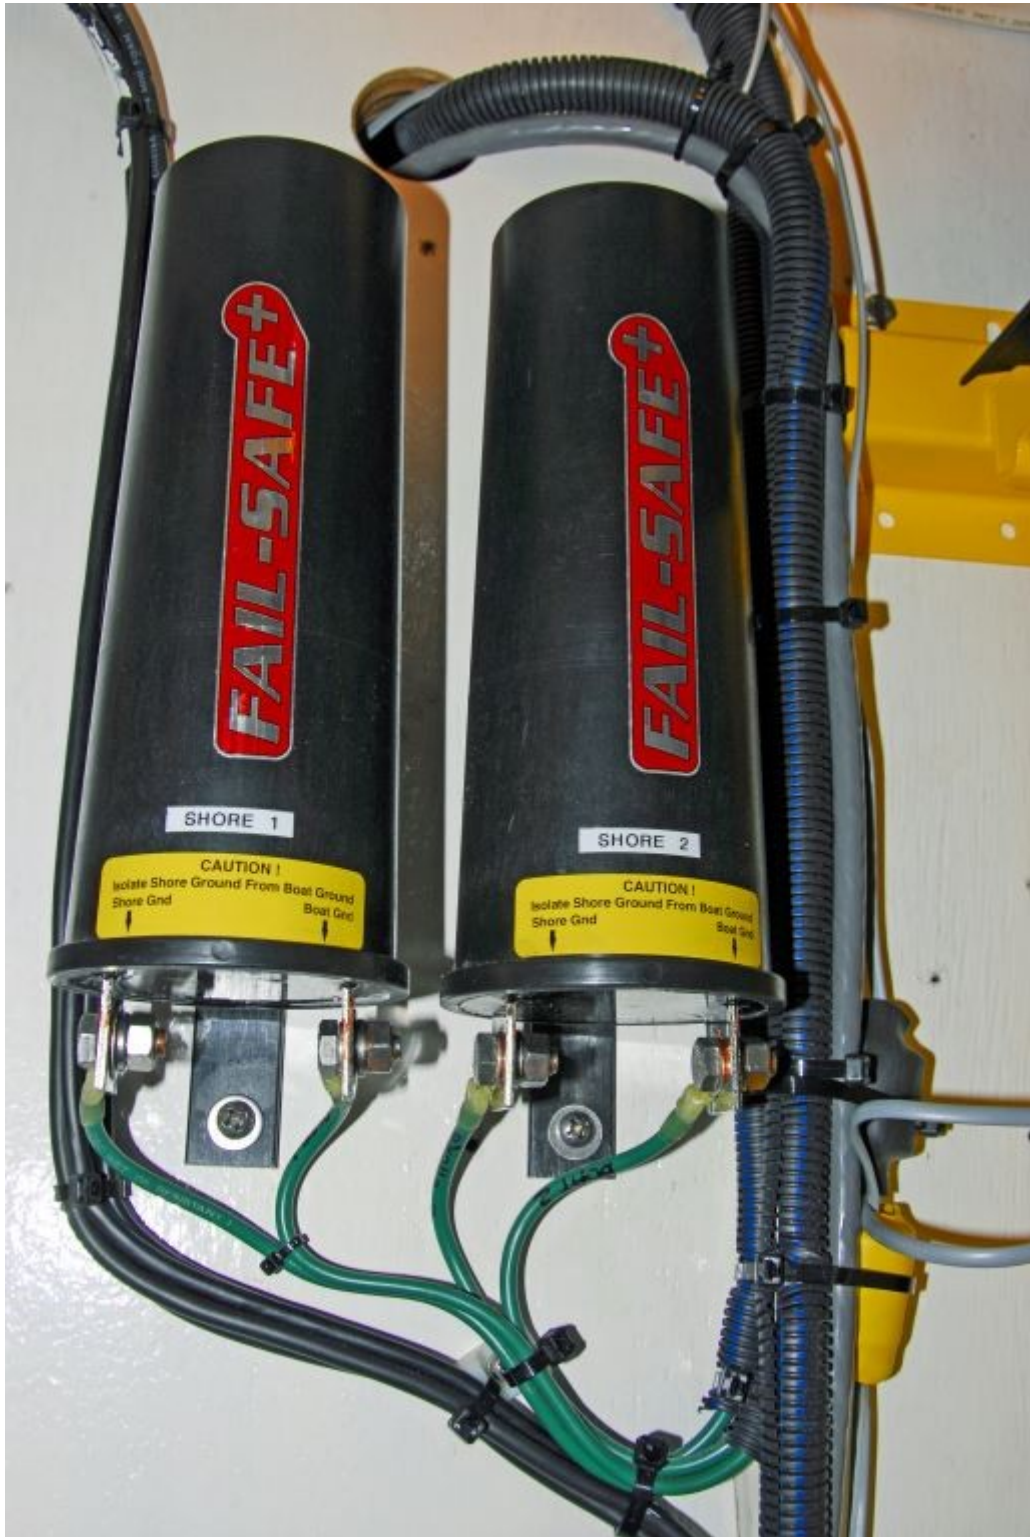
**Galvanic isolators are the first line of defense against galvanic corrosion that originates aboard nearby vessels. They are comparatively inexpensive, and easy to install, every vessel equipped with shore power should have one. The one you select should meet ABYC Standard A-28.**

Galvanic isolators block, up to 1.4 volts (which is above the typical galvanic corrosion voltage threshold), of DC voltage on the AC shore power safety ground wire, while still allowing AC fault current to flow freely, which is critical from a safety perspective. Because galvanic corrosion is DC in nature, the electrical interconnection of adjacent vessels is

prevented by the galvanic isolator. Isolation transformers take this a step further, by isolating *all* shore power connections, including the AC safety ground, between the vessel and the dock, thereby blocking any level of shore power cable-related inter vessel conductivity. Every vessel equipped with a shore power system should utilize one of these devices to prevent shore power safety ground-induced galvanic corrosion. Galvanic isolators are relatively inexpensive, while transformers are more costly; the latter however, offer additional benefits in addition to absolute isolation.

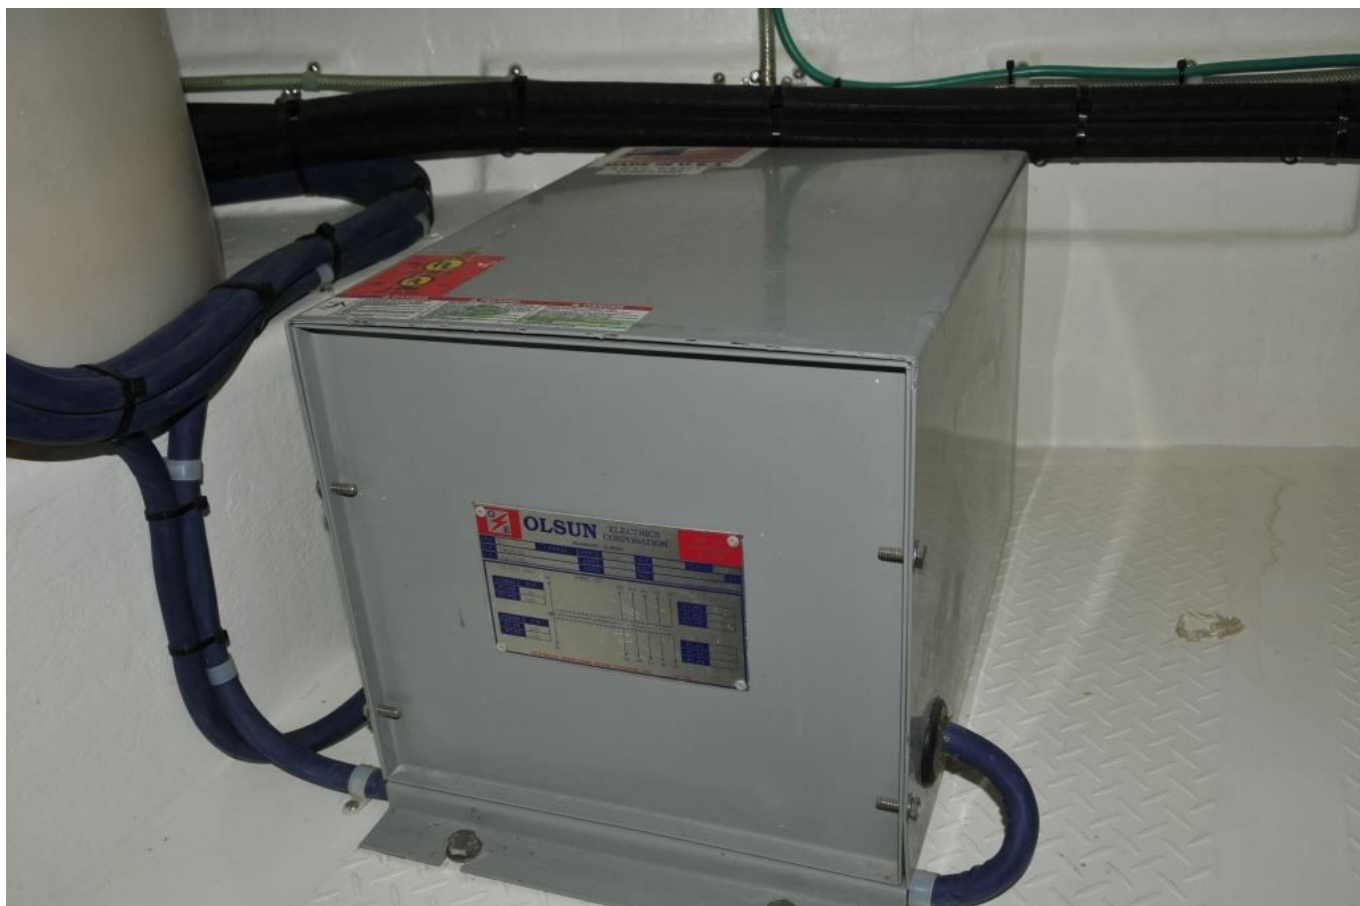
**Shore power transformers, when wired in isolation mode, provide an effective and all but impenetrable barrier to corrosion that originates on other vessels, or in places other than aboard the vessel on which they are installed.**

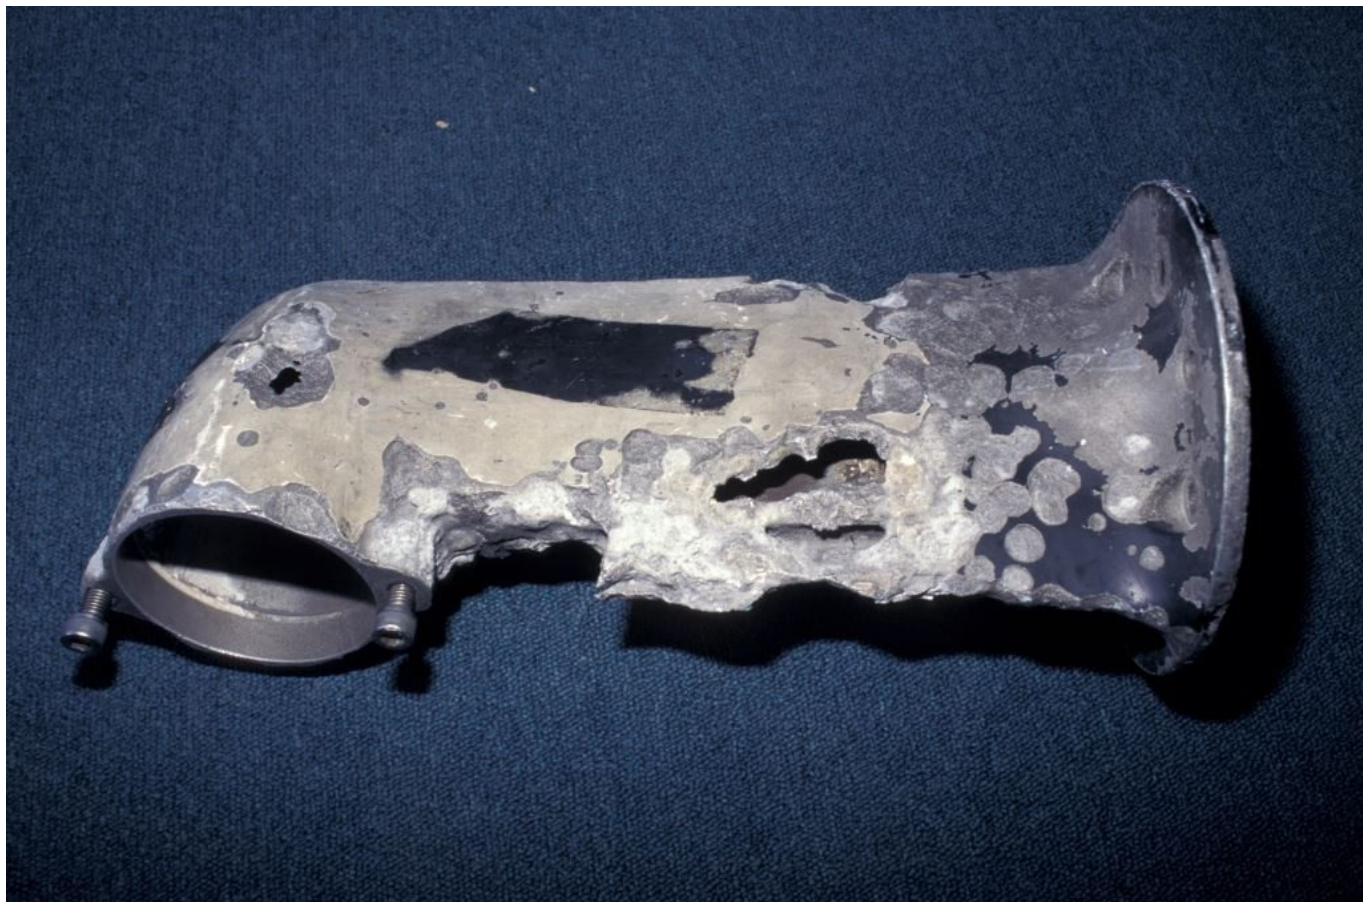
**Stray current corrosion is extremely destructive and it occurs comparatively quickly, it qualifies as a corrosion emergency, as it's capable of impacting a vessel's watertight integrity in a matter of days if not hours.**

This form of corrosion differs from galvanic corrosion in that it only occurs in the presence of an *outside* source of electricity; which is, with very rare exceptions, a vessel's own DC electrical system, or battery or battery charger. Shore power, i.e. AC voltage, does not, again with very rare exceptions, cause this type of corrosion. If it did, the DC voltage blocking ability of a galvanic isolator would be ineffective. Rare though it may be, when it does occur, AC-induced stray current corrosion is of greatest concern where aluminum-hulled vessels are concerned, as well as those equipped aluminum stern drives.

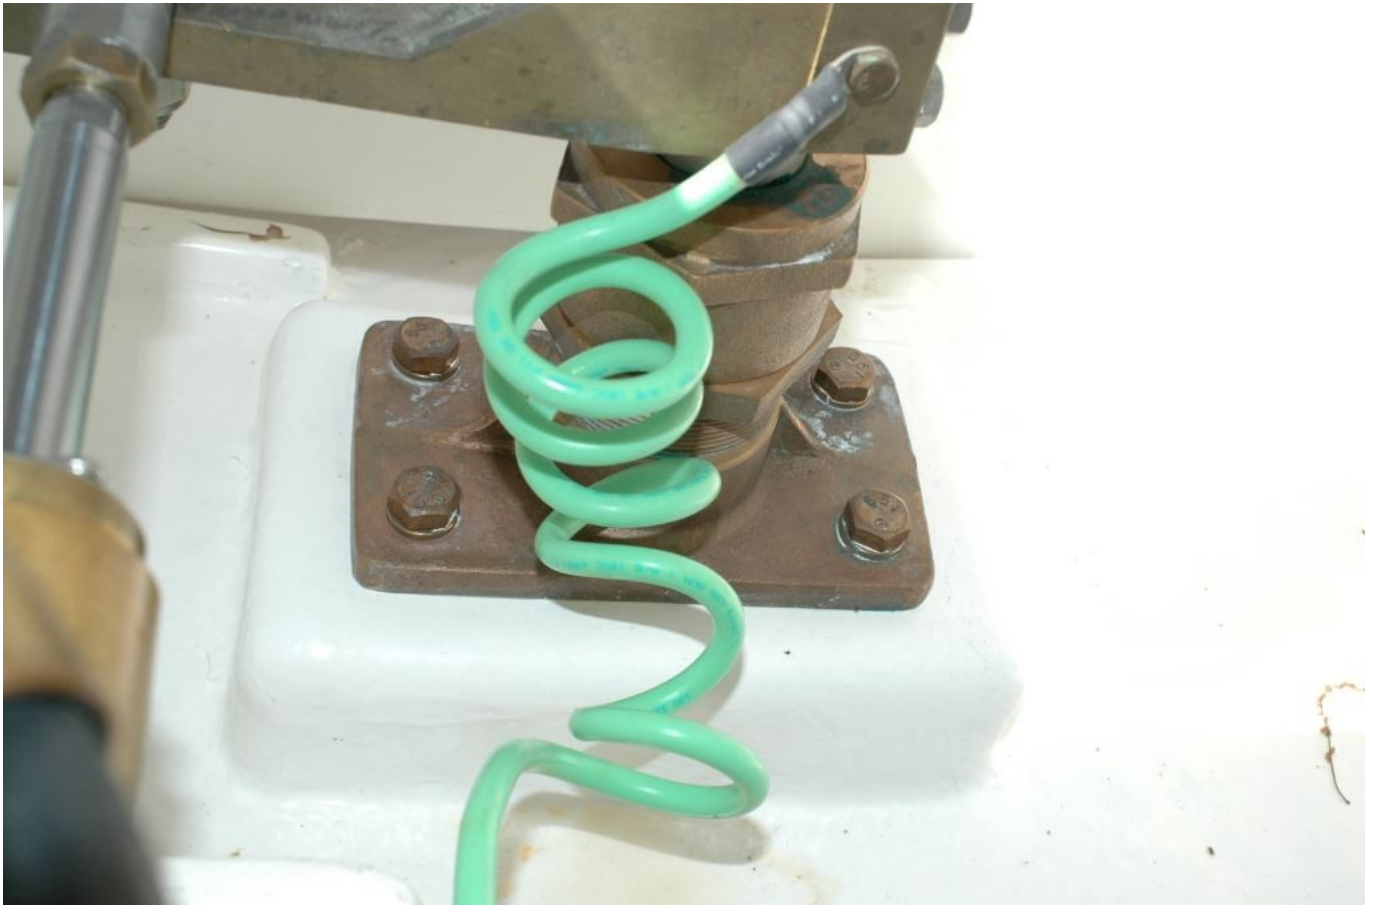
**Moving components, like the rudder post shown here, require some special techniques for making long-lasting bonding connections.**

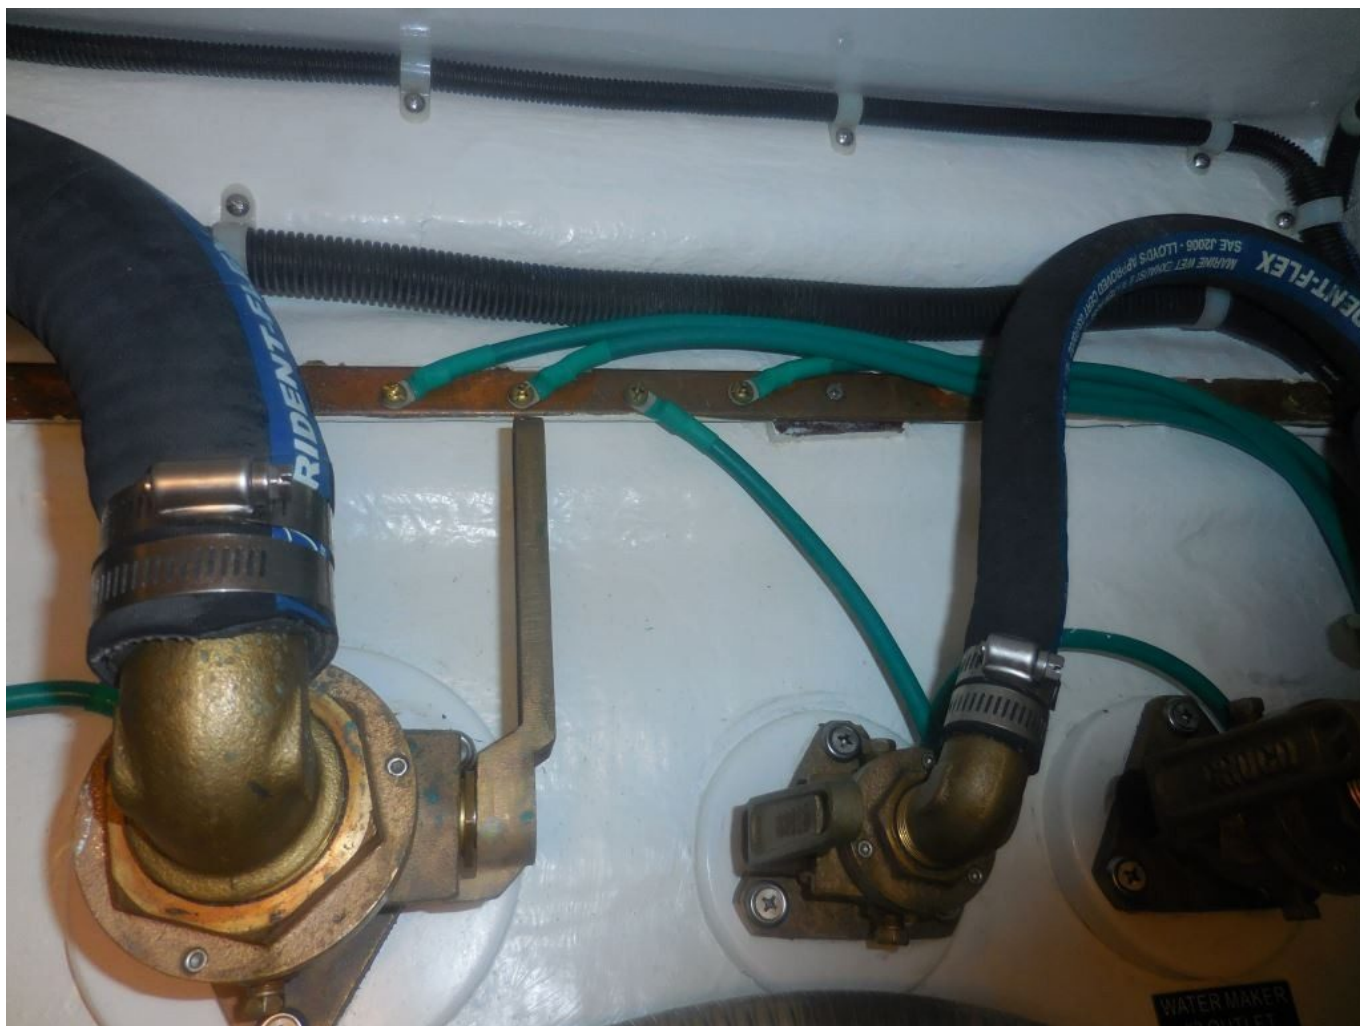
**Using the “home run” system, where each bonded component is wired directly to a bonding bus, is an ideal approach that typically yields low resistance connections.**

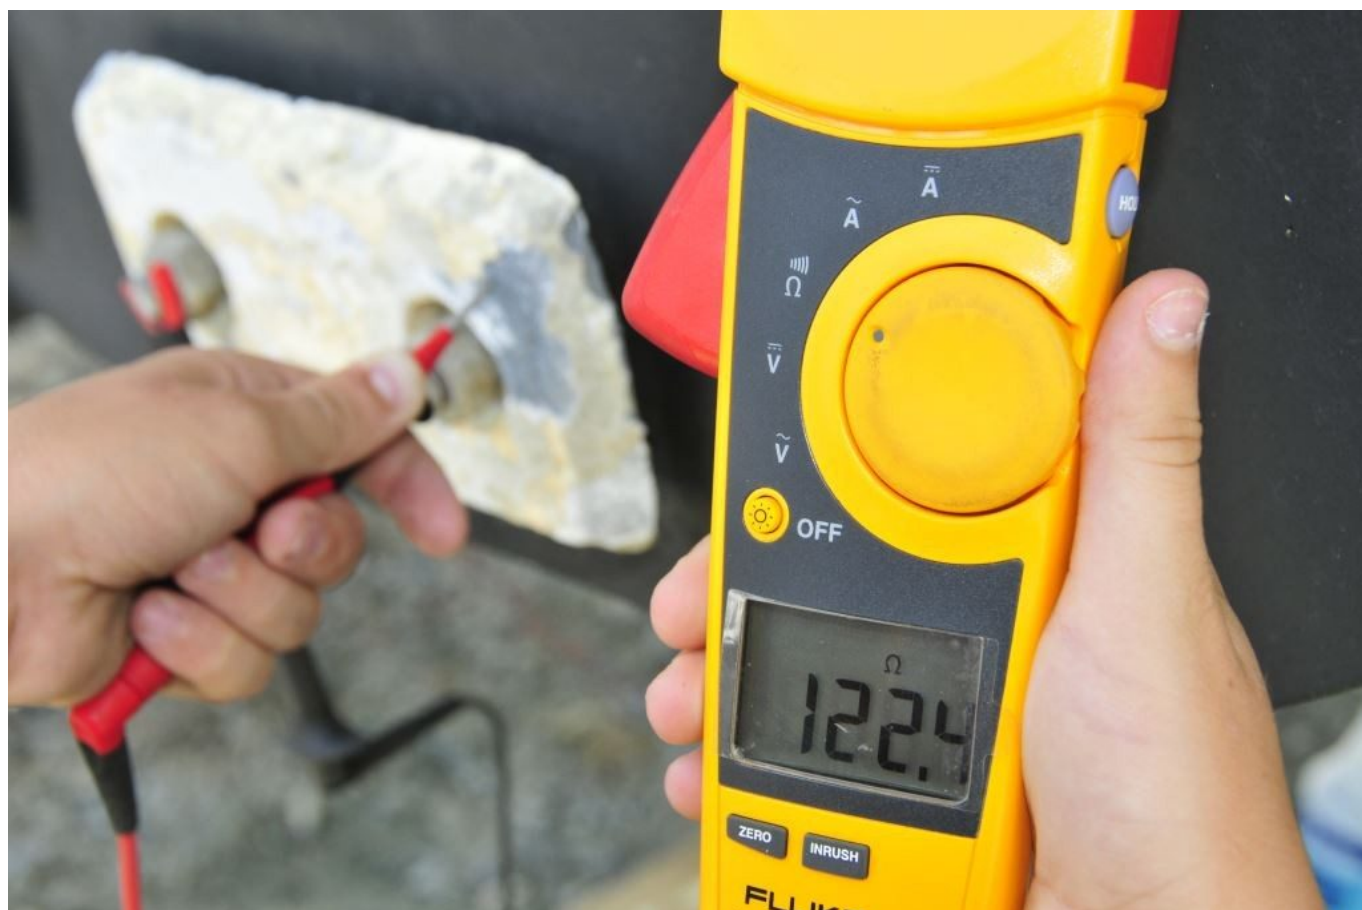
**Resistance between protected underwater metals and sacrificial anodes must be kept to a minimum, no more than one ohm (this one fails to meet that standard), in order for protection to be afforded.**

approach that works provided a handful of guidelines are followed. Chief among these is ensuring low resistance connections are made between bonded components and hull anodes, the standard for which, established by ABYC, is stringent indeed, a maximum of just one ohm.
