The Power and Peril of Stainless

Despite stainless steel's deserved reputation for corrosion resistance, longevity, and durability, this alloy is prone to a variety of failures depending on its actual composition and application in the marine environment.

**Text and photographs
by Steve D'Antonio**

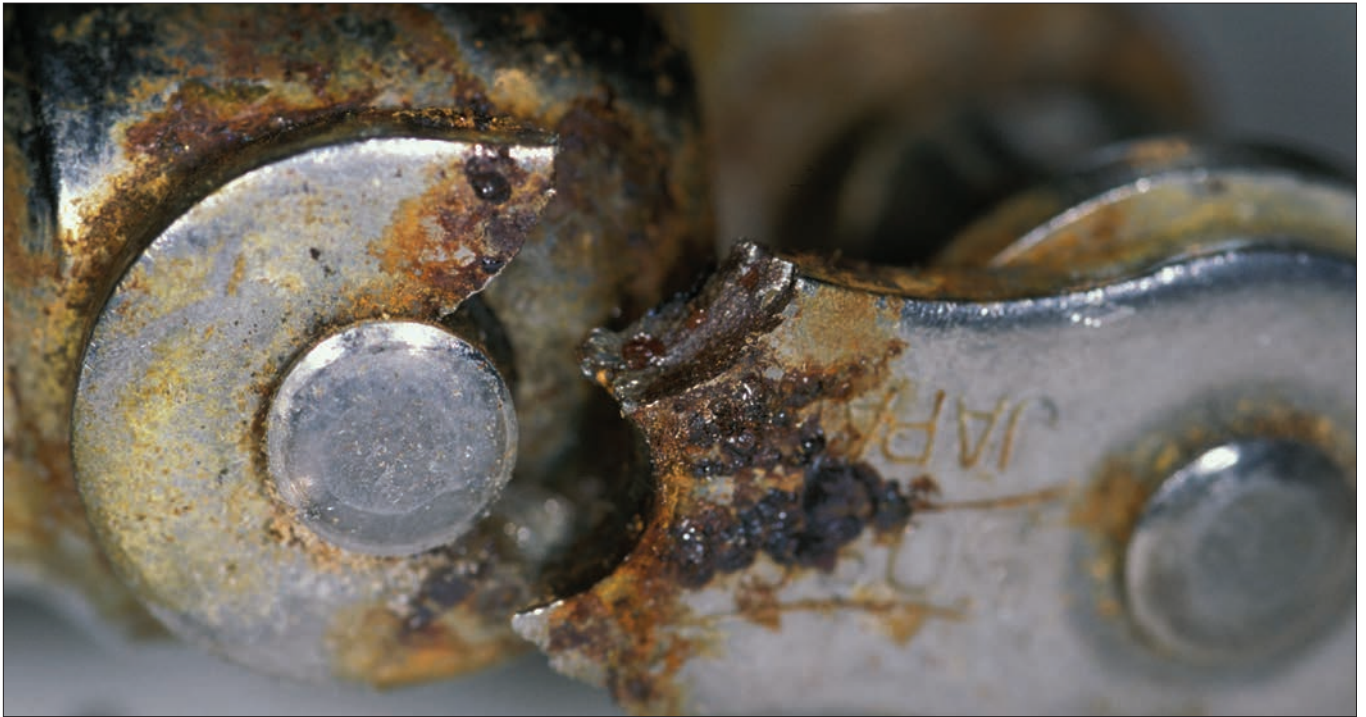
Above—Even good-quality 300-series stainless steel, such as this steering chain, can suffer crevice corrosion and microcracking, and then ultimate structural failure.

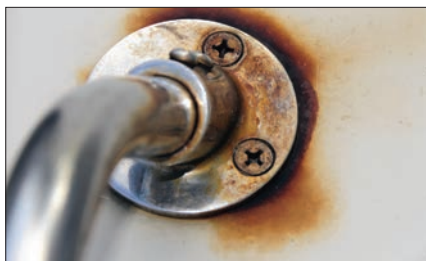
Right—Rust stains running out from under or around stainless hardware nearly always portend crevice corrosion.

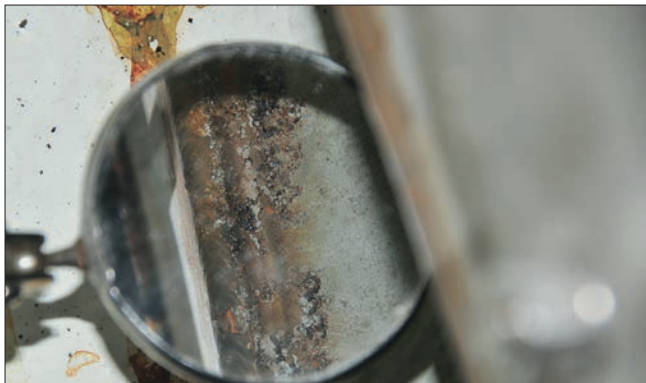
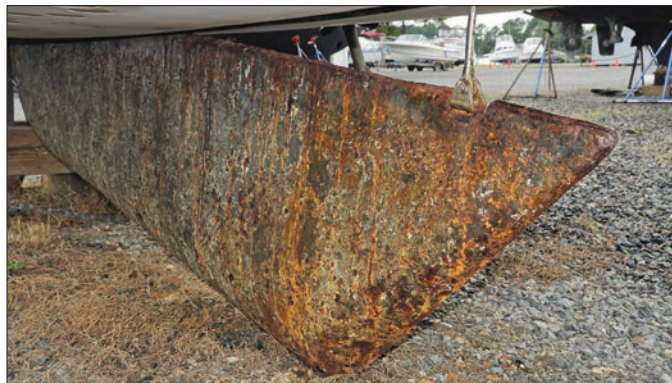
Left—This stainless steel water tank, built of 304 alloy, corroded and began leaking after just four years of service because it lacked the necessary resistance to corrosion. Uniform discoloration adjacent to the welds also points to weld migration, a result of using inappropriate higher-carbon stainless steel. Water tanks fabricated from 316L (low-carbon) stainless steel alloy are unlikely to fail. **Right**—Raw iron has little resistance to corrosion and thus few appropriate applications in a marine environment. Predictably, this cast iron centerboard rusted after its coating deteriorated.

Recently, an exchange with a colleague reminded me how misunderstood stainless steel is, even within the industry. The broker representing the vessel I had inspected was dumbfounded when I told him its stainless steel water tanks were corroding, leaking, and had to be replaced—a costly proposition, particularly for a four-year-old vessel.

The error is common: the tanks had been built from 304 alloy, which is not the most corrosion-resistant stainless choice and is therefore inappropriate for a water tank. (See page 51 for an explanation of 300-series stainless steel.) Yet the tank was clearly labeled as 304 series stainless steel alloy—proof, I believe, that no subterfuge was intended. It was simply an error in design or selection that no one on the boat's build or maintenance crews caught. It seemed adequate that the tank was stainless, thought to be impervious to decay or corrosion.

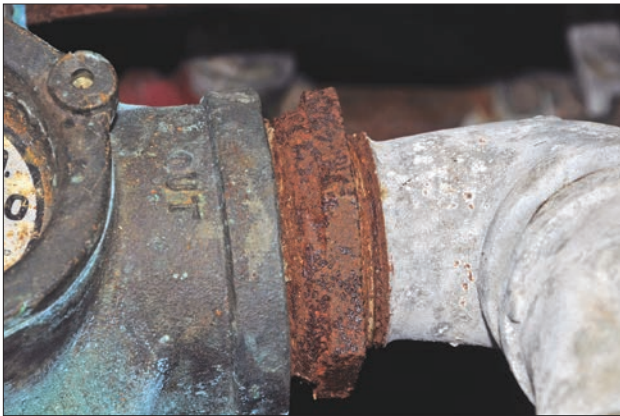
Combining mild steel, galvanized steel, and bronze in this raw-water application can lead to a variety of corrosion-induced failures.

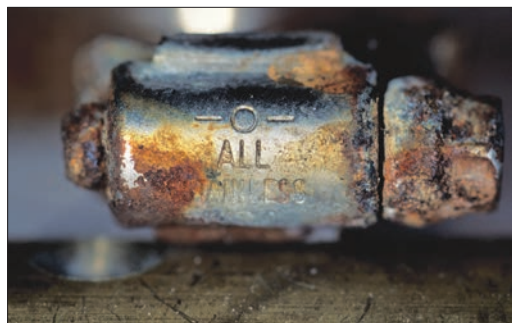
Above left—Although this hose clamp is labeled “ALL STAINLESS,” the screw is mild steel, as the rust reveals.

Experienced pros who have handled thousands of hose clamps and fasteners of stainless and anodized mild-steel can discern the difference between the two, as plated-steel screws often have a slightly different hue than stainless steel ones. The rest of us have to rely on a magnet.

Hose clamps with plated mild-steel screws will come to grief rather quickly in the marine environment, even when not directly exposed to seawater; the same can be said of some varieties of genuine all-stainless steel clamps (see the photograph of a deteriorated all-stainless clamp below). Although many marine engines have “automotive” mild-steel-screw-equipped clamps, some now have all-stainless constant-tension clamps, which are better mechanically as well as more corrosion resistant. Elsewhere aboard, test with a magnet to determine marine suitability; if it is attracted to *any* part of the clamp, replace the clamp with an all-stainless steel model designed for marine applications.

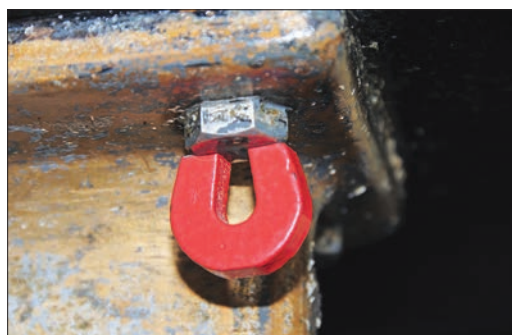
Left—One way you can identify less-corrosion-resistant stainless alloys, like this 18-8 fastener: they are mildly magnetic.

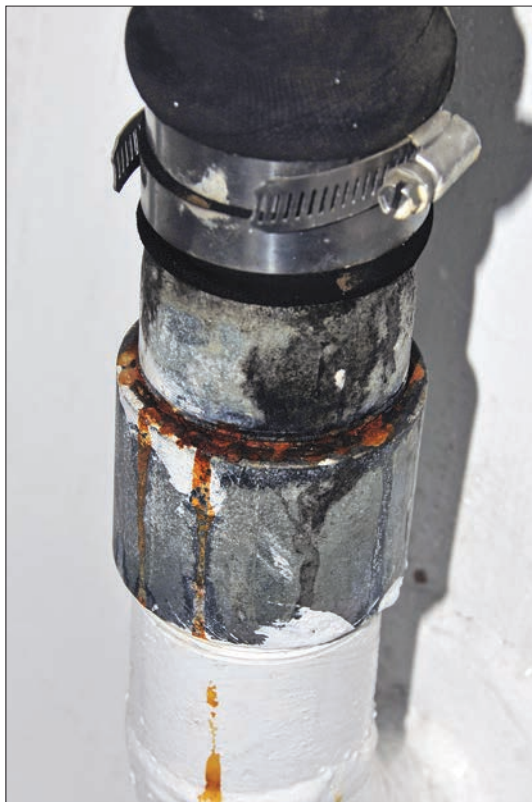
Occasionally seen aboard steel vessels, galvanized steel plumbing will have a limited life span. Because the inside of the pipe is inaccessible and unable to be primed and painted, stainless steel or reinforced plastic is more appropriate here.

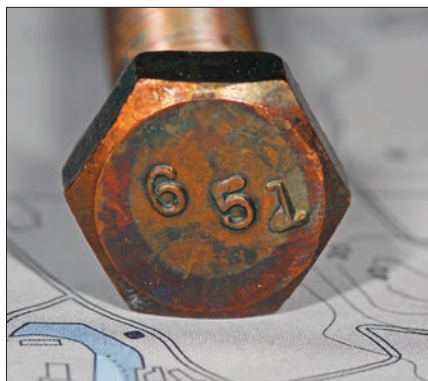
Stainless steel is not ideal in submerged fastener applications. One alternative is copper alloy such as this hex-head bronze bolt.

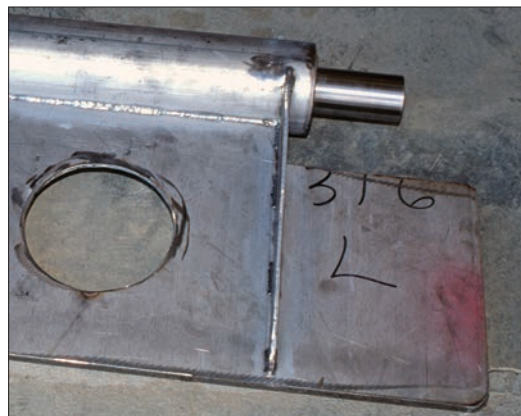
Welded components such as this rudder armature should be fabricated of 316L series stainless, a corrosion-resistant alloy low in carbon and thus less prone to weld decay. The stock should be made of an even more corrosion-resistant shaft stock alloy.

Note that 304 or 316 stainless to be welded must include the suffix "L," as in 304L or 316L, denoting a lower carbon content than in ordinary stainless steel; lower carbon helps prevent weld migration. I'll discuss this later.

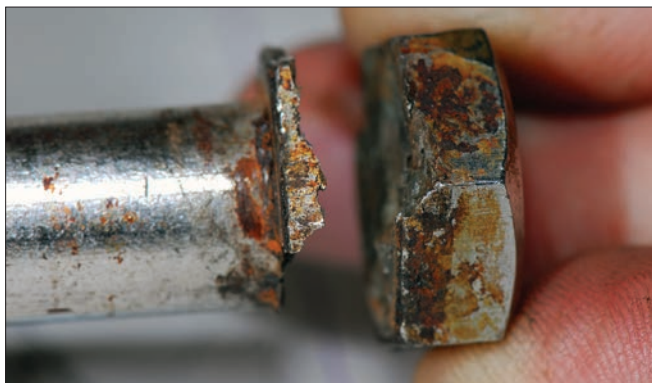
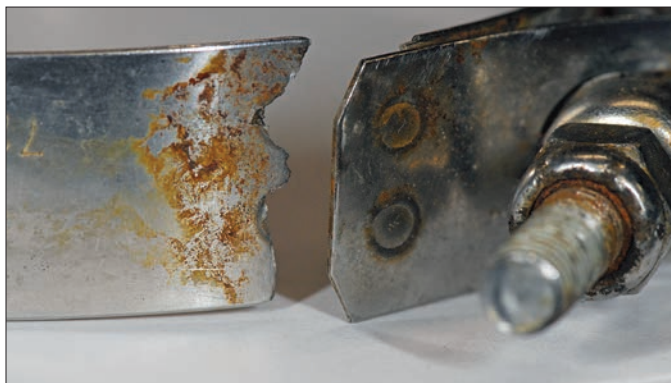
Left—This bolt's head and shank parted ways, likely from a combination of a low-quality manufacturing process and subsequent stress corrosion. **Right**—Crevice corrosion, occurring where the metal is simultaneously starved of oxygen and exposed to stagnant water in a bilge or stuffing box, is a common failure mode on T-bolt clamps like this one, manufactured with a metal fold that traps water.

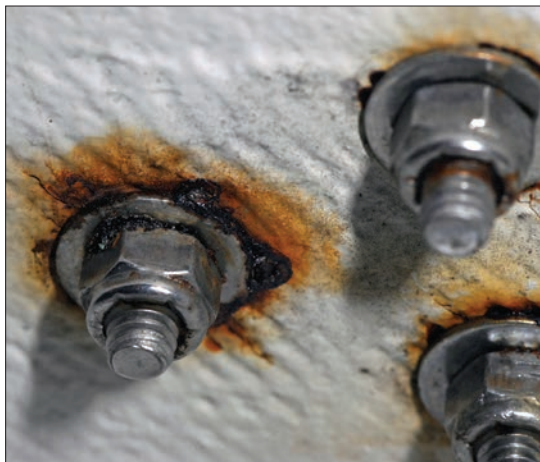
As shown here, crevice corrosion also manifests where fasteners or deck hardware penetrate a cored or solid deck, allowing water to intrude and stagnate around the metal component. Don't rebed these components on the interior, as the bedding will trap water in the bore hole.

This type of corrosion also occurs on deck where water migrates into penetrations through which stainless

steel fasteners pass. Exacerbating this problem is the common practice of bedding the *inside* portion of hardware—washers and nuts—virtually guaranteeing that when deck bedding fails, water will intrude and then stagnate in the void. Without inside bedding, water is more likely to drain, reducing the likelihood of crevice corrosion and core saturation; and the annoying drip

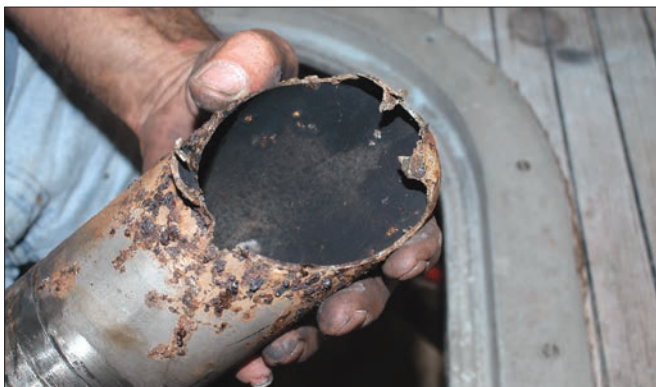
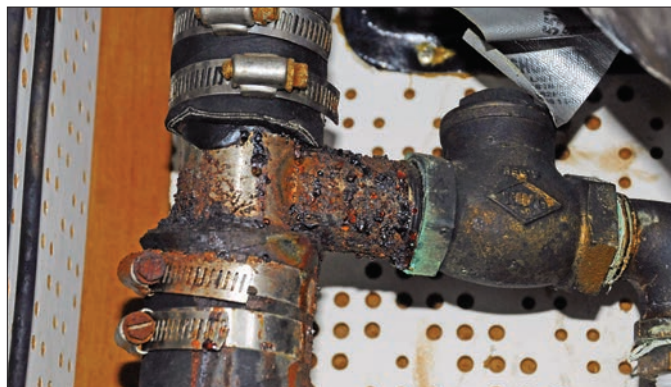
Left—Corrosion emanating from weld decay, also known as weld migration, on this stainless steel exhaust system led to complete failure. **Right**—Susceptibility to crevice corrosion makes stainless plumbing less than ideal for raw-water applications. In this case, the problem is amplified by the use of the incorrect high-carbon stainless alloy.

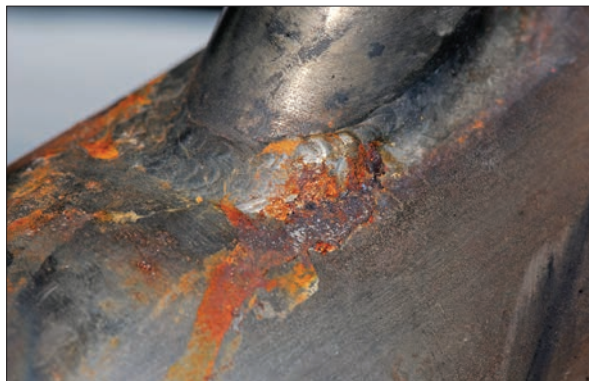
The hard-to-identify characteristics of this failure, which is limited to the weld material rather than the parent metal, are most likely caused by intergranular corrosion.

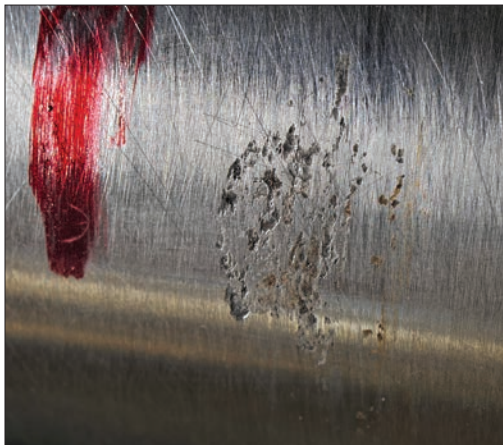
Slight misalignment caused this shaft to be stressed at a supporting bearing, which led to stress corrosion cracking and the pitting visible here, after just 400 hours of operation over six months in tropical water. High friction and poor water flow raised the temperature of the alloy. Combined with exposure to seawater, these conditions created an ideal environment for this type of corrosion.

During shaft removal to diagnose and replace the failed bearing, we found corrosion where stuffing box packing made contact with the shaft and where the shaft was supported by the added bearing. We confirmed the shaft alloy by sending a sample to a

lab for analysis. The percentage of each alloy was within the manufacturer's specifications, ruling out an inferior alloy as the culprit.
